NZ 60

Apia

29 July 2000

“A FREE LESSON”

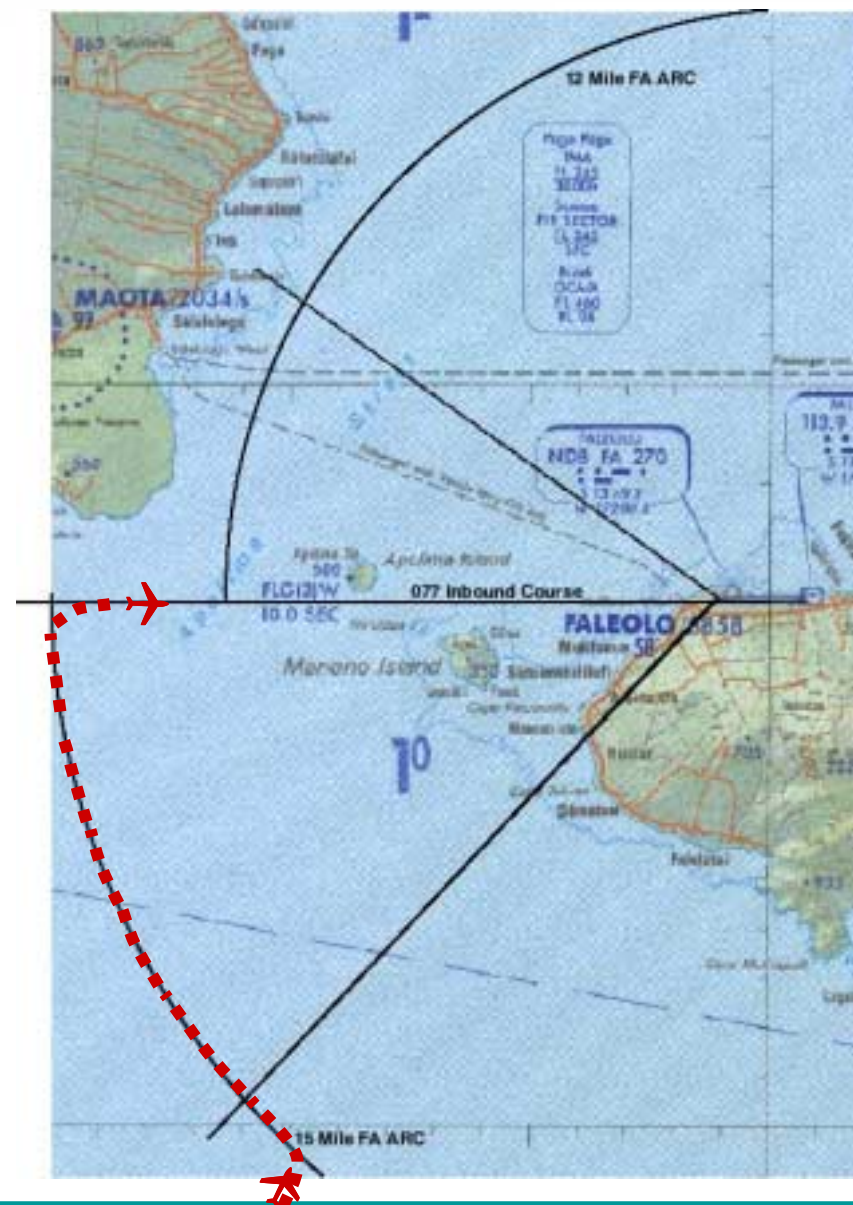
The Localizer 077° inbound course was captured at 14 miles, Flap 1 was selected, speed 220 KIAS

One second after APPROACH was armed the autoflight system captured the glideslope

Approximately 5 seconds after glideslope capture the rate of descent increased

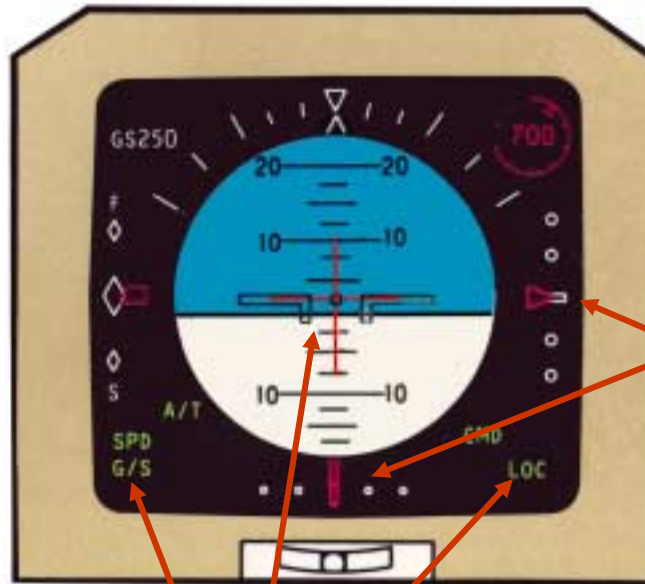
Flight Deck instruments confirmed

the aircraft to be both
“on glideslope” and “on localiser”

**The ILS was identifying correctly
throughout the approach**

the aircraft had captured both the glideslope and localiser

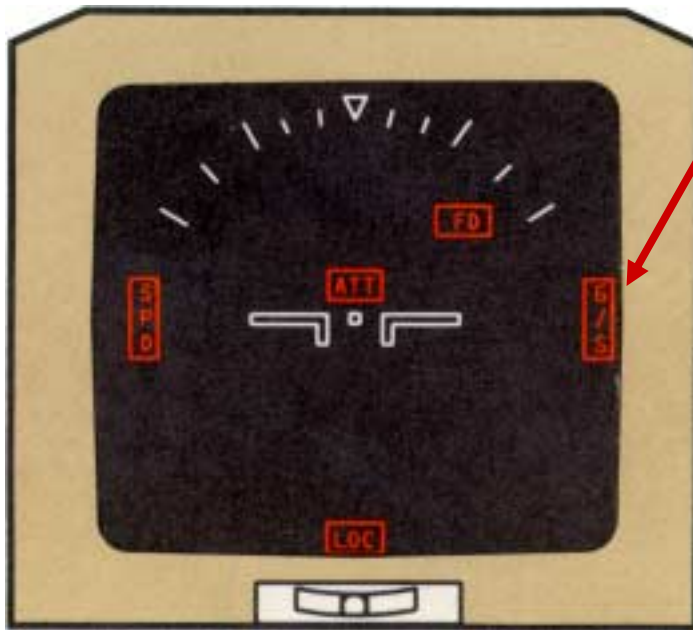
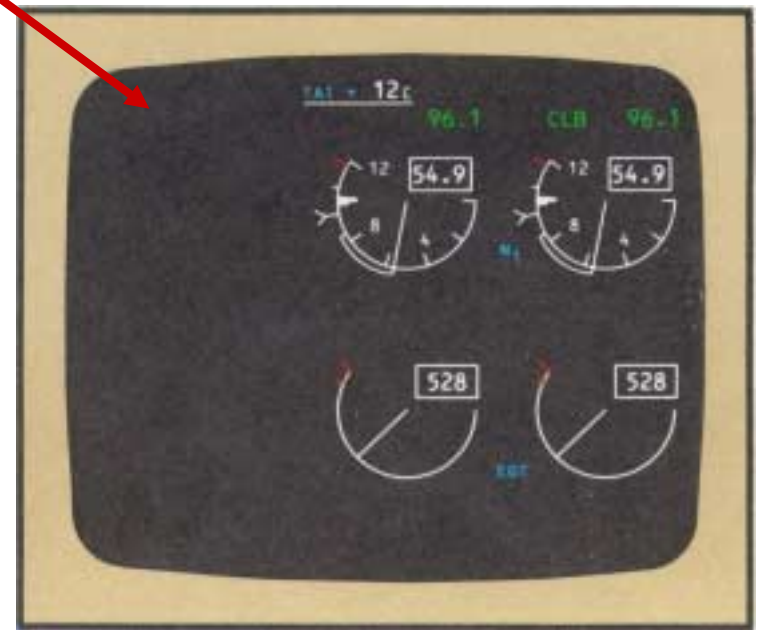
At no stage during the first approach, overshoot or second approach were any “flags” (boxes) or EICAS messages displayed.

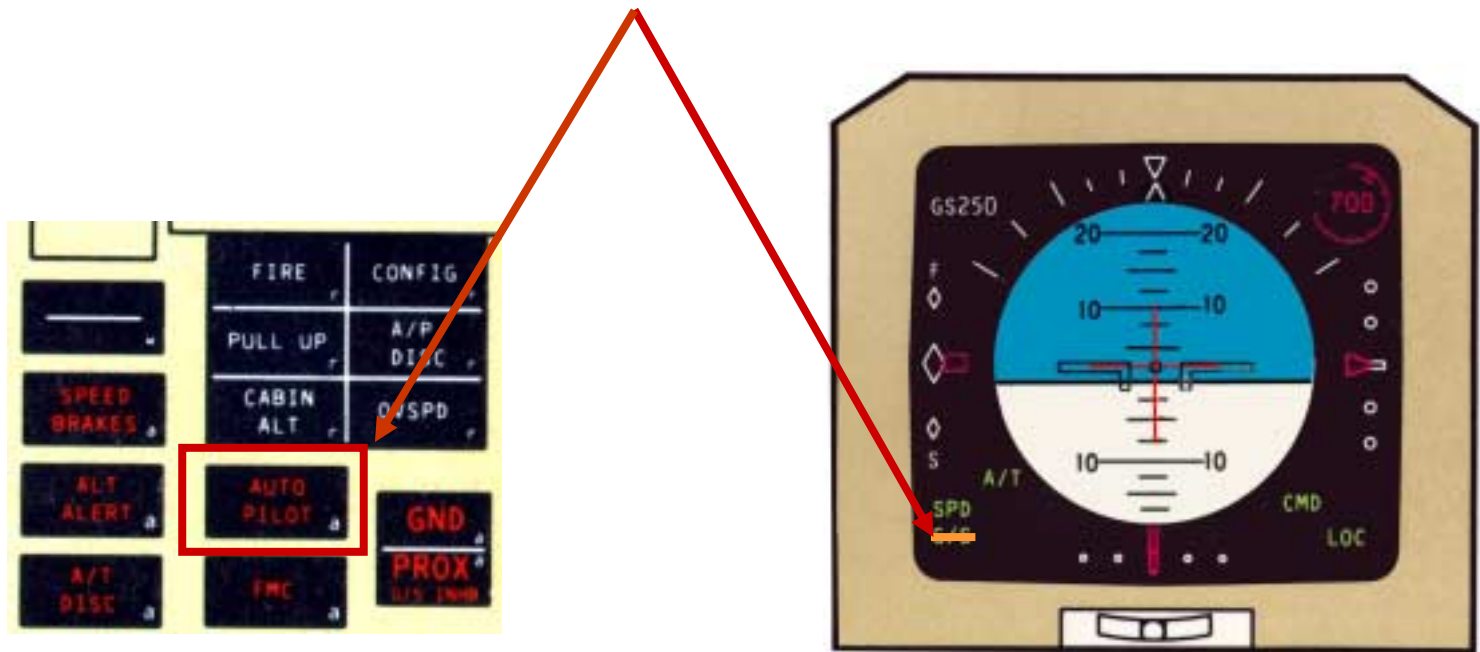
Nor was there any autopilot warning,

or Flight Mode fault indicated (amber line appearing through G/S)

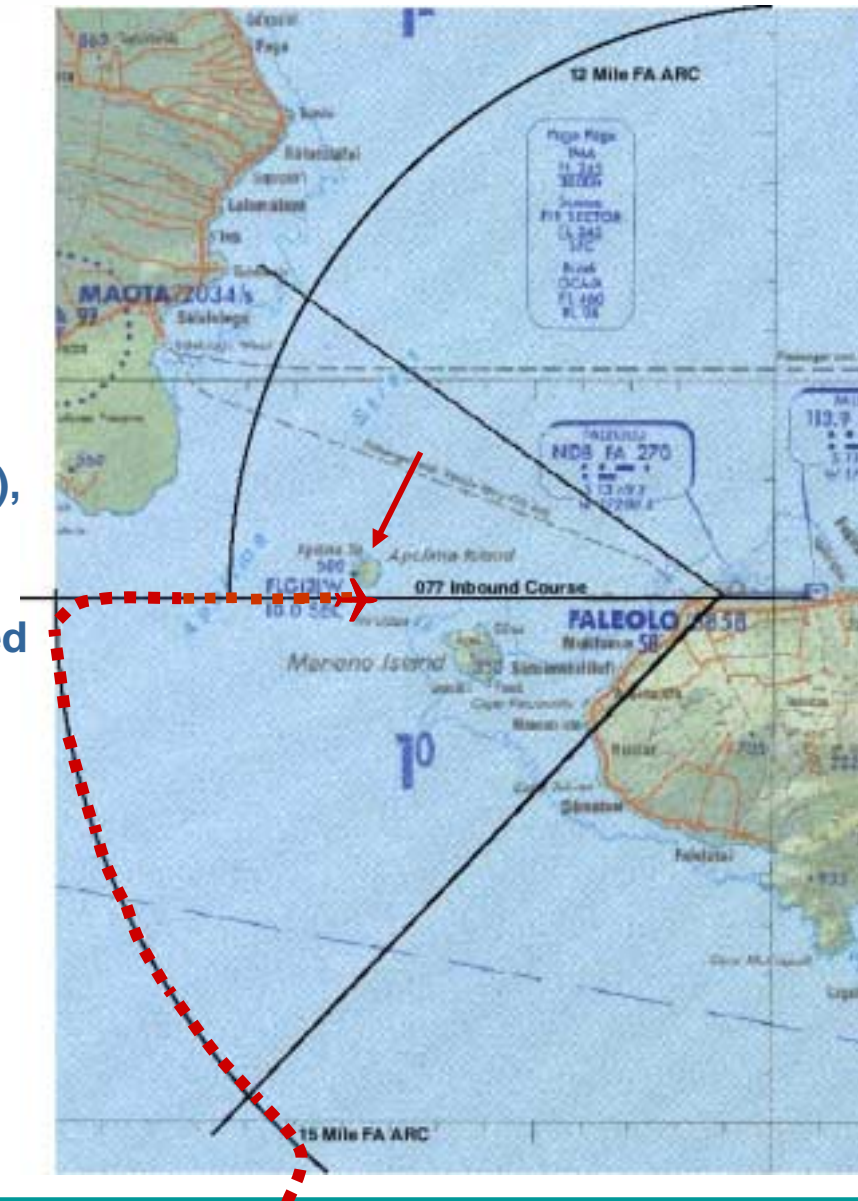
Shortly after landing flap was selected, the PF (Pilot Flying) noted an anomaly in DME vs altitude

Around the same time the PNF (Pilot Not Flying), while trying to establish visual contact with the airfield and runway, became aware that visual cues did not correspond with what was expected

The SP (Supplementary Pilot) also became aware of an anomaly in aircraft position at approximately the same time as the two other crewmembers.

Note the terrain (558') approximately 1/2 mile to the left of the localizer course.

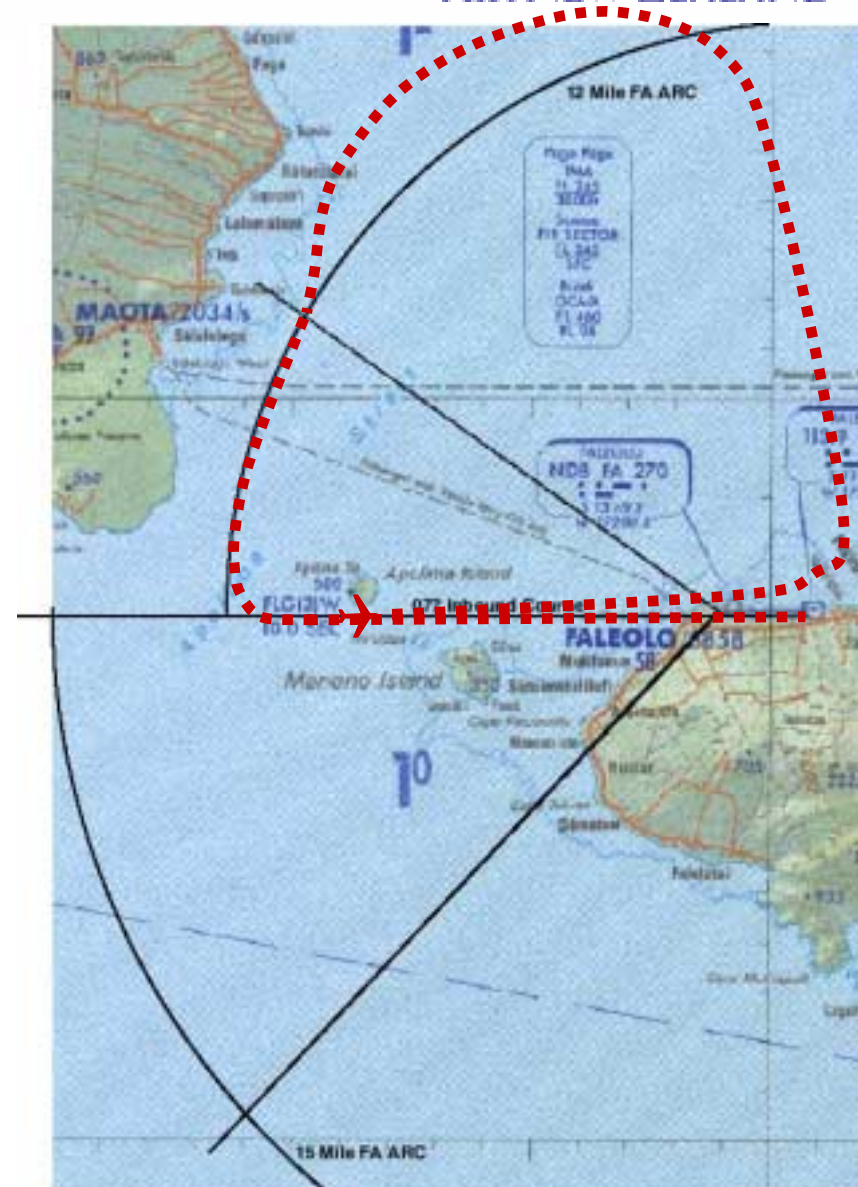
Approximately 6nm from the runway threshold a missed approach was carried out to join the 12 mile arc from the North.

The second approach was planned and flown as a localizer approach, using the DME / altitude profile for glidepath management.

The glideslope deviation indicator indicated "on glideslope" throughout both approaches.
