AIRCRAFT ACCIDENT REPORT

OCCURRENCE NUMBER 01/44

BELL 204 (UH-1F)

ZK-HVY

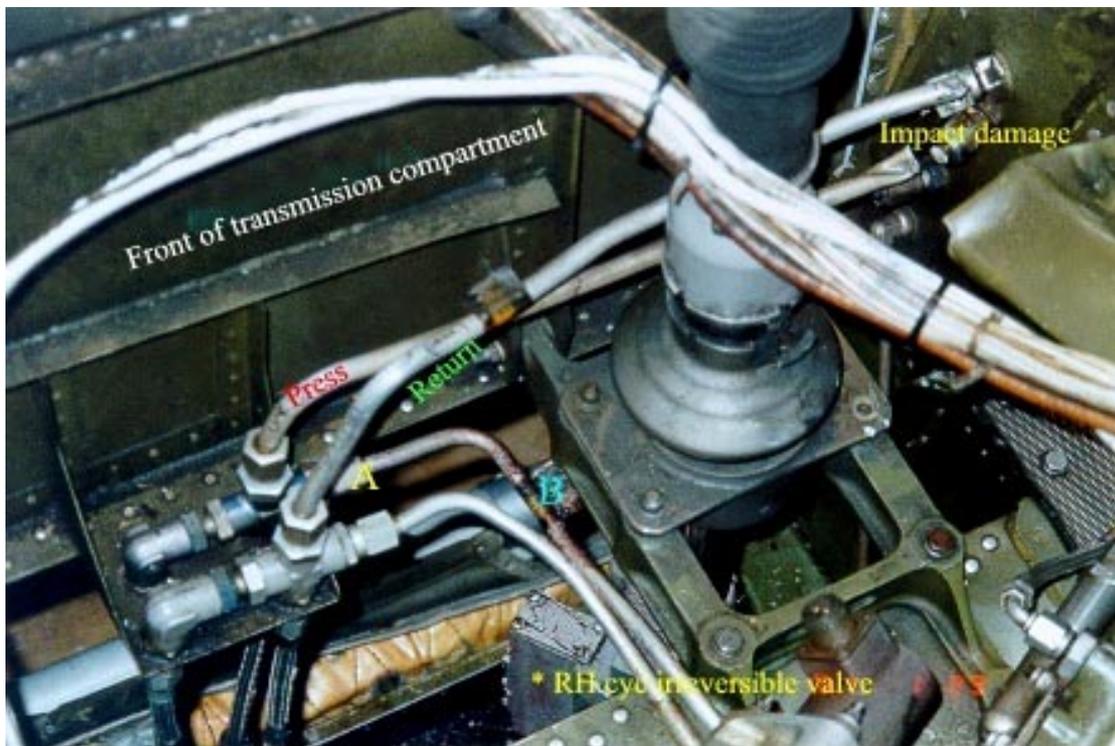
- 1.16.8 In general appearance, the pipe had had a long service life, and at the end where the leak occurred, had tarry deposits of dried hydraulic oil over about 170 mm of its length. The pipe was not readily visible or accessible with the main transmission in place. A general view is shown in Figure A5.

- 1.16.9 The pipe was sent for metallurgical examination, which found a fatigue crack at the end where the leak occurred. The crack ran circumferentially about halfway round the pipe, in the area of the MS21922 sleeve, adjacent to the slight deformation caused by the cutting edge of the sleeve. The pipe also exhibited bending in the area of the sleeve, and the result of this would have been to transfer bending loads to the end of the pipe where the cutting edge of the sleeve made contact. The fatigue crack had multiple origins and had propagated from the outside of the tube to the inside; it had developed over hundreds rather than thousands of cycles. This could indicate that the crack started developing relatively recently; alternatively, the movement of the tube leading to the cracking may have been present only occasionally, such as at a particular combination of aircraft load and speed, in which case it could have developed over a long period.

- 1.16.10 The associated MS21921 nut showed considerably more spanner marks on its surface than did the nut at the other end of the pipe. Additionally, file marks were present on the end of the nut, which had been shortened by 2.7 mm. The tube end also showed evidence of overtightening, being compressed and deformed between the tube end and where it emerged from the sleeve. Wear marks on the tube also indicated that the sleeve had been displaced about 1 mm towards the tube end from its original position at installation.

Figure A5: Hydraulic lines in transmission compartment – transmission removed
A indicates the area of the leak; B indicates hydraulic fluid residue.
