Uncommanded Engine Shutdown
19 kilometres North of Melbourne
B717-200 VH-AFR
3 February 2001

by L.S. (Sam) Webb
Senior Air Safety Investigator
Australian Transport Safety Bureau

B717-200 Engine Shutdown

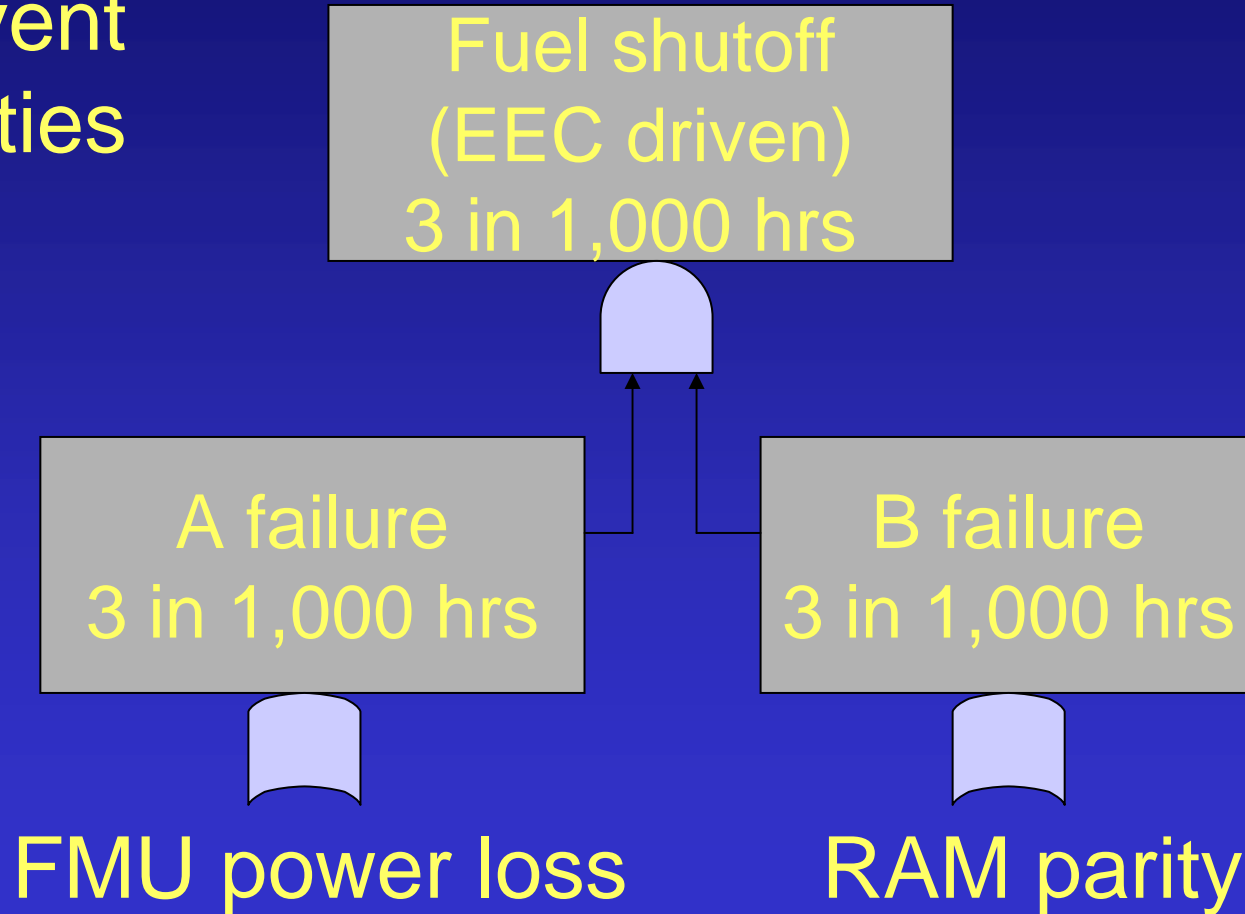
During event
(probabilities
example
only)

- ✈ EEC operating on Channel B only
- ✈ Channel B experienced RAM parity errors and resets
- ✈ EEC reverted to Channel A for primary control
- ✈ Channel A was degraded by pre-existing FMU electrical fault codes

- ✈ Neither channel able to control the engine (redundancy lost)
- ✈ The fuel-control metering valve closed, resulting in fuel starvation and engine shutdown
