AO-2008-070, In-flight upset  
154 km west of Learmonth, WA  
7 October 2008, VH-QPA  
Airbus A330-303

Based on ATSB *Interim Factual Report*  
(6 March 2009) available at  
[www.atsb.gov.au](http://www.atsb.gov.au)

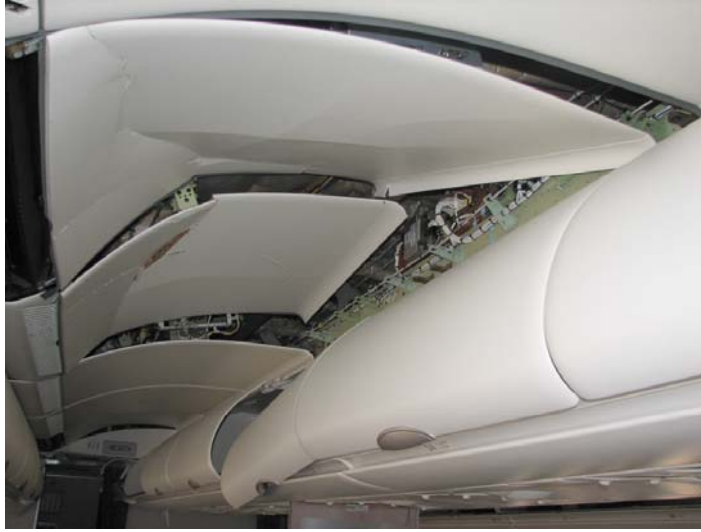
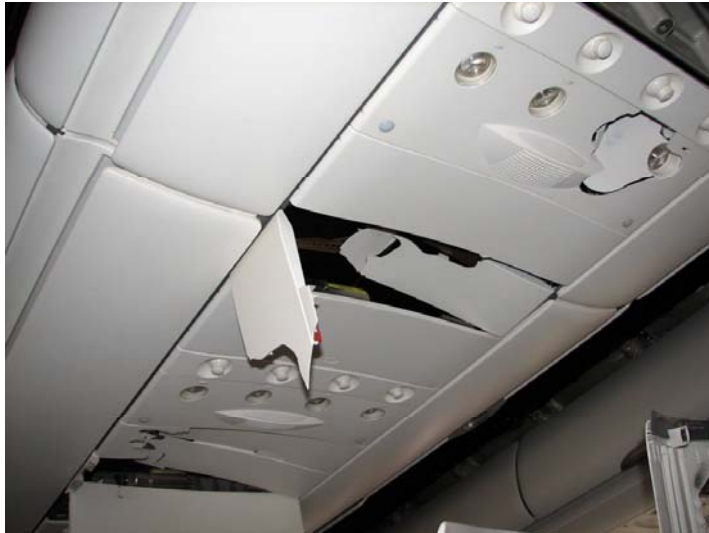
- All injuries at time of first in-flight upset
- Severity of injuries varied considerably

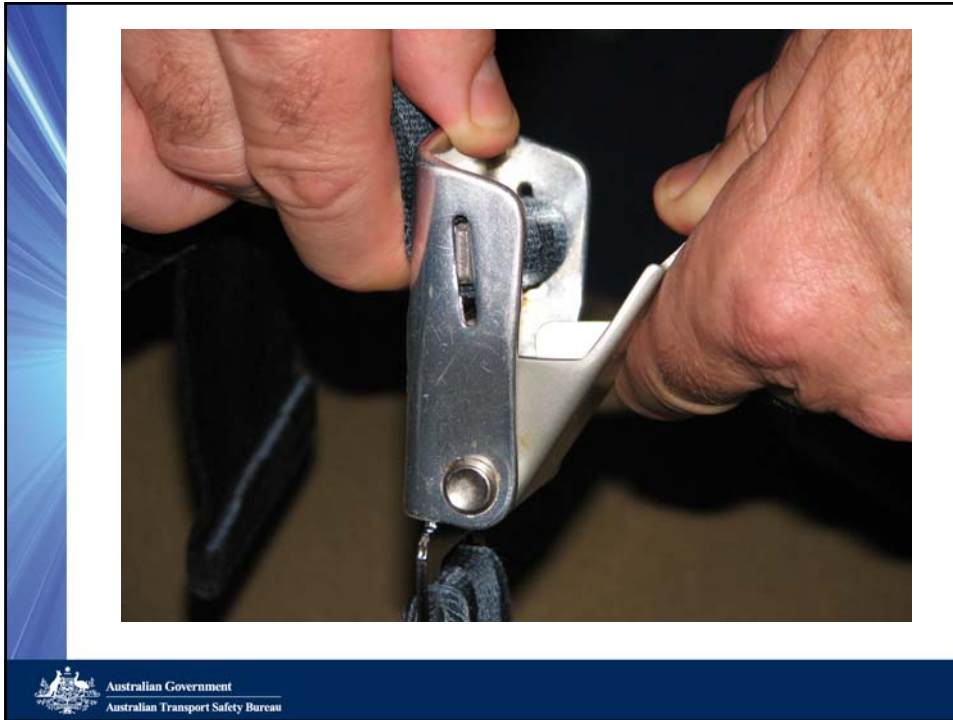
- 4 passengers said had seatbelt fastened, but were not restrained
- Inspected sample of 51 seatbelts
  - including for those attended hospital and unsure whether seatbelt on or not
- No problems with condition of belts examined
- Potential design problem of lift-latch mechanism

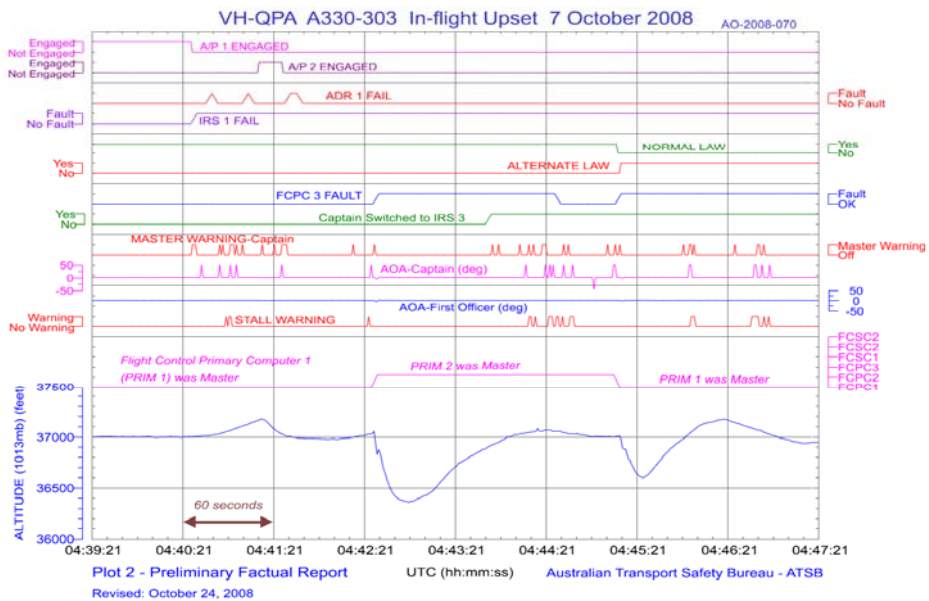
# FDR Data (both pitch downs)

- 0442.27: pitch nose-down
  - max pitch angle 8.4 degrees,  $g$  loading -0.80
  - many injuries in cabin
- Capt promptly applied back pressure
  - initially no response
- Descended 650 ft before return to FL370
- SO put seatbelt light on, made PA
- Crew commenced ECAM actions
  - NAV IR1 fault – switch to Capt on 3
  - PRIM 3 fault – OFF then ON

- 0445.08: pitch down
  - max pitch angle 3.5 degrees, *g* loading 0.20
- Capt promptly applied back pressure
  - initially no response
- Descended 400 ft before return to FL370
- Reviewing ECAM
- Captain made PA
- 0447.39: FO returned
