# Degraded Dampers

## A Case study in Engine Torsional Vibration

2009 Asia – Pacific Regional Seminar

Justin Williams  
Applied Vehicle Systems  
Defence Technology Agency

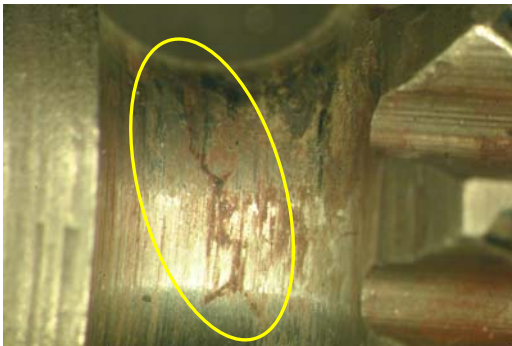
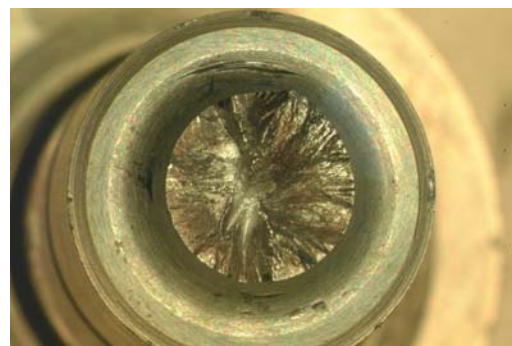
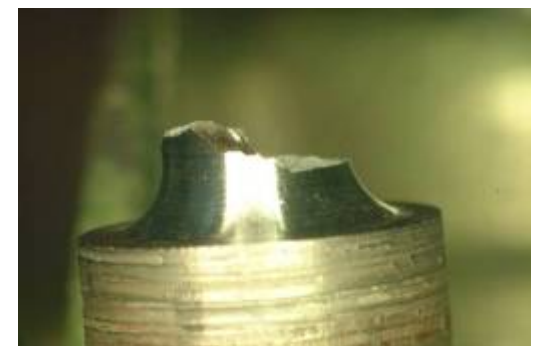
- All failures located at waisted portion of shaft
- Exhibited faceting at  $90^\circ$  and  $\pm 45^\circ$ , indicative of **reversed torsional** and bending **fatigue** loads
- Coupling splines and drive gear burnished on both flanks indicative of oscillatory torsional loading
- Analyses by 3 laboratories show no material or component deficiencies

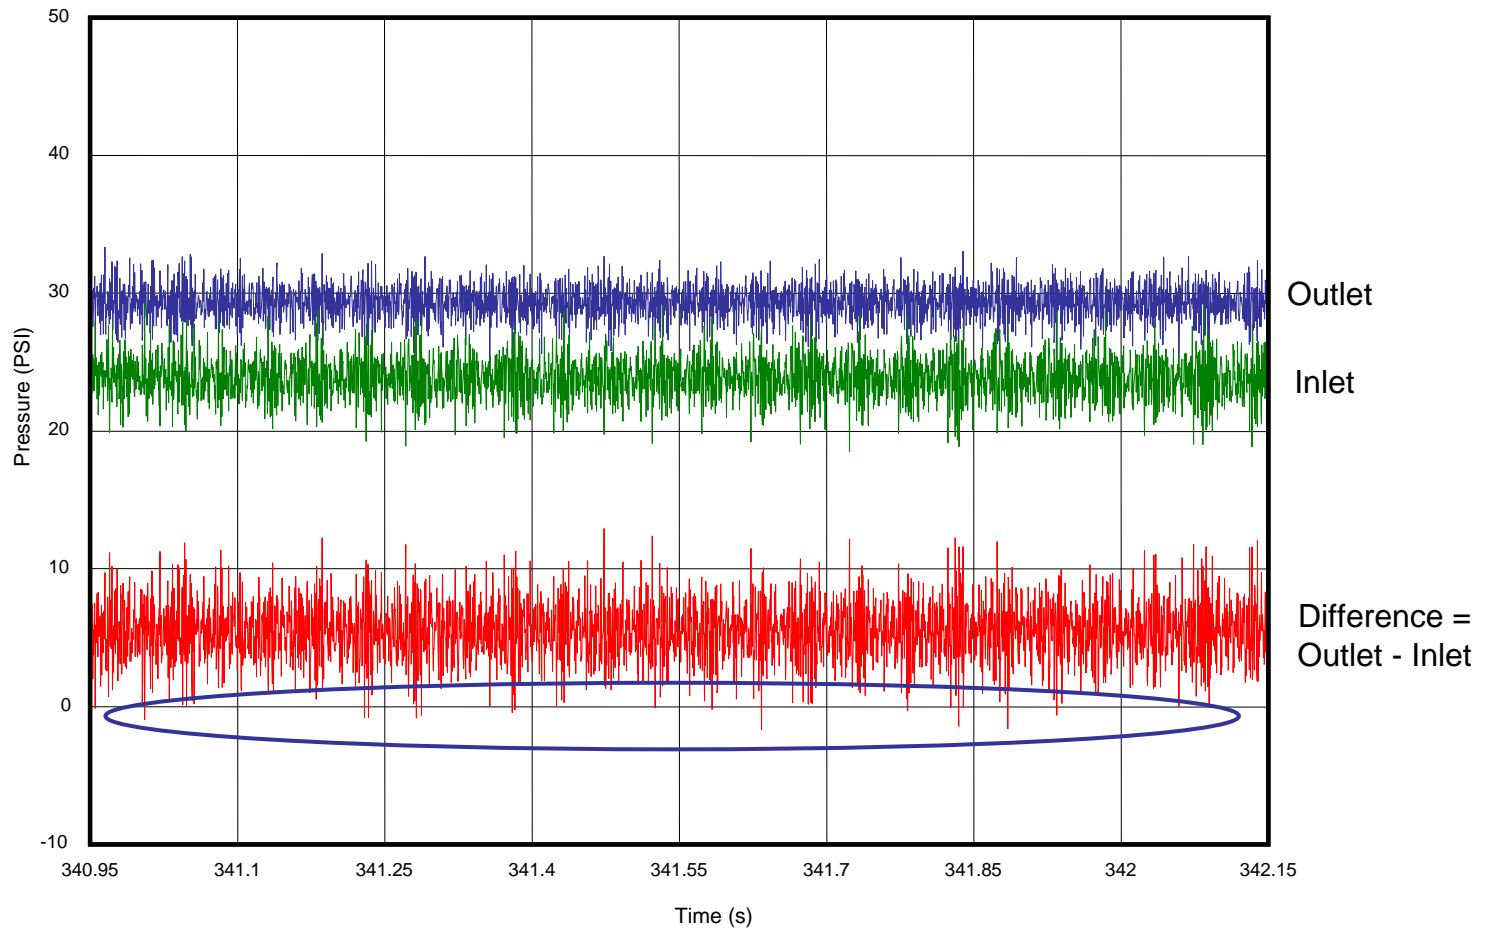
- EDFP load reversal indicated
- Solve failures by increasing EDFP relief valve pressure setting? No

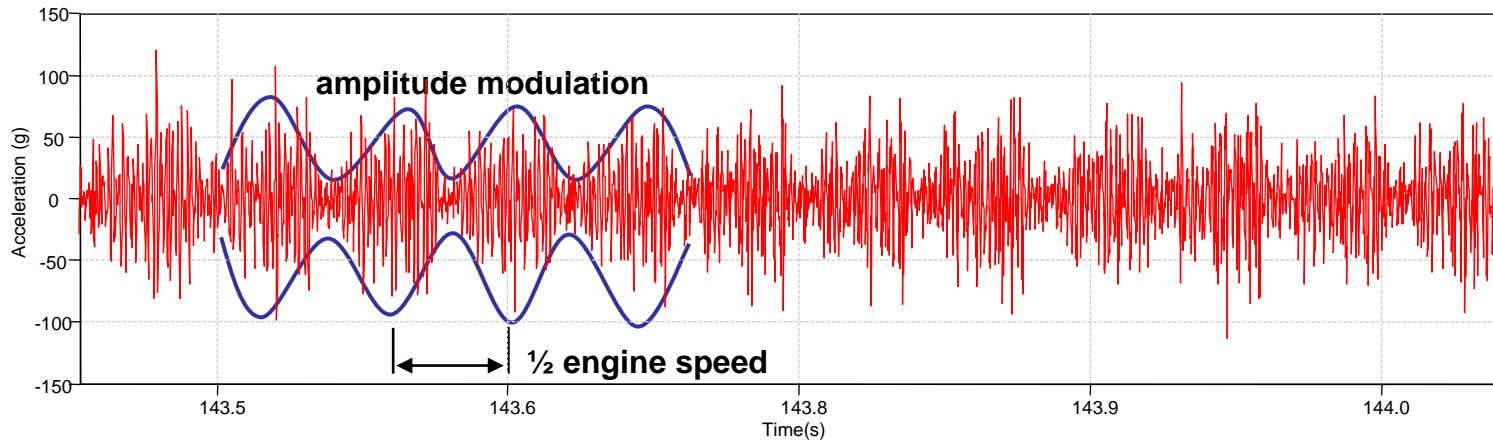
**Vibration on an engine with failures, NZ1988 lateral vibration**

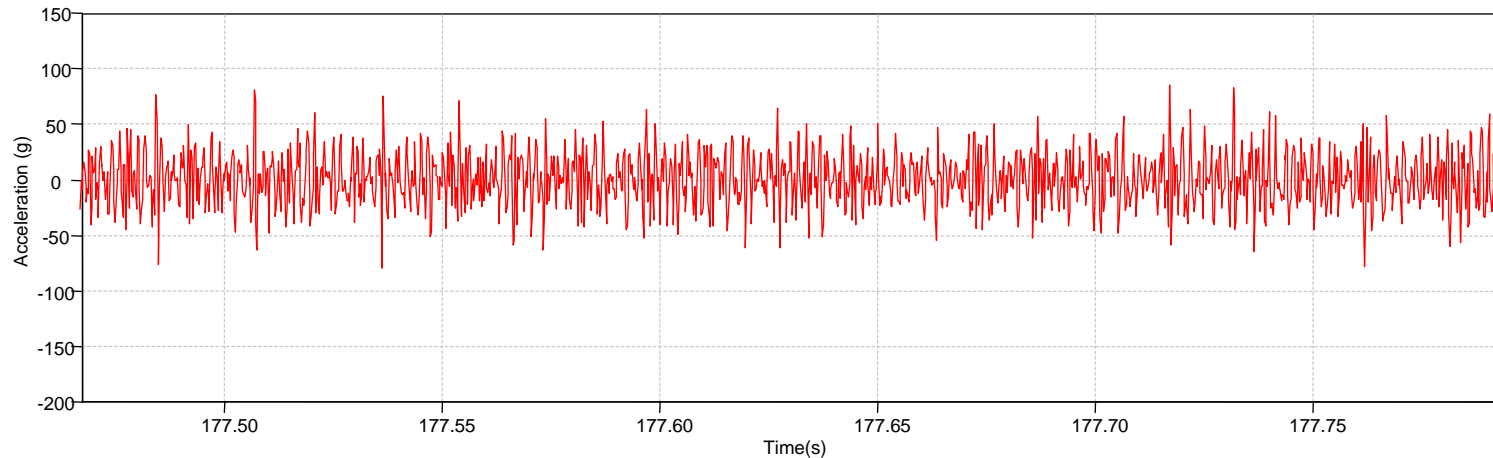
**Vibration on engine with no failures, NZ1990 lateral vibration**

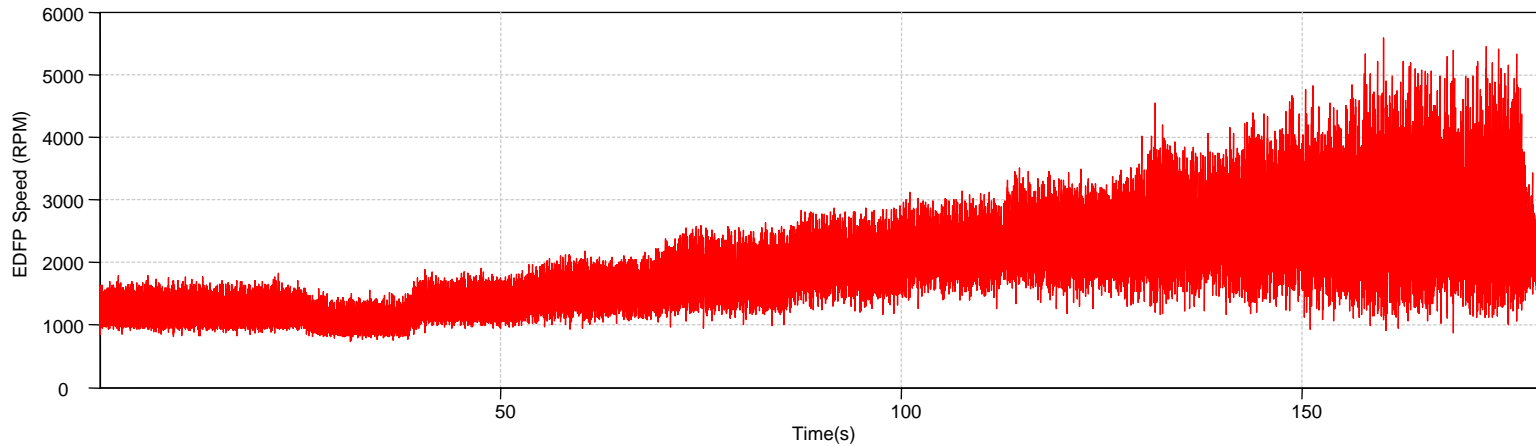
**Torsional vibration on an engine with failures, NZ1988 EDFP speed**

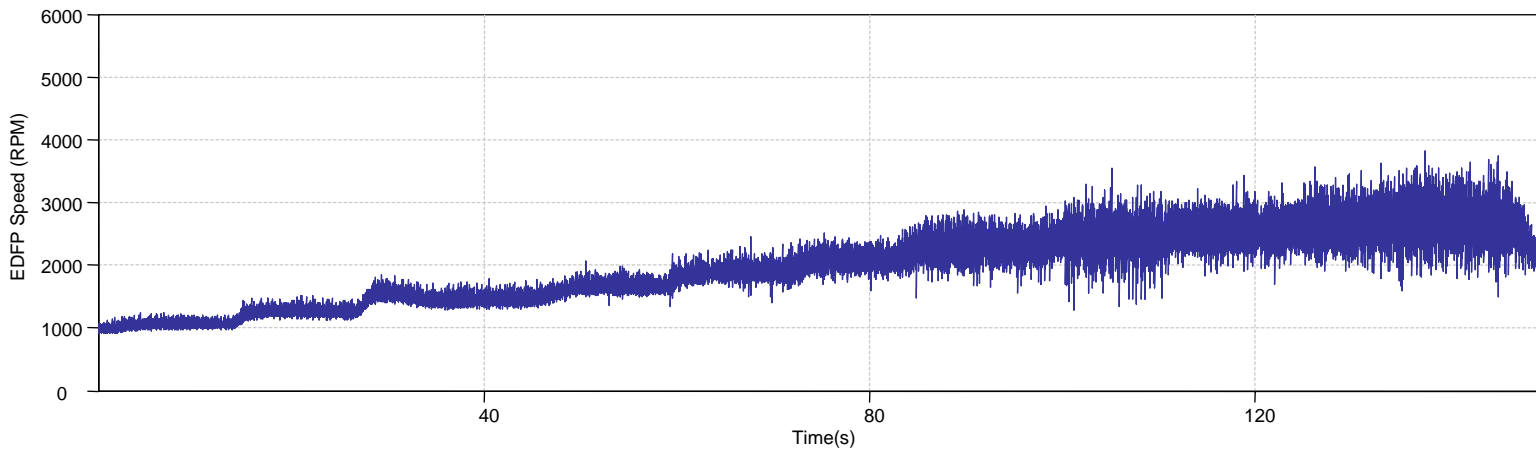
**Torsional vibration on an engine with no failures, NZ1996 EDFP speed**

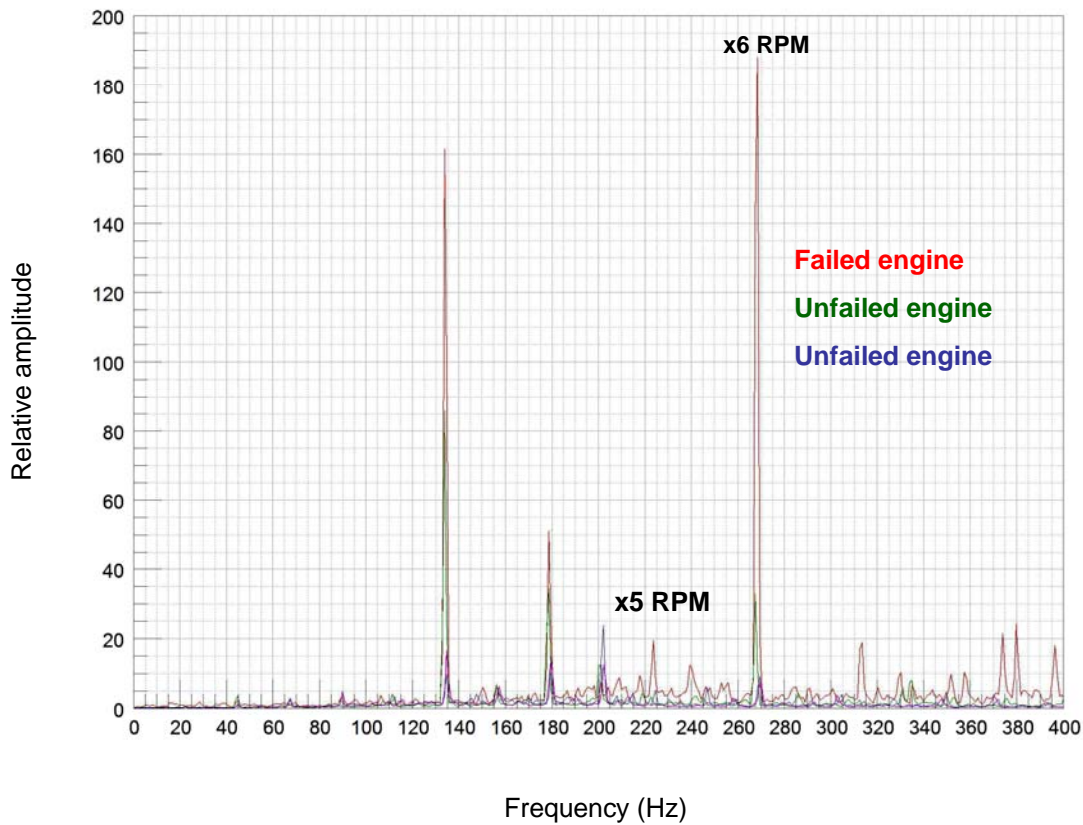
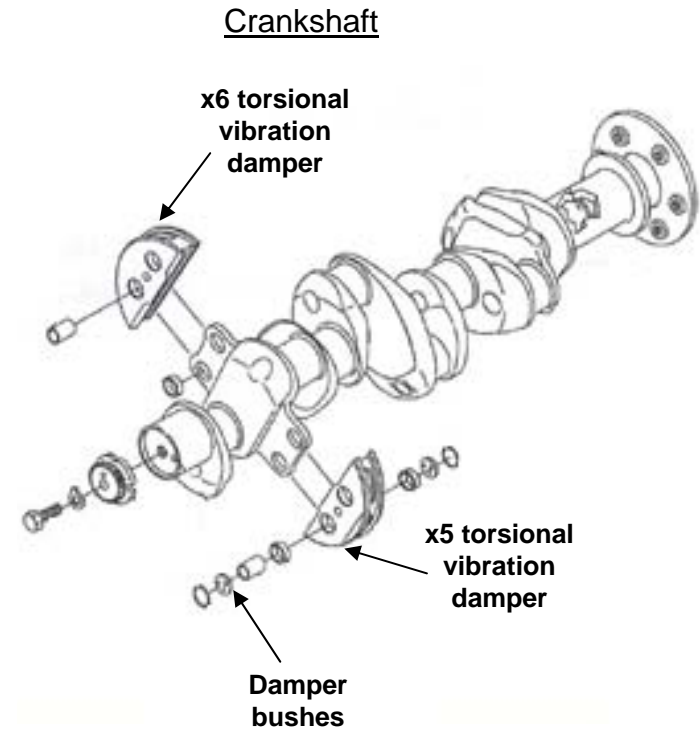
Coupling torsional vibration frequency spectrum at take off power

- Results indicate probable degraded crankshaft torsional dampers

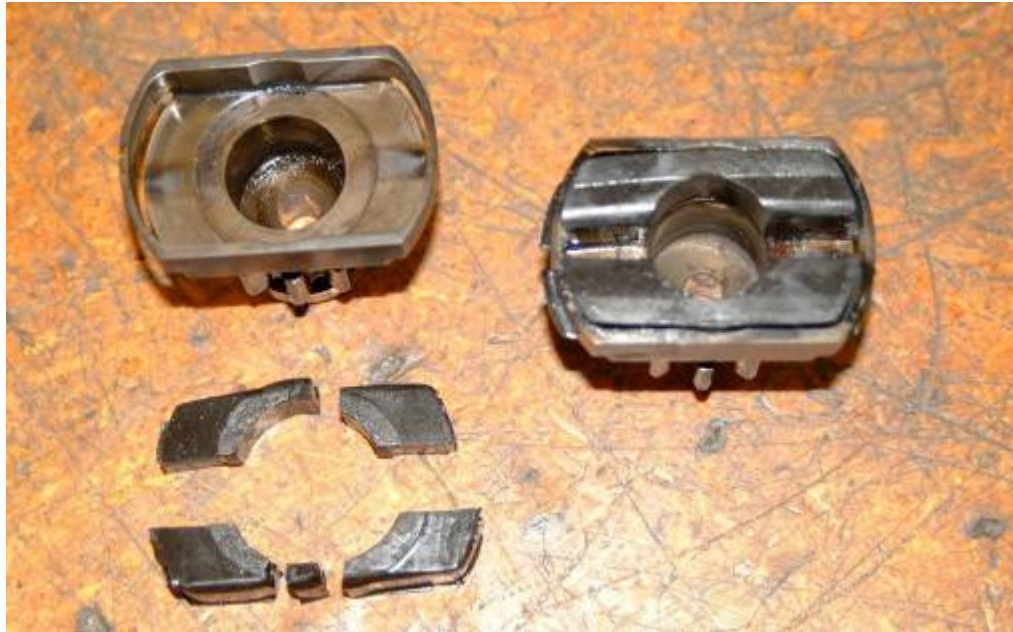
- Engine selected which had experienced 4 EDFP coupling failures
- Left hand magneto drive (torsional) damper had failed

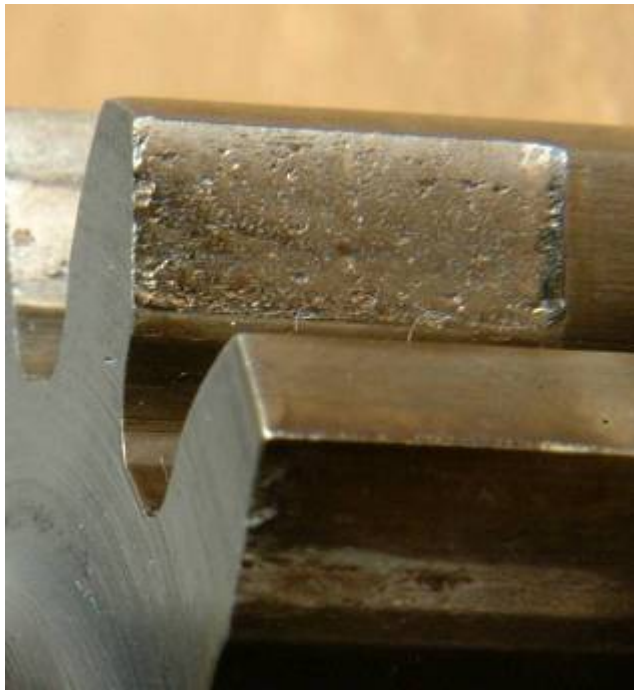
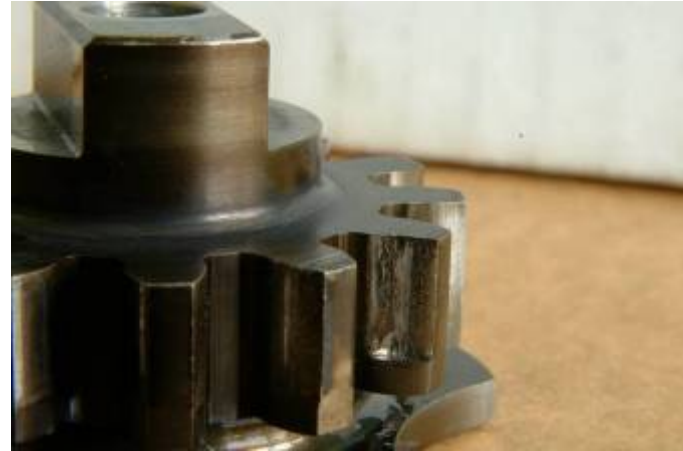
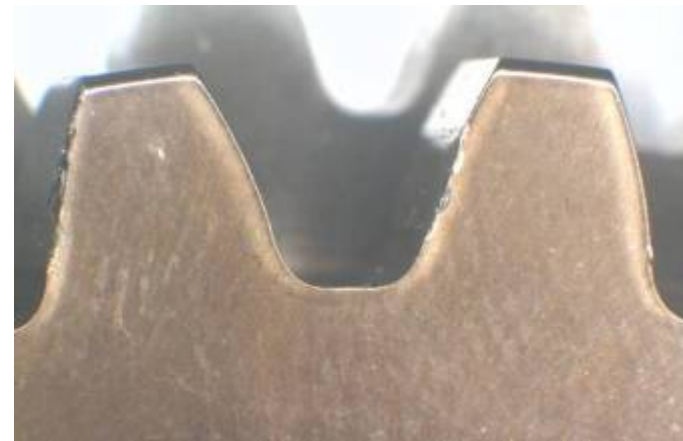
- Excessive wear on accessory drive train
- Gear backlash results are not repeatable

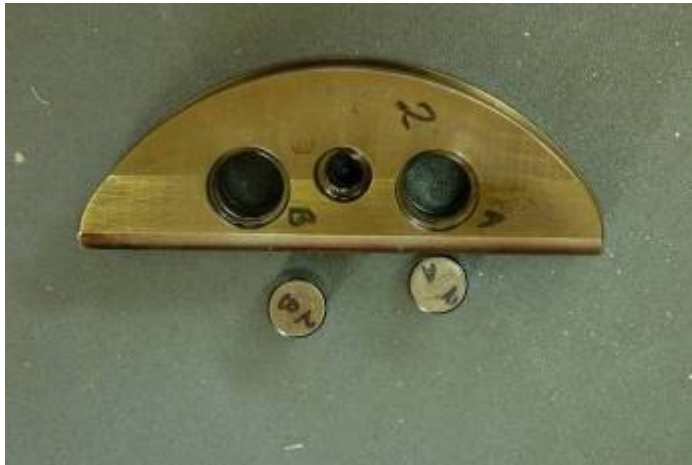
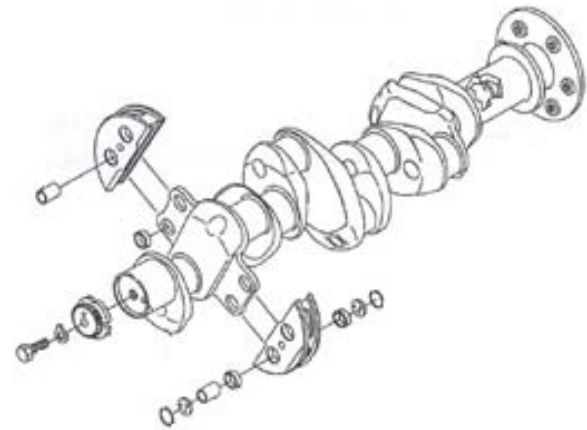
- Crankshaft and counterweight bushes were worn beyond serviceable limits. One bush, 5 times over the serviceable limits

- Counterweight bushings in crankshaft and in counterweights (See latest revision of Service Instructions No. 1142 and 1143 for instructions.)

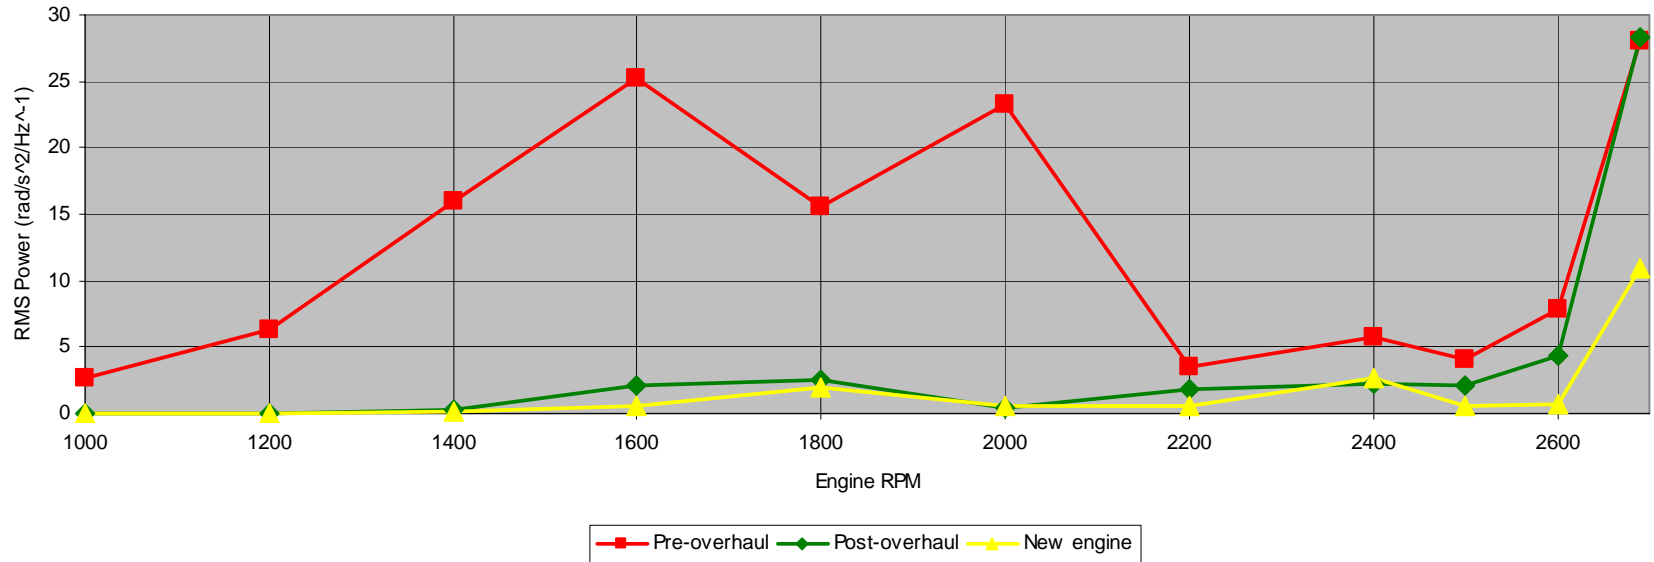
Lycoming AEO-540-L1B5, EDFP coupling 5th engine order torsional vibration

- Significant decrease in 5<sup>th</sup> engine order torsional vibration, across the entire engine operating range

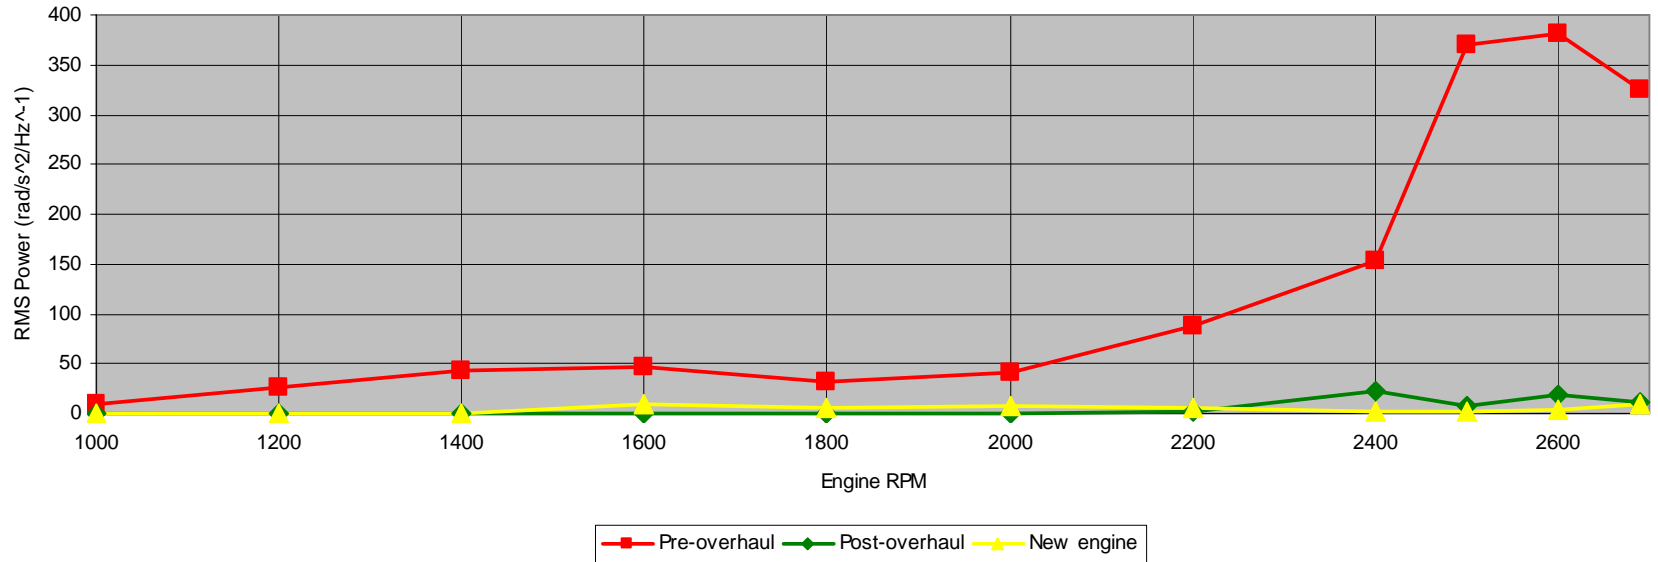
Lycoming ABO-540-L1B5, EDFP coupling 6th engine order torsional vibration

- Significant decrease in 6<sup>th</sup> engine order torsional vibration, across the entire engine operating range
- Confirmed the assumption that crankshaft damper condition is the probable cause of EDFP coupling failure
