Fuel Contamination can still pose a Risk

**Presented by
Captain Victor Liu
Hong Kong Civil Aviation Department (HKCAD)**

Introduction

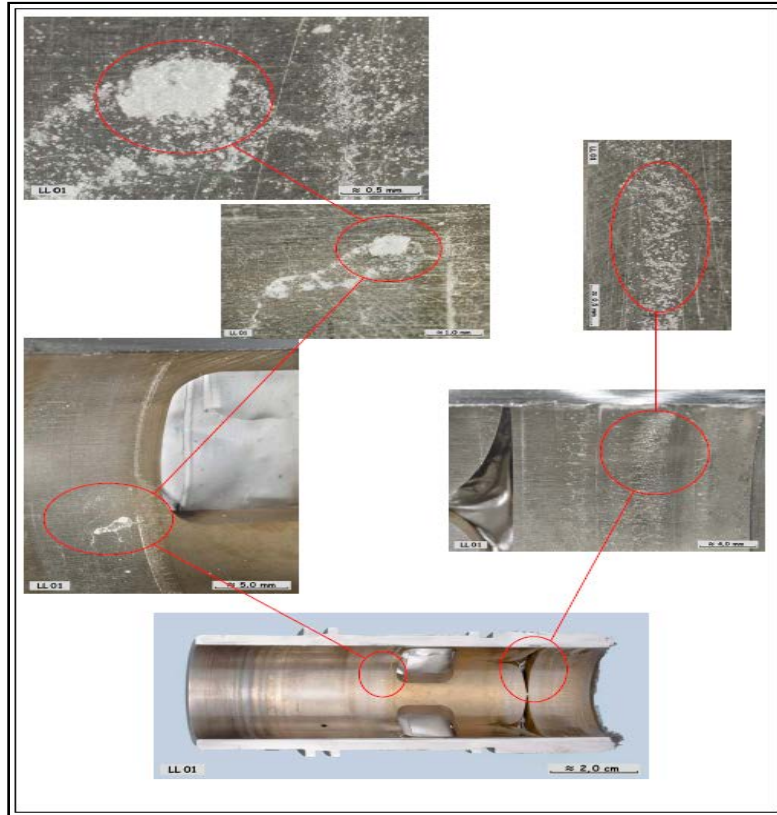
4. The contaminated fuel, which contained super absorbent polymer (SAP) spheres, caused the loss of thrust control on both engines of the aircraft. Laboratory analysis indicated that the SAP spheres contained elements that were consistent with the SAP material used in the filter monitors of the ground refuelling dispenser. Crystalline sodium chloride (i.e. salt) was also present on the surface of some SAP spheres. Most of the SAP spheres found had the size ranging from five to 30 μm with a majority in the order

of five to 15 μm . Further analysis showed that these SAP spheres contained elements of carbon, oxygen, sodium, chlorine, sulphur, and were mainly sodium polyacrylate, which is the SAP material used in a filter monitor of refuelling dispenser.

Figure 2 – The cutaway view of one of the main metering valve of the engine fuel component showing the presence of SAP spheres

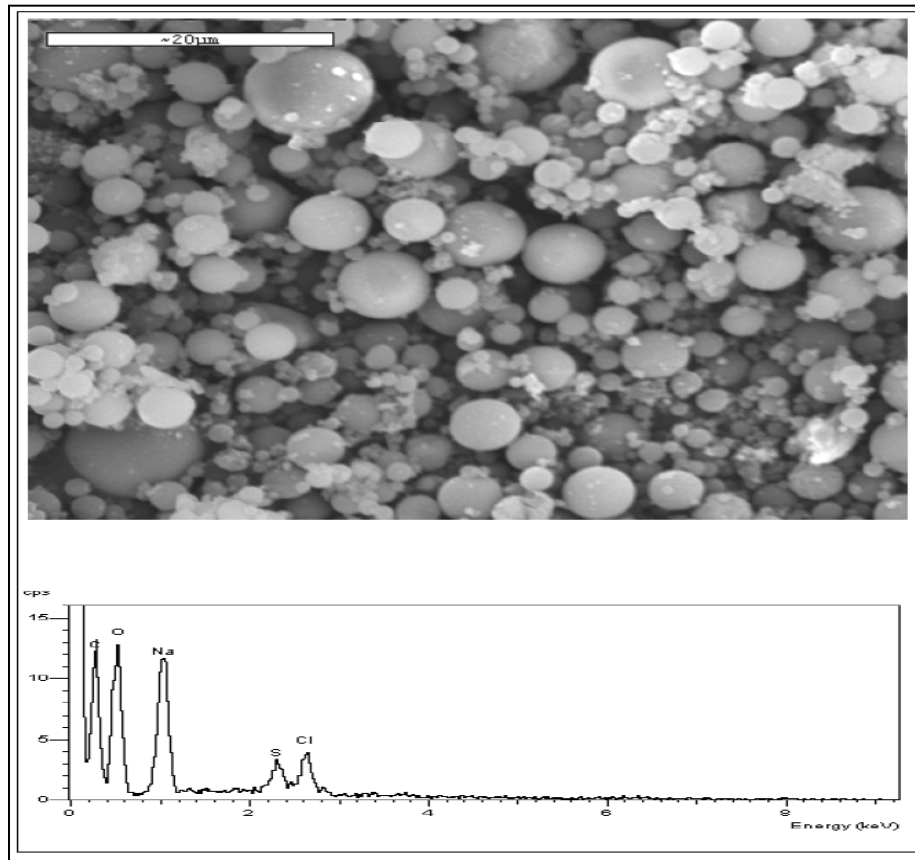
5. While the exact mechanism of SAP spheres generation from the filter monitors during the refuelling could not be established, a mimicking test conducted at a laboratory during the investigation had generated SAP spheres. It demonstrated that the presence of salt water in the fuel and under an operating profile of low flow-rate refuelling, as practiced in WARR, could have generated SAP spheres.

Figure 3 – Microscopic view of spheres and their composition under Scanning Electronic Microscope analysis.

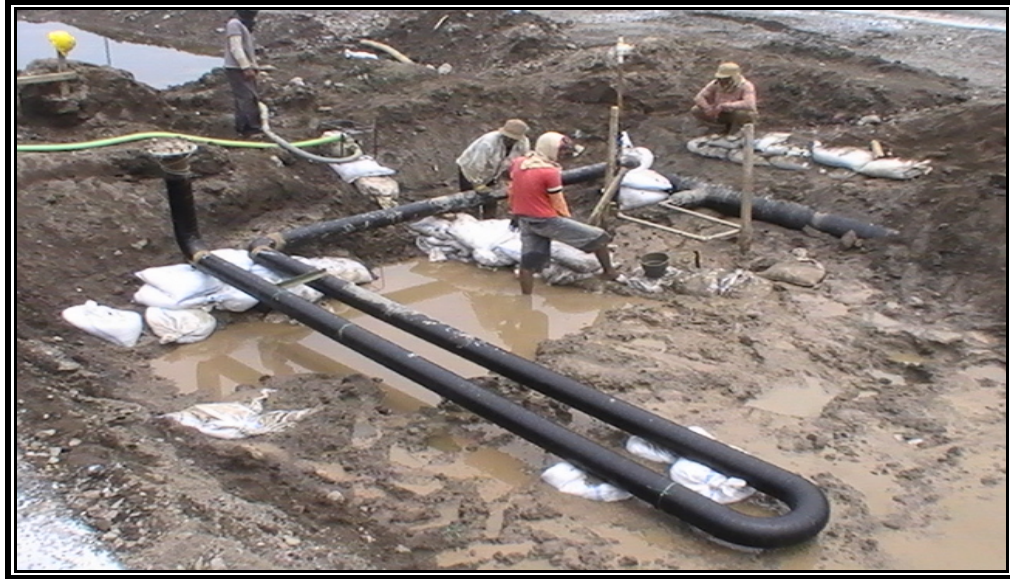
7. WARR had an apron extension project started in year 2009 which involved an extension work of the hydrant refuelling circuit that supplied fuel to Stand No. 8 where the accident aircraft was parked and refuelled before departure. Fuel sample collected from the reworked hydrant after the accident contained salt. WARR is located close to the seashore and has three regulating ponds. The water of the regulating pond closest to the apron extension work site was found to contain salt. The tie-in process of the extended hydrant refuelling circuit required the open cutting of the existing underground piping. Records showed that during the tie-in processing period, there were heavy rainfalls and there were water puddles at the work site. It was likely that the water puddles at the work site contained salt. It was likely that the required tie-in procedures had not been strictly followed and salt water might have therefore entered the hydrant refuelling circuit during

the hydrant extension work.

Figure 5 – A photo taken during the tie-in process

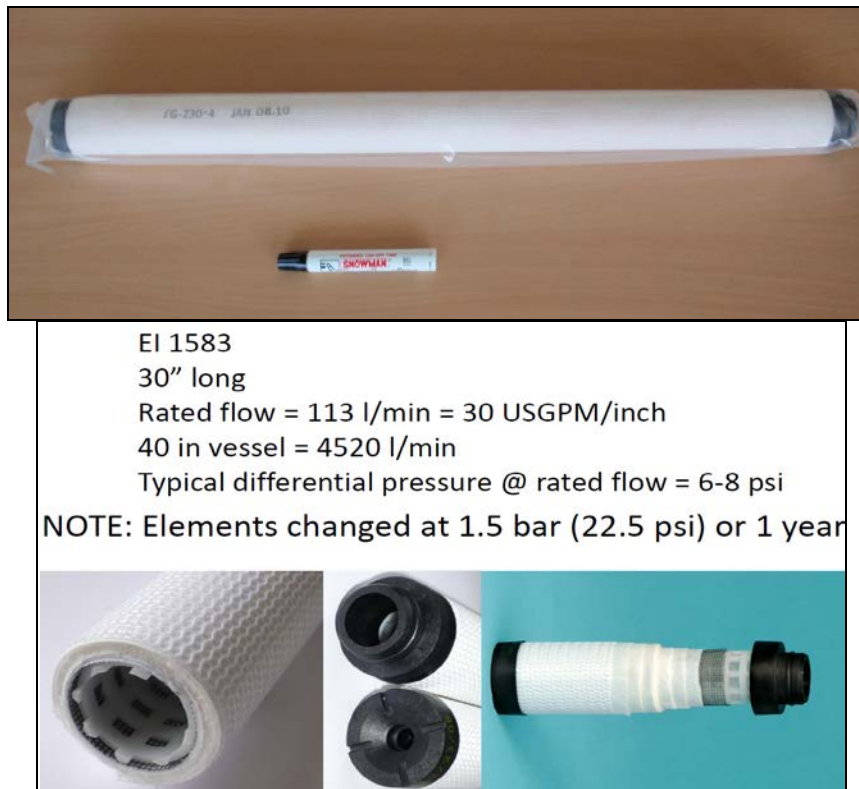
Figure 6 – A typical filter monitor

11. The filter monitors of the dispenser used for refuelling the accident aircraft had in fact been activated by salt water. The SAP media in the filter monitors of the

dispenser when reacted with water containing salt turned into gel state and caused an increase in DP indication and vibration of the refuelling hose during the refuelling of the accident aircraft. However the unusual vibration observed was not immediately stopped and properly investigated. The continued refuelling had eventually led to the uplift of fuel contaminated with SAP spheres to the aircraft!

14. In this connection, apart from making recommendations to the relevant parties in WARR to ensure that the re-commissioning procedures of the hydrant system are

properly completed before resuming the hydrant refuel operation at the affected parking stands, the investigation team has also recommended ICAO to establish civil aviation requirements for oversight and quality control on aviation fuel supply at airports and to specify the requirement of installing a device in the equipment used in refuelling aircraft. This device should be able to automatically alert the equipment operator and stop the refuelling process when the DP across the equipment filtration system is outside the equipment designed value or range.
