# A340 Tailstrike Melbourne Airport

Is good airmanship enough for gross error detection?

**AO-2009-012 A6-ERG Tail-strike and Runway Overrun, Melbourne Airport**

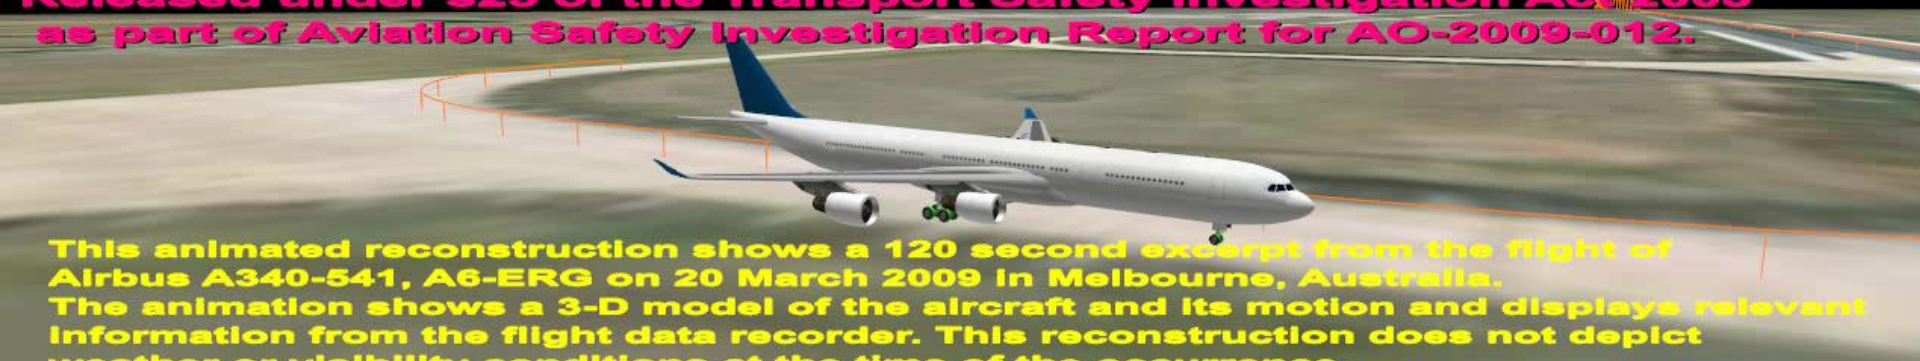
**This animated reconstruction shows a 120 second excerpt from the flight of Airbus A340-541, A6-ERG on 20 March 2009 in Melbourne, Australia. The animation shows a 3-D model of the aircraft and its motion and displays relevant information from the flight data recorder. This reconstruction does not depict weather or visibility conditions at the time of the occurrence.**

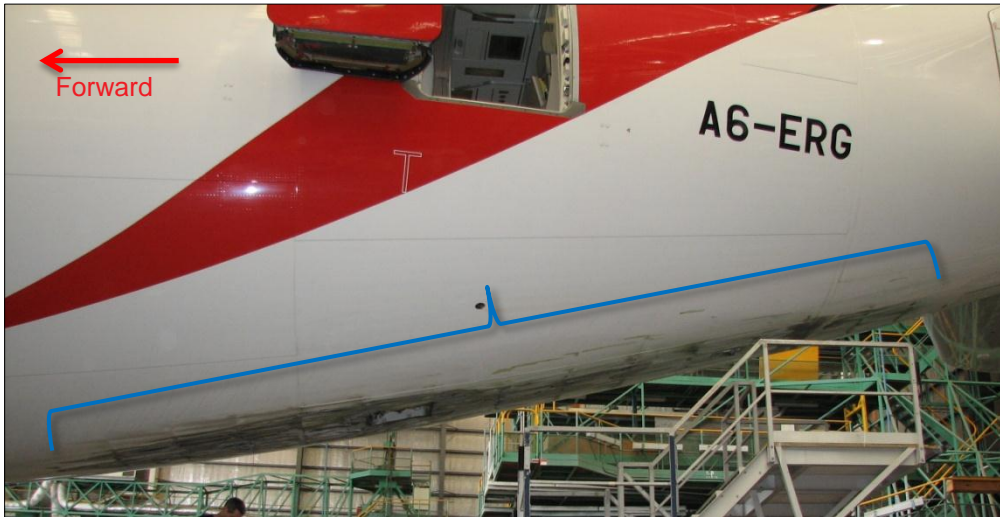
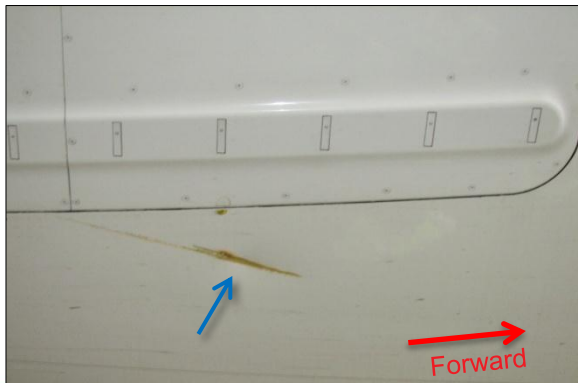
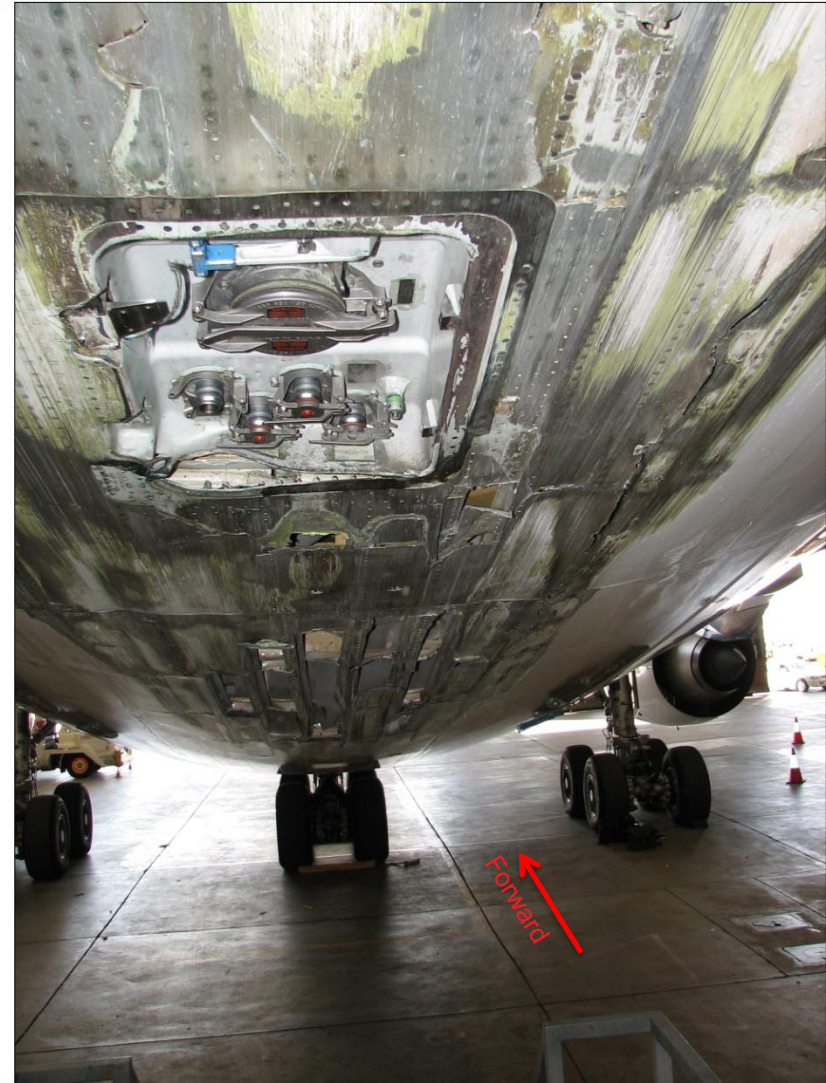
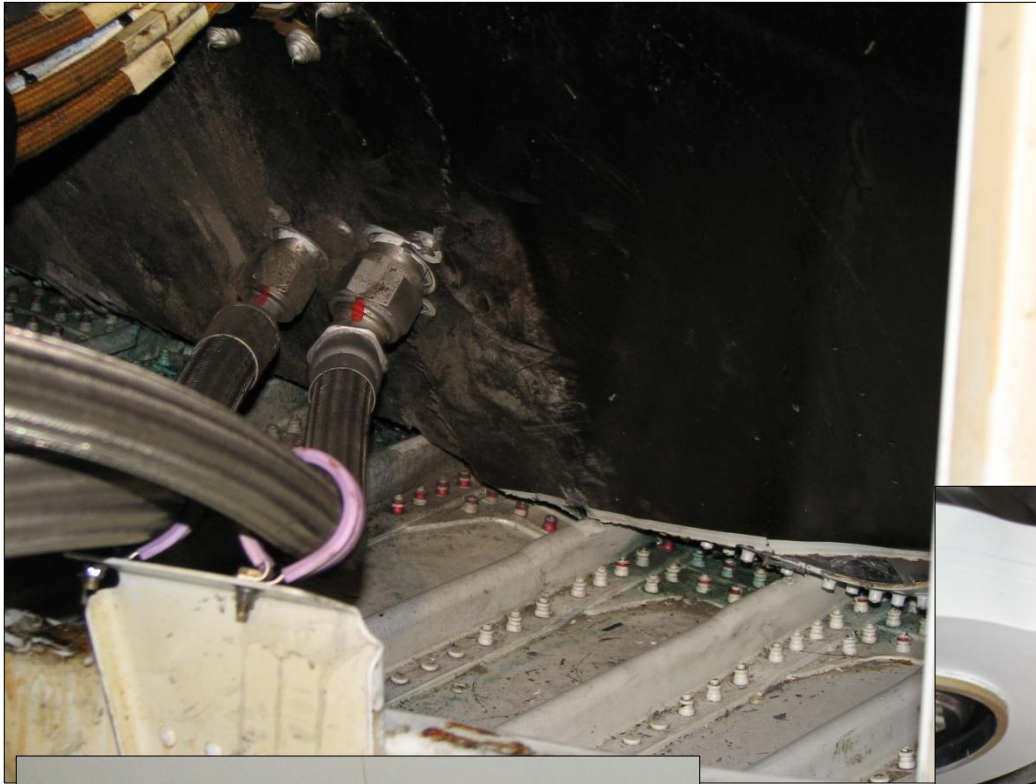
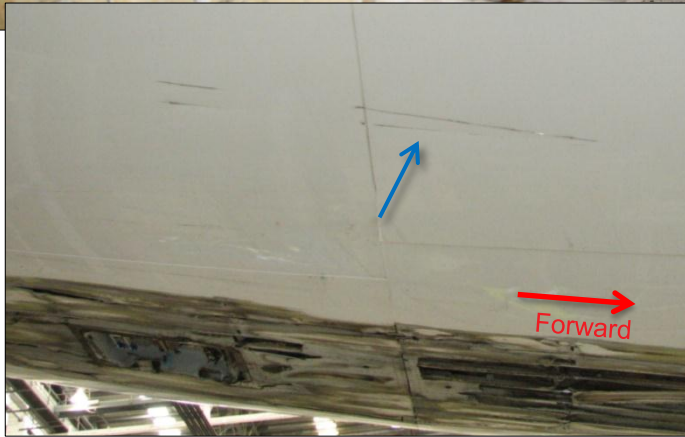
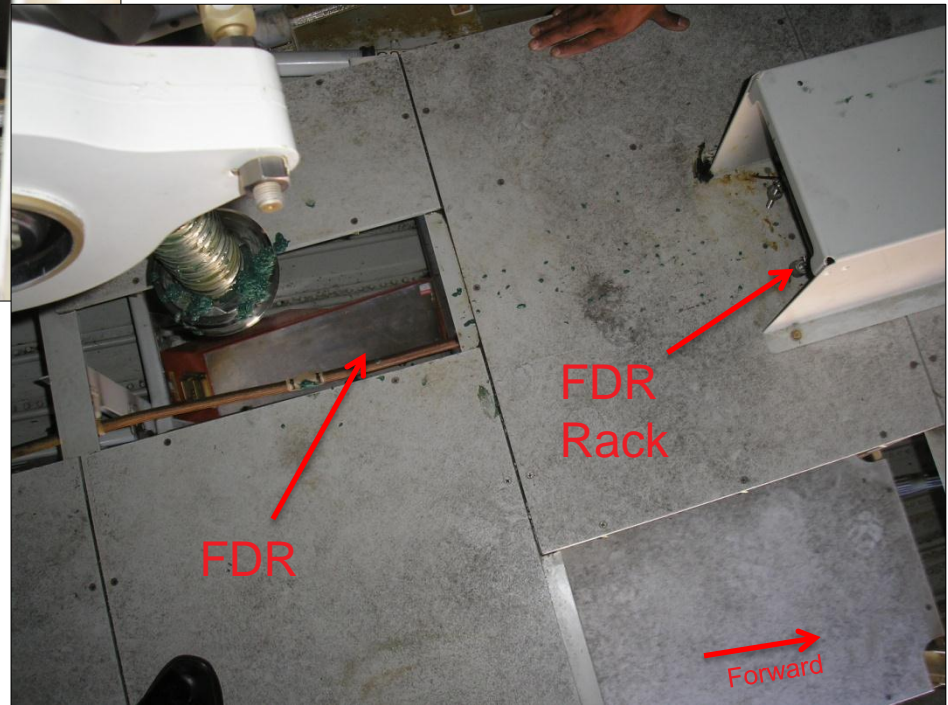
# Damage to aircraft

- Erroneous performance figures resulted in:
  - Over-rotation and tailstrike (low  $V_R$  and flap setting)
  - Long take-off roll and runway overrun (low thrust setting)
- Erroneous TOW entry likely due to ‘finger trouble’
- Erroneous take-off weight in performance calculations not detected (opportunities missed)
  - Non-adherence to standard operating procedures
  - Captain’s check of EFB (task interruption)
  - FO read correct weight during loadsheet check
  - FO changed flight plan without investigation
  - Green dot speed check (2 occasions)
