The Australian Transport Safety Bureau

AIRCRAFT AVIONICS WIRING & ELECTRICAL SYSTEMS

TWA 800
230
LIVES LOST

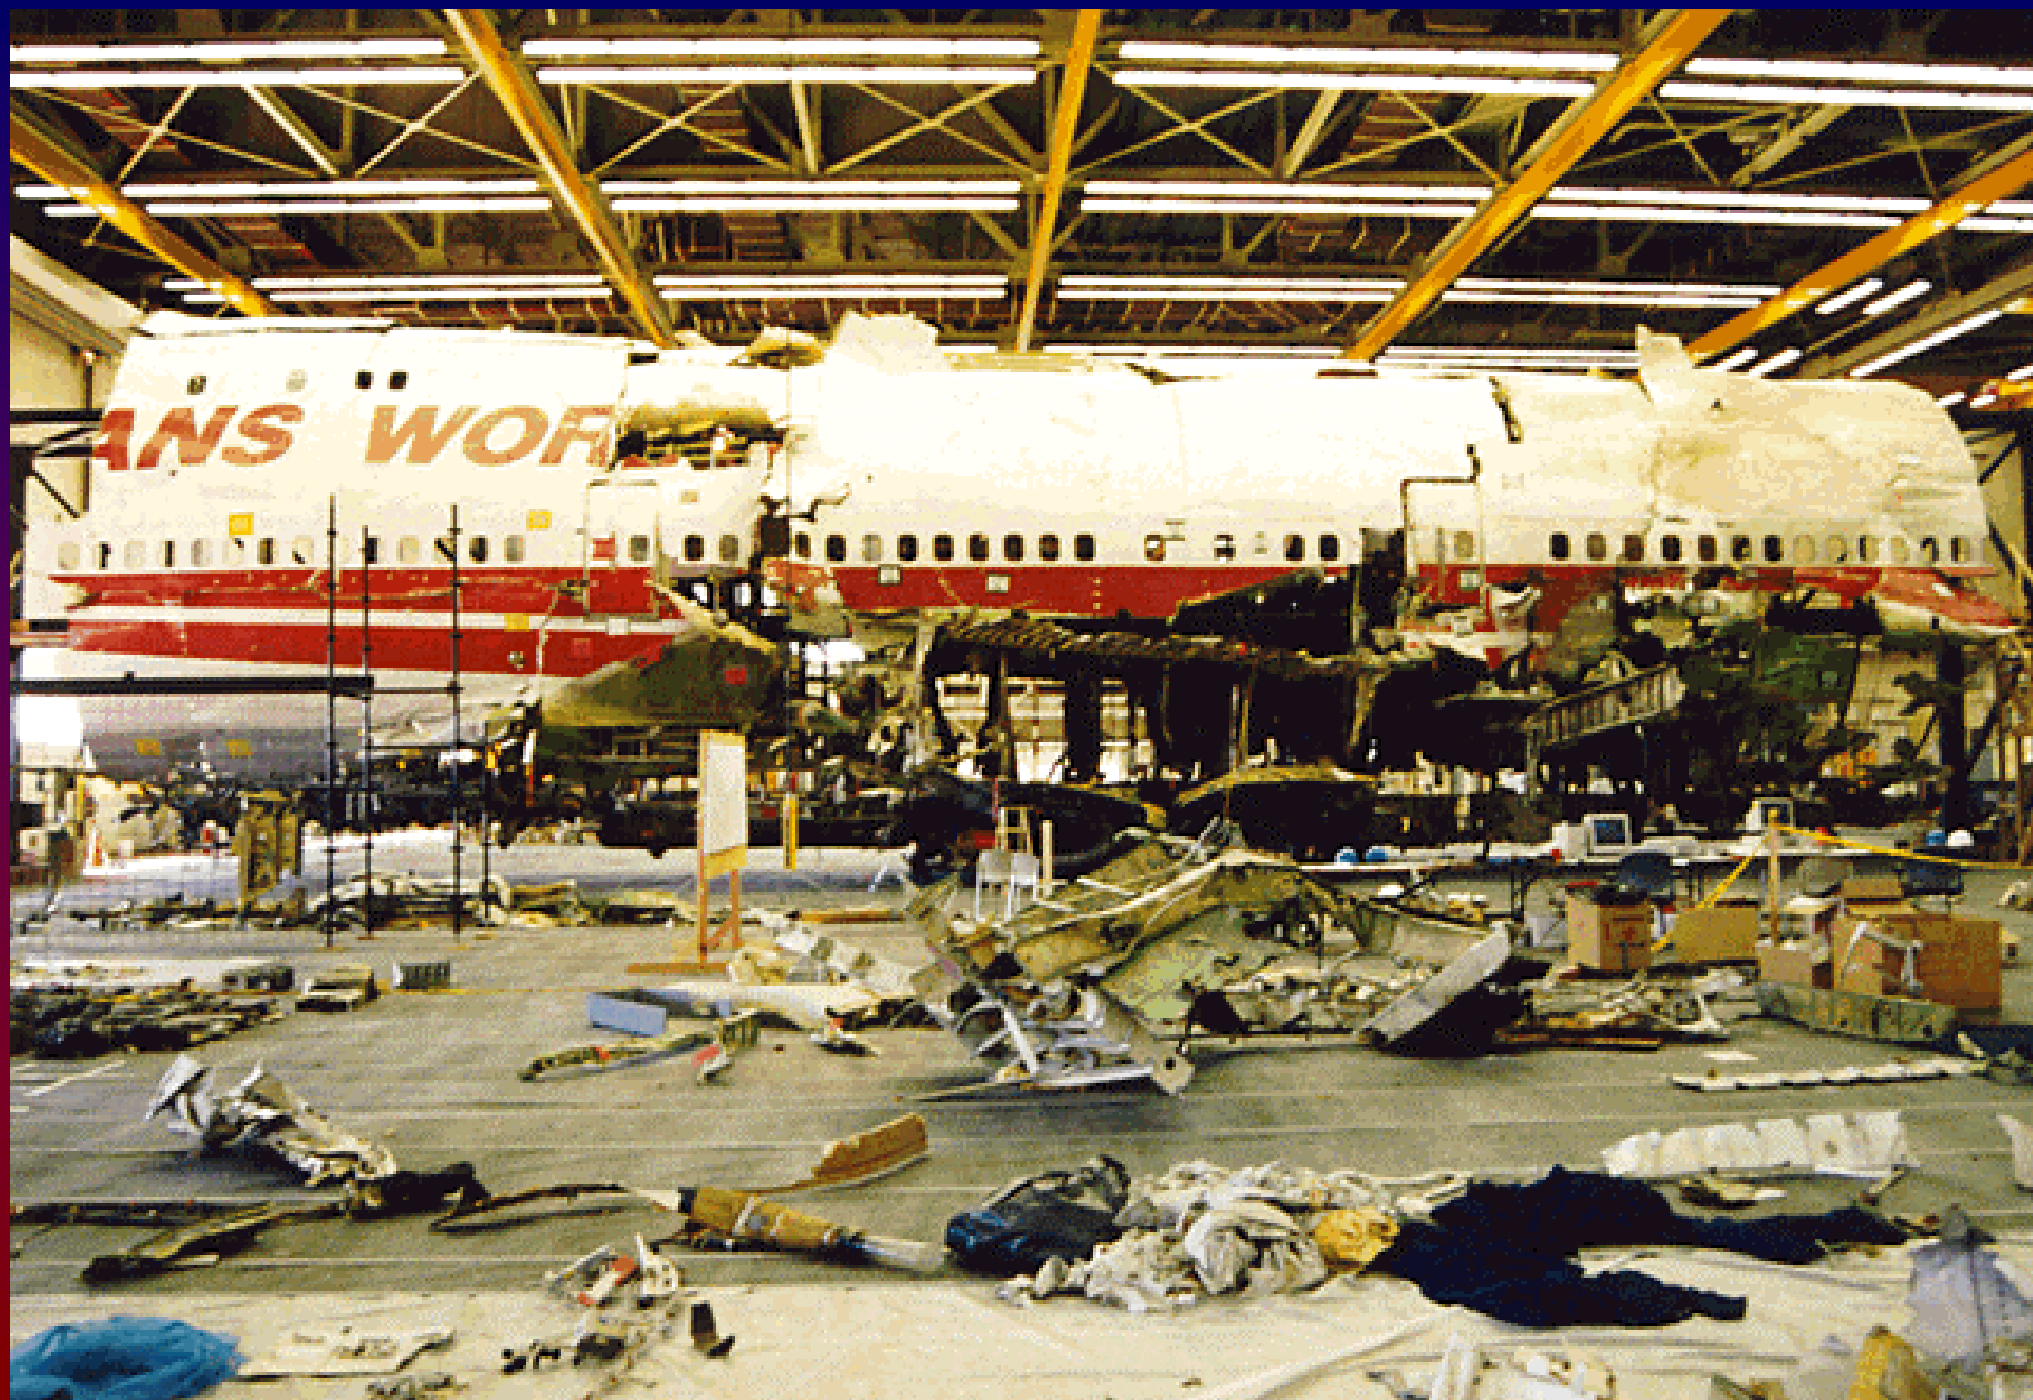
FUEL QUANTITY PROBE

***ALLOWING EXCESSIVE
VOLTAGE TO ENTER THE
CENTRE WING TANK
THROUGH ELECTRICAL
WIRING ASSOCIATED WITH
THE FUEL QUANTITY
INDICATION SYSTEM (fuel probe)***

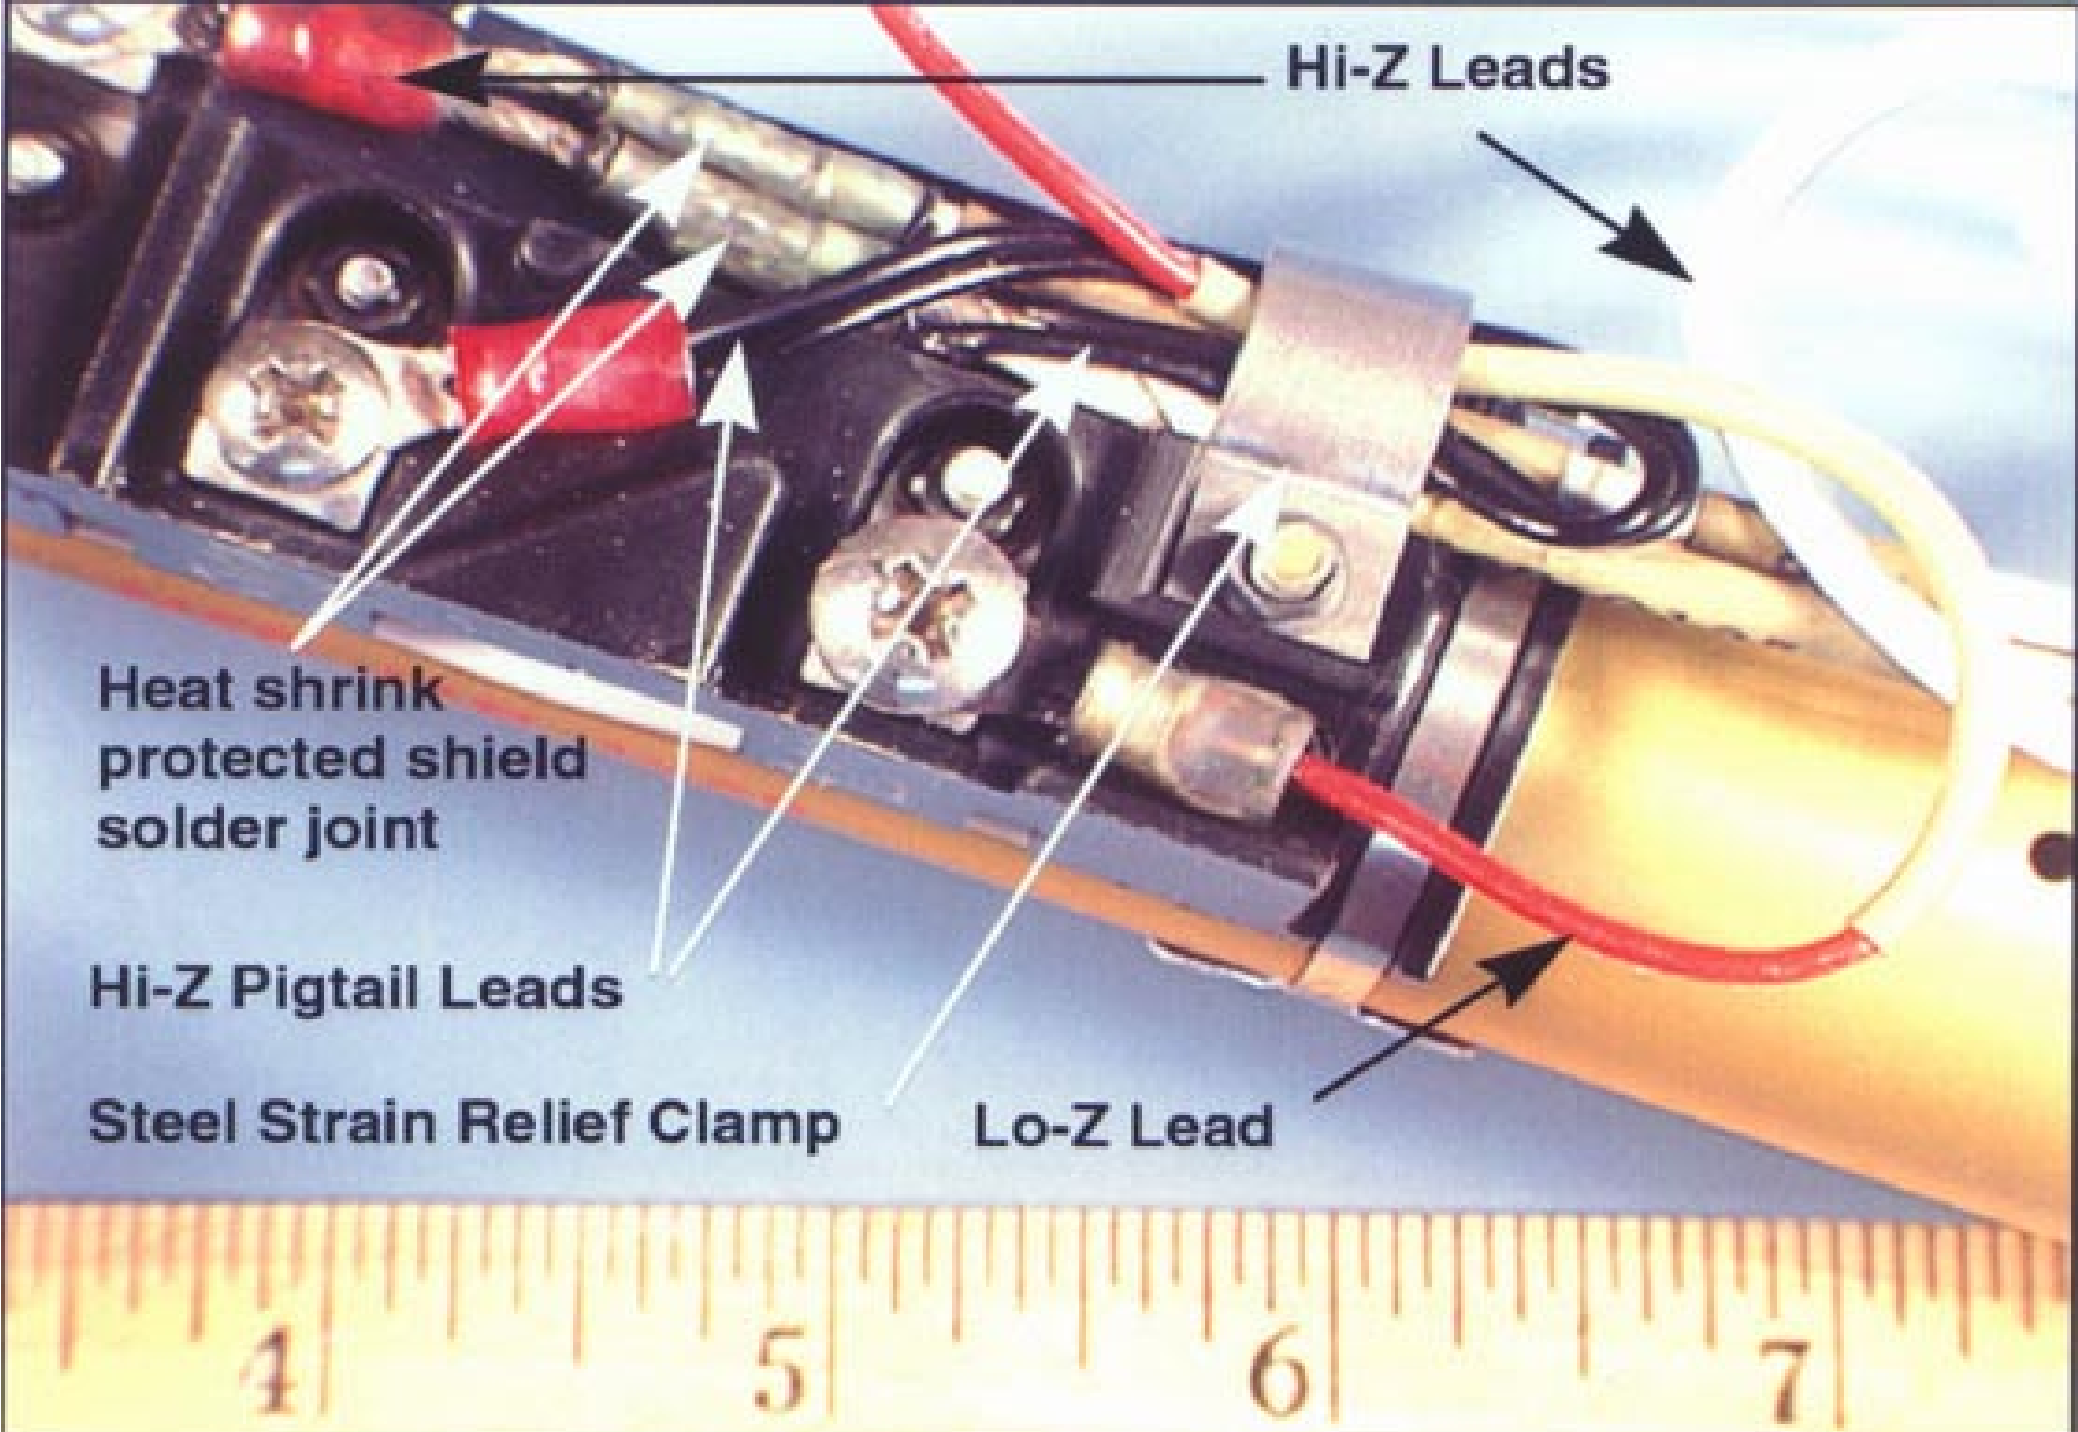
Hi-Z Leads

Steel Strain Relief Clamp

**Steel strain relief clamp shown
rotated out of position**

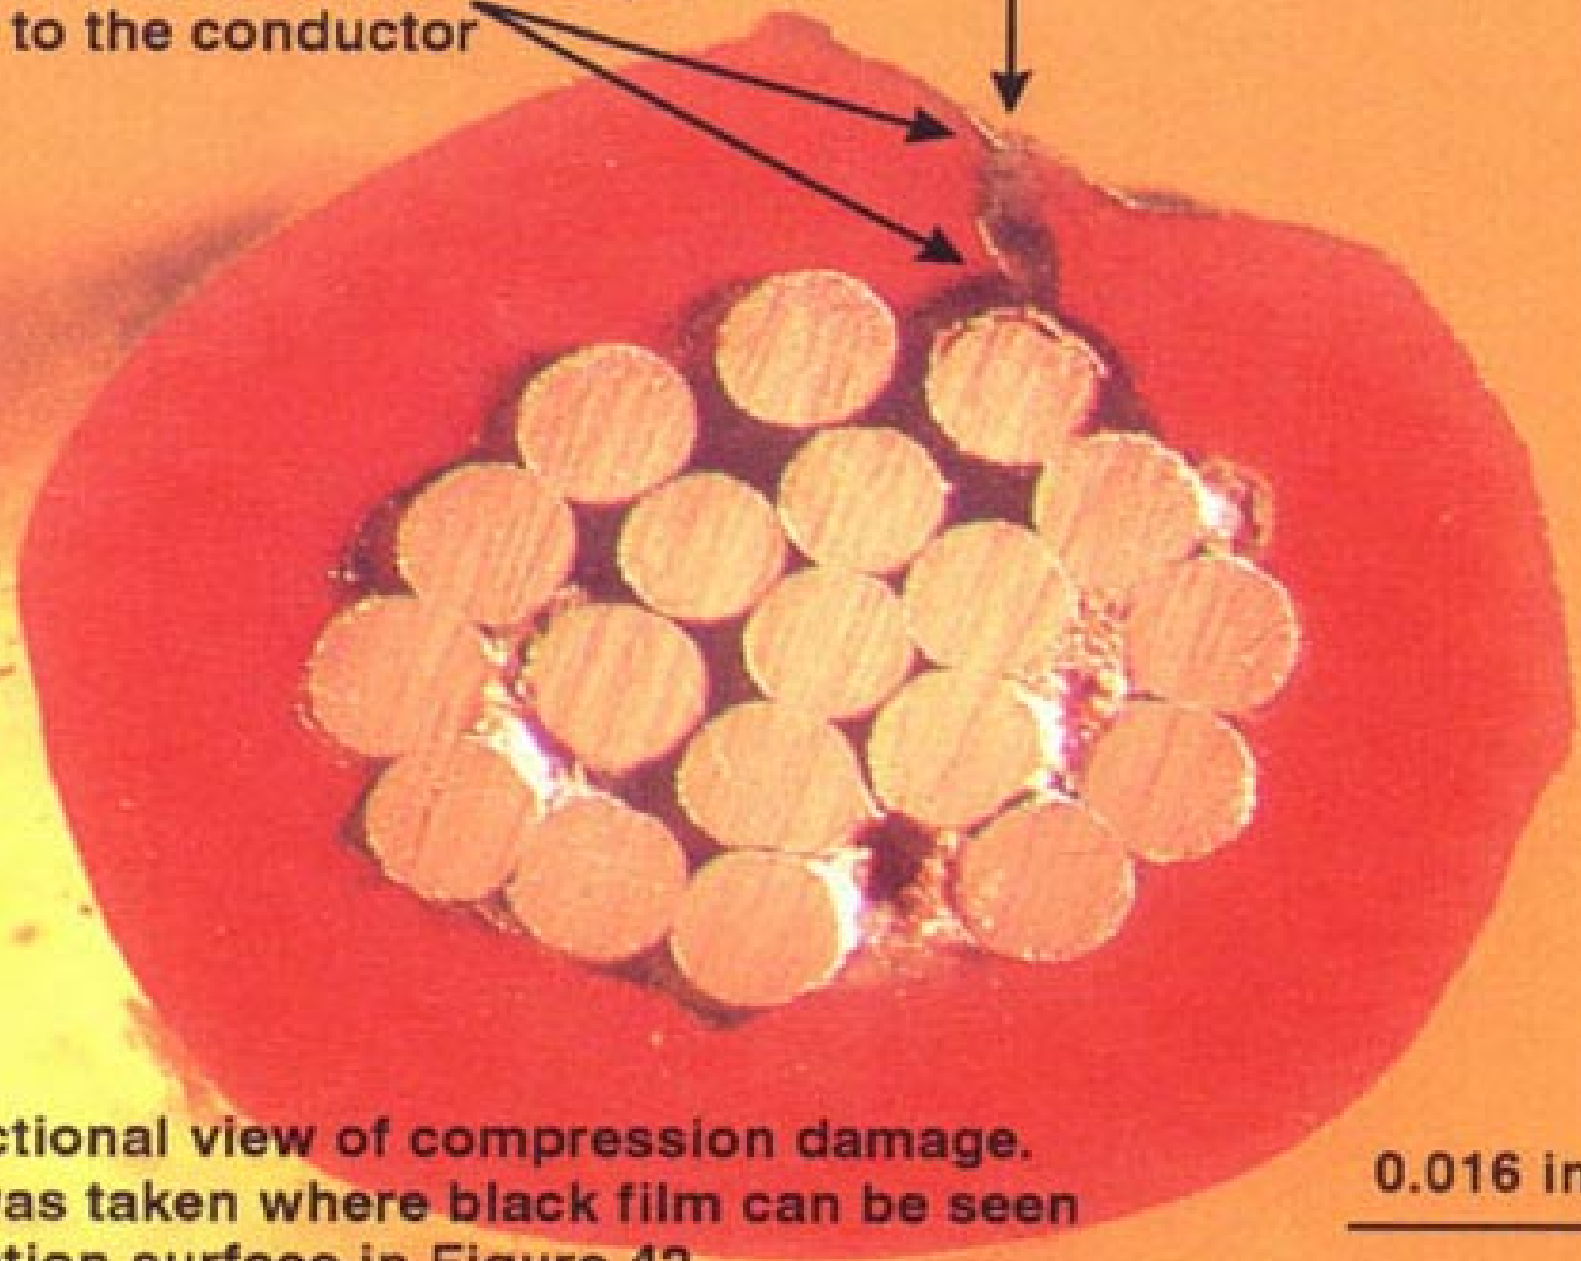
Cross-sectional view of compression damage.
Section was taken where black film can be seen
the insulation surface in Figure 42

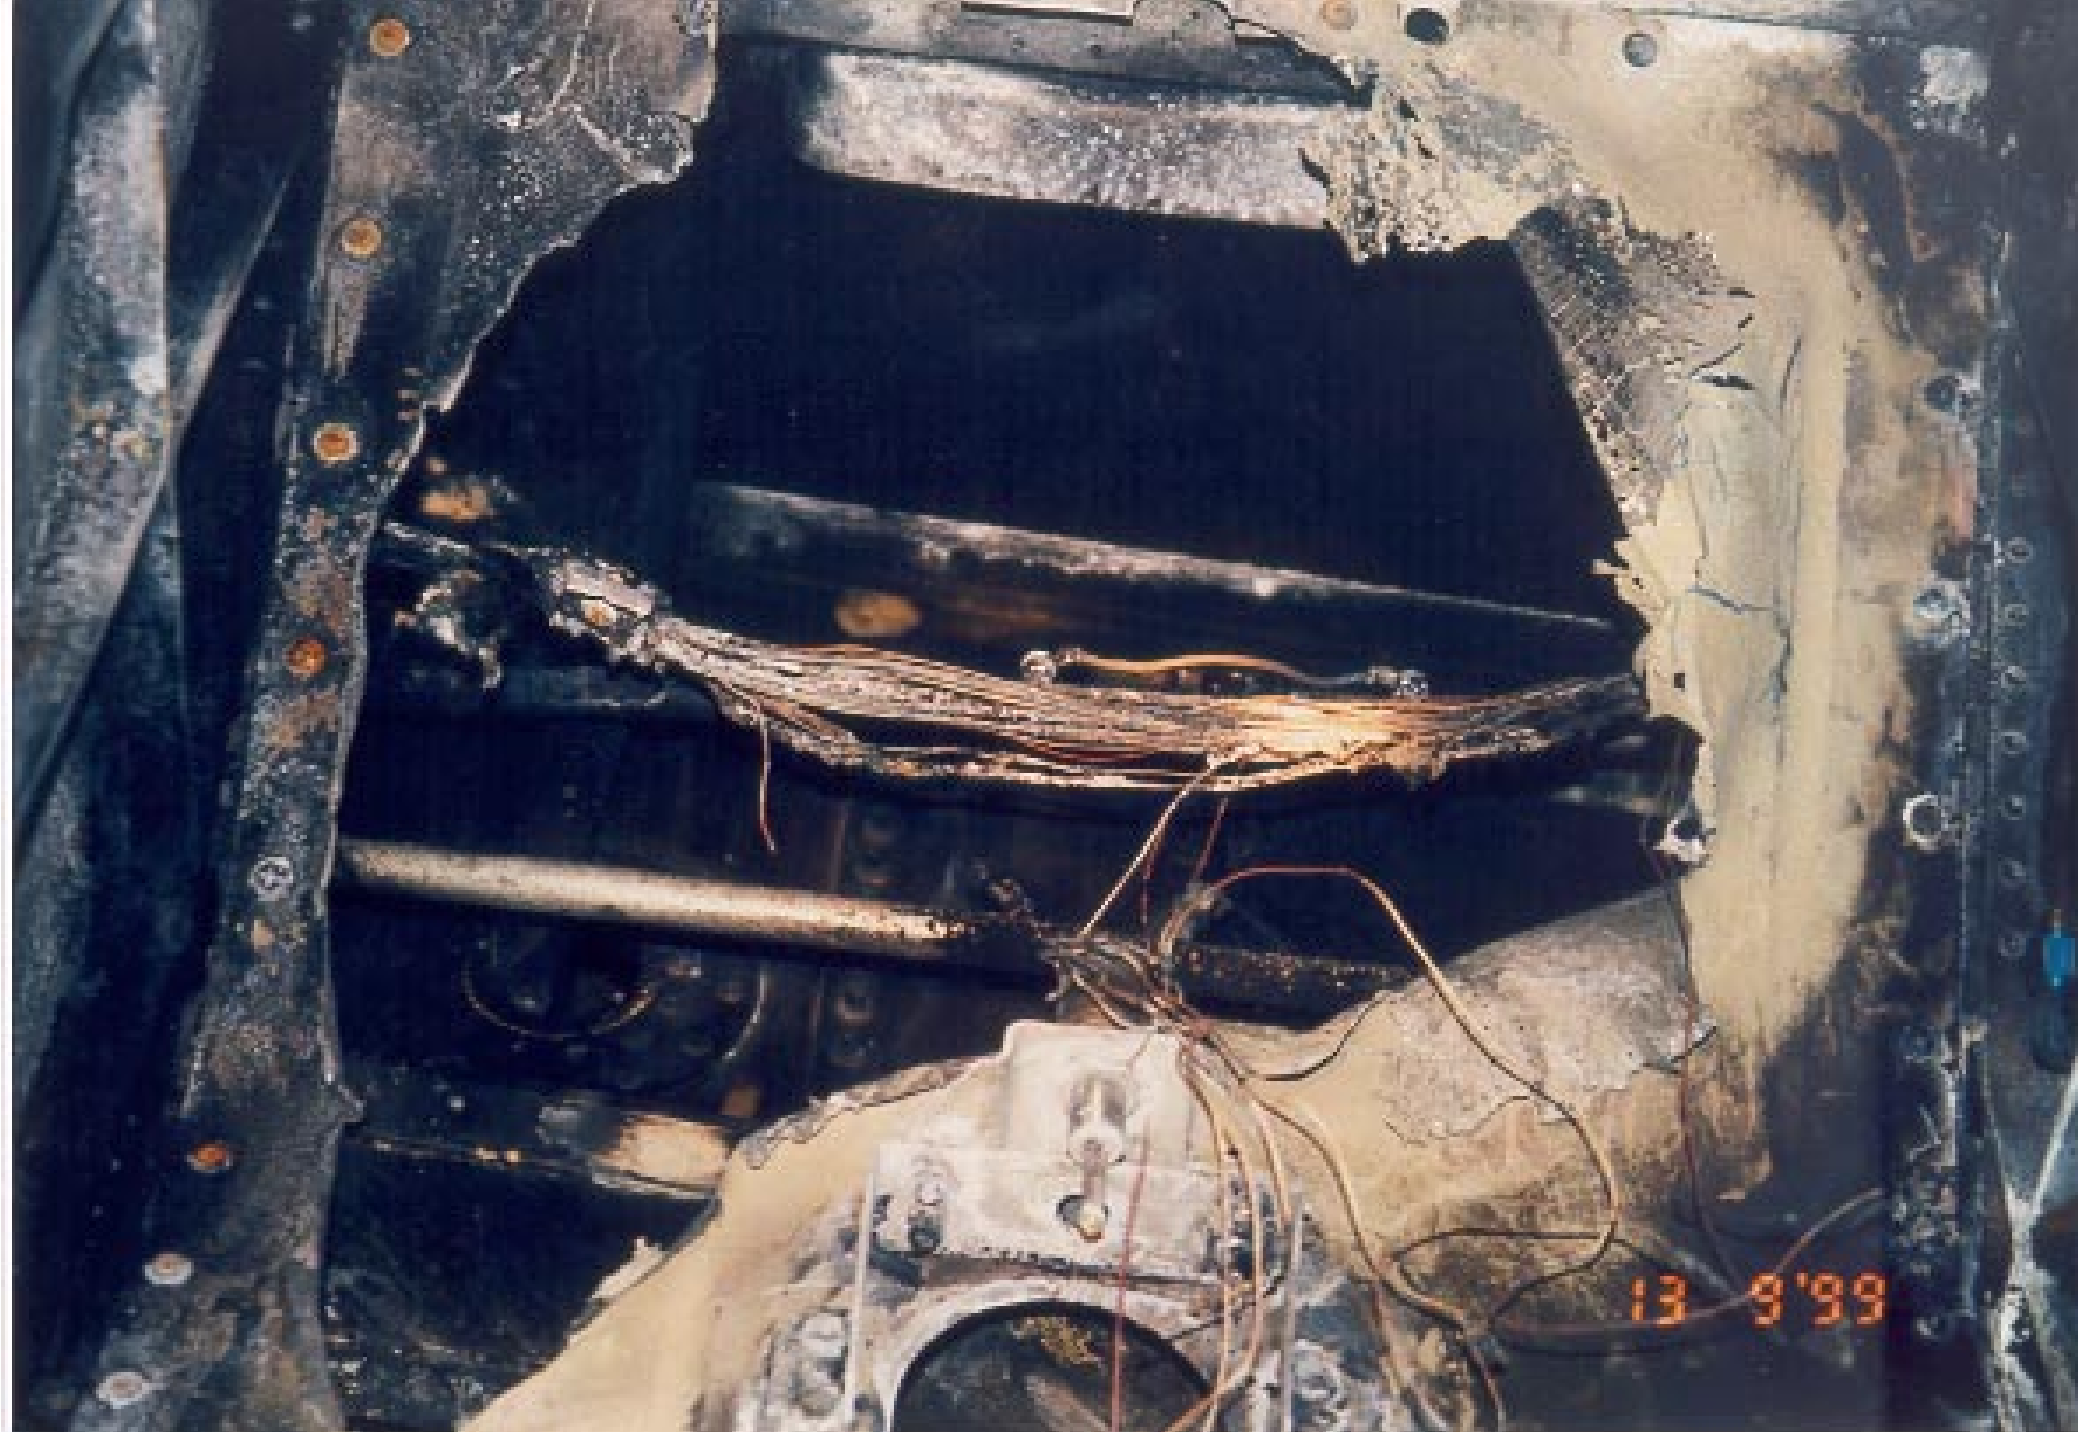
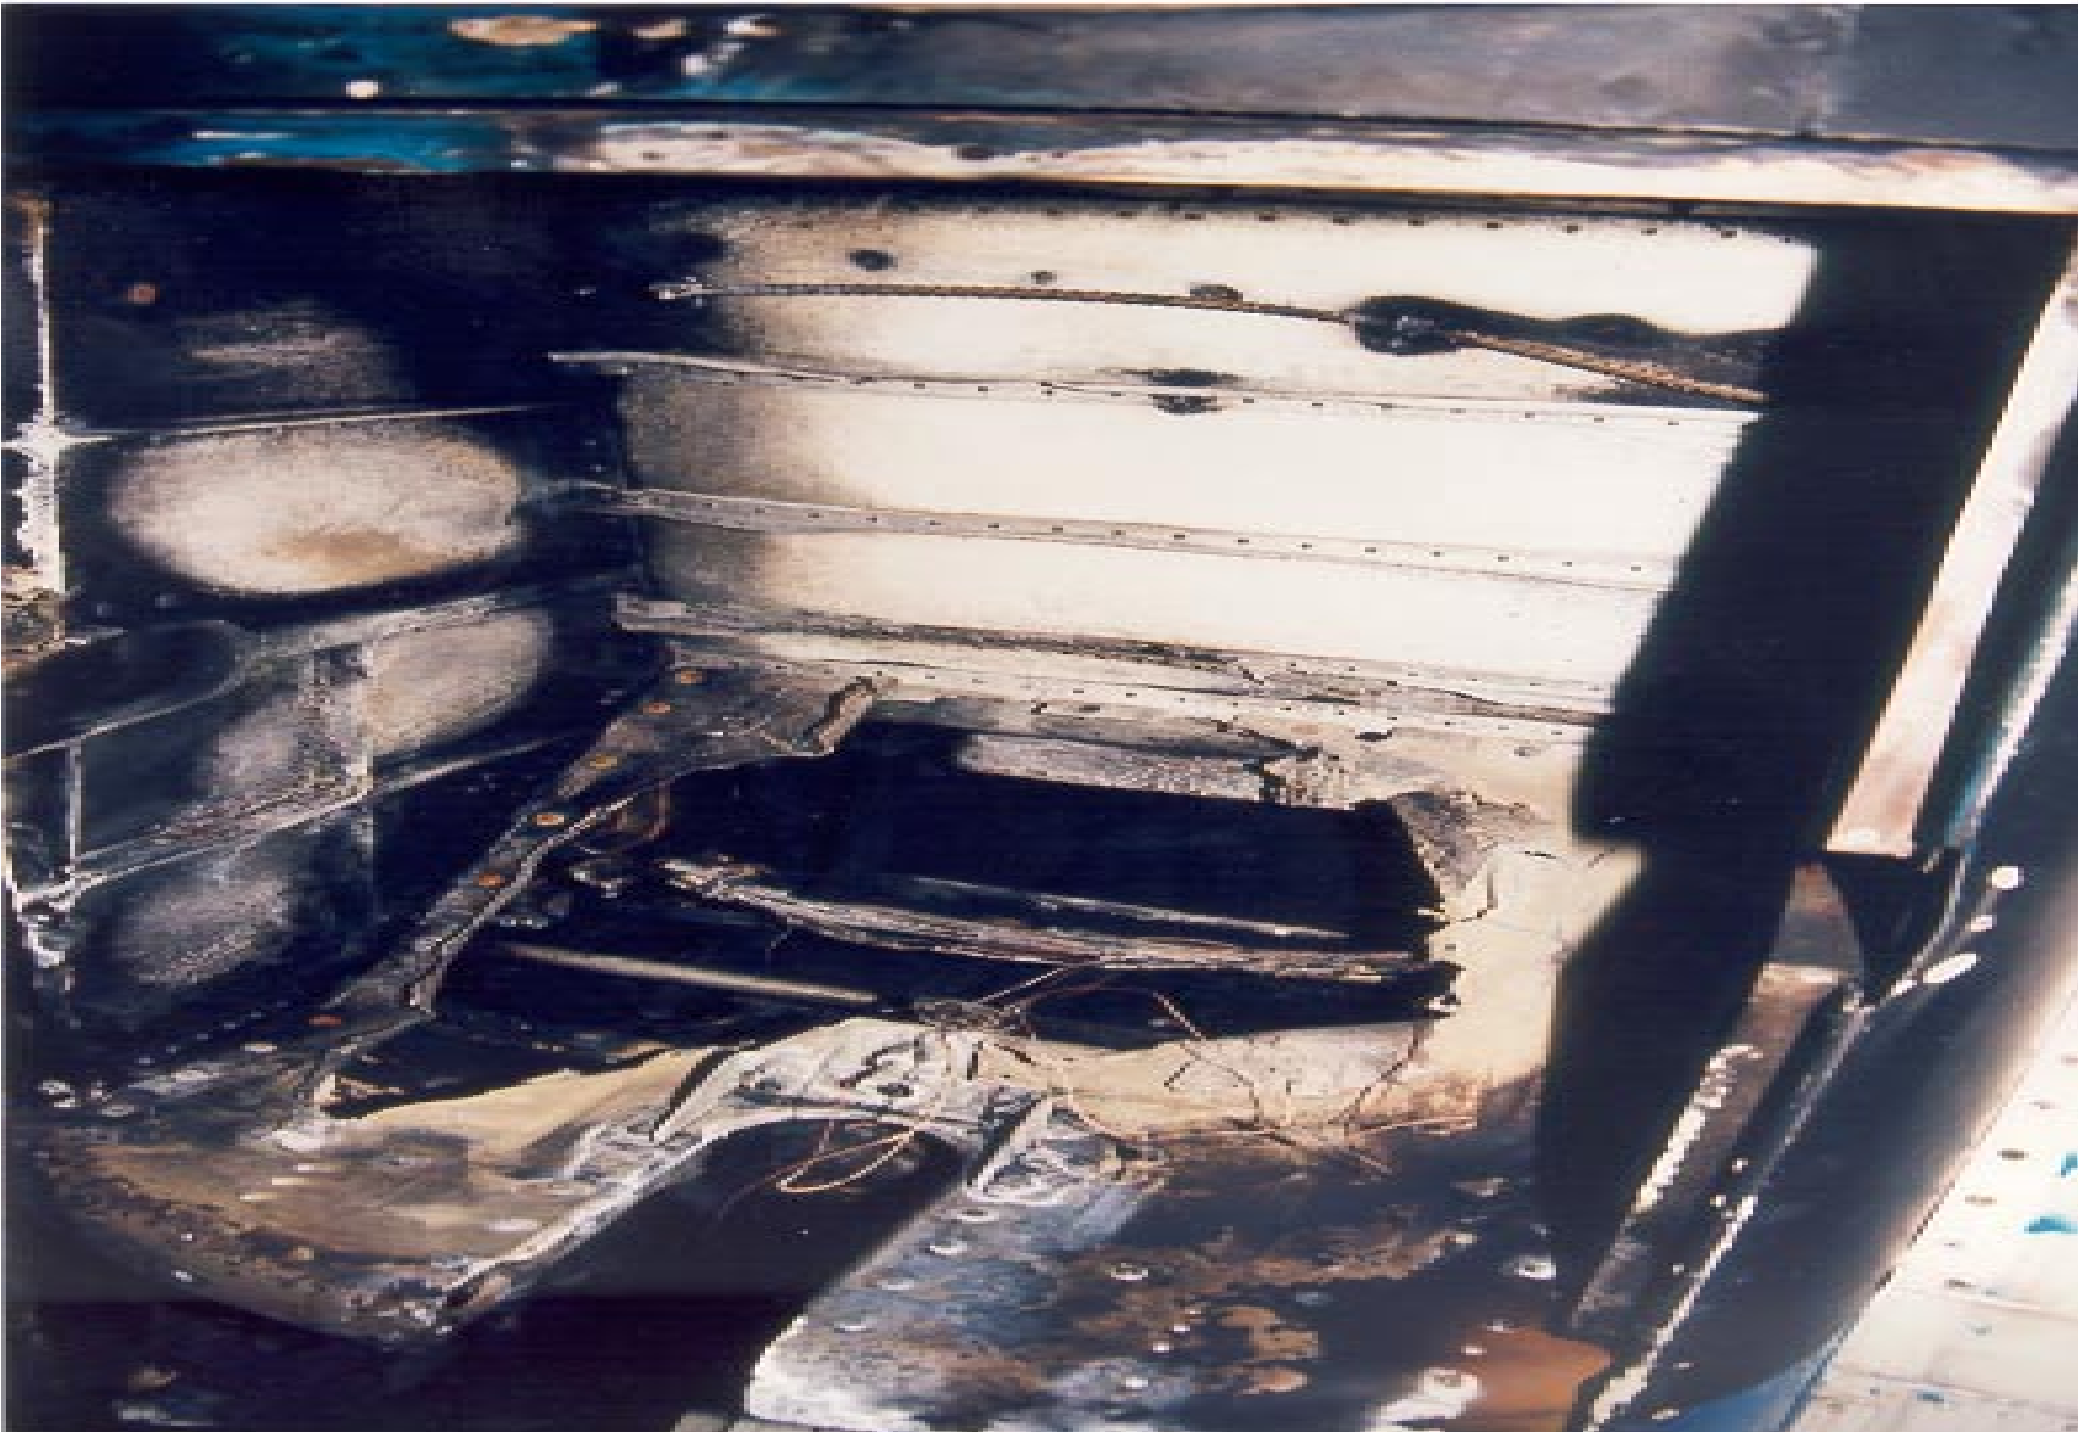
***THE INVESTIGATION FOUND
EVIDENCE OF A FUEL FED FIRE IN
THE AFT AREA OF THE RIGHT
MAIN LANDING GEAR WHEEL
WELL AND IN THE WING
IMMEDIATELY OUT BOARD OF THE
RIGHT ENGINE NACELLE***

***FUEL TO THE FIRE HAD BEEN
SUPPLIED FROM TWO
DAMAGED ALUMINIUM ALLOY
FUEL TANK LINES IN THE
RIGHT WING EQUIPMENT BAY***

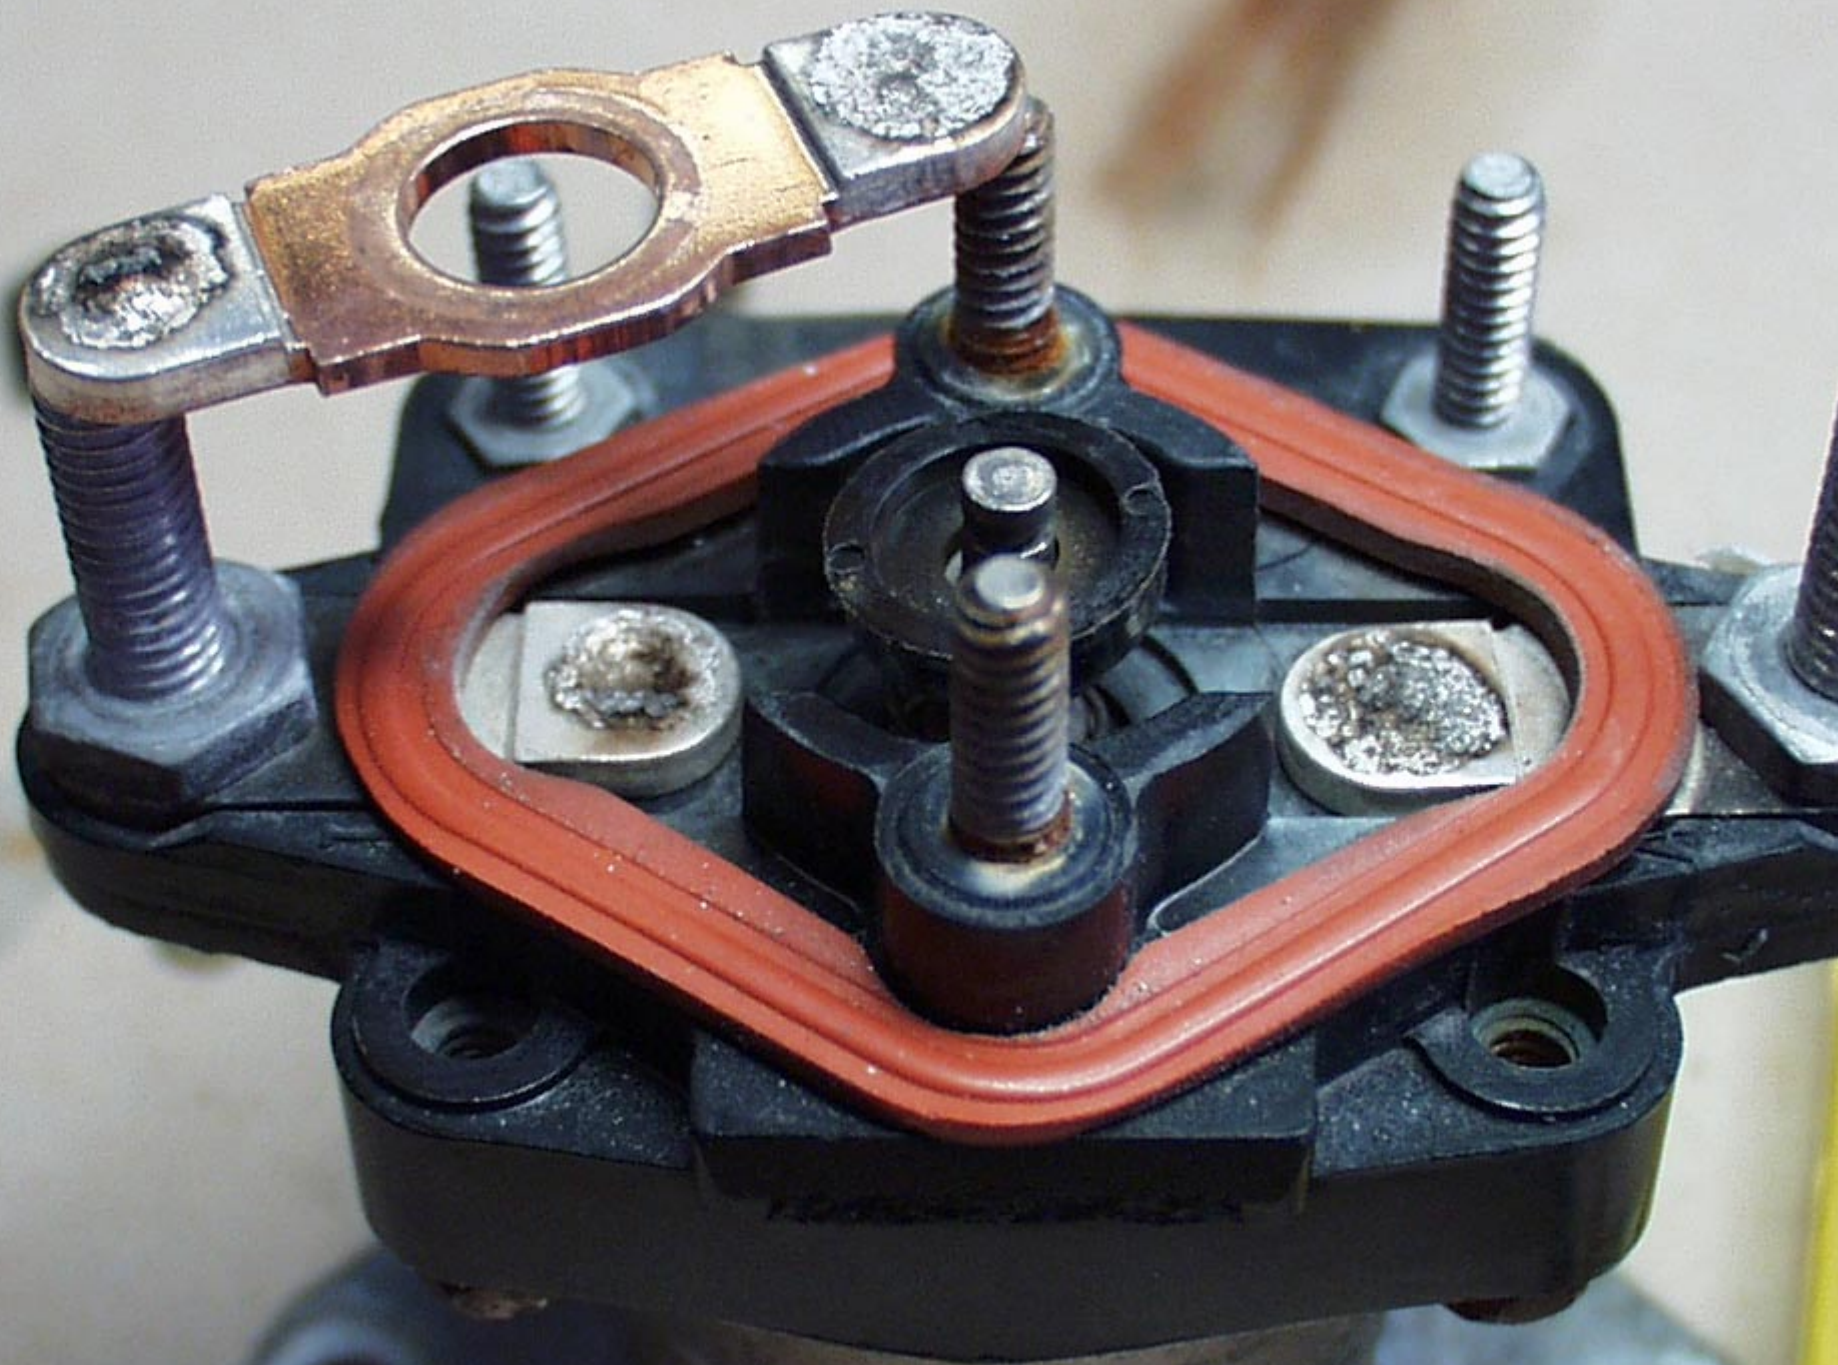
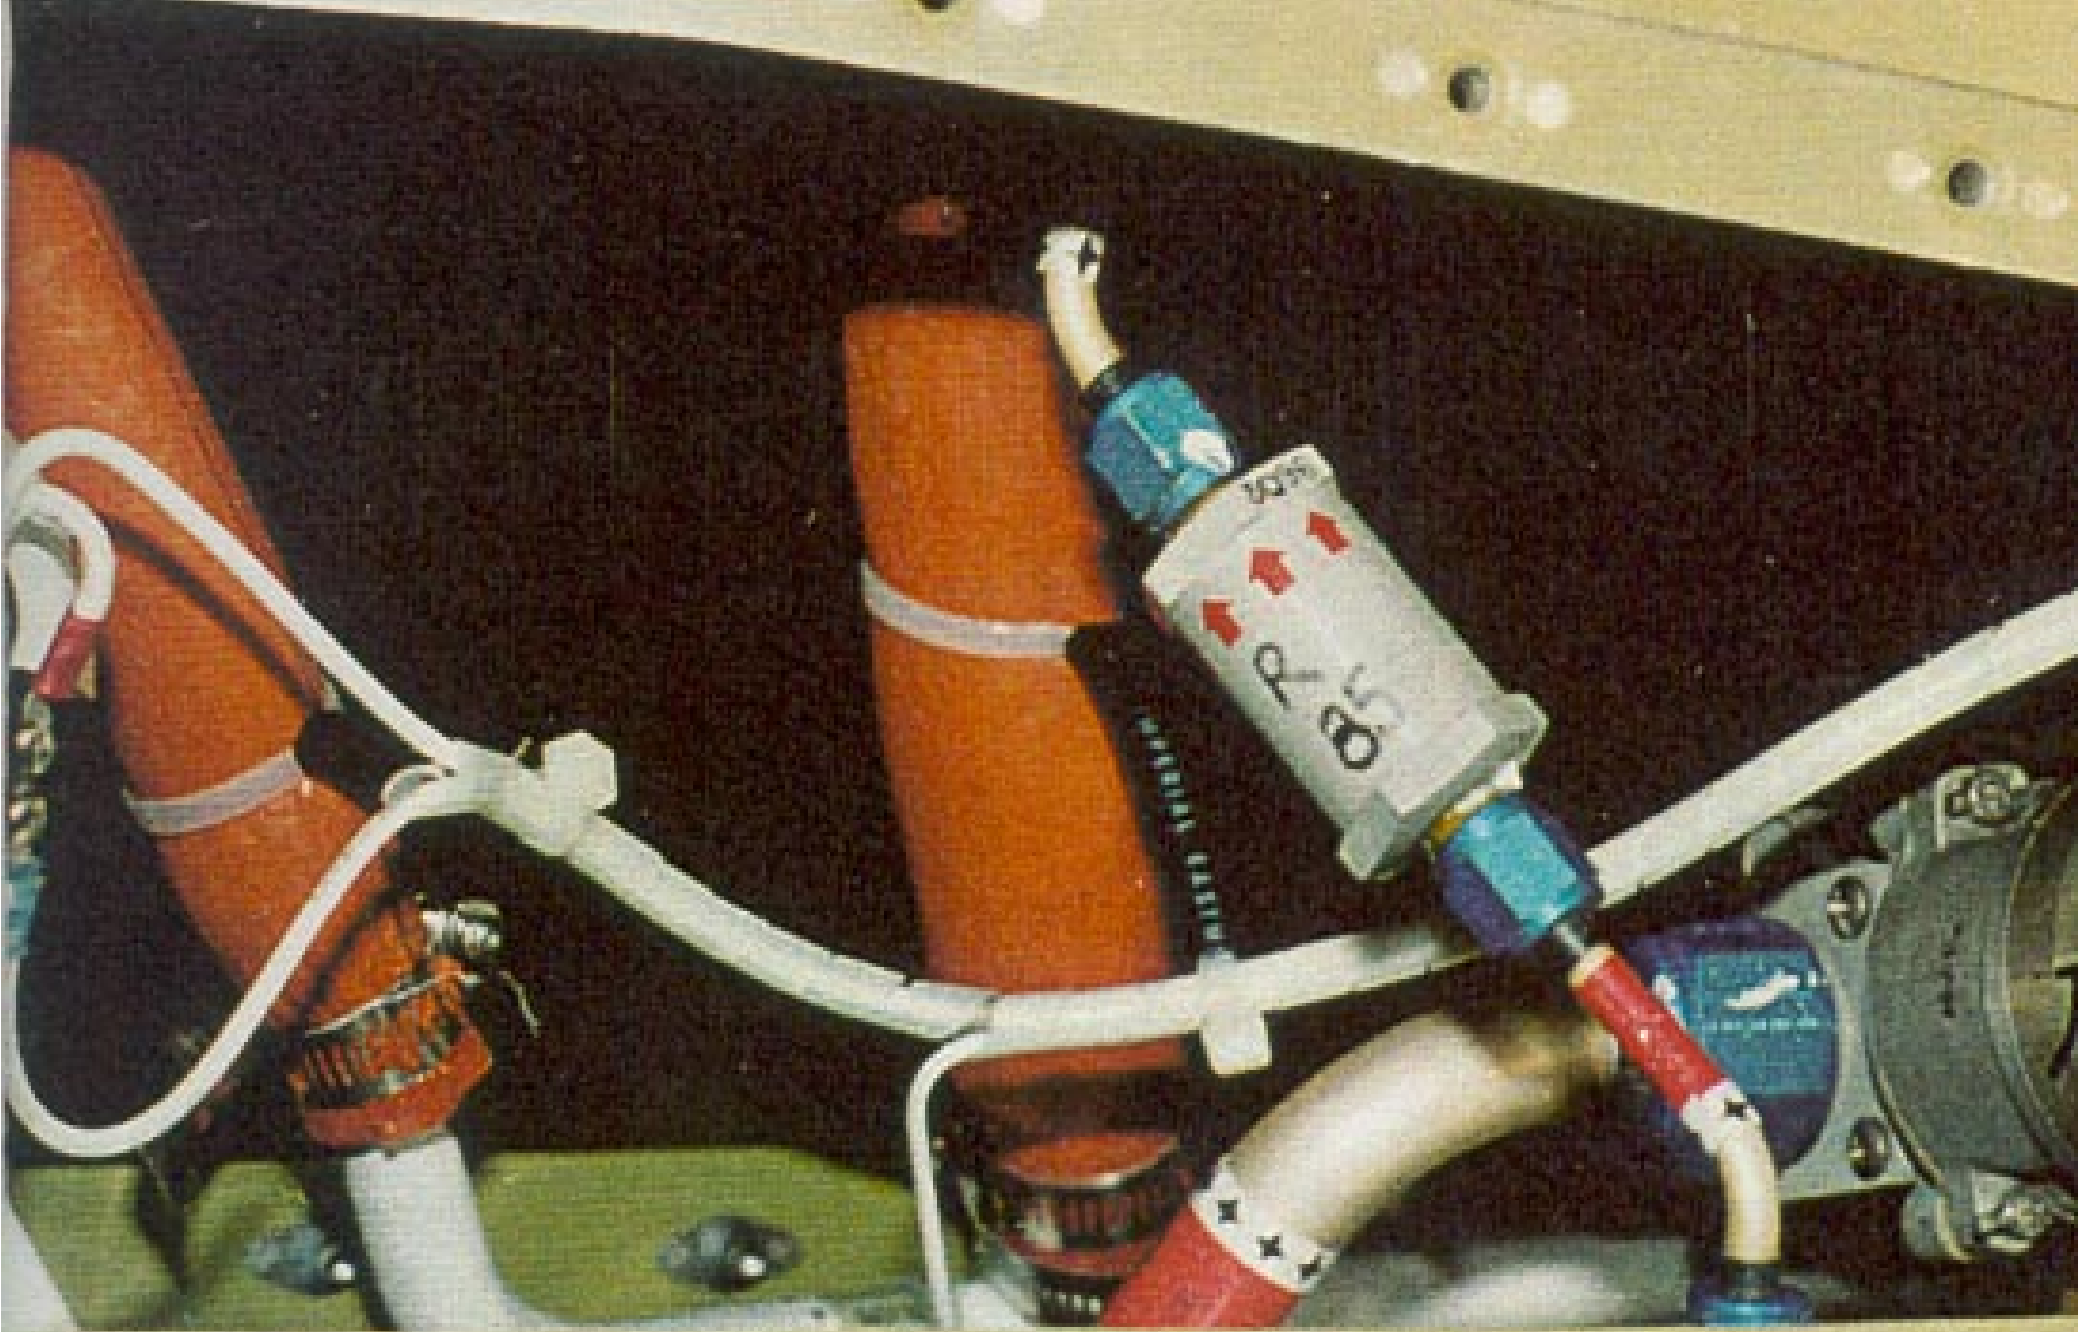
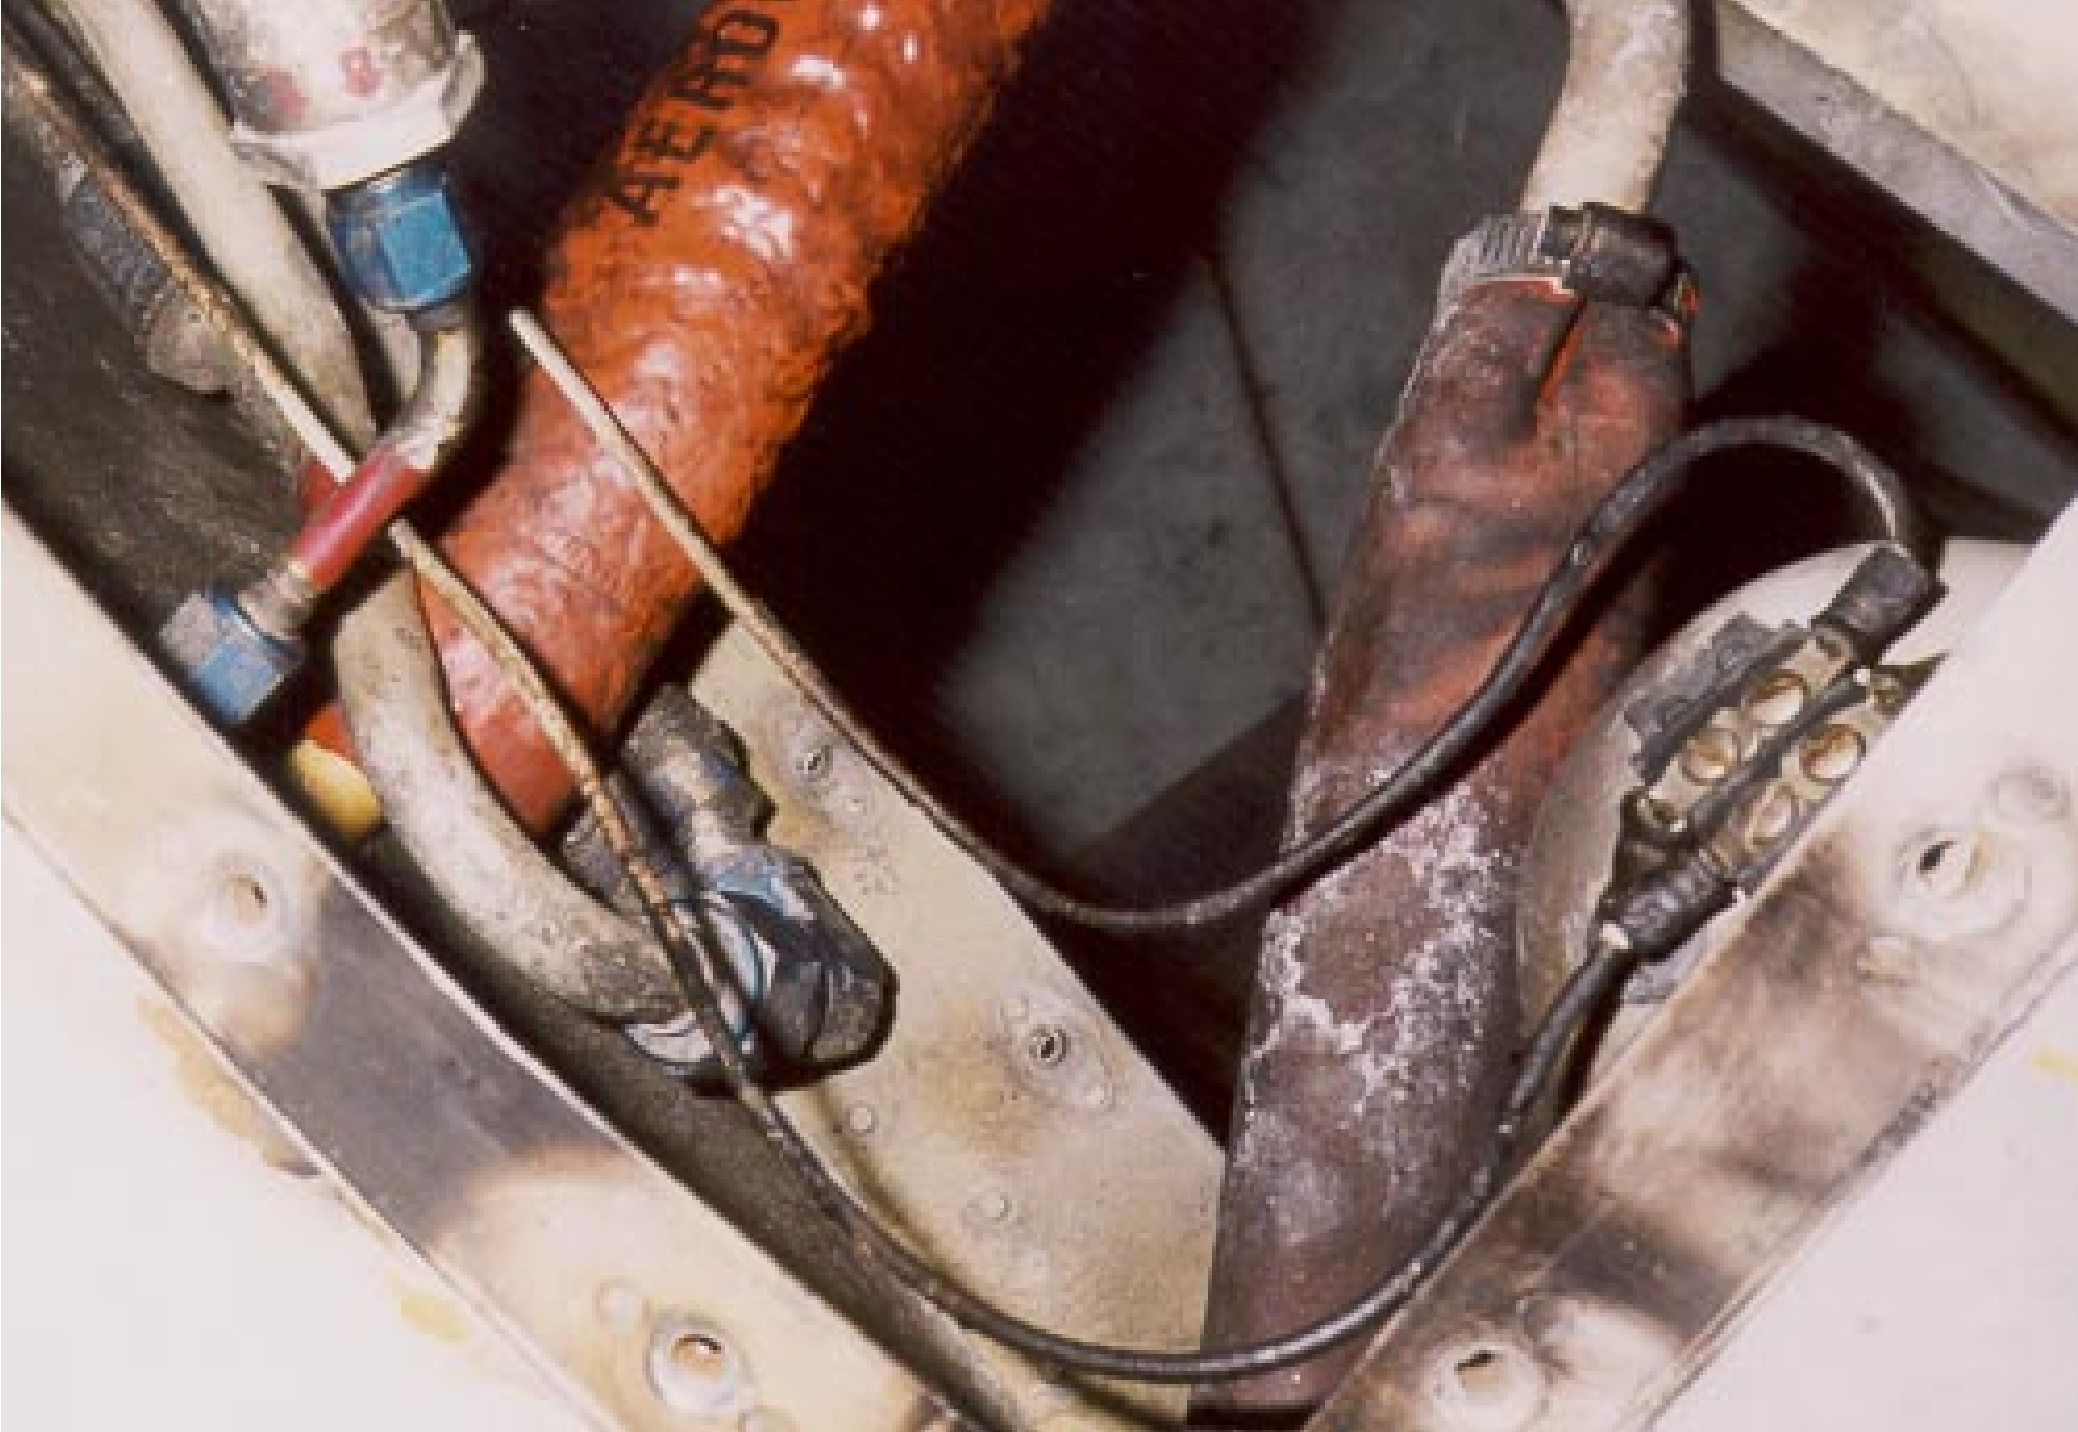
***THE AIRCRAFT INVOLVED IN
THIS ACCIDENT HAD BEEN
REPAIRED PRIOR TO THE
ACCIDENT AND THE
CORRECT WIRING STAND -
OFFS WERE NOT INSTALLED***

INTERIM RECOMENDATION
ALL OPERATORS INITIATE
IMMEDIATE WIRING AND
FUEL LINE INSPECTION IN
WING ZONES 531 & 631
CLOSED AND ACCEPTED
