The Australian Transport Safety Bureau

AIRCRAFT AVIONICS WIRING & ELECTRICAL SYSTEMS

TWA 800
230
LIVES LOST

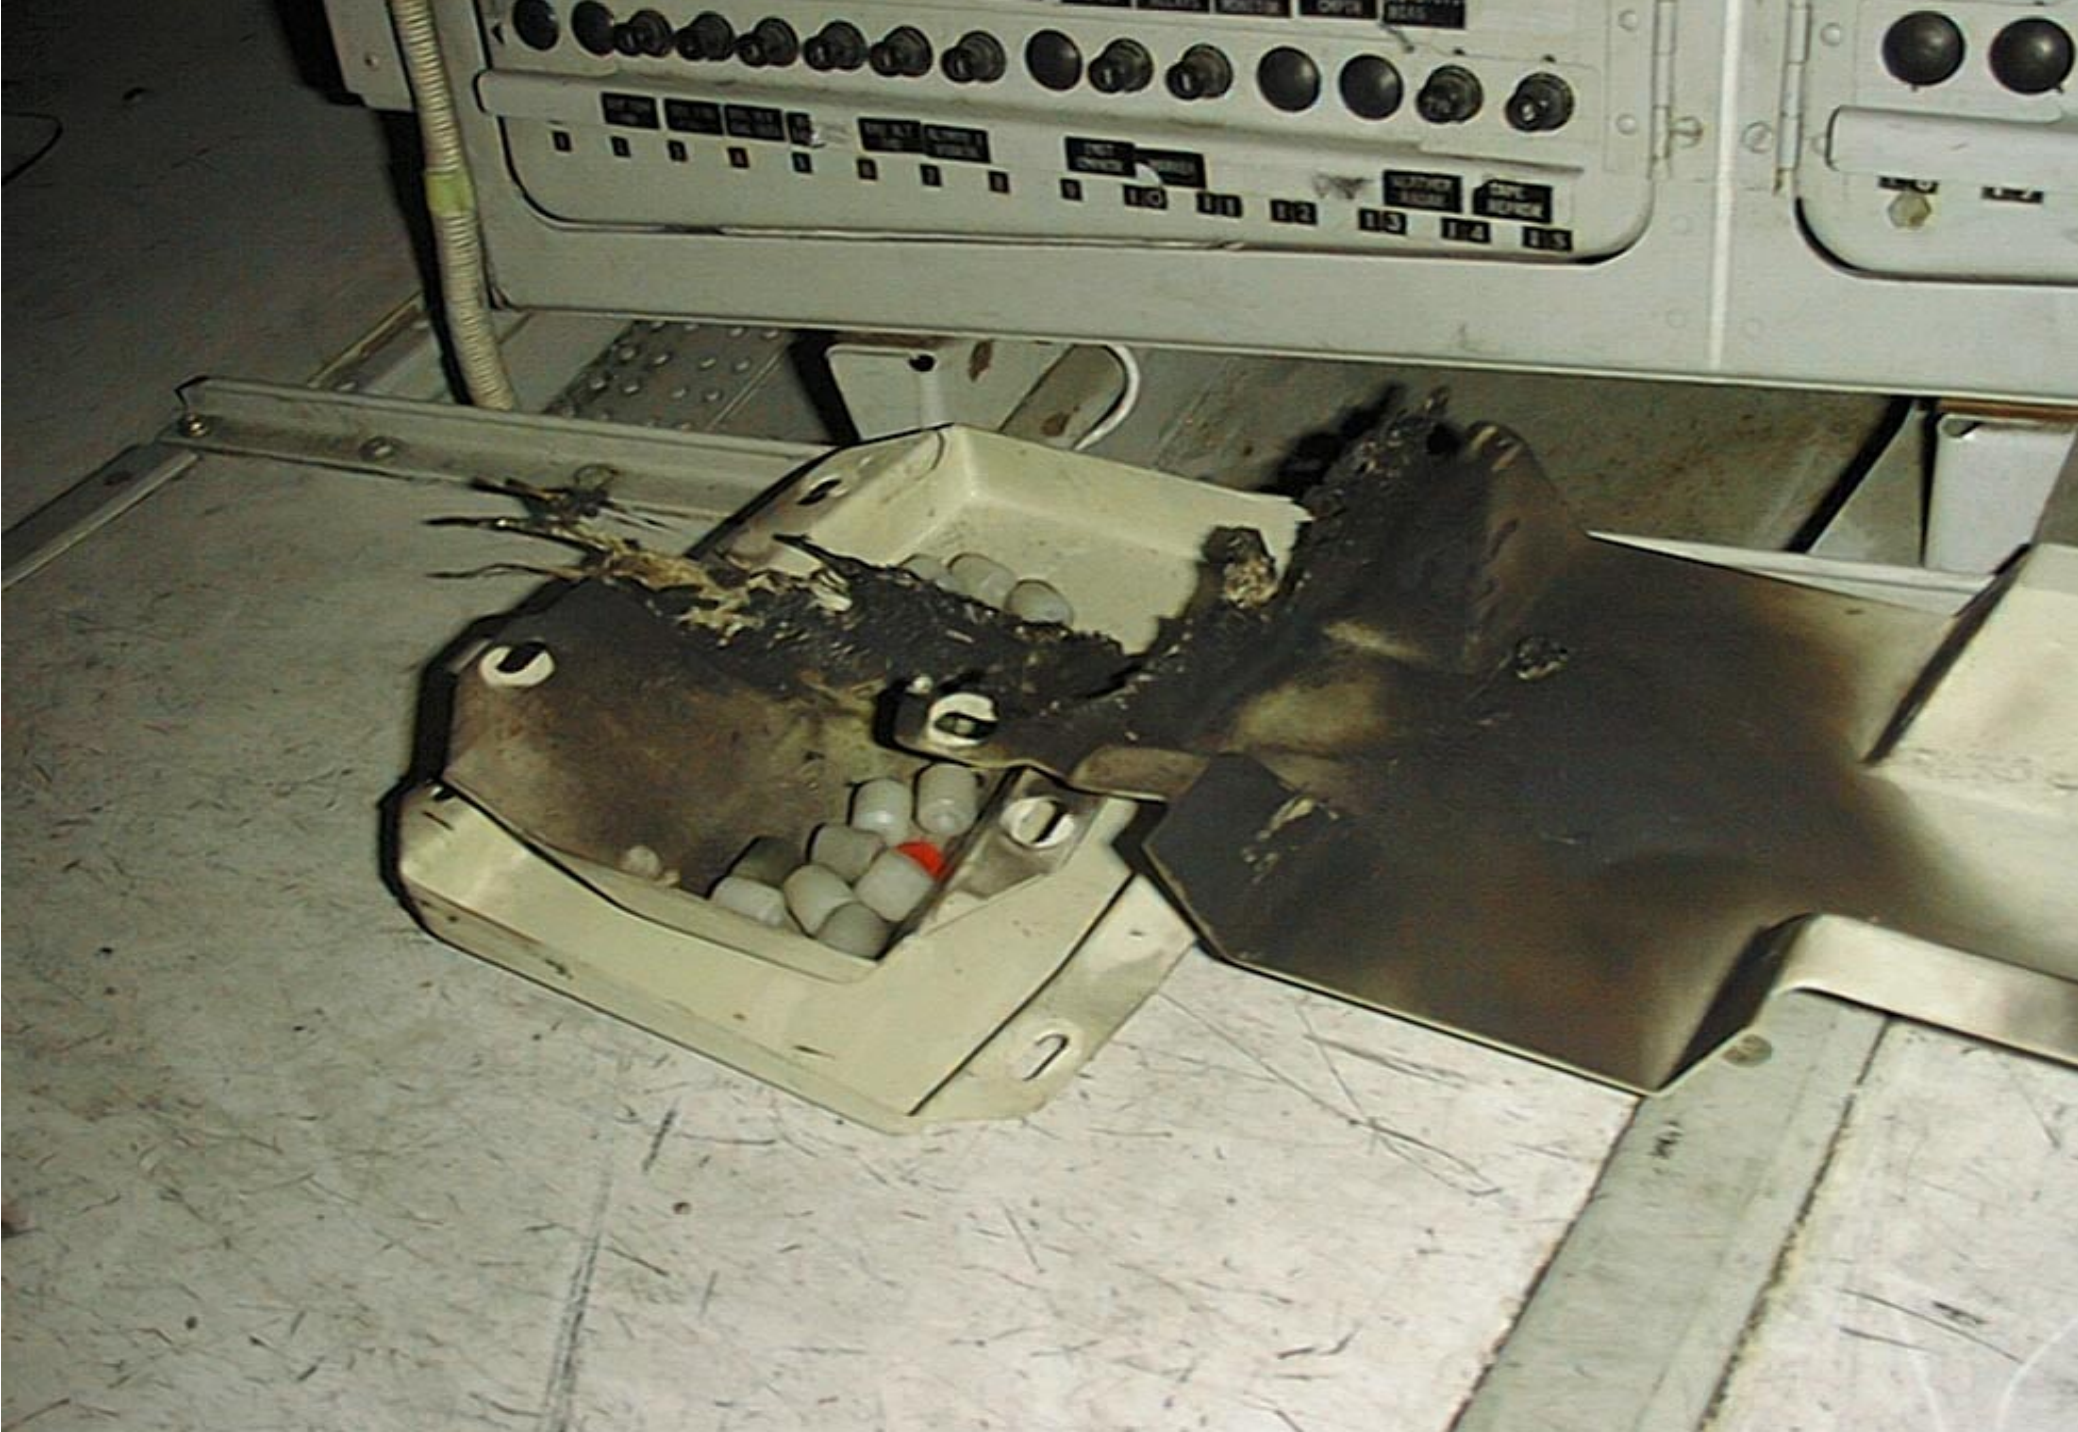
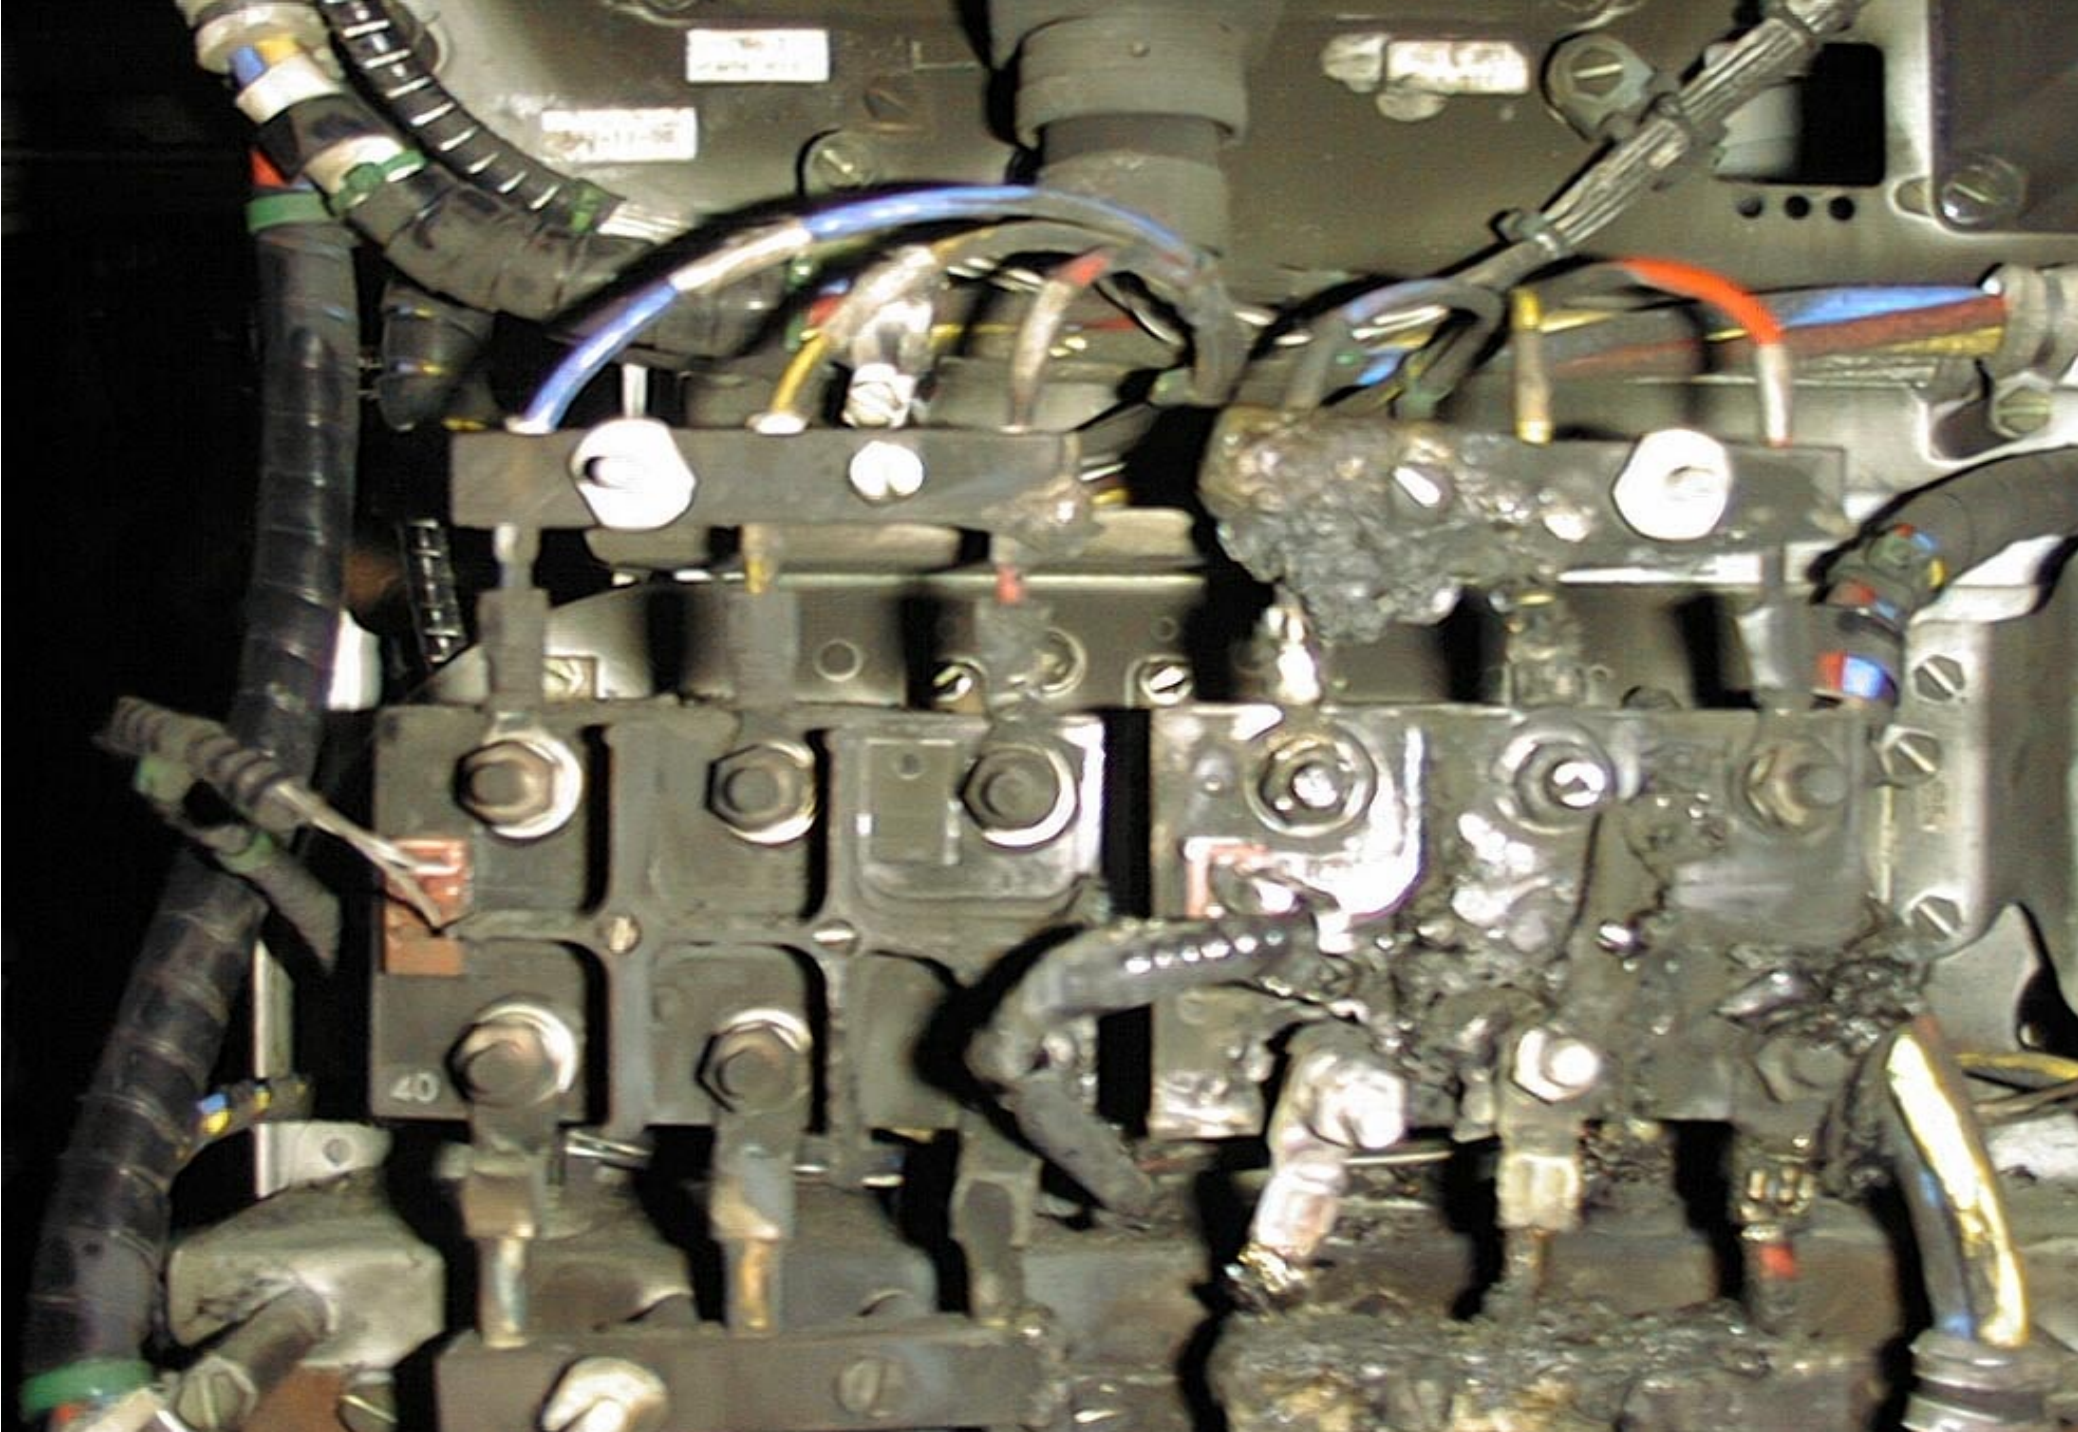
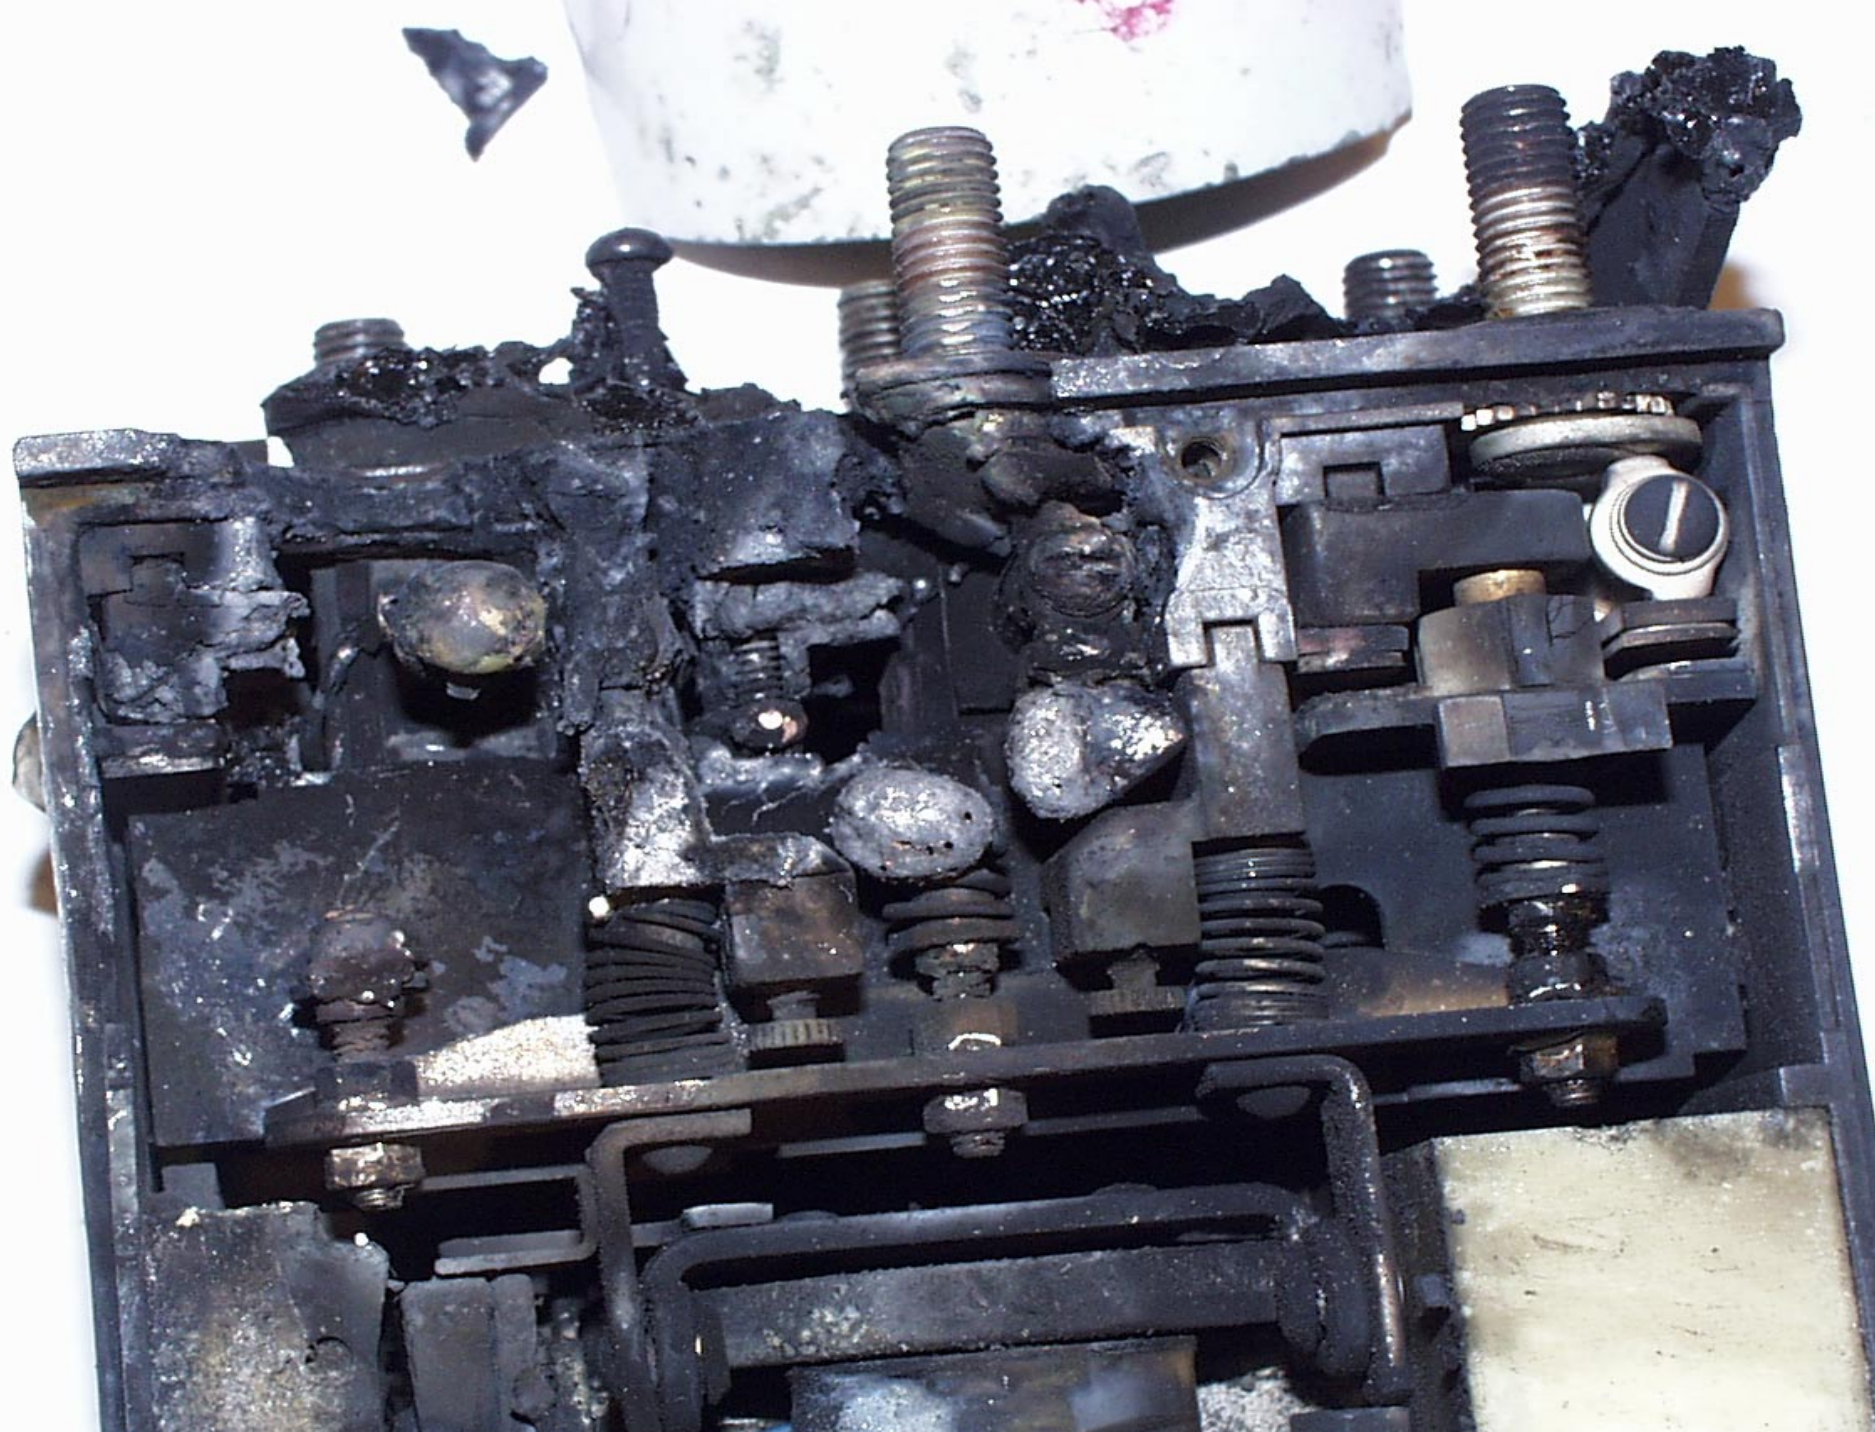
***HIGH CURRENT DRAW
DEVICES SUCH AS A
HYDRAULIC PUMP REQUIRE
SWITCHING DEVICES (RCCB)
OR RELAYS***

***THESE DEVICES REQUIRE
REGULAR MAINTENANCE
INSPECTIONS PARTICULARLY IN
AGEING AIRCRAFT AS THESE
DEVICES ARE DEGRADED BY
THE HEAT PRODUCED BY THEIR
OWN OPERATION***

***THE RCCB LOCATED IN THE
EQUIPMENT BAY WITHIN THE
CABIN IS NOT MONITORED BY FIRE
OR SMOKE DETECTORS THE
TECHNICAL CREW WERE ALERTED
BY SMOKE IN THE COCKPIT,
SYSTEM FAILURES AND THE FIRE***

***AFTER CONSULTATION WITH THE
ATSB THE OPERATOR INSTIGATED
A NEW PROCEDURE TSI-146-24-004***

-
- ***FITMENT OF HEAT SENSITIVE DECALS TO THE RCCB***
 - ***RECORDING THE OPERATING TEMPERATURES IN A DATA BASE TO ANALYSE TEMPERATURE TRENDS THIS METHOD TURNED UP ANOTHER FAULTY RCCB (PROACTIVE)***
-

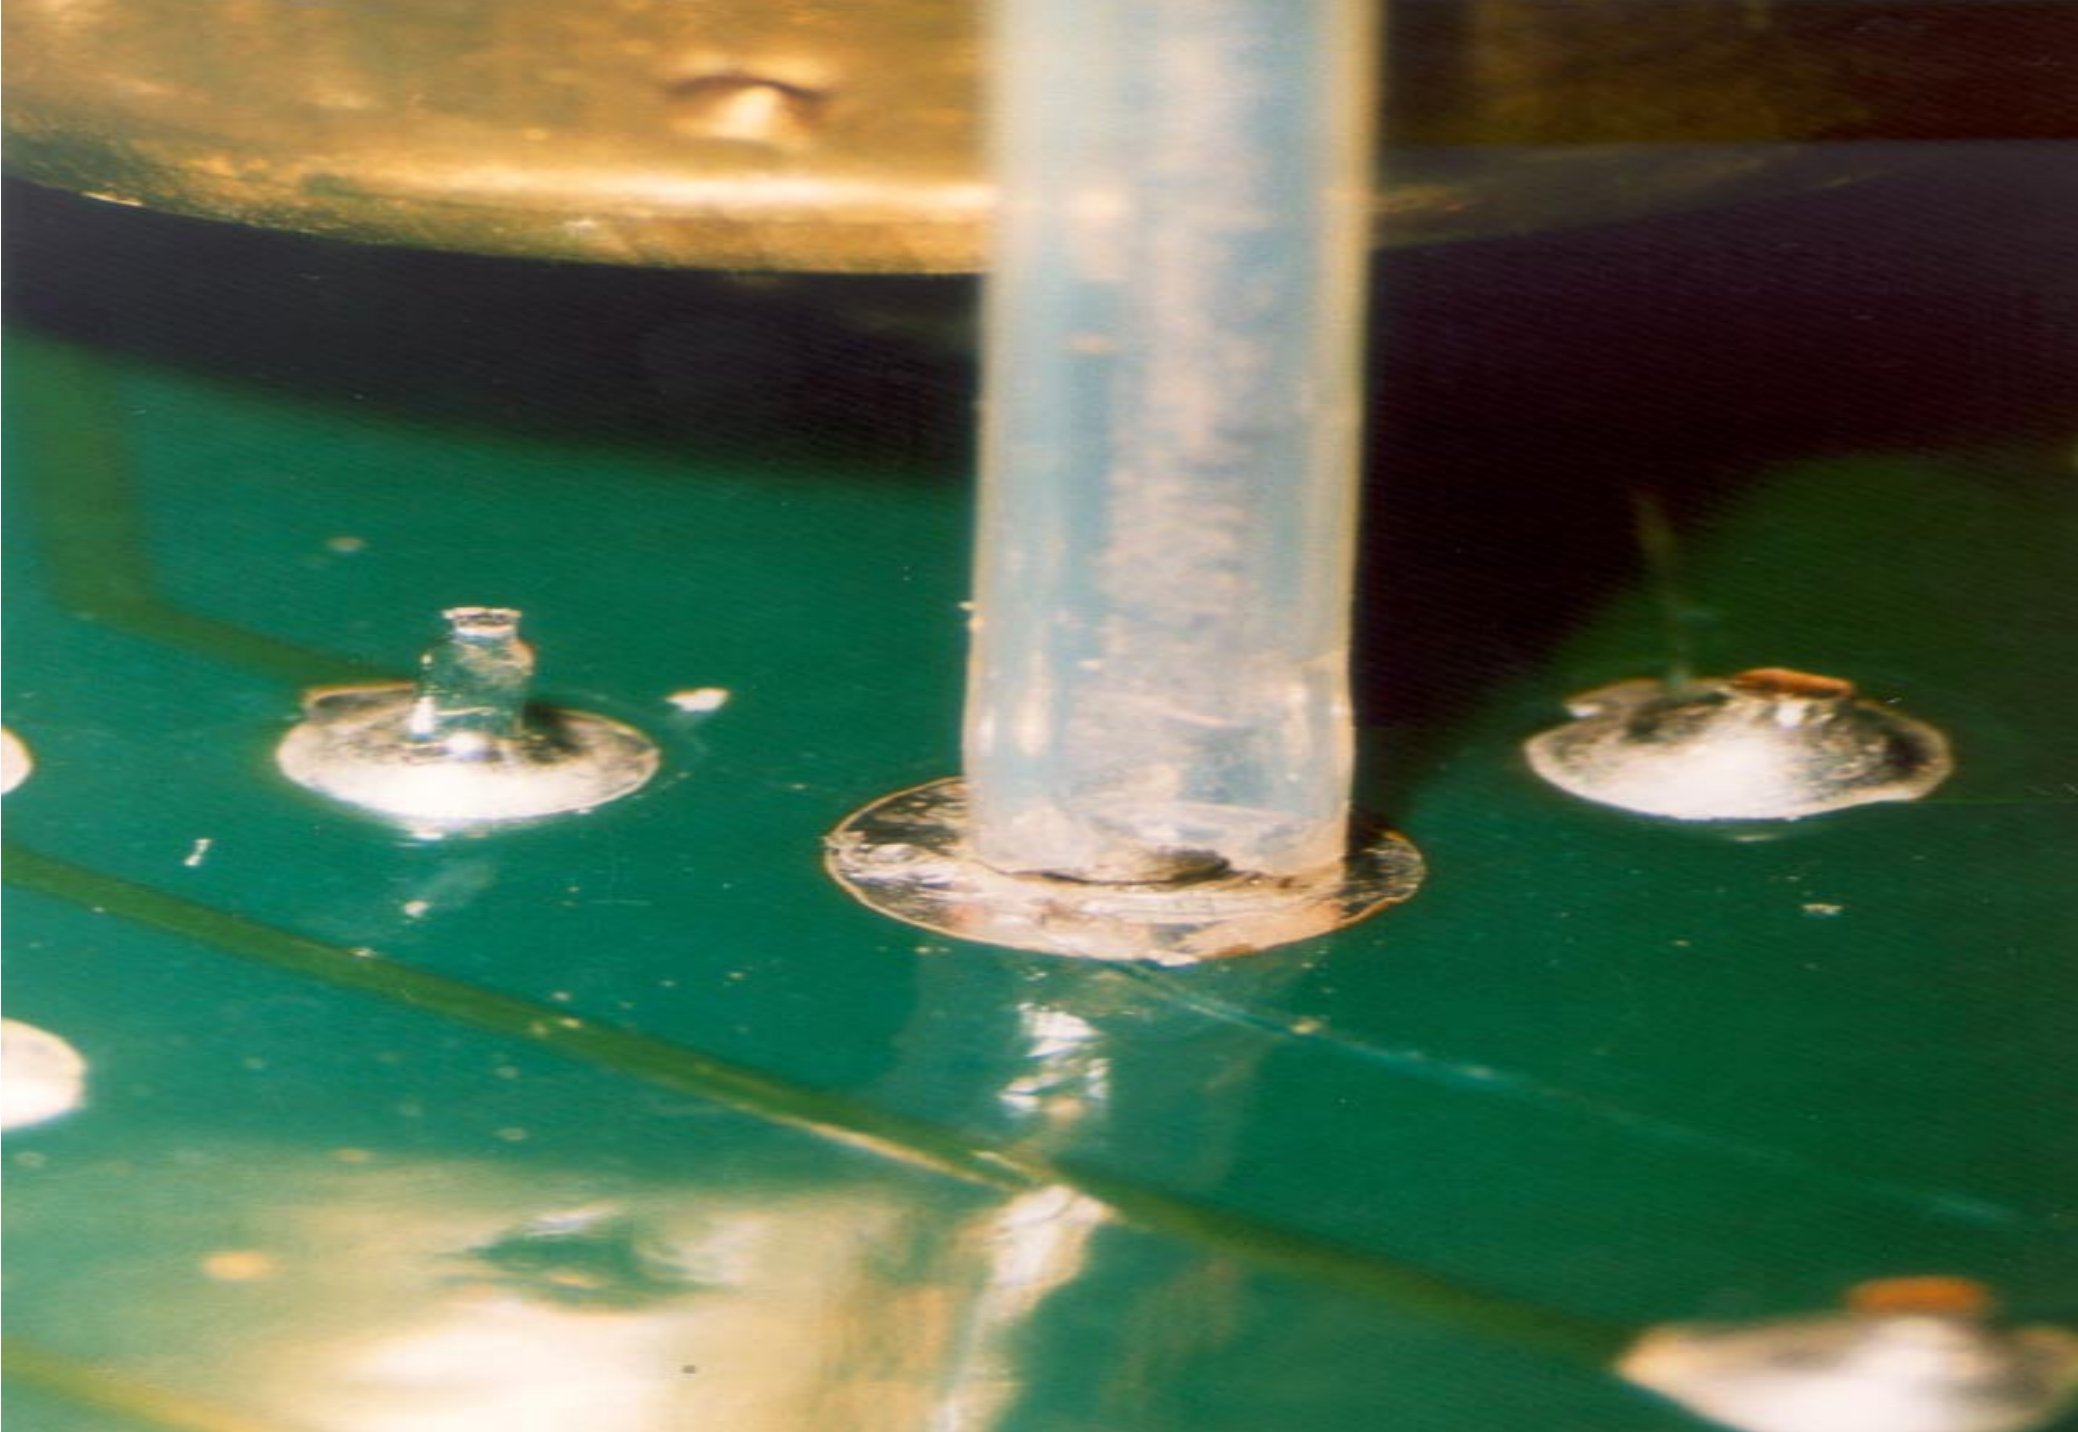
***EXAMINATIONS OF ELT'S
RETURNED FROM ACCIDENT
SITES HAVE REVEALED
FAILURES OF DIFFERENT TYPES
IN THIS CASE THE UNIT DID NOT
TRANSMIT A SIGNAL DUE TO A
ELECTRONIC FAULT***

***WHEN TESTED THE UNIT
OPERATED INTERMITTENTLY
EXAMINATION OF THE CIRCUIT
BOARD REVEALED A DRY
JOINT AT THE “G” SWITCH***

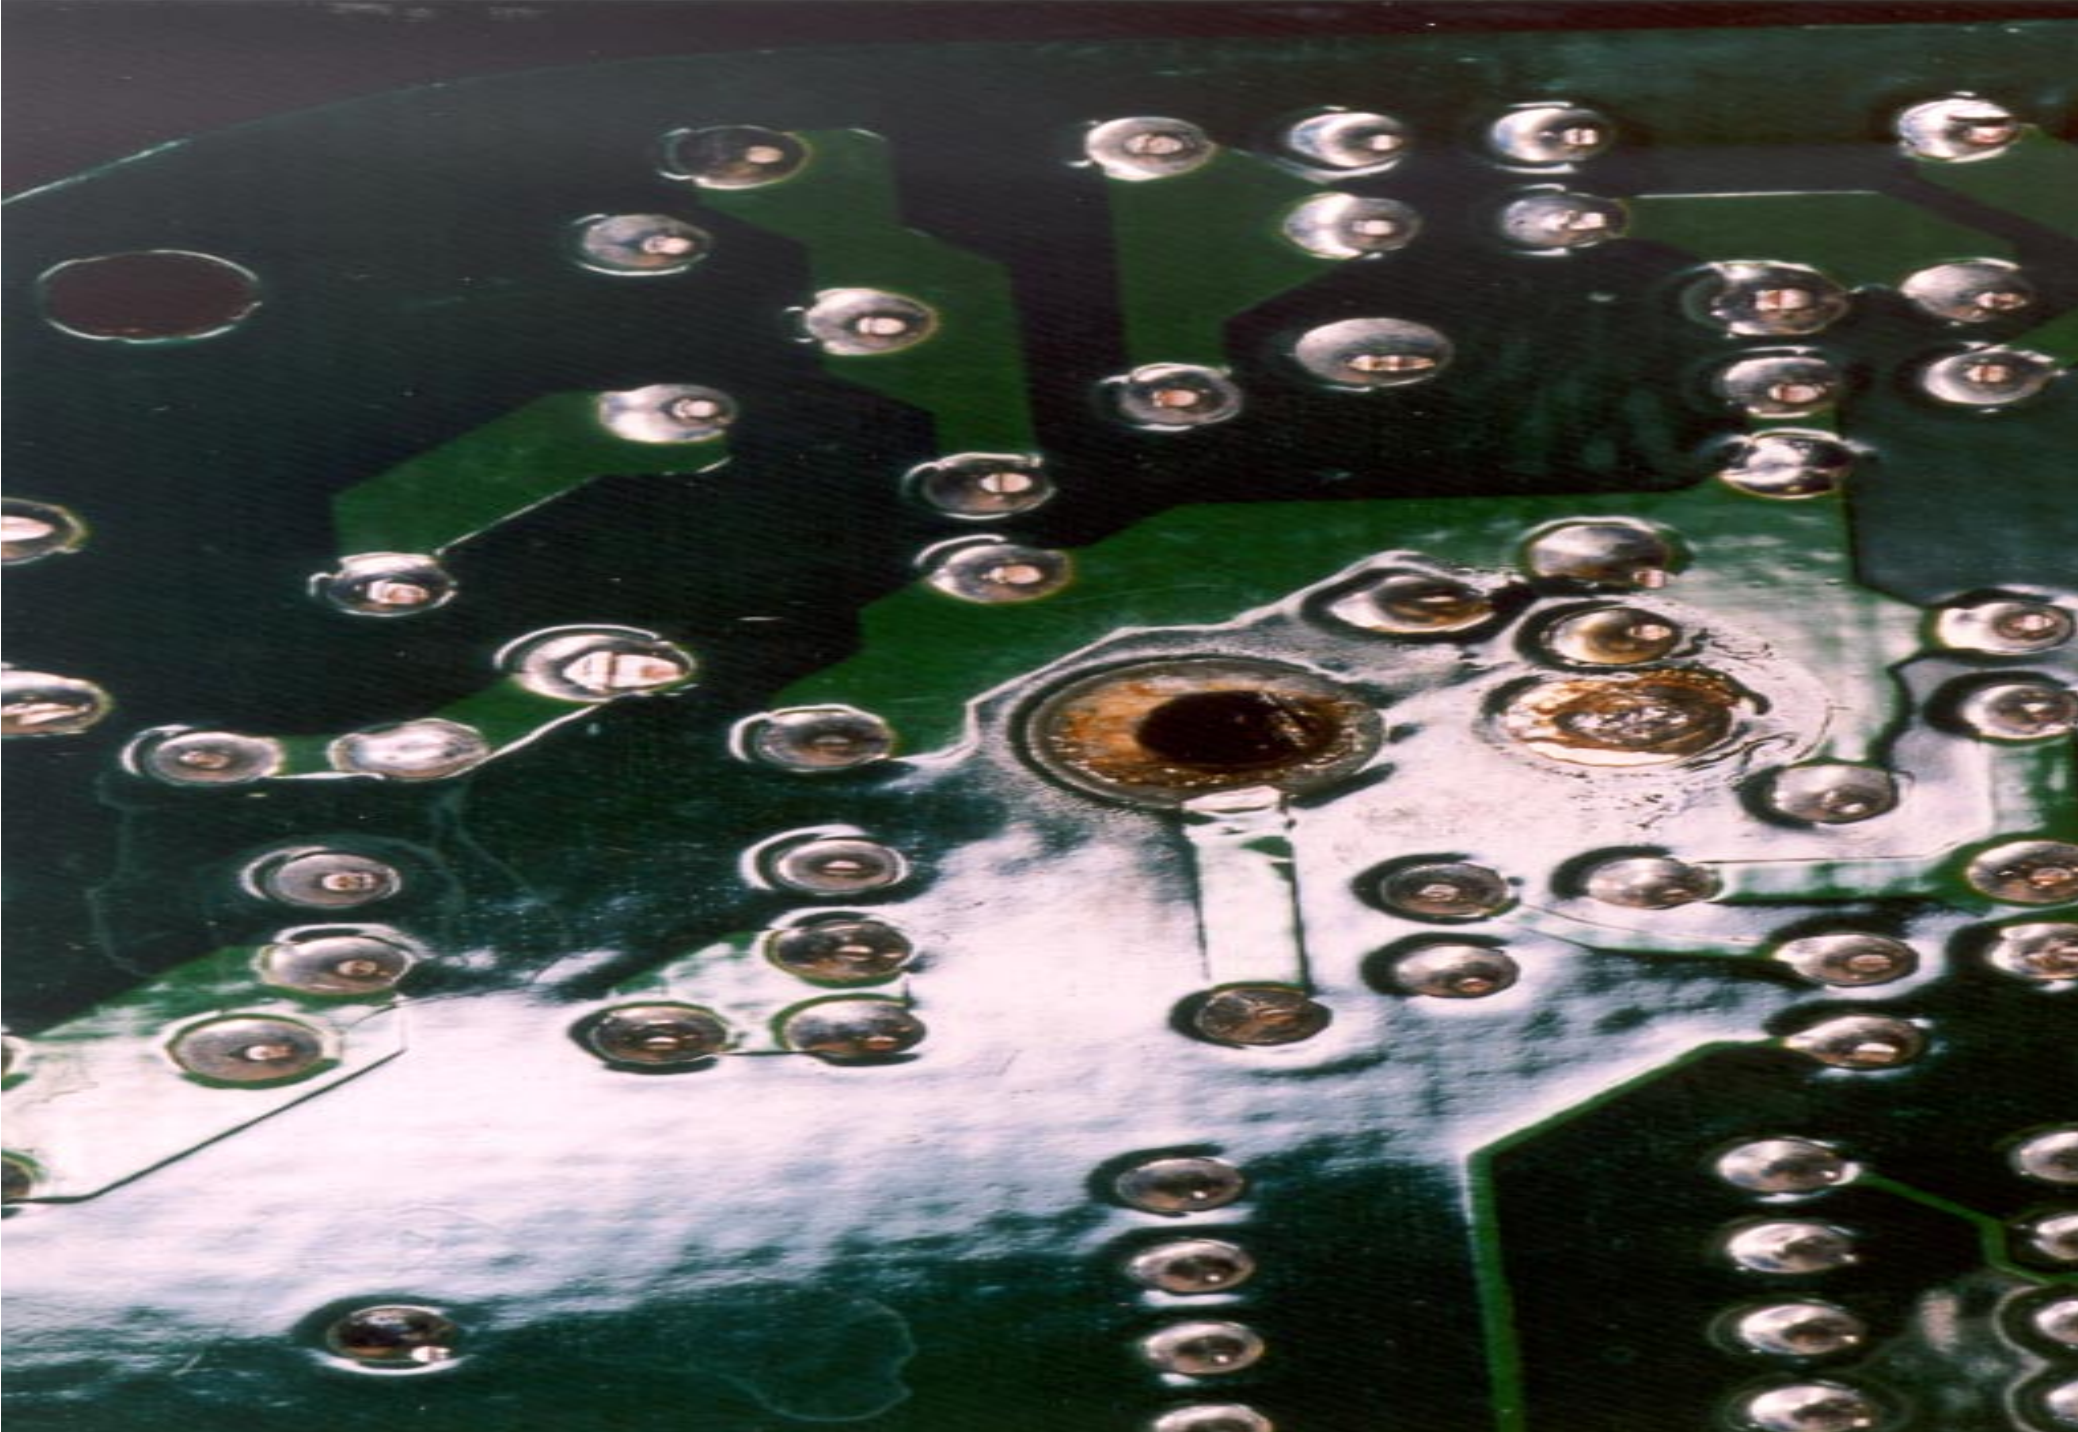
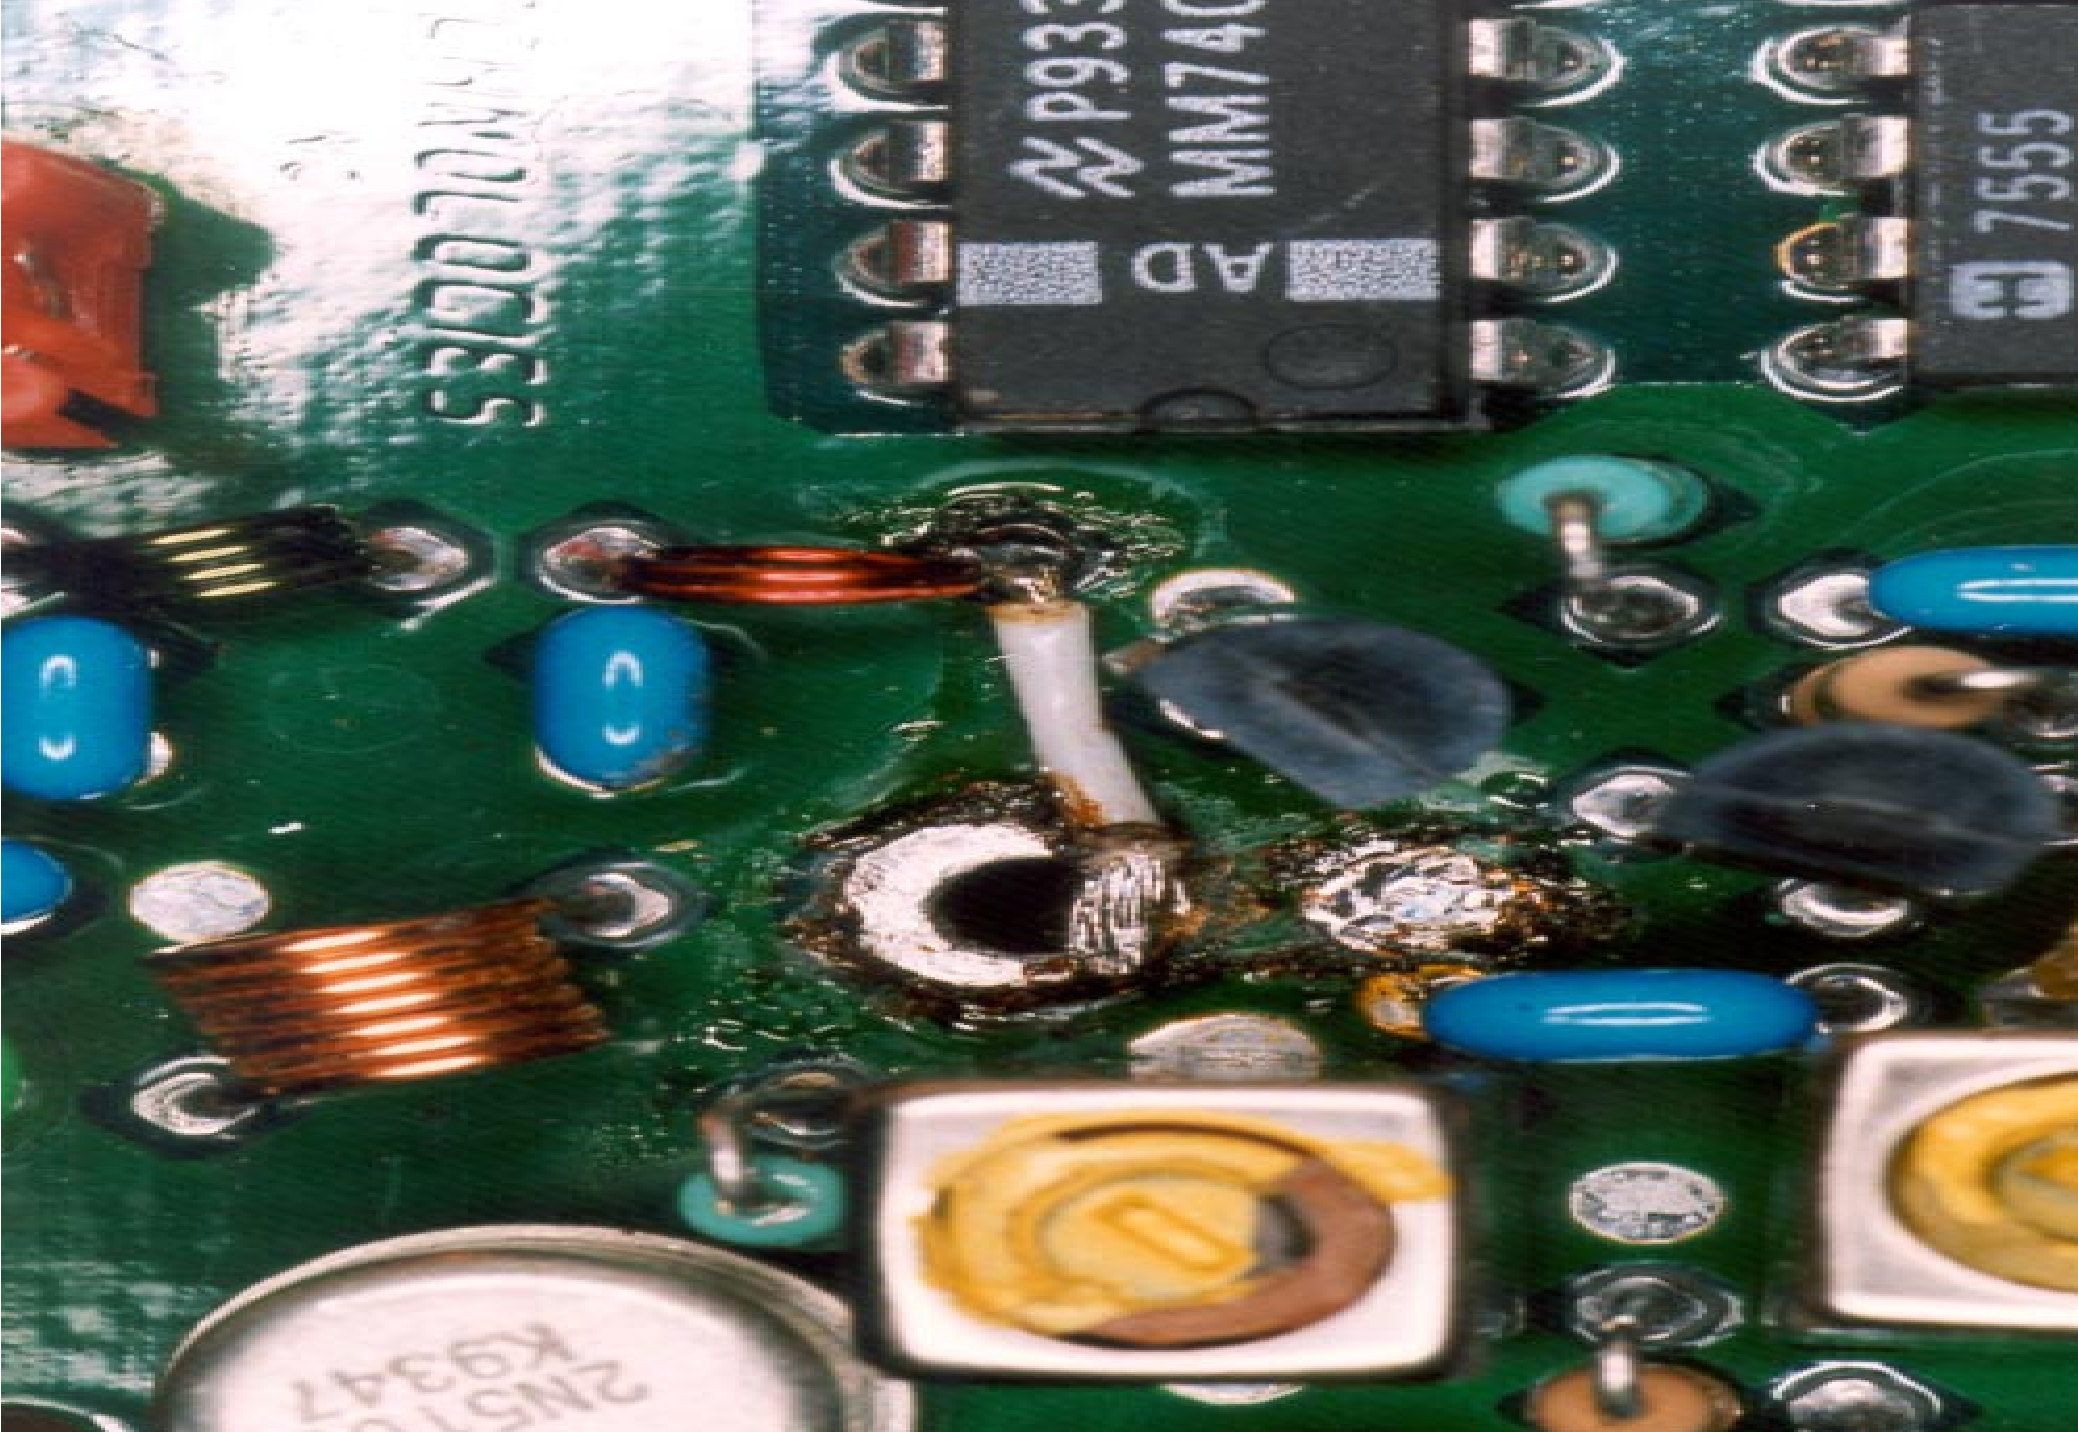
***WITH CLOSER EXAMINATION OF
THE CIRCUIT BOARD IT WAS
FOUND THAT MODIFICATIONS
HAD BEEN DONE TO REPAIR A
DAMAGED SOLDER PAD***

***THE HEAT TRANSFERRED WHEN
SOLDERING CAN EFFECT
OTHER PARTS OF THE CIRCUIT
EXTREME CARE MUST BE
TAKEN WITH REPAIRS***
