Breakdown of separation B737 / WW24, 22 km S Williamtown, NSW 1 February 2011

Presented by
Samantha Moran
Senior Transport Safety Investigator

Breakdown of separation 22 km S Williamstown (Newcastle Airport), NSW 1 February 2011

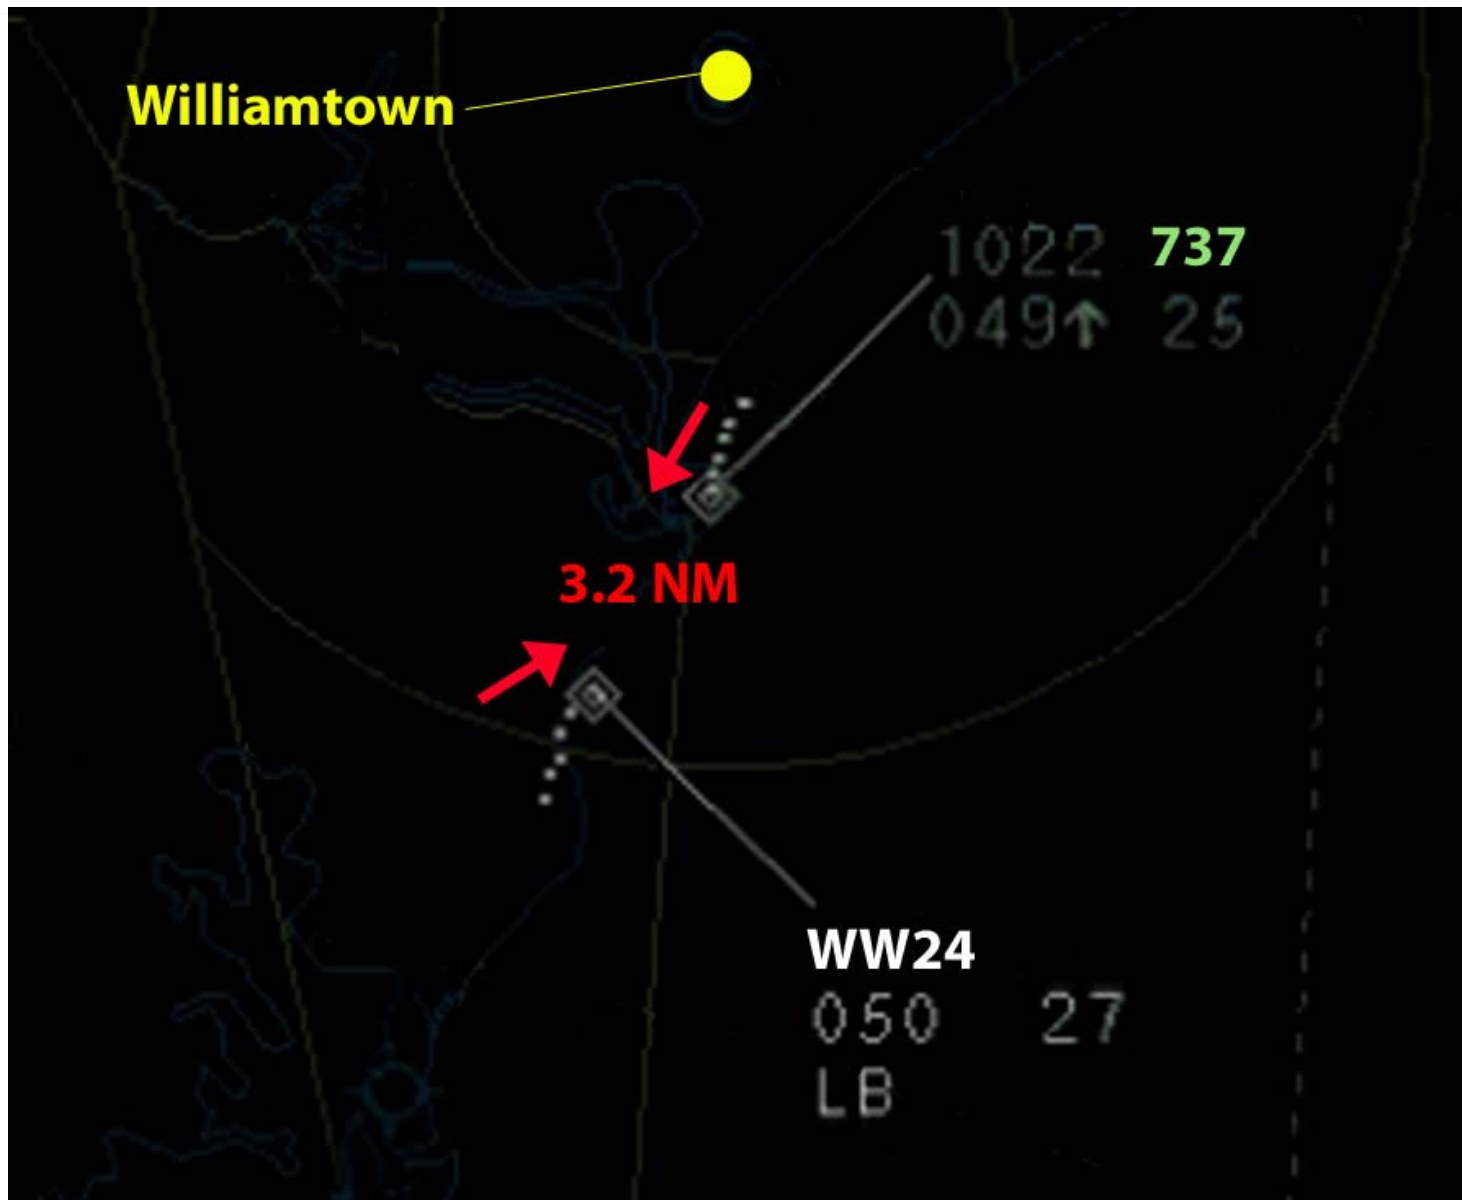
1305:24 local

Separation continues to reduce

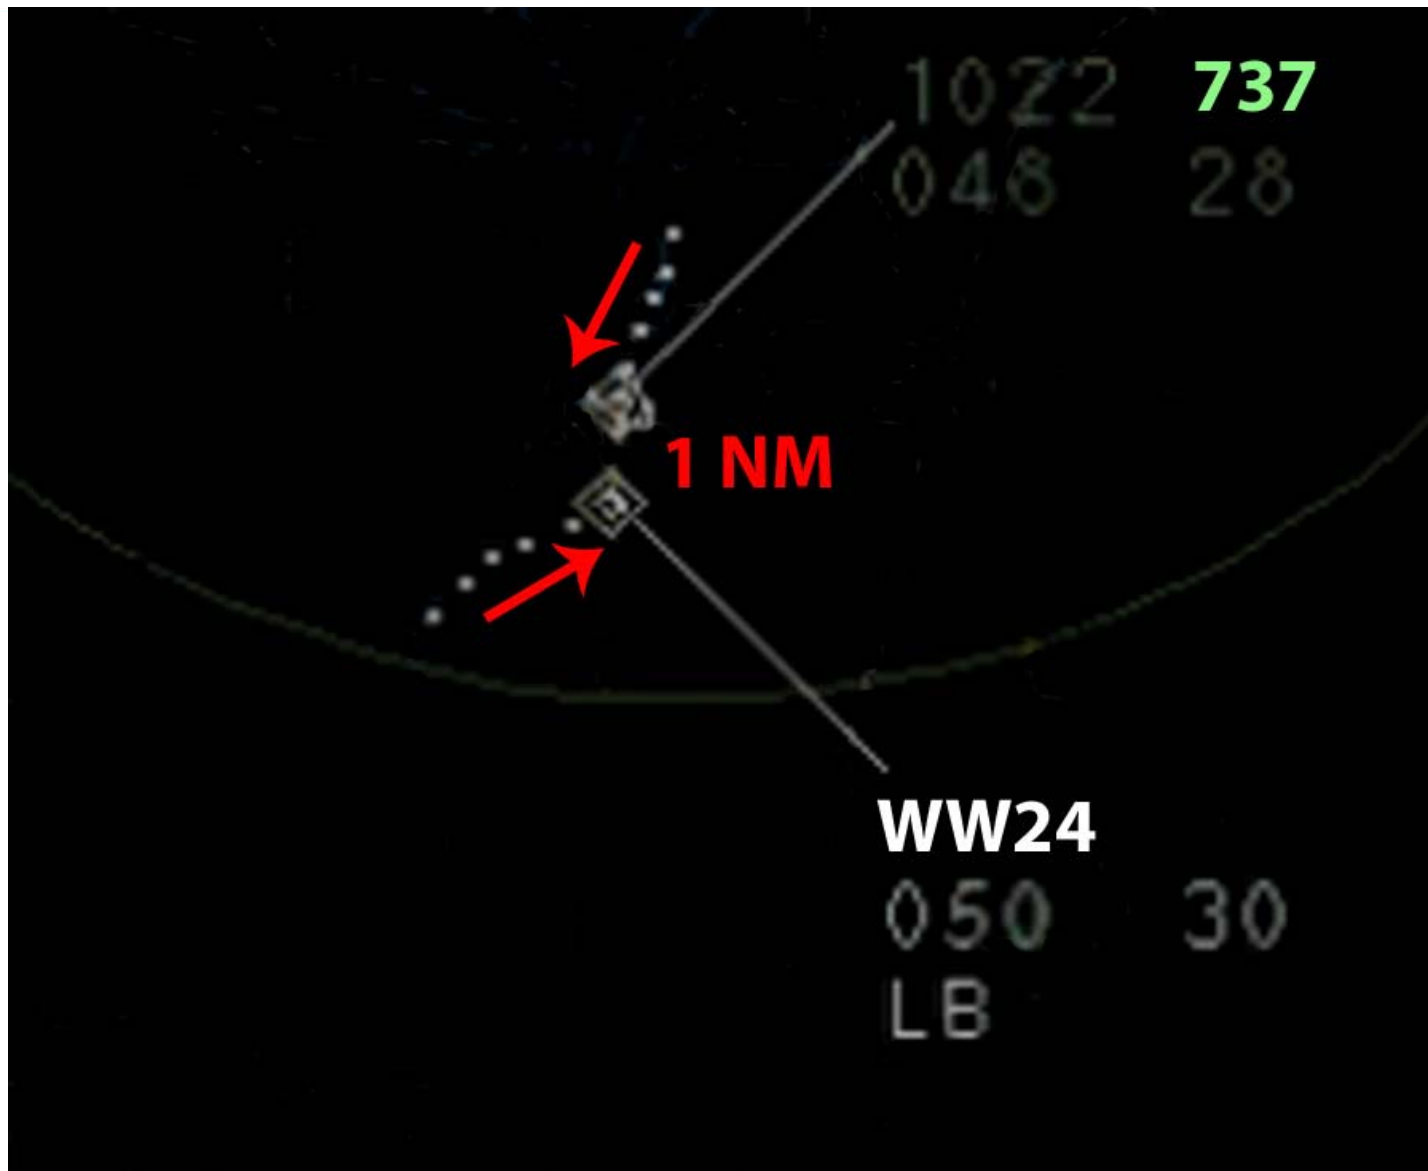
1305:34 local

BOS between the WW24 and B737

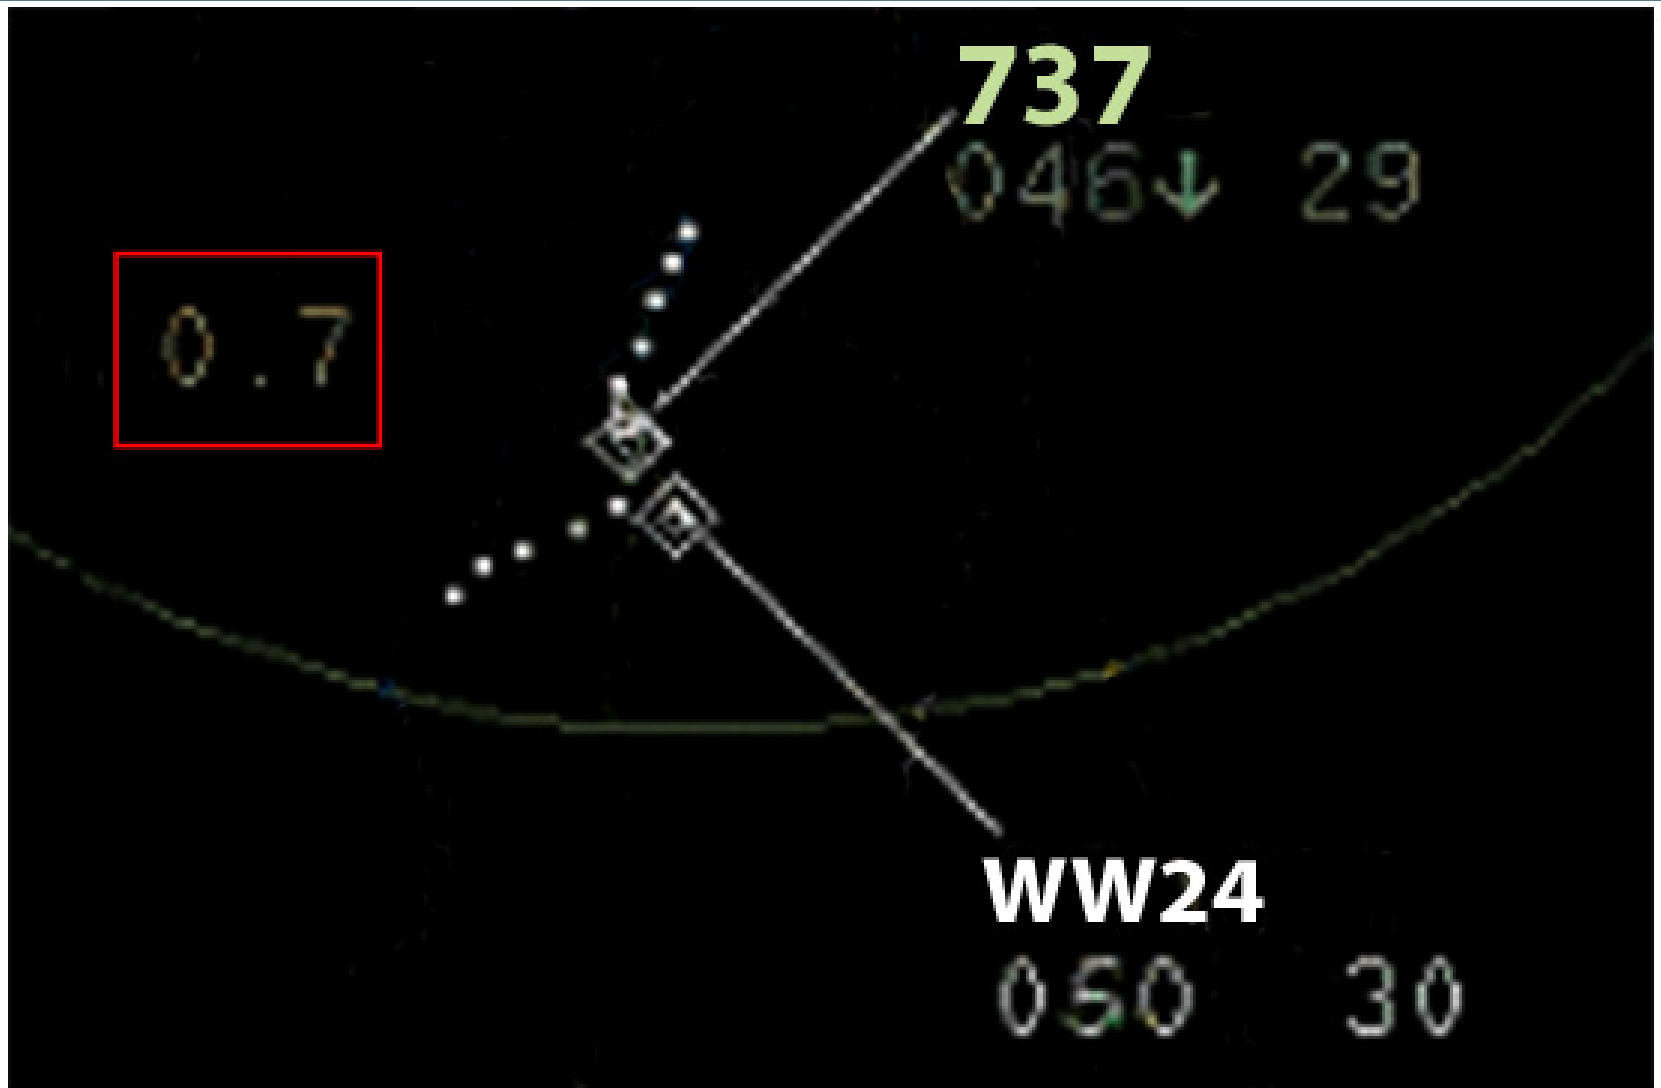
1305:44 local

Approach Low controller issues a safety alert to the WW24 as the B737 passes behind

Separation reduces to 0.7 NM.
Vertical separation of 400 ft due to B737 crew response to TCAS RA

B737 reported visually sighting the WW2.
WW24 crew do not sight the B737

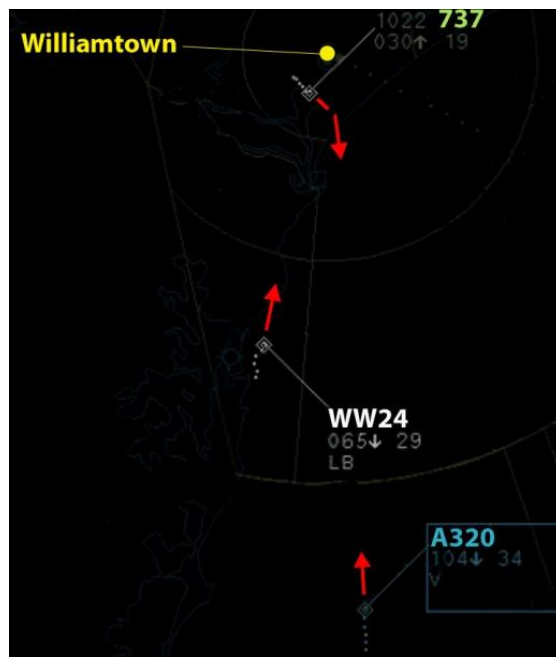
Figure 2: Proximity of aircraft at 1303:56

At 1303:56, after a frequency transfer by the ADC, the 737 flight crew called APP (H) on climb to 5,000 ft. The aircraft was about 1.8 NM (3.3 km) south of Williamtown in a left turn to intercept the 161 radial, and passing 3,100 ft with a groundspeed of 190 kts. After dealing with military jet formation traffic, the APP (H) controller acknowledged the call, radar identified the aircraft, and issued the crew with an instruction to turn right onto a heading of 200° to enable separation with inbound traffic. The controller also advised the crew to expect further climb shortly. At that time, the inbound WW24 was about 10.7 NM (19.8 km) south of Williamtown, passing 6,400 ft on descent, with a groundspeed of 290 kts (Figure 2).

The APP (H) controller later reported that they had not yet reviewed the details of the pending departures and were not expecting the 737 on frequency. They had based the vector instruction on the expectation that the WW24 was tracking for left base runway 30, which would have it tracking across the departing 737's planned outbound route. However, at that time, the WW24 had not been cleared by APP (L) to track for a left base to runway 30 and it was still tracking direct to the airport. The APP (L) controller later reported that their intention was that, if the WW24 tracked directly to the airport, it would pass behind the 737 with the required lateral separation.

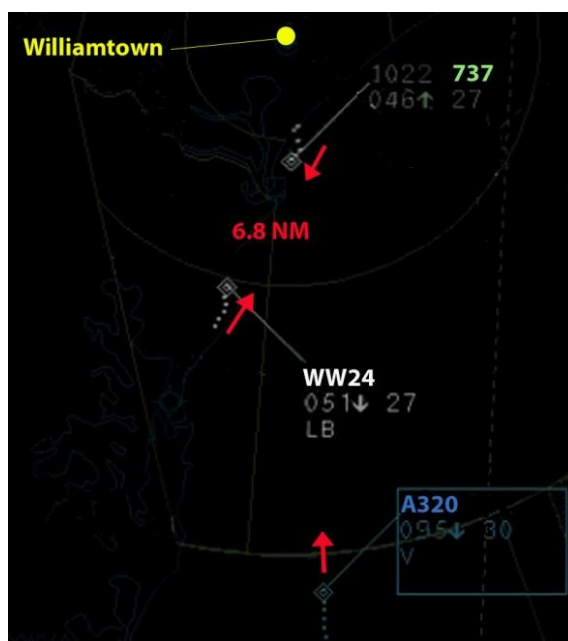
Figure 3: Proximity of aircraft at 1305:01

At the time the training officer made the instruction, the WW24 was descending from 5,100 ft to level off at 5,000 ft, in the 737's 12 o'clock position, at 6.8 NM (12.6 km), with a groundspeed of 270 kts (Figure 3). The 737 was passing through 4,600 ft on climb at the same speed. The A320 was about 27 NM (50 km) to the south of Williamtown, inbound on the 161 radial and passing 9,500 ft on descent. The A320's level assignment of 6,000 ft provided separation assurance with both the 737 and WW24 (both assigned 5,000 ft).

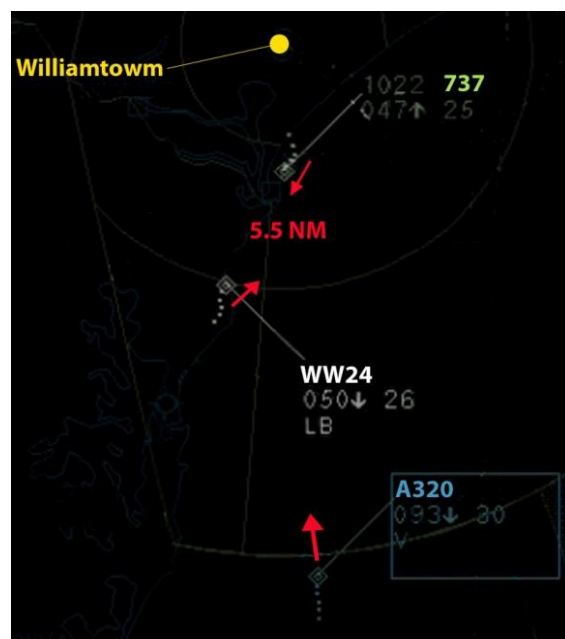
Figure 4: Proximity of aircraft at 1305:10

At this time, the WW24 was about to maintain 5,000 ft at 12 NM (22.2 km) from Williamtown, with a groundspeed of 260 kts, and the 737 was about 6.5 NM (12.0 km) from Williamtown,

passing 4,700 ft on climb with a groundspeed of 250 kts. There was 5.5 NM (10.2 km) between the aircraft (Figure 4).

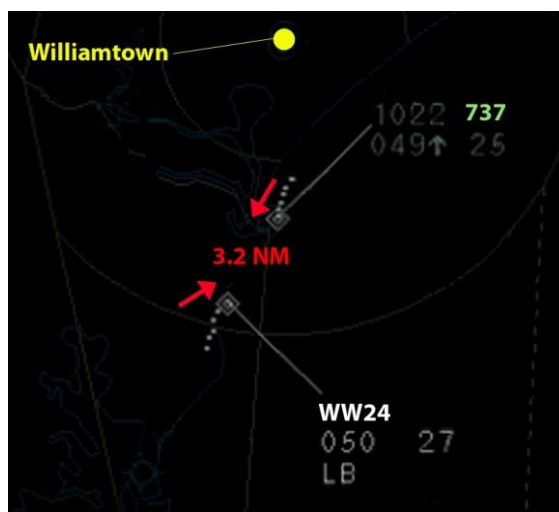
Figure 5: Proximity of aircraft at 1305:24

At 1305:24, there was 3.2 NM (5.9 km) between the aircraft, with the 737 at 5,000 ft with a groundspeed of 250 kts, and the WW24 maintaining 5,000 ft, with a groundspeed of 270 kts (Figure 5). The 3 NM (5.6 km) radar separation standard between the 737 and WW24 was infringed 1 second later, resulting in a breakdown of separation.⁵

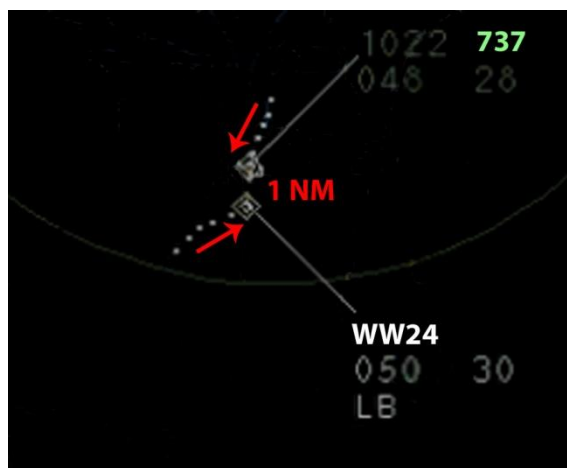
Figure 6: Proximity of aircraft at 1305:34

At 1305:34, there was 1 NM (1.9 km) between the aircraft, with the 737 maintaining 4,800 ft (within the 200 ft radar tolerance for an aircraft maintaining 5,000 ft), at a groundspeed of 280 kts, and the WW24 in the 737's 12 o'clock position, tracking right to left at 5,000 ft, with a groundspeed of 300 kts (Figure 6).

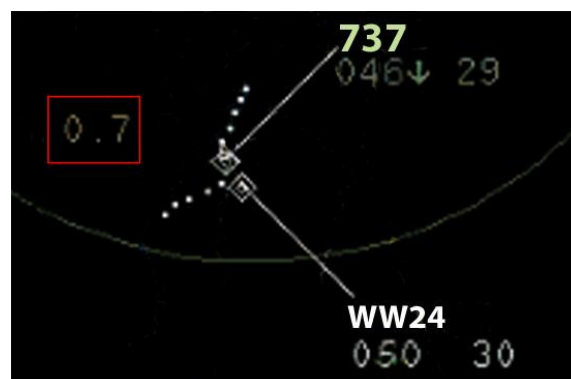
Figure 7: Proximity of aircraft at 1305:44

At 1305:44, the APP (L) controller issued the WW24 flight crew with a safety alert, advising that a 737 was passing behind their aircraft. The transmission did not include the level or direction of travel of the 737. At that time, the aircraft reached their closest point of radar separation of 0.7 NM (1.3 km) (Figure 7).

At the point of closest radar separation, there was 400 ft vertical separation between the two aircraft. The vertical separation was due to the 737 flight crew responding to a resolution advisory (RA)⁶ collision avoidance manoeuvre prescribed by their aircraft's traffic alert and collision avoidance system (TCAS).

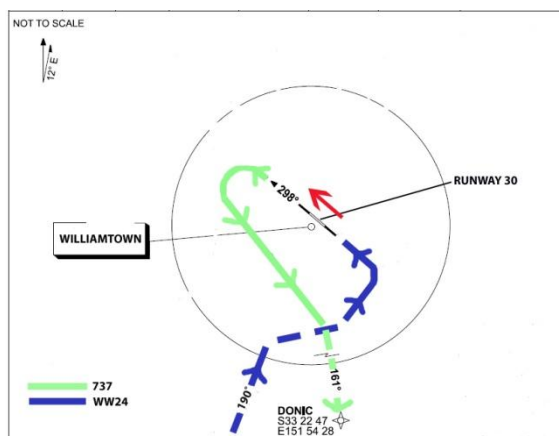
Figure 8: Approach Low separation plan

The APP (L) controller had determined a plan to maintain radar separation between the 737 and WW24, with the aircraft remaining under different control jurisdictions. The APP (L) controller had delayed tracking the WW24 for left base so the aircraft was tracking direct to the airport, with the intention that that would have provided segregation between the aircrafts' tracks (Figure 8). However, that plan was not communicated to the APP (H) controller, who believed that the two aircraft would have been in conflict. The initial response by the APP (H) to resolve the perceived problem by vectoring the 737 exacerbated the situation.

In addition to the APP (L) controller not communicating their separation plan, there were other coordination and communication errors. The APP (L) controller did not coordinate the departure of the 737 with APP (H) when the radar label did not couple with the aircraft's track. The APP (L) controller also did not coordinate the tracking restrictions for the 737. The reasons for the communication errors could not be determined.
