# The ATSB Ansett Class A Investigation

**L. Brown, R. Batt, S. Garniss, M. Watson, and J. Walsh**  
Australian Transport Safety Bureau

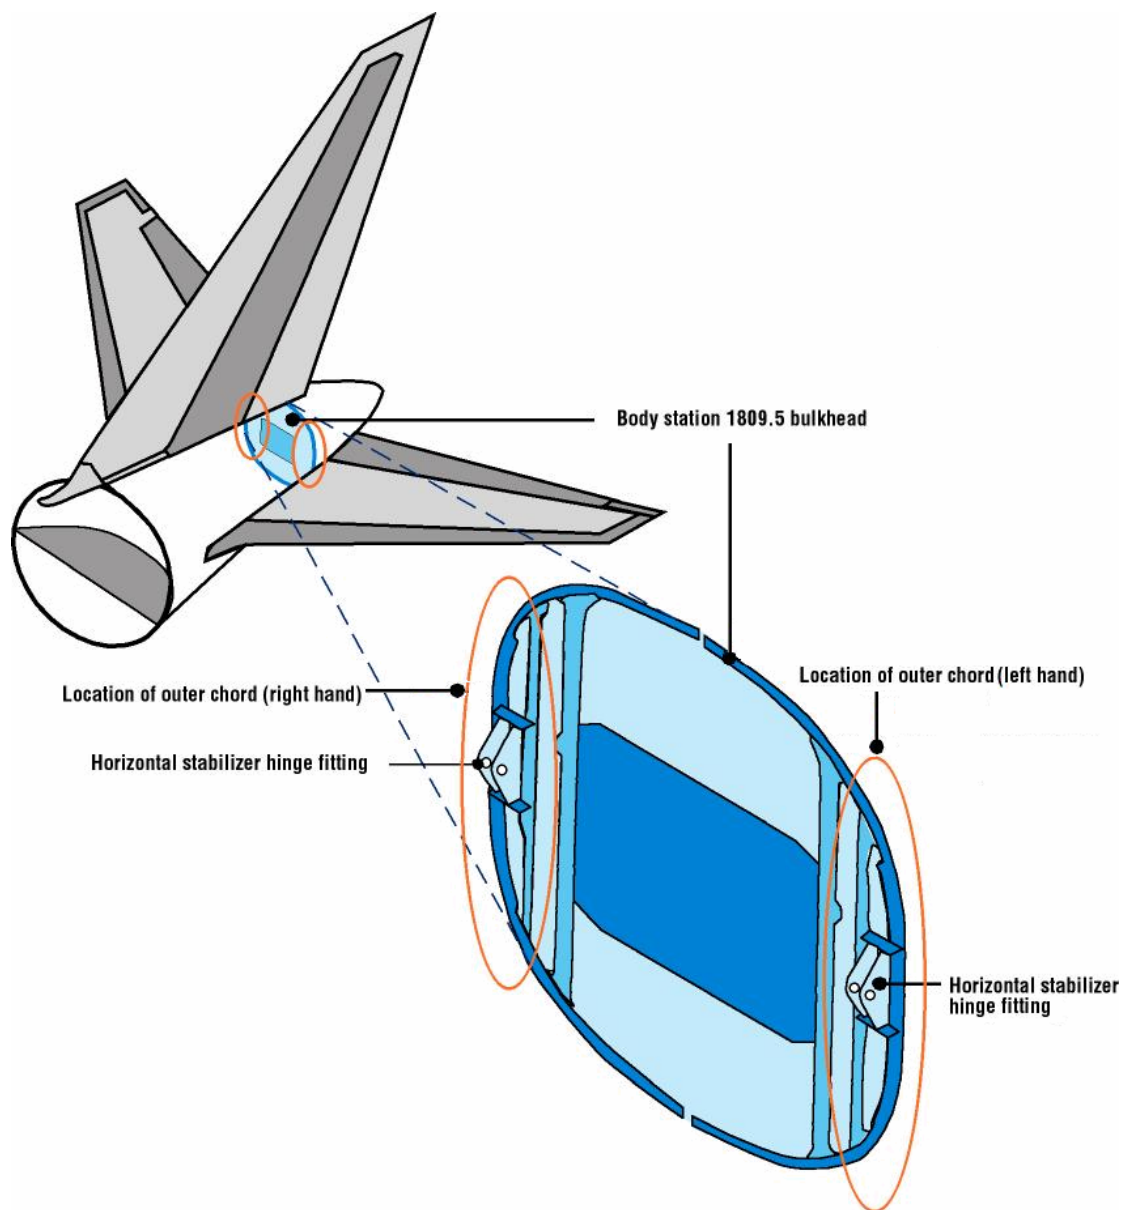
In June 1997, Boeing introduced the Airworthiness Limitations Structural Inspections program for the B767. The program was an essential part of the damage tolerance requirements and was designed to detect fatigue cracking in susceptible areas that had been identified through testing and in-service experience. Ansett staff did not initially recognise that some Airworthiness Limitations Structural Inspections were required by 25,000 cycles and a period of almost two and a half years elapsed before that error was identified. At the time that the inspection program was introduced, some Ansett B767 aircraft had already flown more than 25,000 cycles. In June 2000, further 25,000 cycle inspections were

introduced, including in the area of the Body Station 1809.5 bulkhead outer chord. Ansett did not initially act on this.

Figure 2. Location of B767 Body Station 1809.5 bulkhead

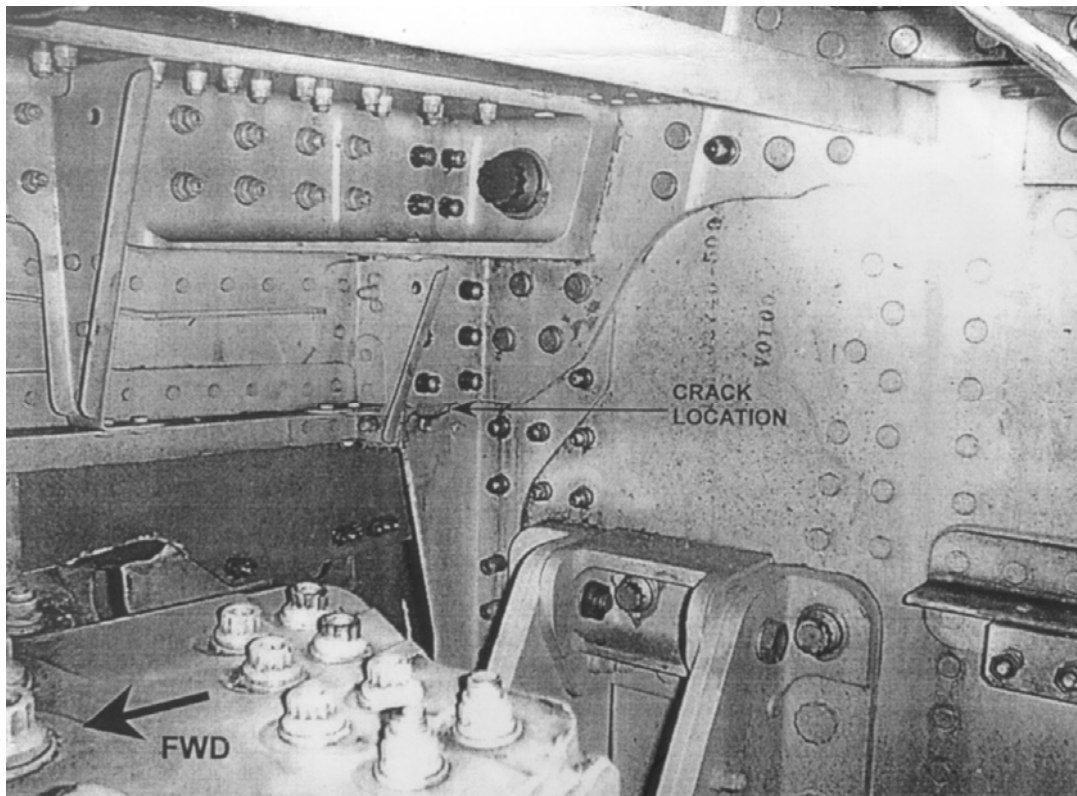
In December 2000, Ansett senior management became aware of the missed inspections and the aircraft were withdrawn from service on 23 December 2000. At that time, both Ansett and CASA were of the belief that compliance with the missed inspections was mandatory. Subsequent legal advice indicated that the regulatory basis for mandating compliance with the Airworthiness Limitations Structural Inspections for Australian operators was unclear.

Figure 3: Fatigue crack in an Ansett B767 Body Station 1809.5 bulkhead outer chord

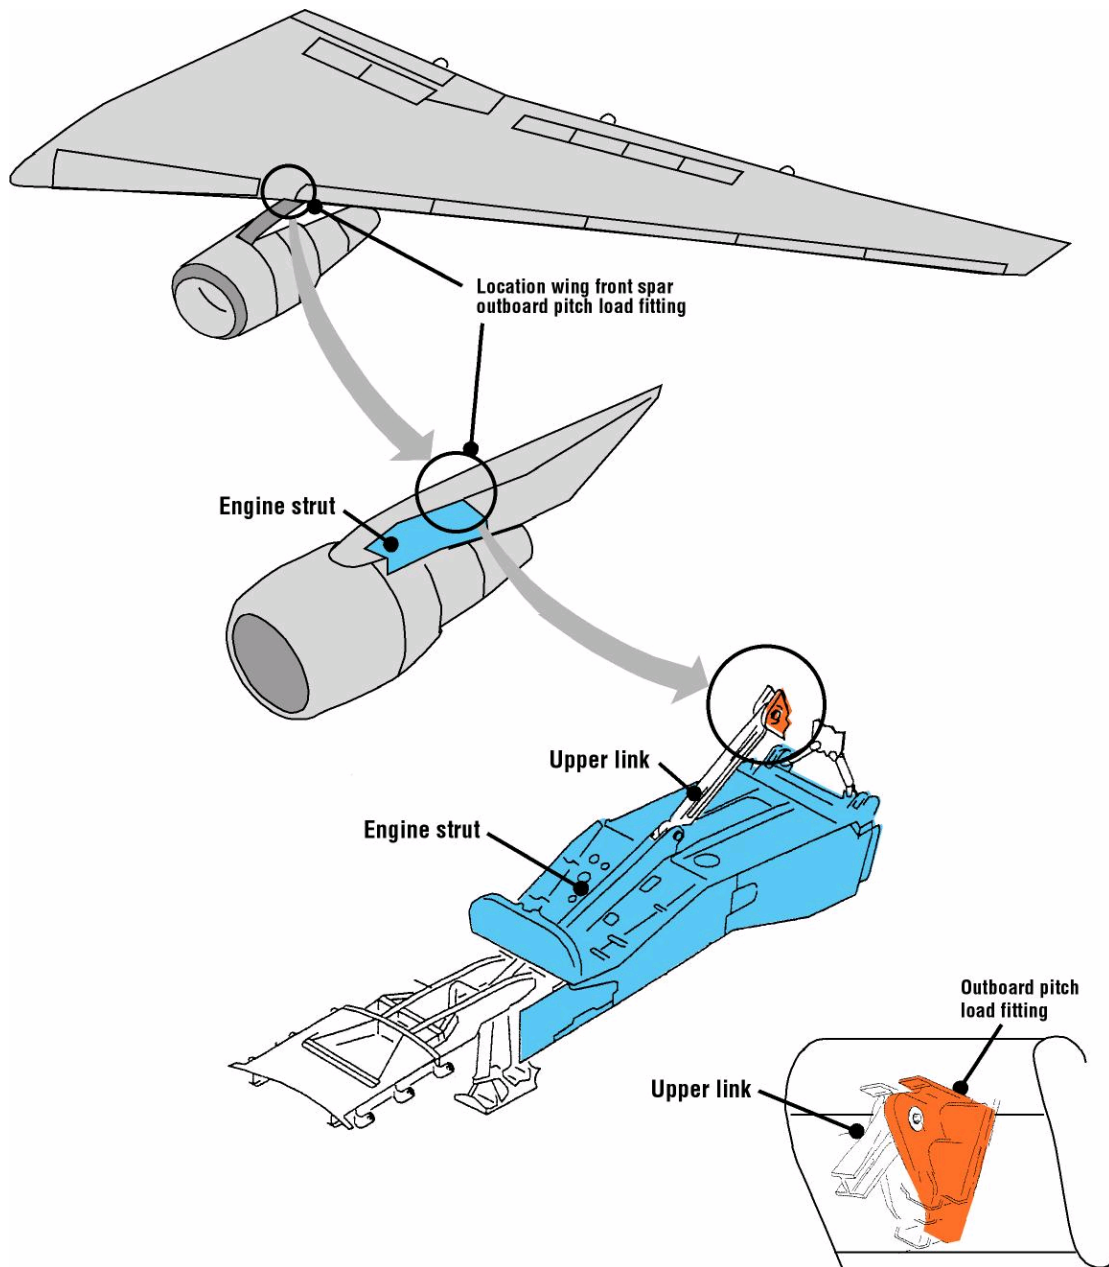
Figure 4. Location of B767 wing front spar outboard pitch load fitting

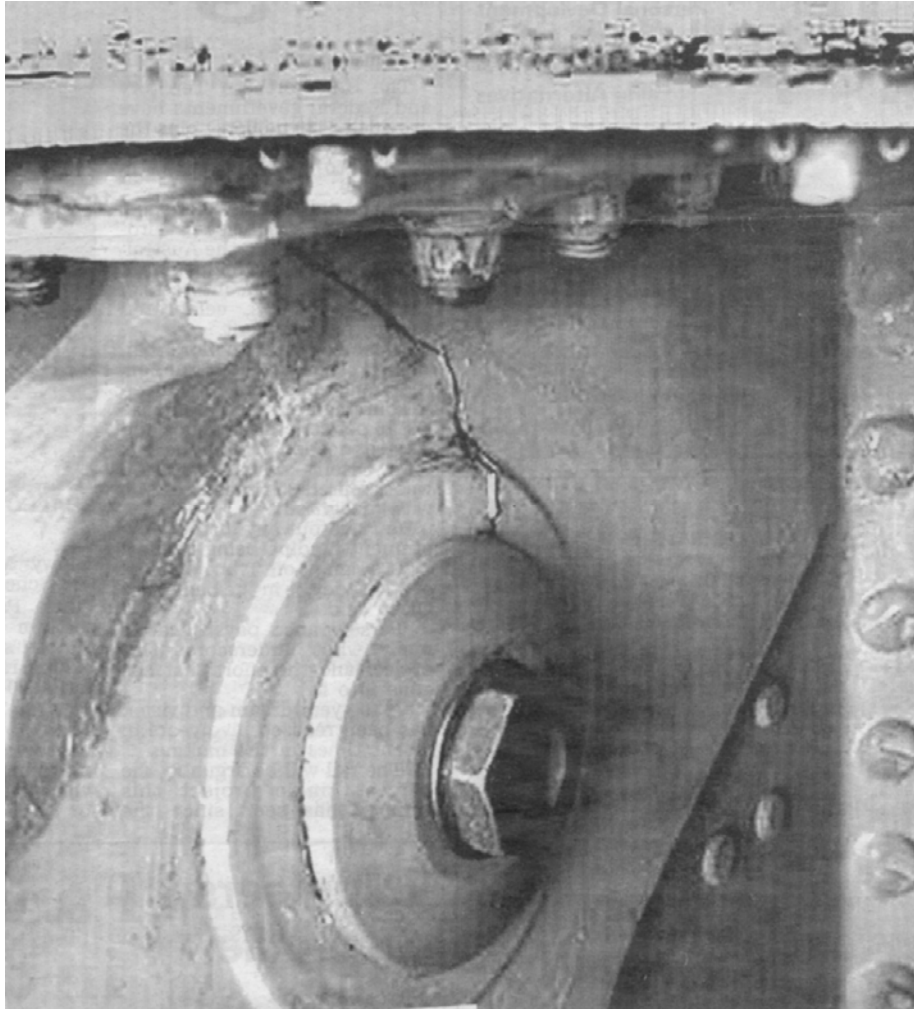
In March 2000, Boeing issued an Alert service bulletin to detect and repair fatigue cracks in the wing front spar outboard pitch load fitting of the B767 engine mounting strut. Boeing recommended that the work be carried out within 180 calendar days. A revision to the service bulletin was issued in November 2000. The wing front spar outboard pitch load fitting was part of the upper link load path between the engine and the wing. Cracks in the wing front spar pitch load fitting could have caused possible loss of the upper link load path and separation of the strut and engine from the wing.

In March 2001, Ansett became aware that they had not acted on either the original or the revised service bulletins. During the period from 7 to 9 April 2001, inspections revealed cracks in the pitch load fittings of three of the Ansett B767 aircraft and they were withdrawn from service. On 9 April 2001 CASA required that a further four Ansett B767 aircraft be withdrawn from service.

Figure 5: Fatigue crack in an Ansett B767 wing front spar outboard pitch load fitting
