**Investigation of Fatal Double Engine Flame-out to Shorts SD 360
Turboprop, Shortly After Take-Off From Edinburgh, Scotland 27 Feb 2001**

**A New Approach to Powerplant Investigation and an Unusual Cause
Determined**

**Peter R Coombs
Senior Inspector of Accidents
Air Accidents Investigation Branch
United Kingdom**

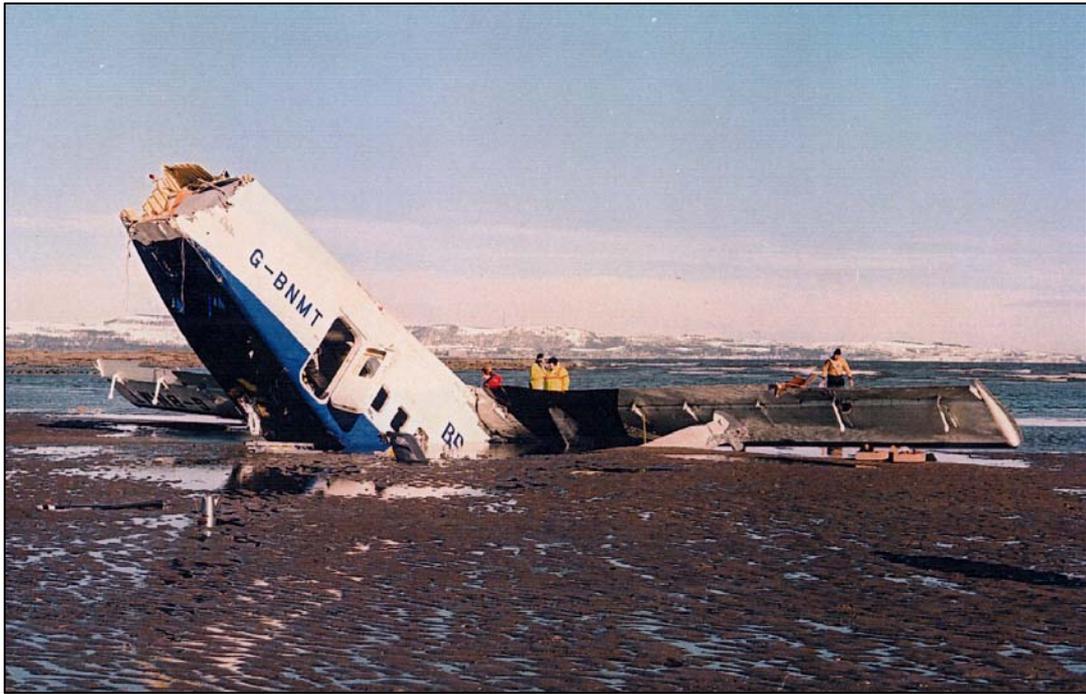
The wreck site was such that the aircraft could only be accessed on one occasion on foot (Figure 1) before the changing tidal cycle dictated that at the lowest tides the aircraft still remained partly submerged (Figure 2). This situation was to continue until approximately a week had passed. The recovery task was further hampered by the extent to which the aircraft became buried in the sand with succeeding tides (Figure 3).

Figure 1: General view of main section of wreckage at low tide, on morning after the accident

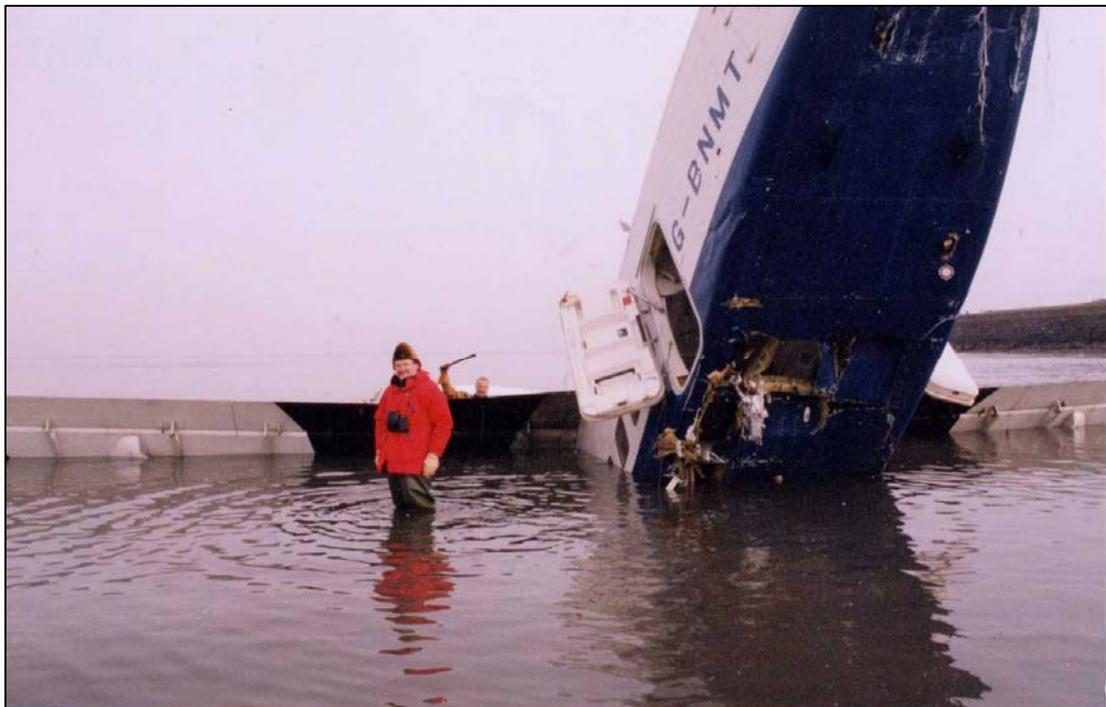
Figure 2: View of partly submerged wreckage at subsequent low tide

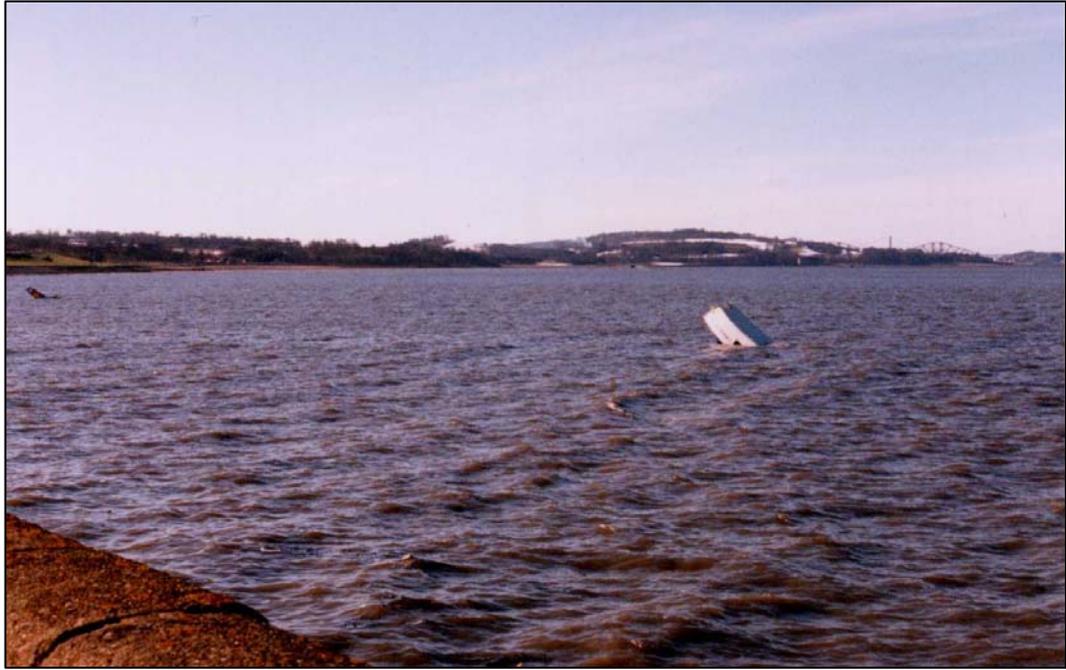
Figure 3: View of almost submerged wreckage at high tide

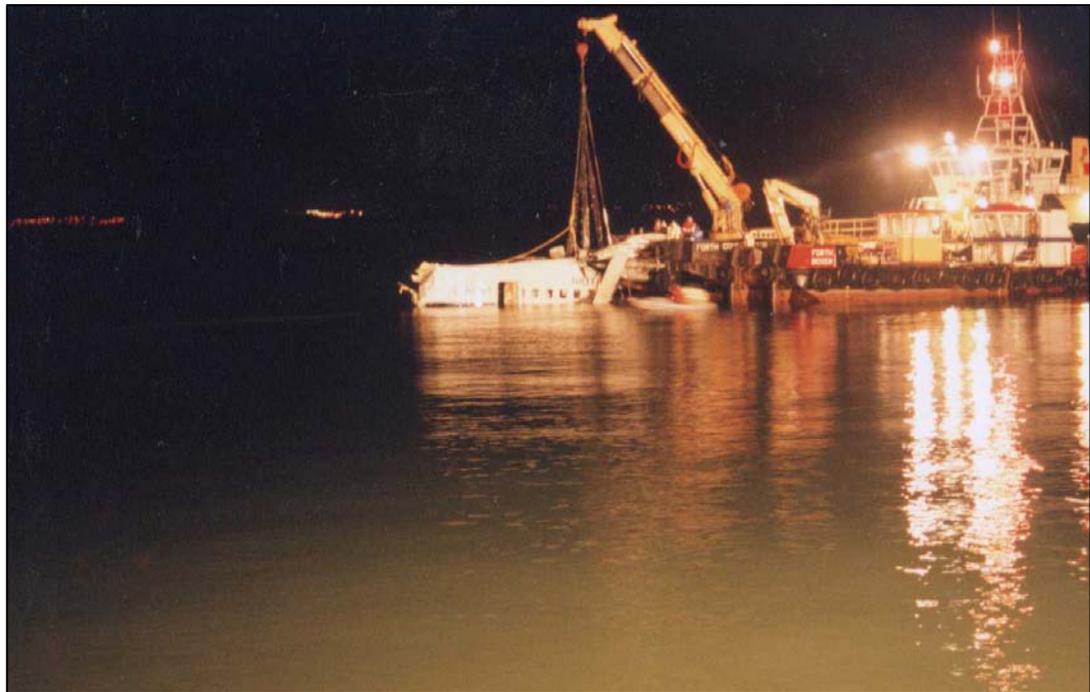
Eventually, however, the wreckage was salvaged (Figure 4) and detailed examination began. In the meantime both DFDR and CVR were recovered, de-contaminated and replayed successfully.

Figure 4: Salvage ships in position during lifting 6 days after accident

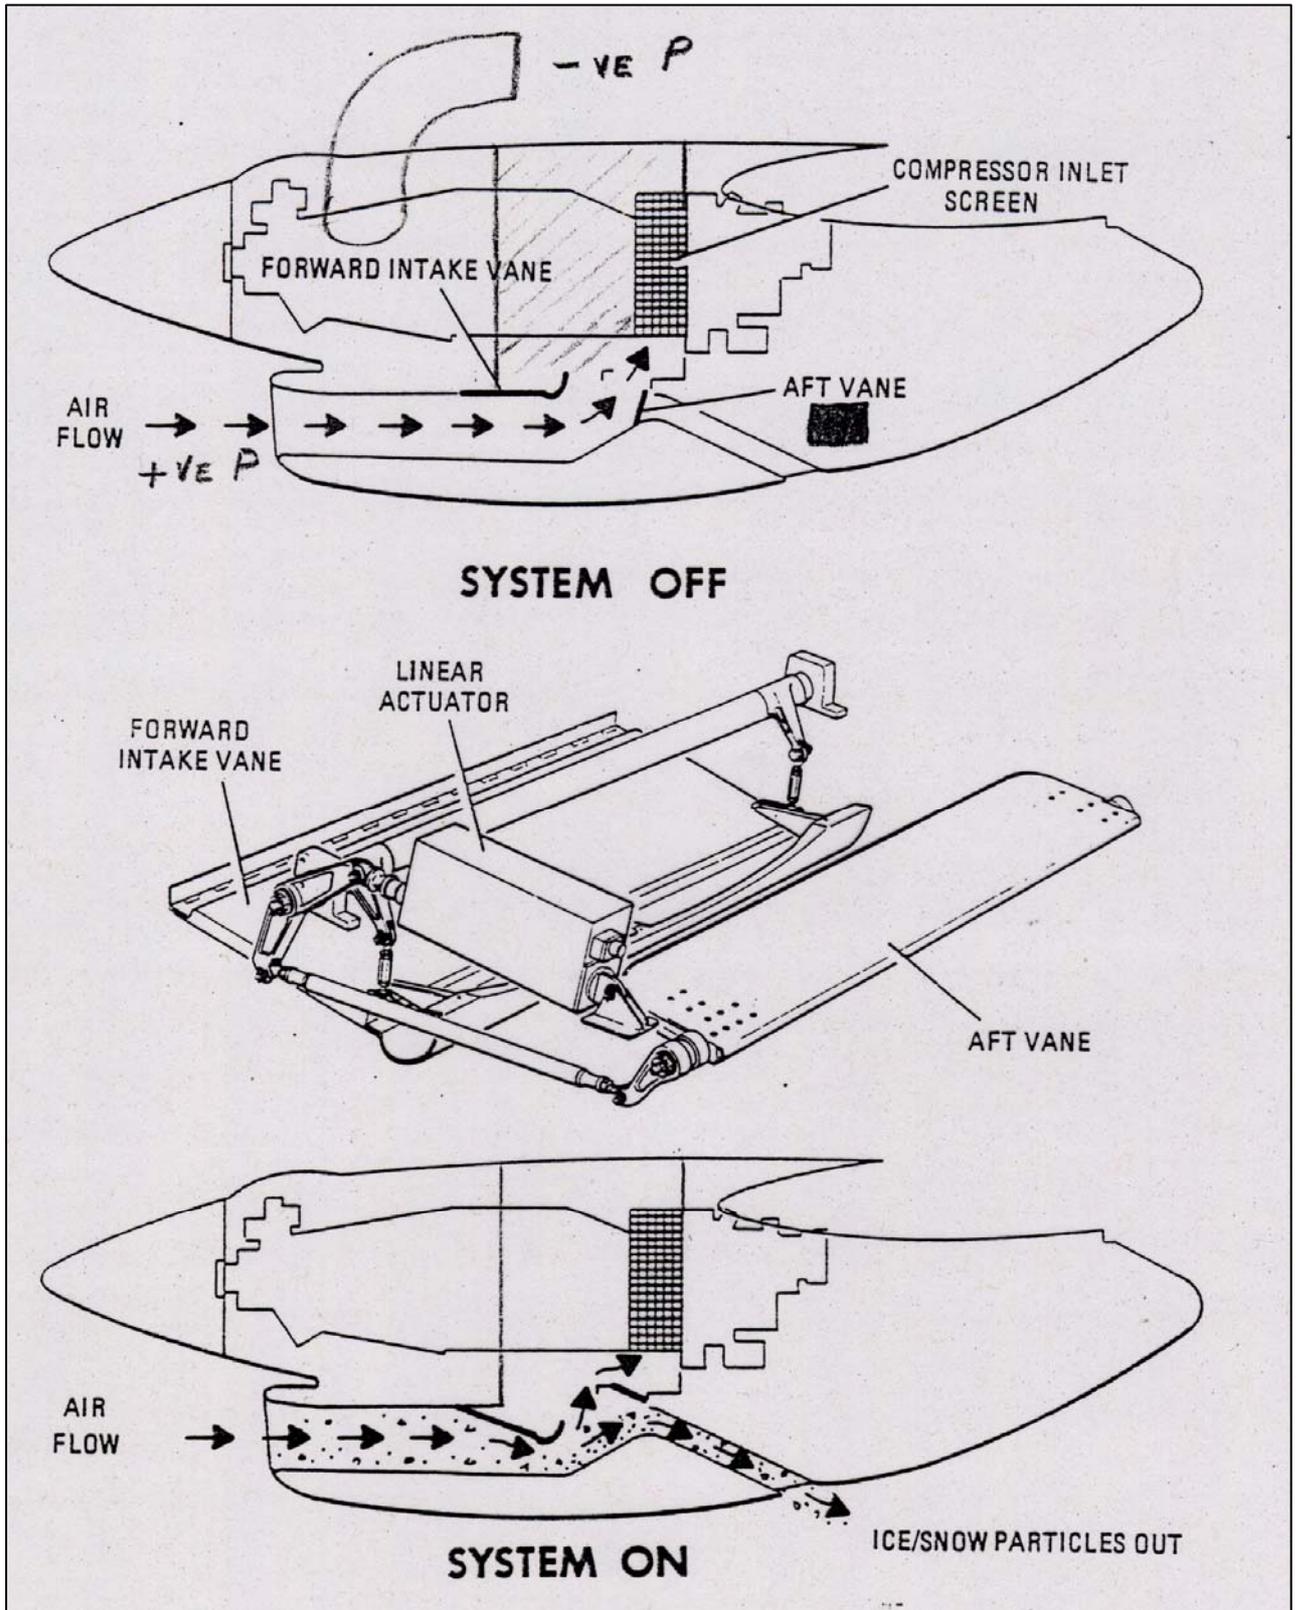
The aircraft type is powered by two PT 6A series reverse-flow turbo-prop engines. Each engine is orientated with its compressor at the rear. There are a number of reversals of air and combustion gas flow directions within each power plant, (a total of 720 degrees direction change of flow axis between the external intake and the aft facing exhausts). As shown in Figure 5, air is supplied to the engines via a forward facing intake behind and below each propeller, whilst exhaust gases leave via a pair of curved pipes at the front of each engine, arranged to direct the gases backwards. The air, having entered each external intake, passes below the whole length of the relevant engine, before turning through a right angle and travelling vertically upwards into air tight plenum chambers. From these, it is drawn into each engine compressor through a cylindrical mesh guard. (Figure 5). An external view of a nacelle on

In icing conditions, the crew may select so called anti icing vanes to the ON position (Figure 5). Under these circumstances, a ramp (or forward vane) is lowered from the top surface of each air intake path, reducing the available cross-section for the airflow and causing it to both accelerate and change direction through a bigger angle than would be the case without the vanes deployed. This centrifuges solids and liquids to the outer radius of the curved airflow path. At the same time, a bypass door (or aft vane) opens in each airflow, causing that part of the flow cross section containing the solids and liquids to be ejected overboard rather than to enter the plenum chambers to risk forming a frozen obstruction on the mesh guard covering the inlet to the relevant engine.

Tests carried out on an example of the linear actuator type which drives the inertia separators (Figure 5) confirmed that the frequency of the electrical 'noise' produced was identical to that of the acoustic noise present on the CVR initiating 5 seconds before engine torque was recorded as lost by the DFDR. It therefore became clear that staggered operation of the selector switches of each inertia separator took place 5 seconds before a similarly staggered sudden loss of all power on both engines occurred. There was thus little doubt that deployment of each inertia separator had lead to the consequent power loss of the corresponding engine. This left the question of how this entirely normal system operation could have had such a dramatic and abnormal effect on both engines.

A downstream pressure drop was created by the fan, having similar magnitude to the pressure difference between the intake face and exit pipe pressures (Figure 5) calculated for the known average headwind speed recorded during the night's snow storm. The speed of the airflow created in the extractor tube was measured by means of the digital test set and the corresponding speed in the intake system calculated. Despite the complex flow path through the total power-plant and the effect of at least 7 stages of fixed and a similar number of

Figure 5: Schematics of Nacelle with Inertia Separator Vanes in Normal (or OFF) Position, above and Deployed (or ON) position below. Plenum Chamber Volume is Shaded in Upper Section., Vane drive Mechanism is Shown in Middle Diagram

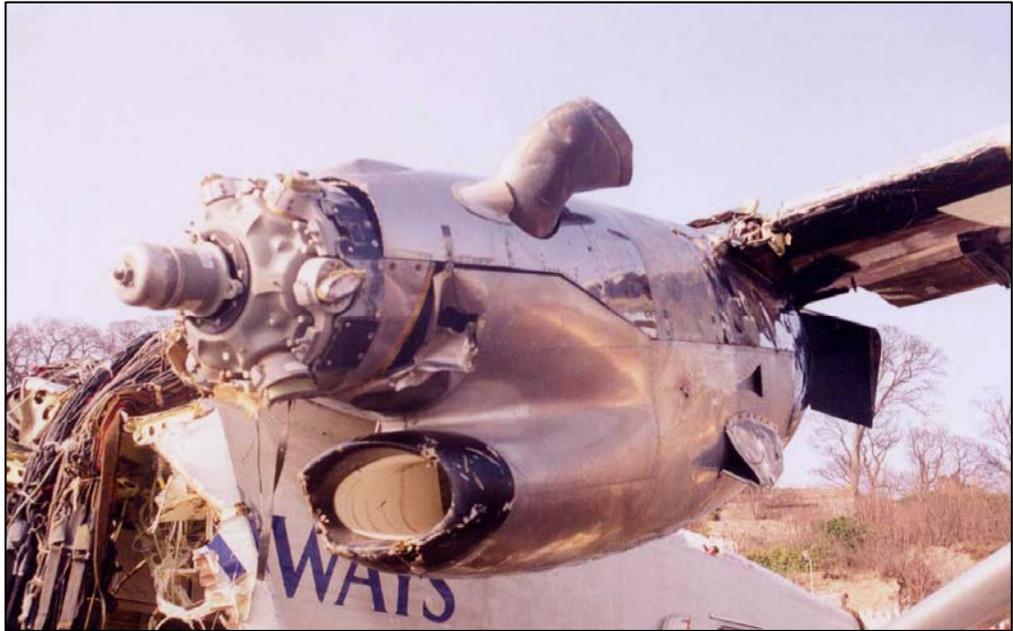
the salvaged wreck, showing the intake and one exhaust stack, is shown at Figure 6.

Figure 6: Left engine nacelle with external intake and one exhaust stack visible after wreckage recovery

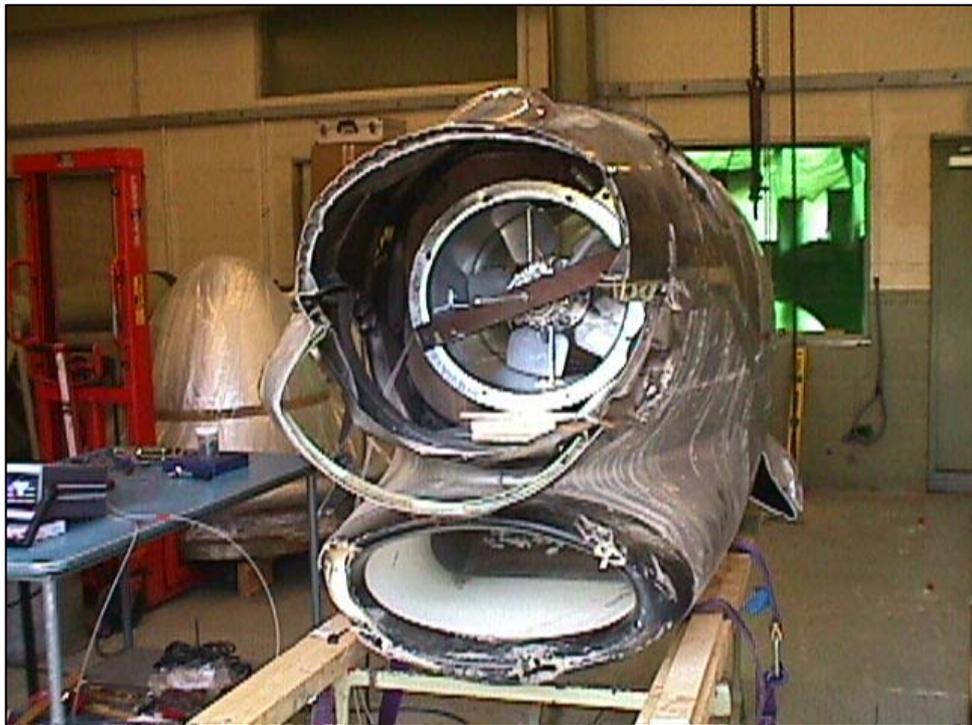
An engine intake system and engine cowling panels, salvaged from the wrecked aircraft, were then assembled into a mock-up of a nacelle incorporating a dummy engine, complete with the intake mesh. Sealed plenum chamber bulkheads were manufactured from Plexiglas and fitted in representative positions within the cowlings. An electric extractor fan was mounted within the dummy engine and an adjustable shut-off valve was fitted at the forward end. Figure 7 shows the front of the arrangement before the adjustable shut-off valve was fitted. The fan was run and the valve adjusted to create airflow velocities in the mock intake system of similar values to those measured and calculated earlier in the intake of the borrowed aircraft.

Simulated snow flakes, comprising finely cut fragments of expanded polystyrene, were released near the external intake and their progress through the trunking and into the plenum chamber was observed via the Plexiglas rear bulkhead. It was found that the flakes readily rose up to and over the top of the dummy engine.

Figure 7: Assembled Nacelle Mock-Up, utilising panels salvaged from wrecked aircraft, incorporating cylinder forming dummy engine. Extractor fan can be seen. Adjustable valve has yet to be fitted to threaded shaft in front of fan. Transparent Plexiglass bulkheads are fitted in place of metal bulkheads at front and rear of plenum chamber (not visible).

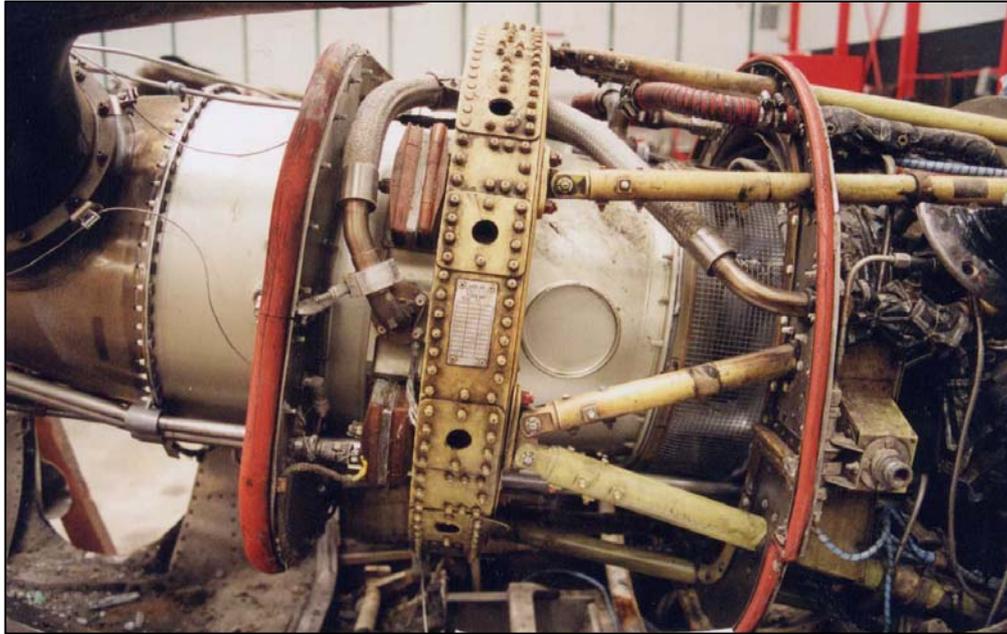
Figure 8: View of Interior of Plenum Chamber with Cowlings Removed. Enclosed Volume is Between Orange Coloured Seals. Exhaust stack Visible at Top Left.
