Directorate of Defence Aviation and Air Force Safety

MRH-90 Main Rotor Head Incident 19 March 2014

WO Brendon Blank DDAAFS—Rotary Wing (Technical)

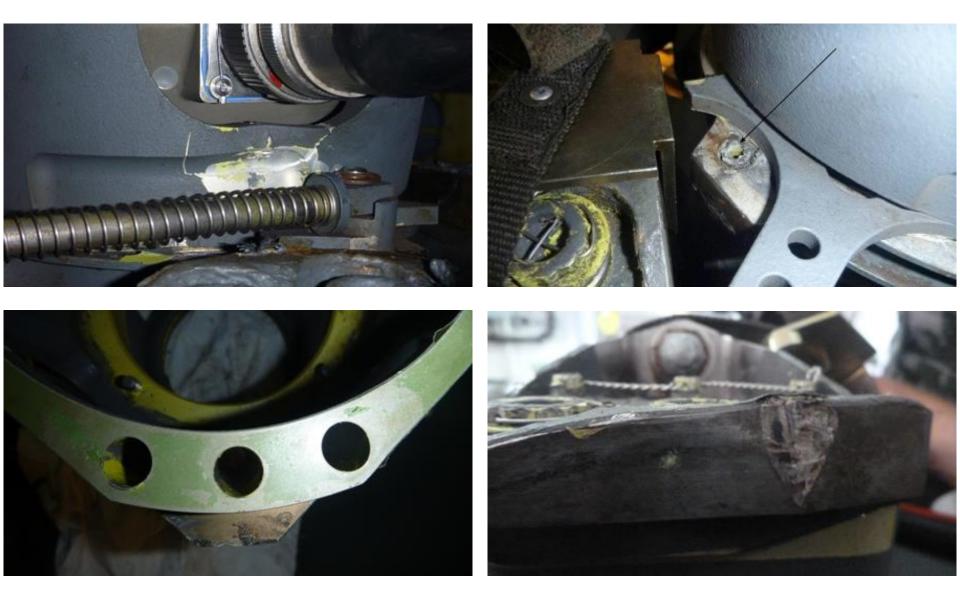
Damage to Aircraft

- HMAS *Success* Flight 1 training and development
- Tasked to OP SOUTHERN INDIAN OCEAN (MH370)
- Main rotor blade sleeve replacement
- Engaged ground run then Maintenance Test Flight for vibration analysis
- Blade droop noticed during blade fold process
- Further investigation discovered damage
- Command informed and aircraft secured in ship's hangar

— Main rotor head damage to A40-017 was a consequence of the failure of the upper flapping stop assembly to rotate from the Ground position to the Flight position during start, due to the fitment of non-compliant parts
