# Bombardier DHC 8 Propeller Overspeeds

**Eric Blankenstein** – Australian Transport Safety Bureau

**David McNair** – Transportation Safety Board of Canada

REPORT ON SERIOUS INCIDENT DURING  
DESCENT TO SØRKJOSEN AIRPORT, NORWAY  
ON 21 FEBRUARY 2006 WITH BOMBARDIER  
DHC-8-103, LN-WIE OPERATED BY WIDEREØES  
FLYVESELSKAP AS

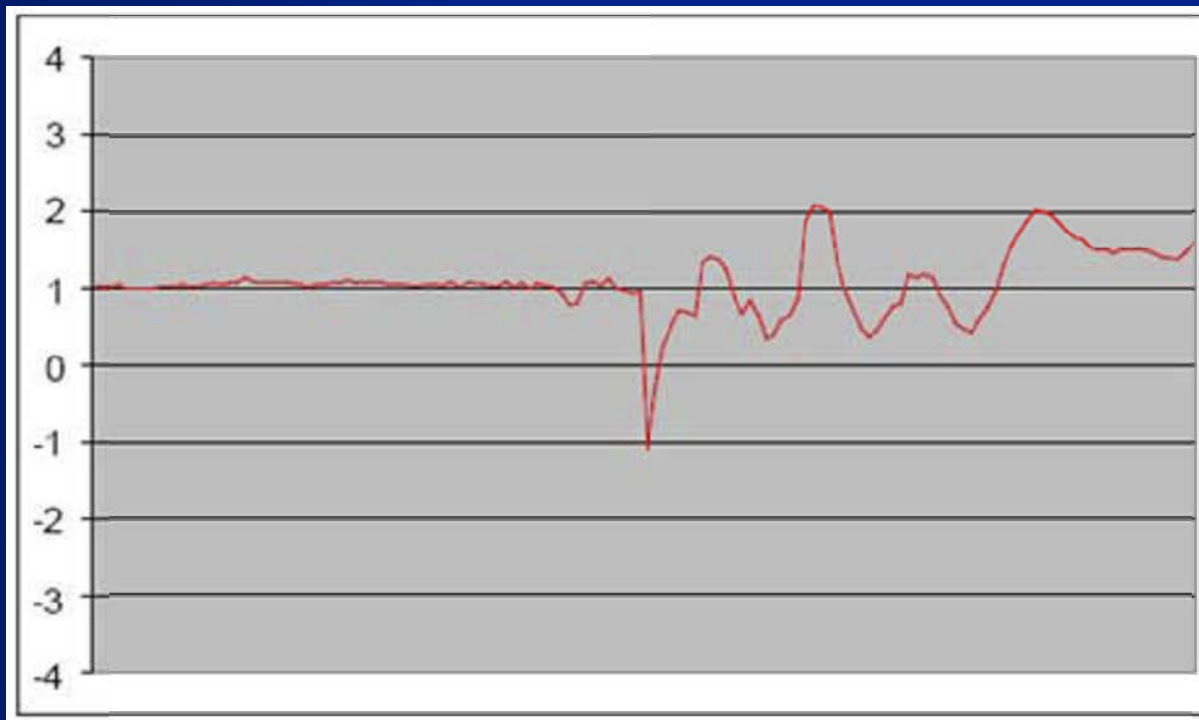
Vertical acceleration (g) over a period of 20 Seconds

The lowest value of -1.07 g was recorded in the same second that the torque on the right engine fell from 42.6% to 6.1%.

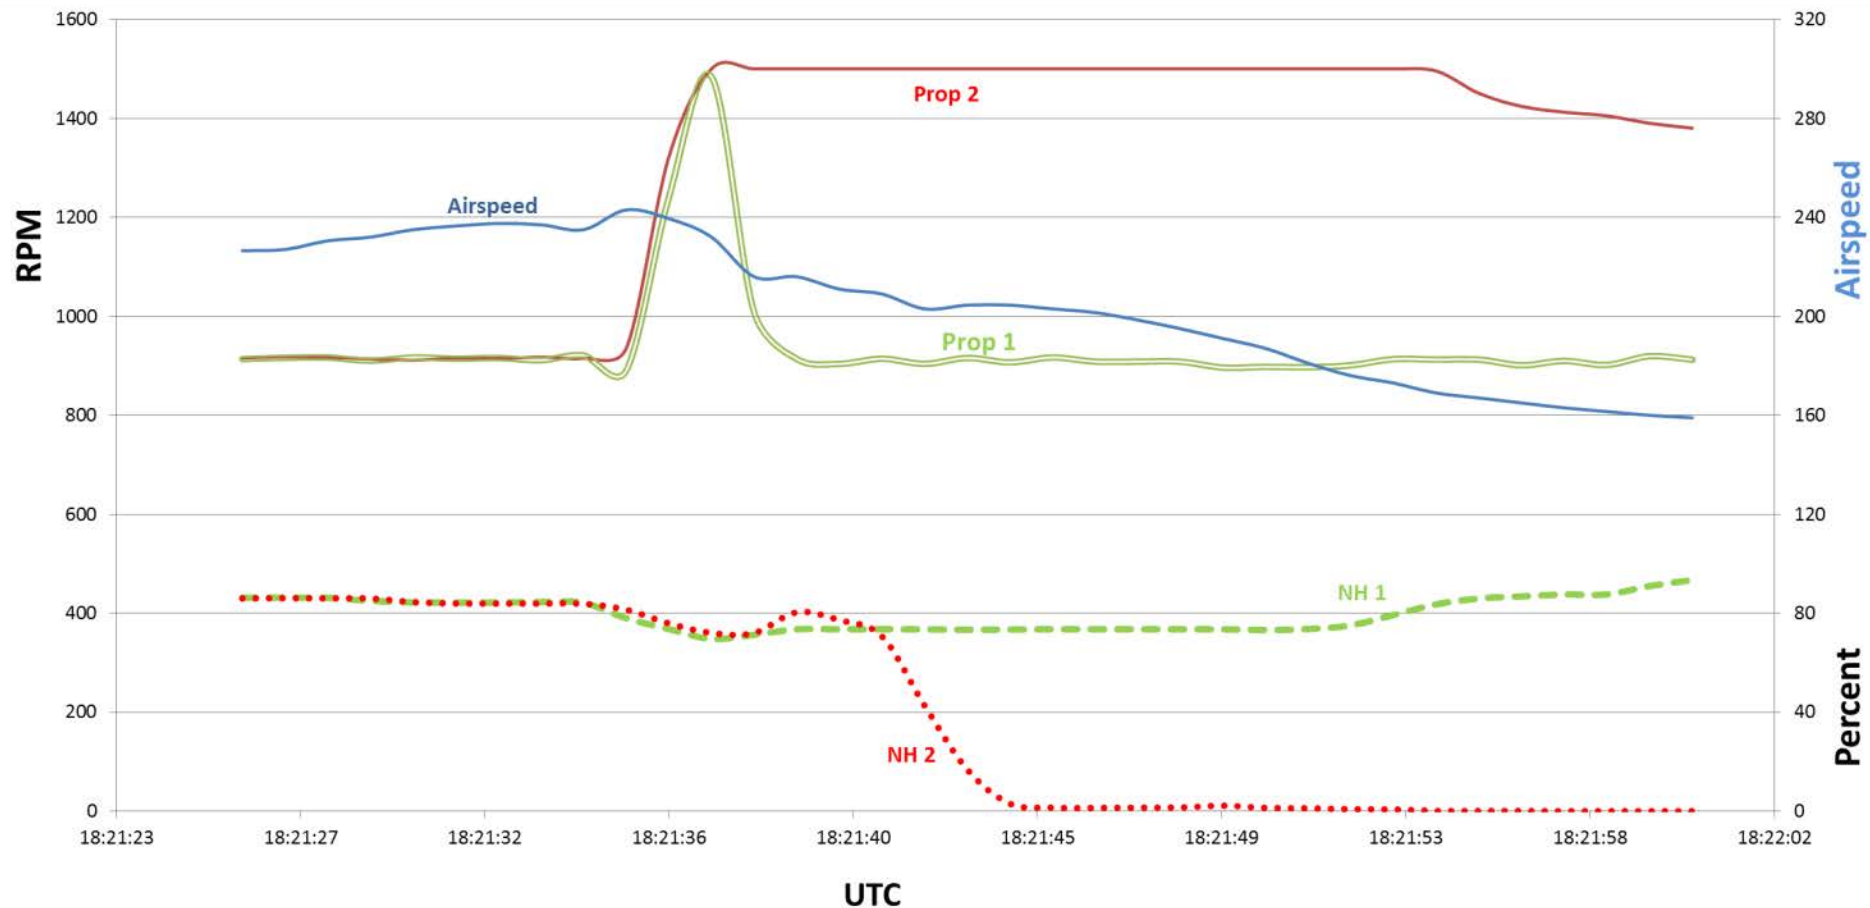
- The RPM on the right propeller rose from 911 to above the highest recordable value of 1,500 over the course of 7 seconds.
- The right propeller RPM was above 1500 for about 18 seconds.
- During the same period, the RPM for the left propeller rose from 916 to the highest recorded value of 1,483.

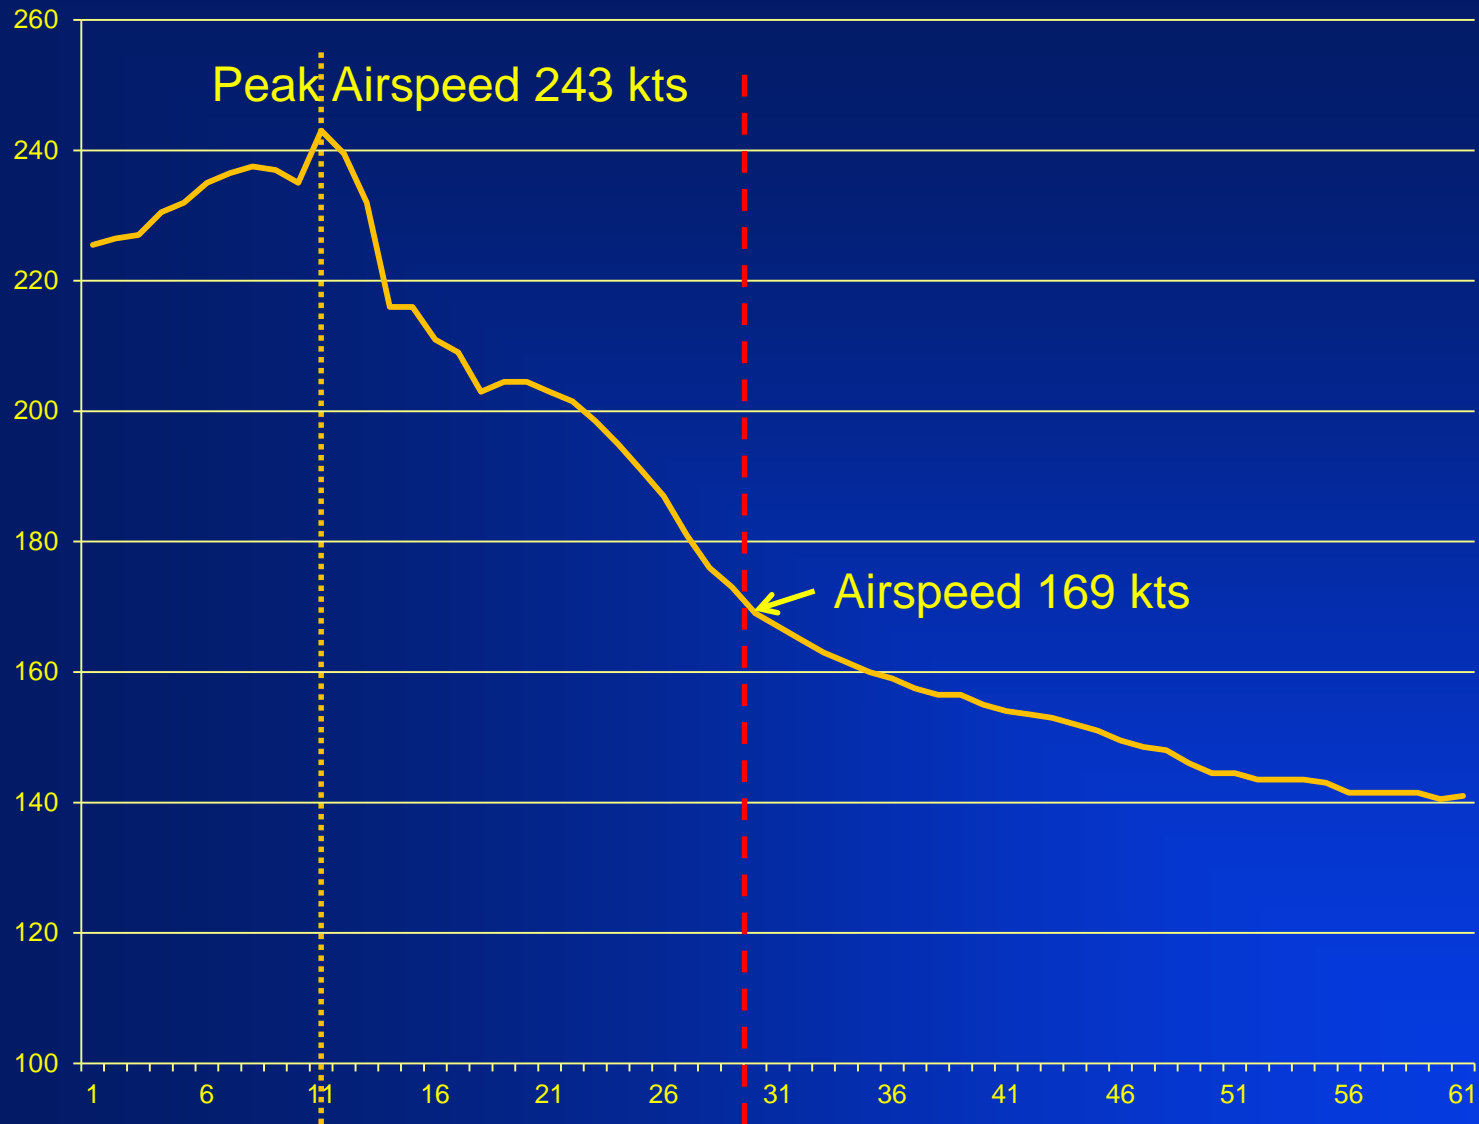
FDR - Airspeed

- CVR was overwritten (left powered on ground).
- Engine power lever position not recorded.
- Airspeed was initially 225 kt, but increased significantly to 243 kt ( $V_{NE}$  is 242 kt) during the last 10 seconds before the propeller speed started to increase.
- Over a 4-second period, the vertical acceleration (g) varied from 1.0 through 0.2 to 2.0 and for a brief moment, it reached -1.07 g.

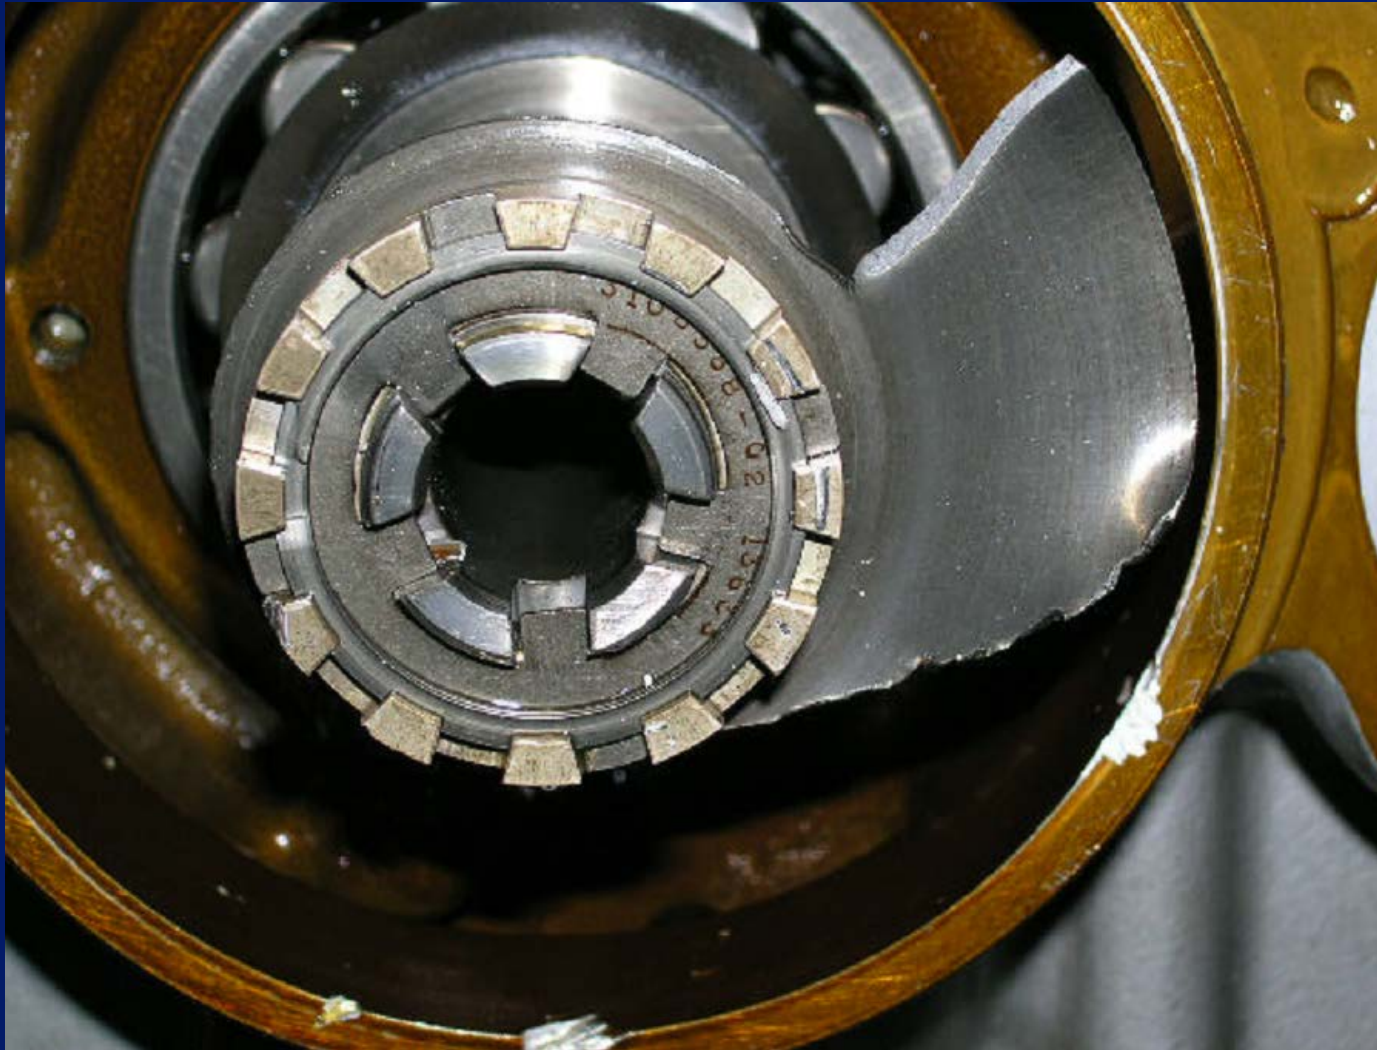
Torque Shaft Forward Web

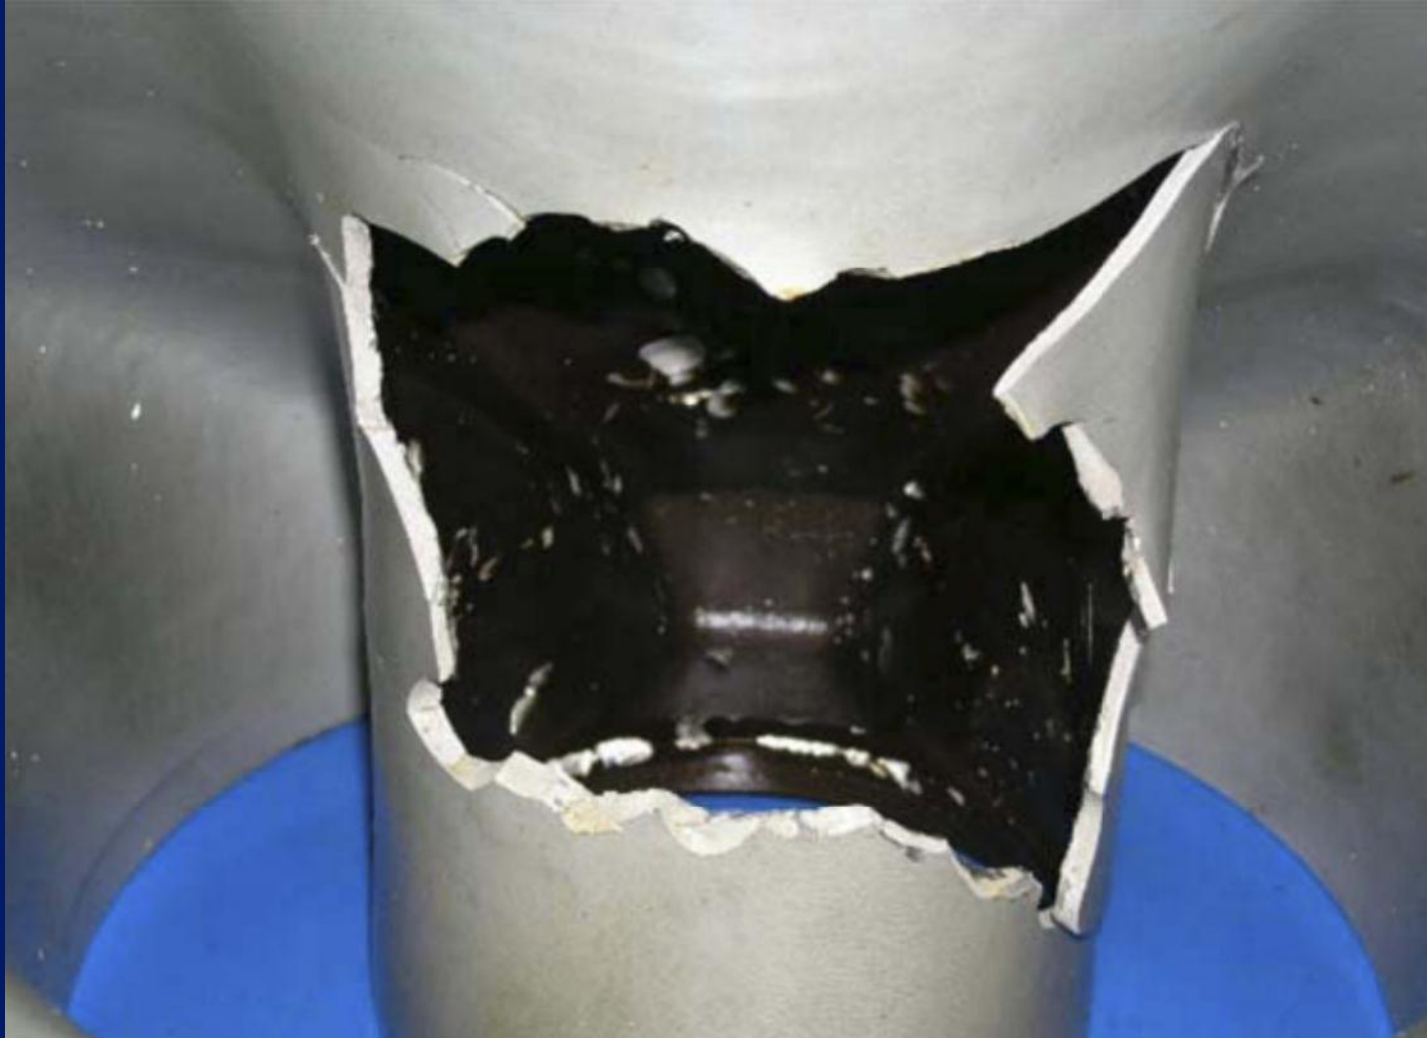
Inlet Plenum

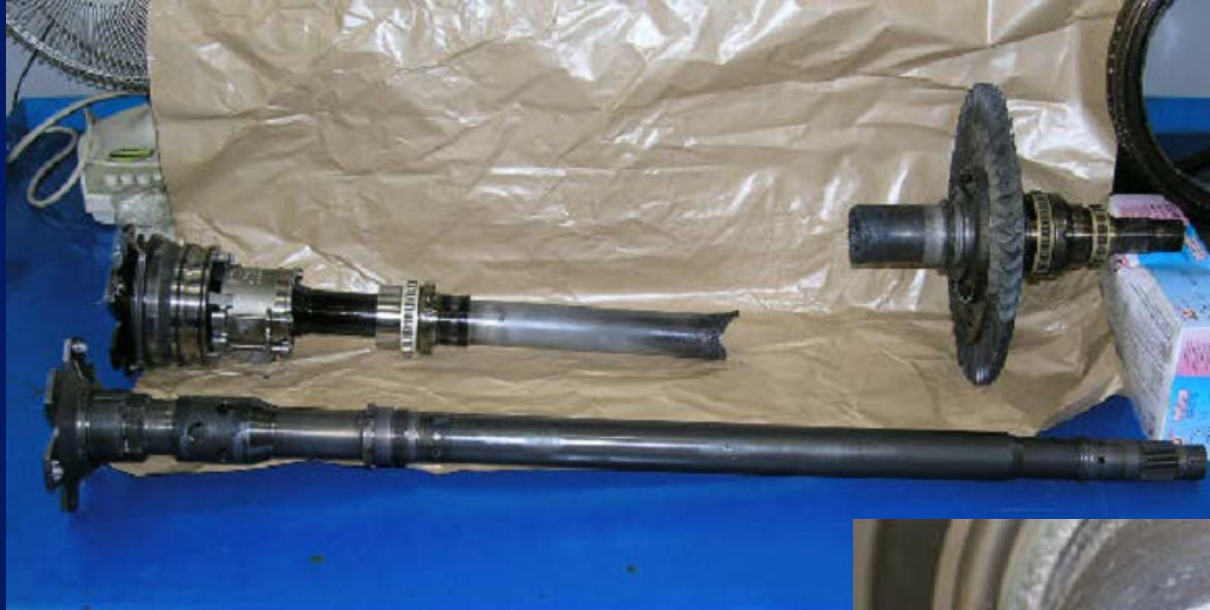
The low-pressure turbine shaft had separated and partially melted

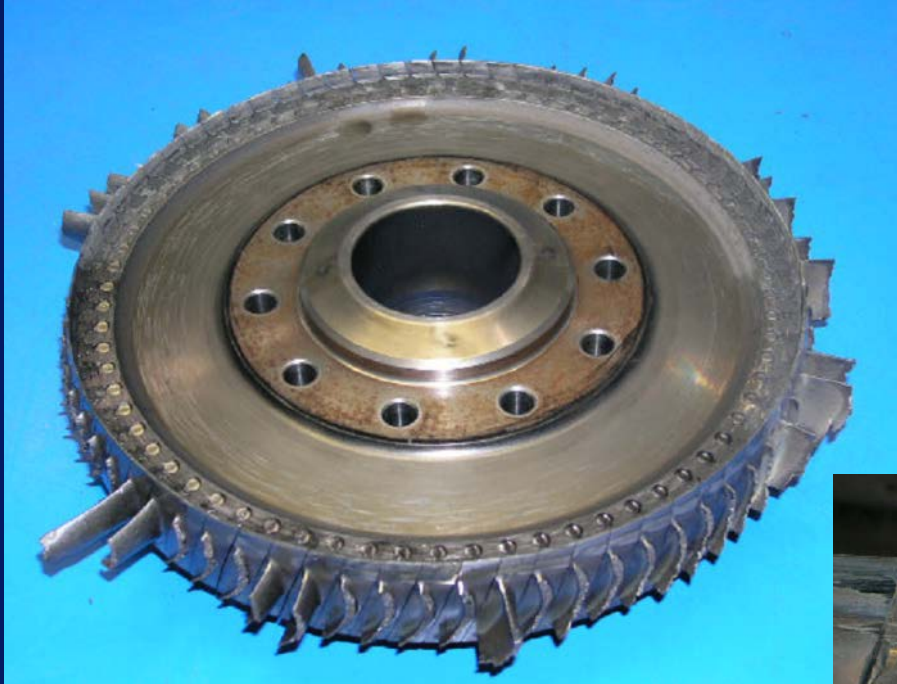
2<sup>nd</sup> Stage Power Turbine

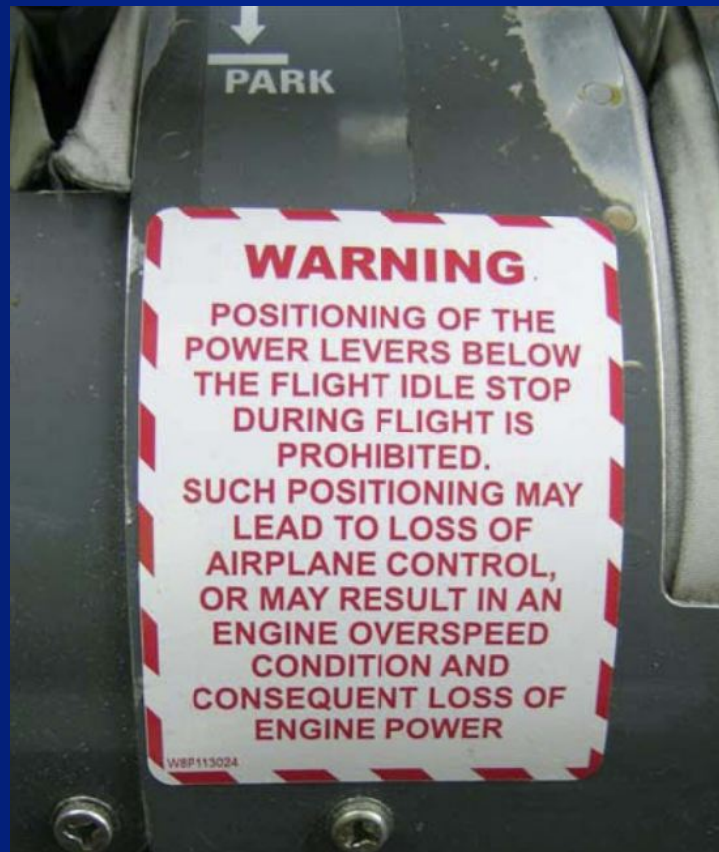
The company installed warning signs near the Power Levers of all their DHC-8-103 and DHC-8-311 aircraft in May/June 2006. Installation was based on Bombardier Service Bulletin 8-11-103.

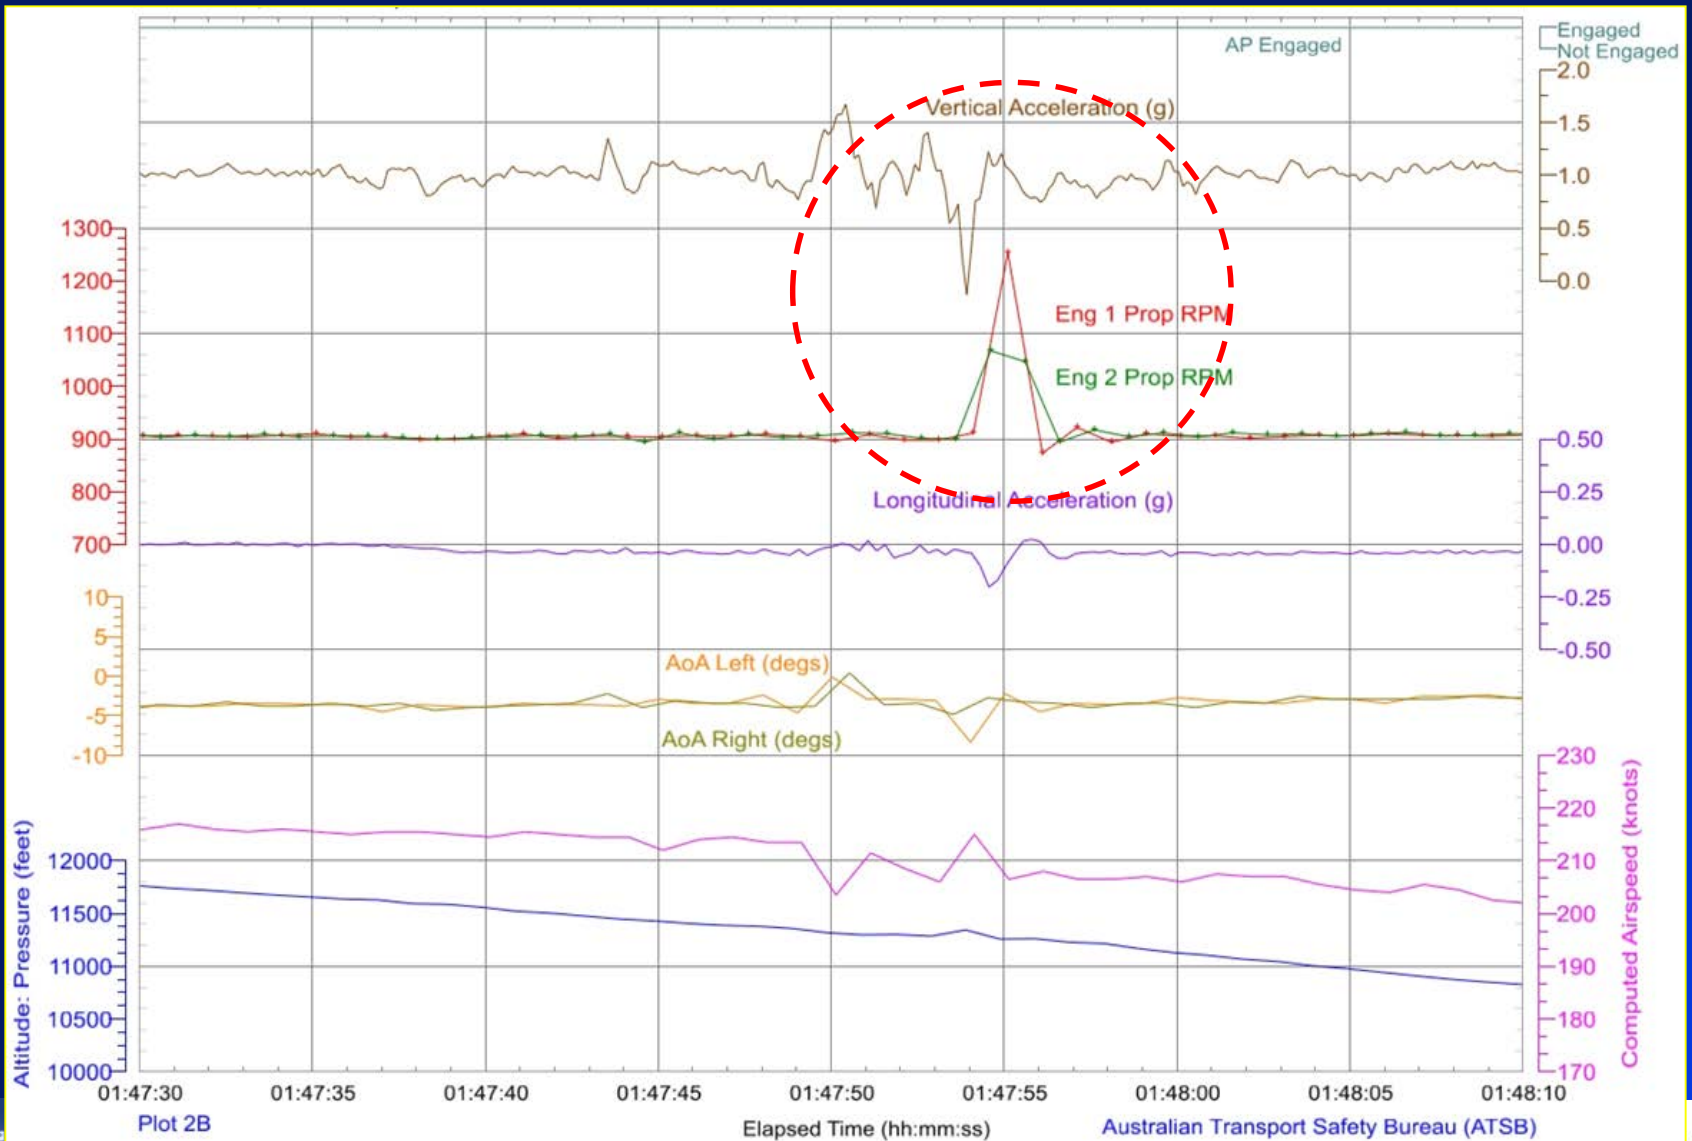
- During descent the power levers were inadvertently moved into the ground beta range due to turbulence, the pilot moved the power levers back above the flight idle gate within a second.
- During that time both propellers accelerated above their governed 900 RPM to 1275 RPM on the left engine and 1215 Rpm on the right engine.
- The trigger warning horn sounded during that event.
