Double De-Fuelling Incident Blackhawk 104 & Blackhawk 205 Gold Coast Airport 7 Jun 05

*SQNLDR Marcus Bromet
Headquarters Air Command, Australia*

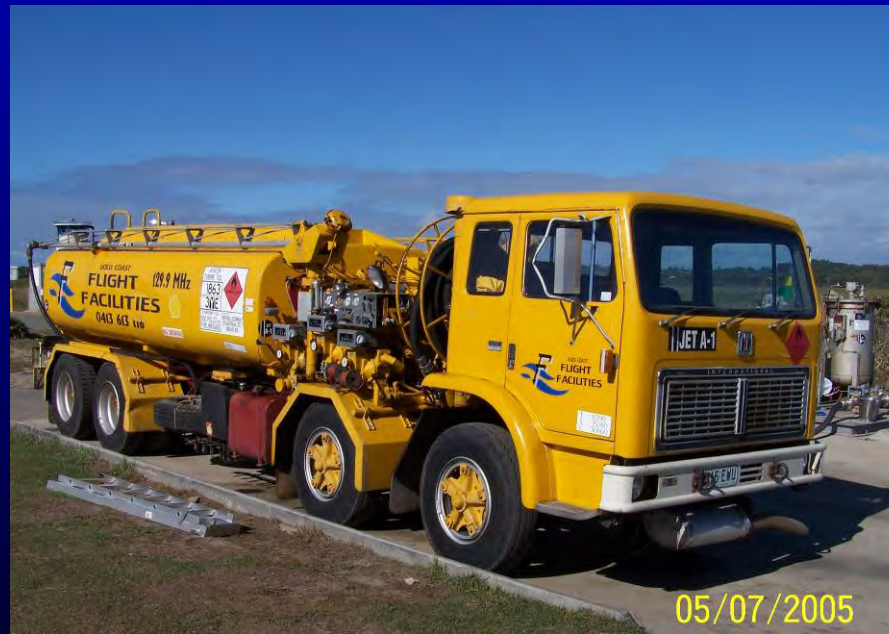
- ➔ Daily quality-control (QC) checks were completed
- ➔ Commenced refuels on civil aircraft using openline/overwing refuelling
- ➔ Waited for Blackhawk 104 at Bay 16

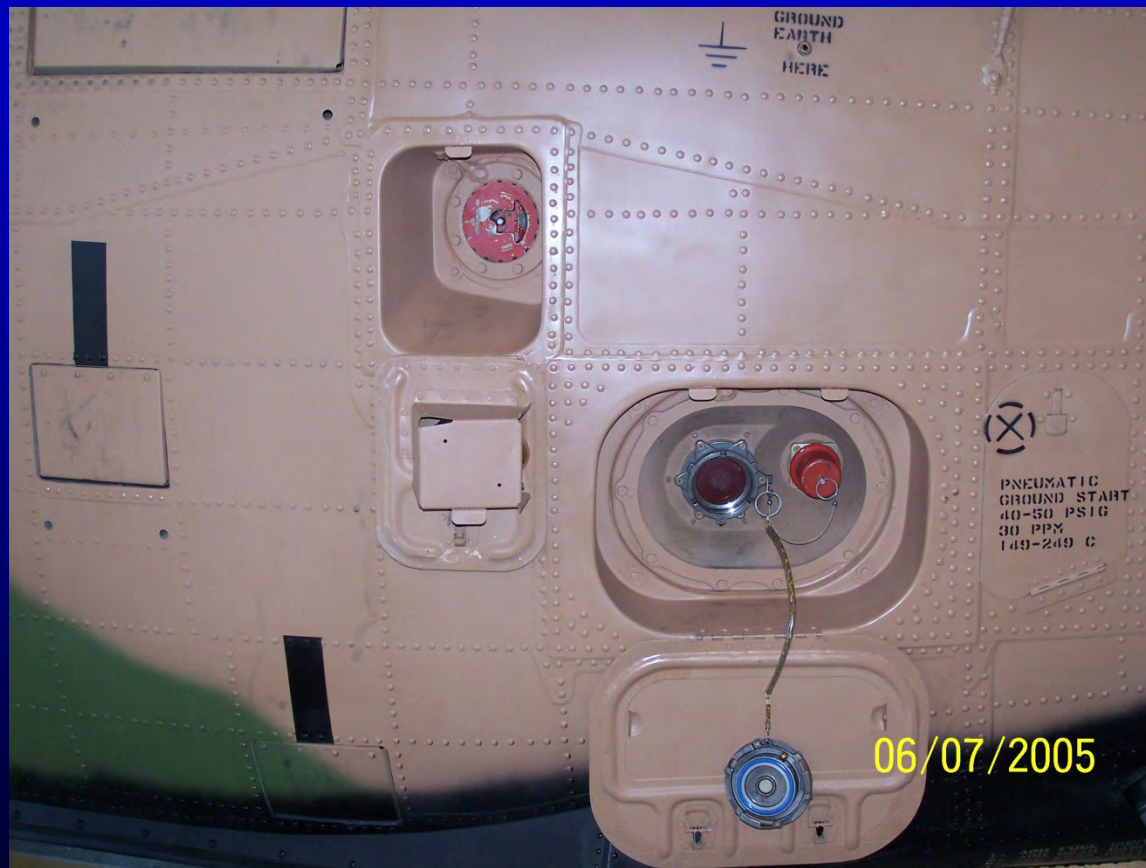
- Commenced refuels on Blackhawk 104 using closed line / single point refuelling
