## **Enhancing Safety Through Engineering Analysis**

### **– The ATSB Technical Analysis Unit**

### Case Study #1: The Impact of Secondary Accessories on Primary Engine Reliability – Electrical Discharge Damage

### Case Study #2: Service Life Issues with Repaired HP Turbine Blades

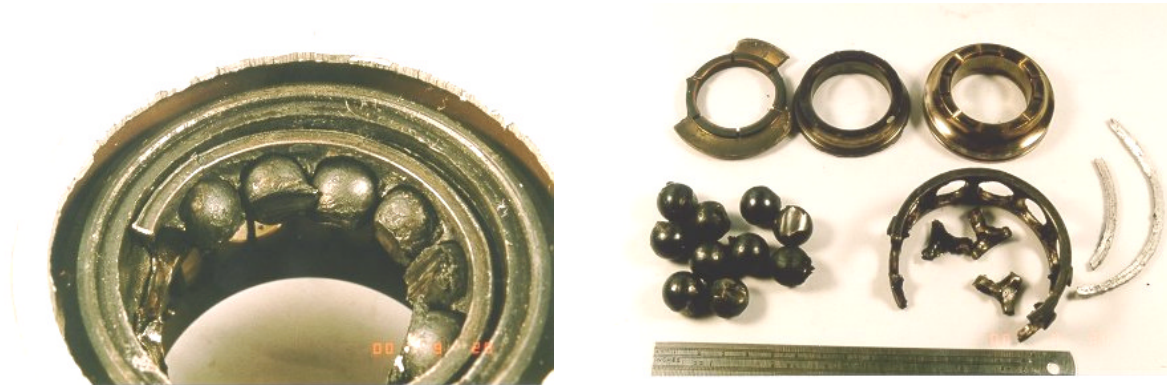
A twin-engine RPT aircraft fitted with modern and common turbo-prop power plants experienced an uncommanded auto feathering of one engine in response to an engine compressor failure. The subsequent strip examination showed the primary shaft bearing to have overheated and seized against the races, producing extensive wear and damage (figures 1 & 2).

**Figures 1 & 2.** Destroyed main shaft bearing as recovered

When bearings suffer breakdown and failure, there is generally a very significant increase in frictional heating that often leads to thermal runaway and extensive surface melting. The case in question was no exception and considering the high turbine shaft speeds, the progression of the final stages of this failure would have been rapid.

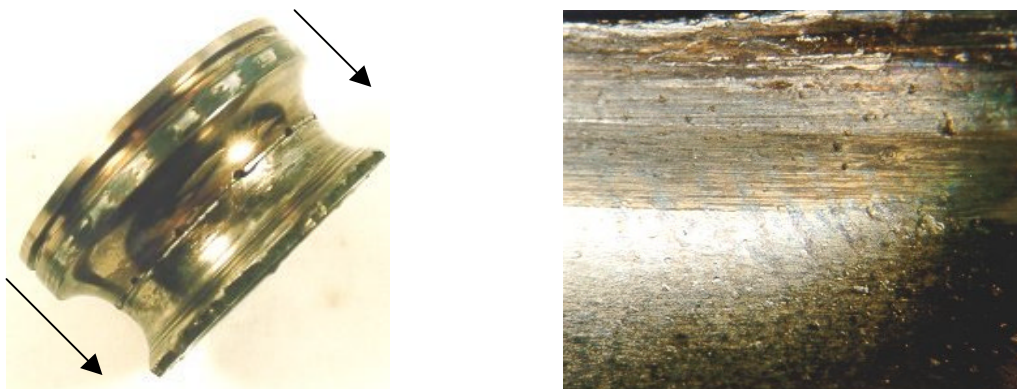
In this case, bearing seizure had occurred, with extensive accompanying heat and wear damage to the balls, races and cage. Due to the effects of compressor thrust loads, the wear on the inner races was biased toward one side, leaving one half of the raceway able to be studied in more detail (figures 3 & 4).

**Figures 3 & 4.** Inner race damage and pitted appearance of the race surface under magnification

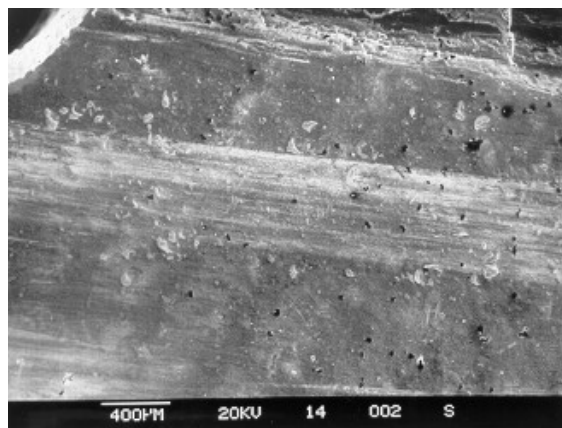
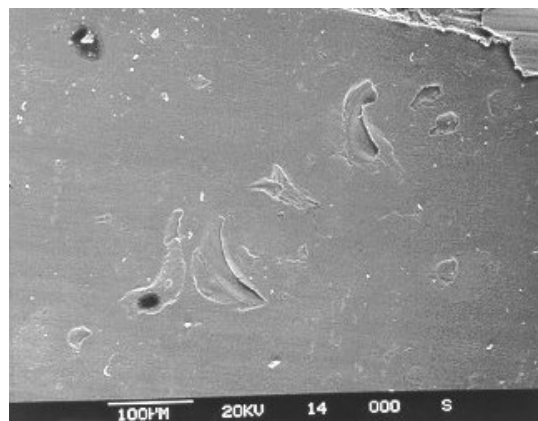
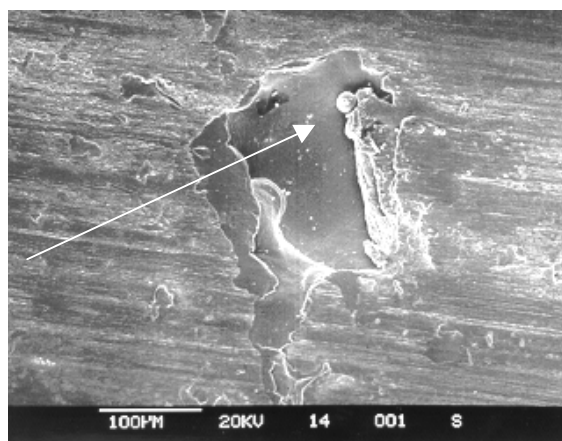
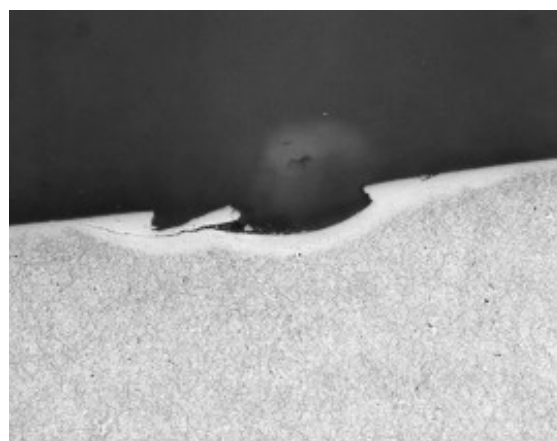
**Figures 5 & 6 (Top).**  
**Figure 7 (Btm L).**  
**Figure 8 (Btm R).**

Scanning electron microscopy provided the key. Small pits found toward the inner edge of the race showed characteristic evidence of electrical arcing damage, including small globules of remelted race material within the pit confines (figures 5, 6 & 7). Metallographic sectioning and examination of the race microstructure surrounding these pits showed prominent light-etching transformed zones, typical of localised heating and characteristic of arc damage (figure 8).

Inner race surfaces under the SEM, showing the typical pitting form.  
Closer view of a pit showing the globule of re-melted material, typical of arc damage.  
Metallographic section through a surface pit, showing the surrounding light transformed region.

So there is the answer – the bearing failed from electrical arcing damage that produced:

- Pitting of the contact surfaces
- Interruption of the normal rolling contact between the bearing elements
- Increase in frictional heating
- Thermal runaway and seizure of the unit.

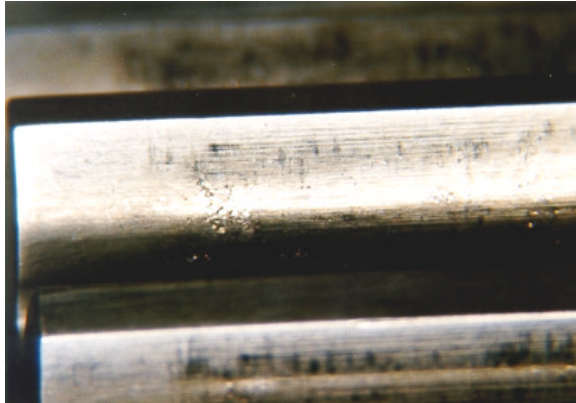
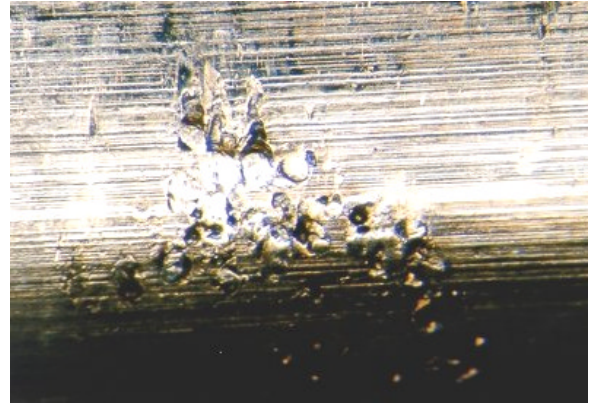
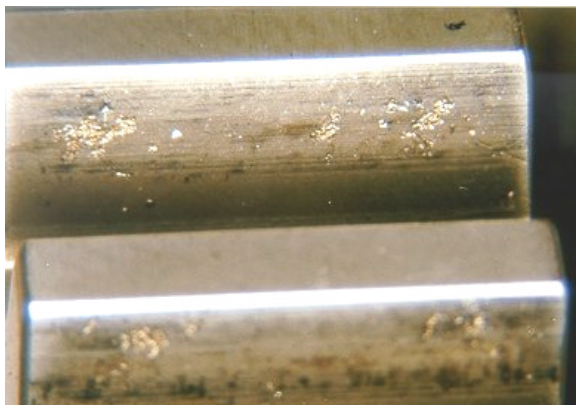
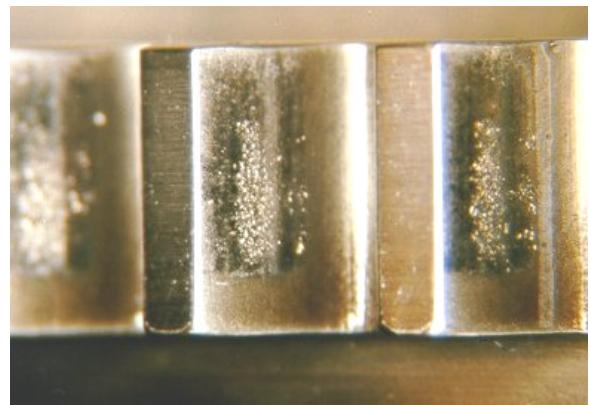
The main shaft of the turbine was coupled to the accessory gearbox via a short splined shaft and a series of reduction gears. The accessory gearbox carries the starter / generator for the engine and aircraft electrical services. Each of the drive train components leading from the main shaft to the starter-generator showed small areas of surface pitting damage in the areas of contact with the adjacent components (figures 9 – 12).

**Figures 9 - 12.** Pitting from electrical discharge found on the contact surfaces of the accessory gearbox gear teeth.

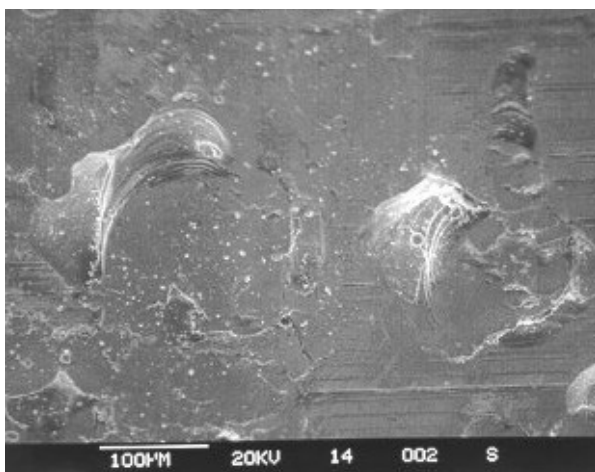
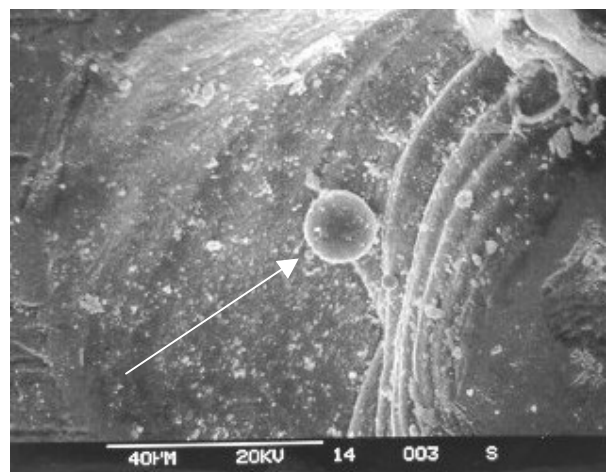
The gear faces presented damage which appeared to be spalling or rolling-contact fatigue damage. Closer scrutiny however, again under the electron microscope showed the damage to be very similar to the bearing race pitting – having all the hallmarks of electrical discharge damage (figures 13 & 14).

**Figures 13 & 14.** SEM views of gear teeth pitting, again showing clear evidence of re-melting.

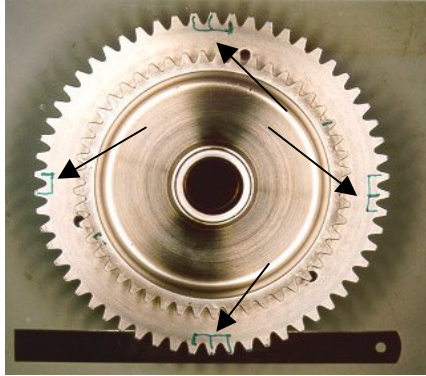
Additionally, patterns were found within the distribution of the damage around the starter gear that suggested the current was alternating in potential in phase with the gear rotation. Logically, the markings also indicated the direction of current flow to be away from the starter generator (figure 15).

**Figure 15.** Starter gear profile view showing the dominant locations of electrical discharge pitting.

In this way, it was possible to confirm the starter-generator unit as being the source of electrical leakage current, which sought the path of least resistance down through the accessory gearbox and into the number one bearing. Tests have subsequently confirmed that the starter-generators in question can produce an alternating current on the armature shaft when certain conditions exist.

The root cause of this failure was thus a fault within the starter-generator unit, allowing leakage current into the accessory gear train and producing damage to the main bearing, rendering it incapable of continued low-friction operation. It would further be expected that the analysis process would be continued to identify the nature of the fault within the starter-generator and why that fault originated.

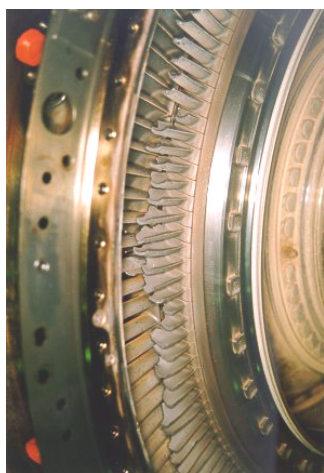
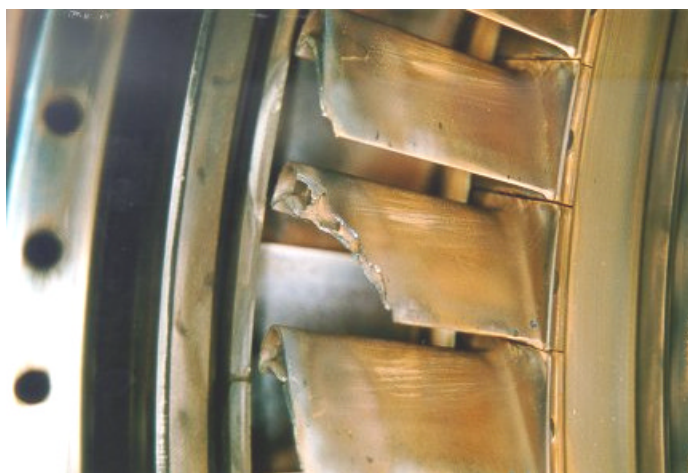
**Figure 16 (Left).**  
**Figure 17 (Right).**

The subsequent engine strip examination showed very extensive damage to the low-pressure turbine blades of all four stages. Most blades had fractured at the root or mid-section and created a large amount of debris which carried through the turbine (figure 16). Exposure of the high-pressure turbine disk showed only one blade to have any damage – this being the loss of a 15 x 20mm section from the tip trailing edge (figure 17). All other HPT blades were intact, although many contained radial notch-like cracking from the tip edges on both concave and convex sides (figures 18 & 19).

Damage presented by the first stage low-pressure turbine blades.  
Damage shown by only one blade of the high-pressure turbine.

Given that no significant damage or loss of components was found forward of the HPT stage, it appeared likely that the loss of the segment from the HPT blade had caused the 'avalanche' collapse of the downstream blades. Supporting this, all examined LPT blades were confirmed to have failed in overload.

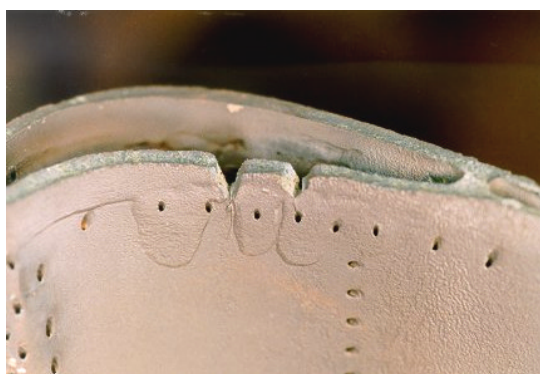
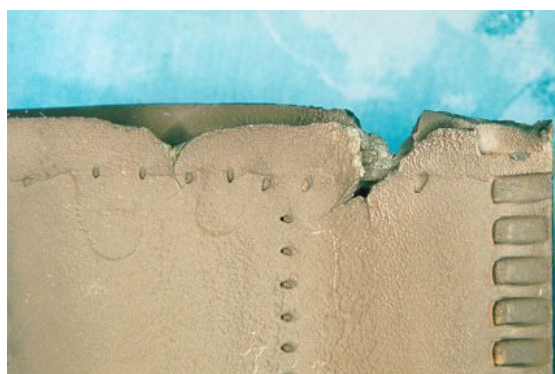
**Figures 18 & 19.**

Cracking and notching of the tip edges found on many of the HPT blades.

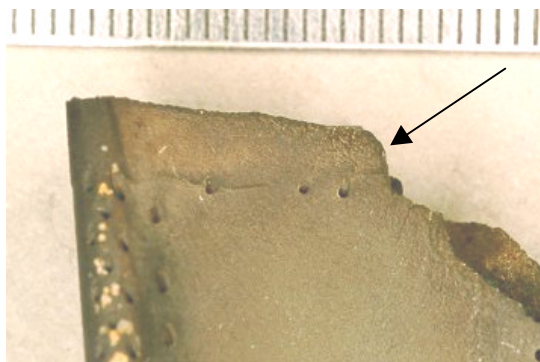
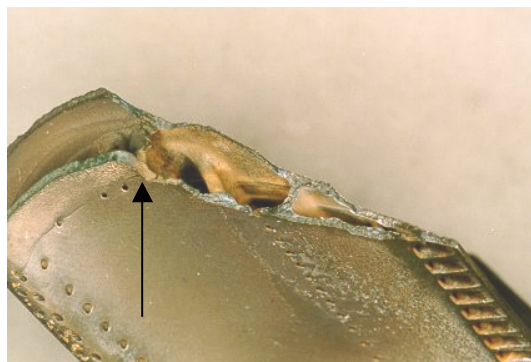
Why did the HPT blade liberate a segment? This was the question driving the examination and led to the close visual and metallurgical inspection of the failed component. The radial tip notching effect observed on many other blades was quite prominent on the failed item and was located at the tip end of the liberated segment, suggesting the influence of this phenomenon (figures 20 & 21).

**Figures 20 & 21.** Failed HPT blade showing the orientation and size of the liberated section. Note also the effects of the tip notching (arrowed).

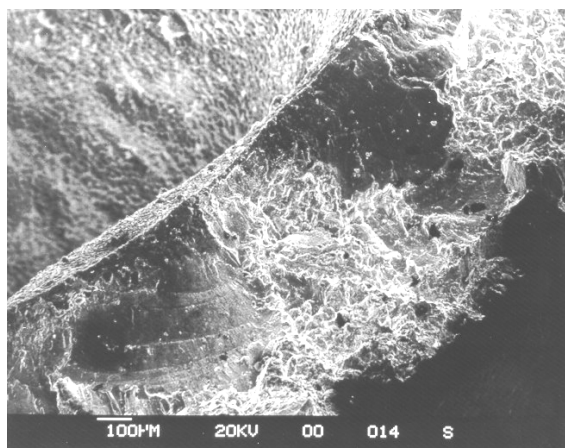
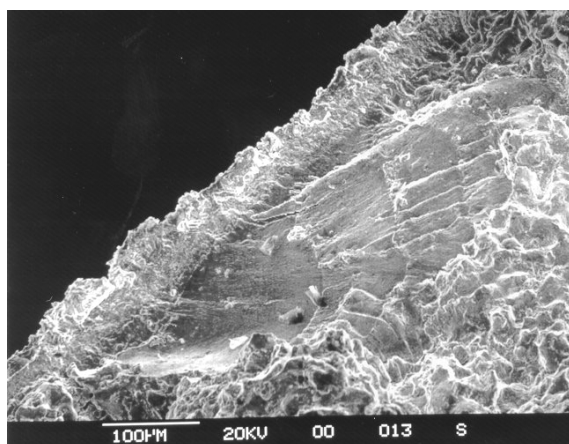
Electron microscopy revealed good evidence of the fatigue propagation of cracking beyond the notched area (figures 22 & 23). The orientation of the fatigue beach marks indicated blade thrust loads were a dominant driving force. The absence of excessive high temperature oxidation of the blade edges (from the loss of cooling air flow) indicates that the engine had been shut down very shortly after the blade segment was lost – additional evidence that the HPT blade failure caused the downstream damage.

**Figures 22 & 23.** Clear evidence of fatigue cracking found over the fracture surfaces beneath the blade tip.

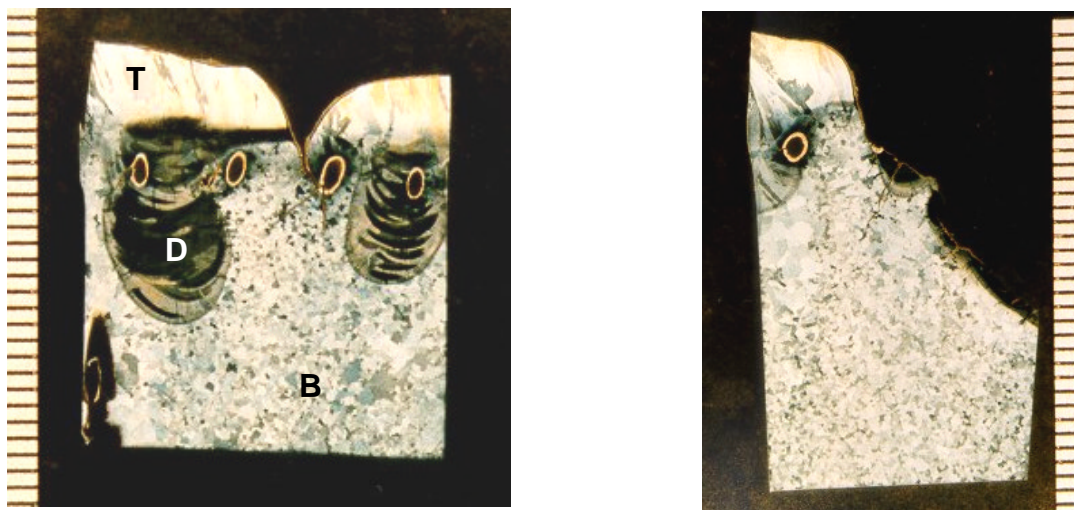
Many of the HPT blades contained tip welding – a life extension procedure to repair the notching damage and rebuild the tip profile (figures 24 & 25). In the failed blade's case, the tip notching had intersected a rather large and deep tip weld repair and had subsequently propagated along this repair into the blade body, eventually growing beyond critical size and liberating the tip segment.

**Figures 24 & 25.** Polished and etched micro-sections showing the base metal (B), deep repair welds (D) and tip repair weld (T).

Why had the cracking propagated so rapidly along the weld repair, when other cracking from tip notches had not? The answer lay in the properties of the materials used. Investigation revealed the deep weld repairs were completed using a consumable with an inferior creep rupture, oxidation and fatigue resistance when compared with the blade base metal. The reason for the use of this material was the need to create sound, reproducible welds. The higher ductility of the selected filler material allows deep repairs to be carried out with a lower risk of defects induced by the welding process itself.

Normally, such areas were protected by a capping layer of a more resilient alloy, however once a tip crack had penetrated this and encountered a region of deep weld repairs, further propagation was promoted by the inferior properties of the weld material. Cracks entering these repairs were characterised by more rapid propagation and shortened time to failure. Indeed, it is likely that growth to failure may have occurred within a single inspection period.

In this case, we have a premature failure that occurred as a product of a thermal fatigue cracking intersecting an area of repair work on the blade face. As the repair material was inferior to the base material in terms of its crack resistance,

cracking propagated rapidly and blade failure resulted. In essence, the premature failure was a result of the repair/s carried out on the blade – thus indicating that blades repaired in this manner are inferior to new items in their resistance to this manner of failure.

- Allocate the repaired blades a lower life than their new counterparts, thus ensuring that any items that may be prone to failure in this way are removed from service before they fail.
- Increase the frequency of inspection of engines fitted with repaired blades.
- Re-design the repair (or the blade) to remove the susceptibility to failure in this manner.
