## **Fuel Contamination can still pose a Risk**

**Presented by  
Captain Victor Liu  
Hong Kong Civil Aviation Department (HKCAD)**

## **Introduction**

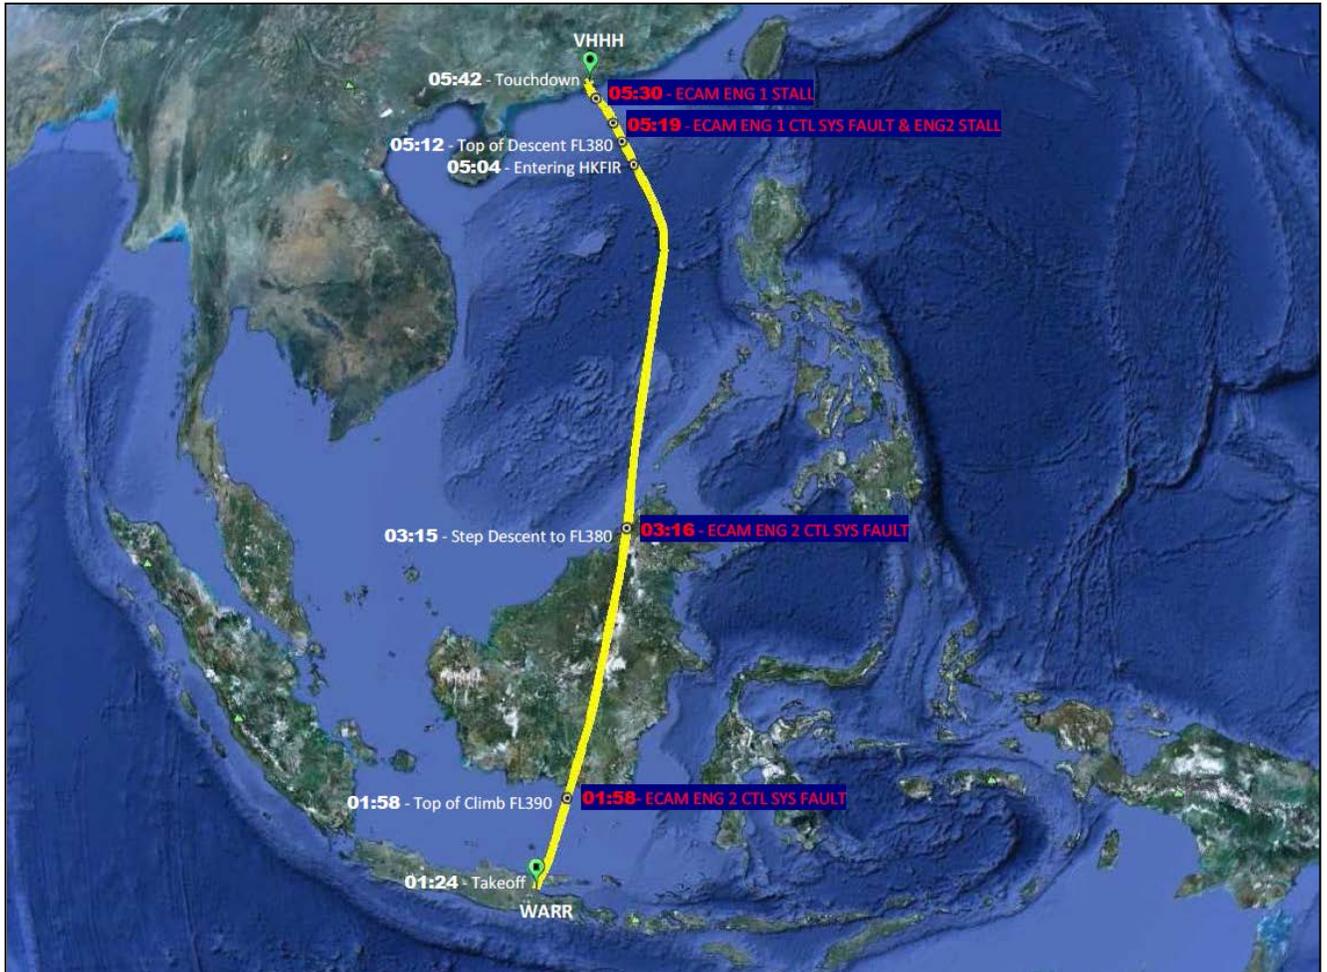
On 13 April 2010, the flight crew of an Airbus A330 aircraft from Juanda International Airport (WARR), Surabaya, Indonesia to Hong Kong International Airport (VHHH) declared "MAYDAY" when approaching VHHH. The aircraft experienced control problem on both engines. The aircraft landed at a groundspeed of 231 knots, with No.1 engine stuck at about 70% N1 and No.2 engine stuck at about 17% N1. Five main tyres were deflated after the aircraft came to a complete stop on the runway. After being advised by the rescue leader that there was fire and smoke on the wheels, the aircraft commander initiated an emergency evacuation of passengers. Some passengers and cabin crew were injured during the evacuation.

Figure 1 – Event Details of the flight from WARR to VHHH

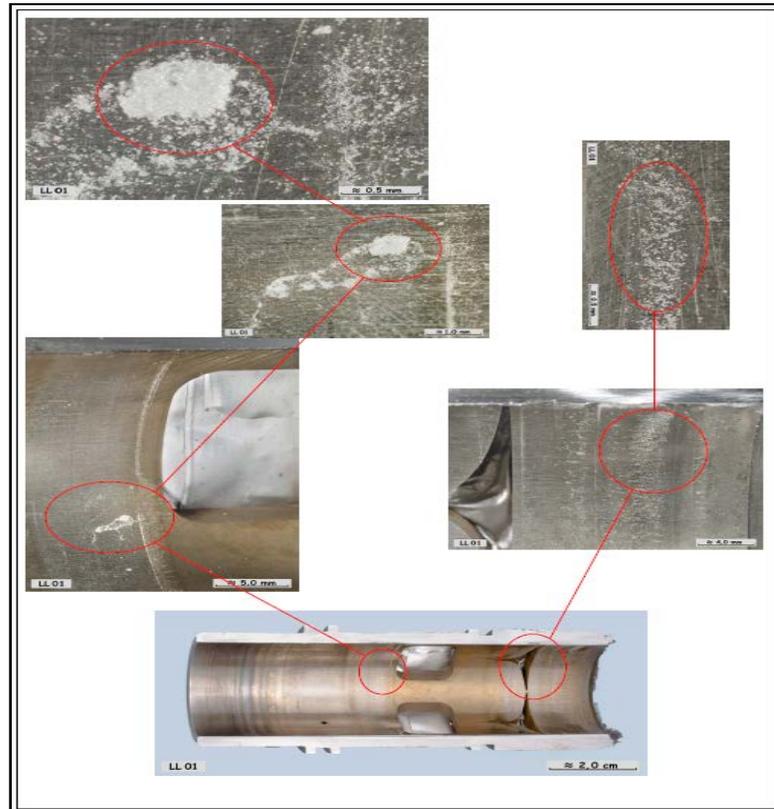
4. The contaminated fuel, which contained super absorbent polymer (SAP) spheres, caused the loss of thrust control on both engines of the aircraft. Laboratory analysis indicated that the SAP spheres contained elements that were consistent with the SAP material used in the filter monitors of the ground refuelling dispenser. Crystalline sodium chloride ( i.e. salt ) was also present on the surface of some SAP spheres. Most of the SAP spheres found had the size ranging from five to 30  $\mu\text{m}$  with a majority in the order

of five to 15  $\mu\text{m}$ . Further analysis showed that these SAP spheres contained elements of carbon, oxygen, sodium, chlorine, sulphur, and were mainly sodium polyacrylate, which is the SAP material used in a filter monitor of refuelling dispenser.

*Figure 2 – The cutaway view of one of the main metering valve of the engine fuel component showing the presence of SAP spheres*

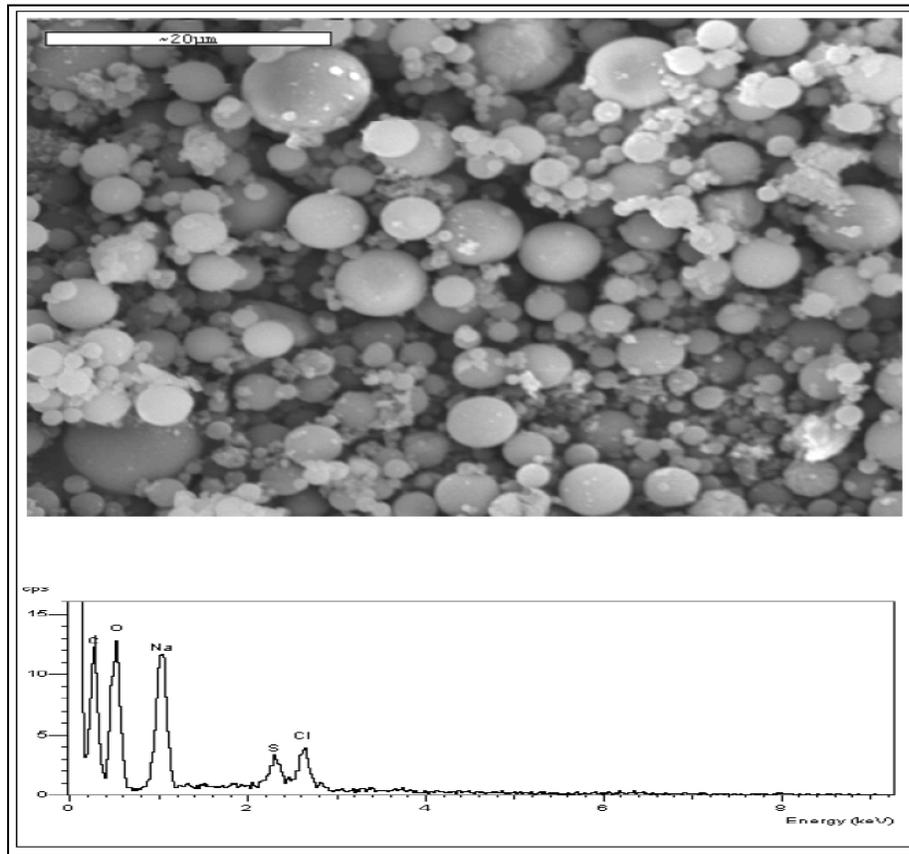
*Figure 3 – Microscopic view of spheres and their composition under Scanning Electronic Microscope analysis.*

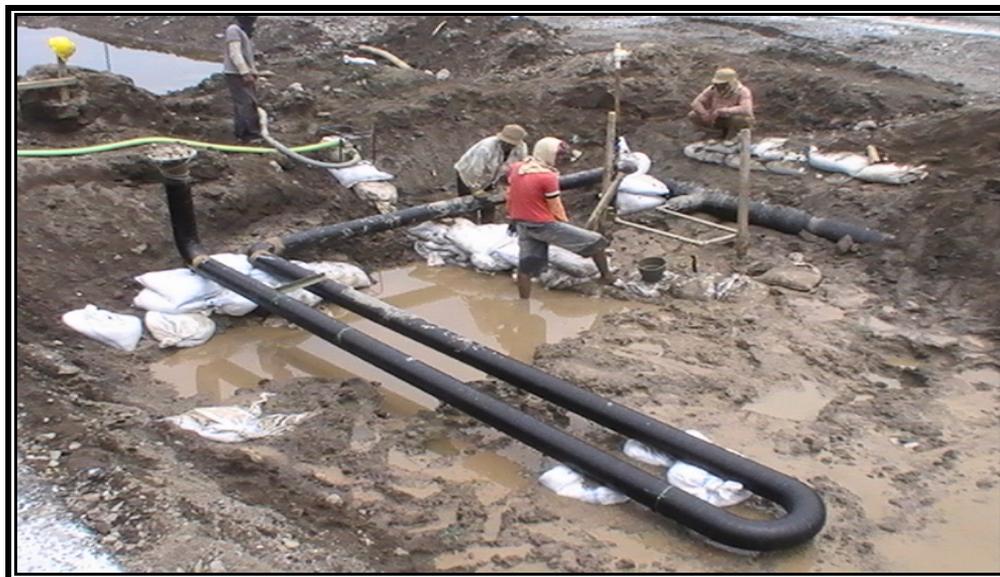
7. WARR had an apron extension project started in year 2009 which involved an extension work of the hydrant refuelling circuit that supplied fuel to Stand No. 8 where the accident aircraft was parked and refuelled before departure. Fuel sample collected from the reworked hydrant after the accident contained salt. WARR is located close to the seashore and has three regulating ponds. The water of the regulating pond closest to the apron extension work site was found to contain salt. The tie-in process of the extended hydrant refuelling circuit required the open cutting of the existing underground piping. Records showed that during the tie-in processing period, there were heavy rainfalls and there were water puddles at the work site. It was likely that the water puddles at the work site contained salt. It was likely that the required tie-in procedures had not been strictly followed and salt water might have therefore entered the hydrant refuelling circuit during

the hydrant extension work.

*Figure 5 – A photo taken during the tie-in process*

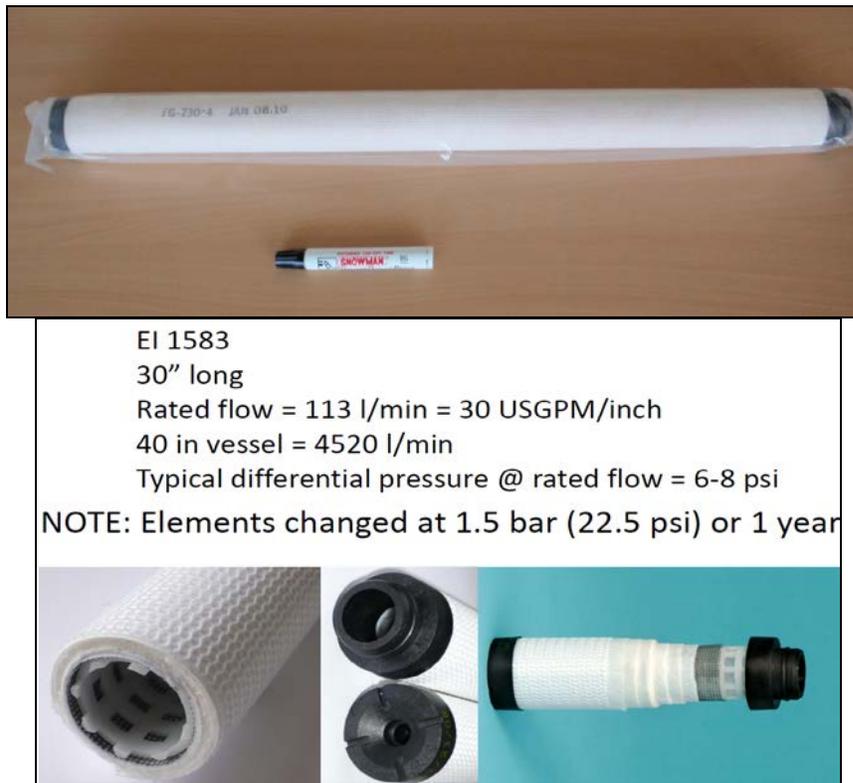
*Figure 6 – A typical filter monitor*

11. The filter monitors of the dispenser used for refuelling the accident aircraft had in fact been activated by salt water. The SAP media in the filter monitors of the

dispenser when reacted with water containing salt turned into gel state and caused an increase in DP indication and vibration of the refuelling hose during the refuelling of the accident aircraft. However the unusual vibration observed was not immediately stopped and properly investigated. The continued refuelling had eventually led to the uplift of fuel contaminated with SAP spheres to the aircraft!

properly completed before resuming the hydrant refuel operation at the affected parking stands, the investigation team has also recommended ICAO to establish civil aviation requirements for oversight and quality control on aviation fuel supply at airports and to specify the requirement of installing a device in the equipment used in refuelling aircraft. This device should be able to automatically alert the equipment operator and stop the refuelling process when the DP across the equipment filtration system is outside the equipment designed value or range.
