## ZK-NBU

(B747-400)

## Inflight Wing Panel Separation NZ99 AKL-NRT

Operational Safety – Air New Zealand

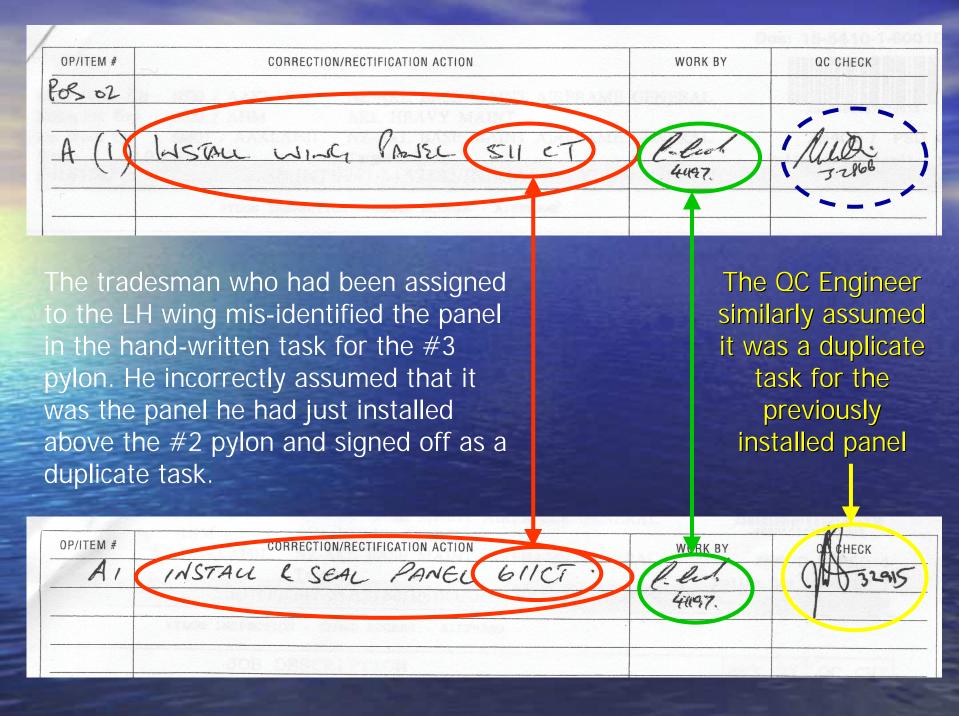
#### Target: SB(INT)/747-54A2182/INBOARD PYLON INSPTN

# Generic Task Card Produced from Service Bulletin

**Unnecessary Task**

No Reference Manual for Procedures

Inappropriate Panel Identification

A.	Pylo	on Inspections - Close Access:				
			Pylon No #2	7		1	5
		(1)	Wing leading edge gap cover installed.	PT	O	Ro	/
6,33.0	BIGHAL	(2)	Diagonal brace fuse pin access doors installed. AMM 54-62-00.	-4	ū47	M	eon
	AGEST 9	(3)	Midspar fitting fuse pin access doors installed (Inboard pylon only). AMM 54-62-00.	N	ites	L	1
