Kalkara Investigation

A Kalkara Target Aircraft was lost during an operational flight.

A DSTO investigation determined the cause of the failure and provided recommendations to prevent similar occurrences.

A complete teardown inspection of the aircraft is under way, primarily to determine the effects of long term salt water exposure.

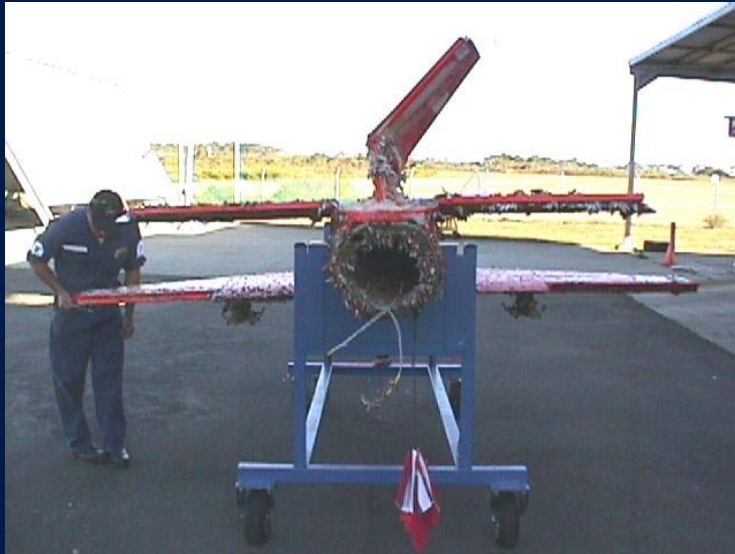
Six months later the aircraft was found washed up, upside down, on a beach 150km north of the original target area.

The aircraft was in remarkably good condition - the only significant damage was:

- Both plastic wing-tip caps missing
- Port aileron missing
- Rudder missing
- Substantial marine growth

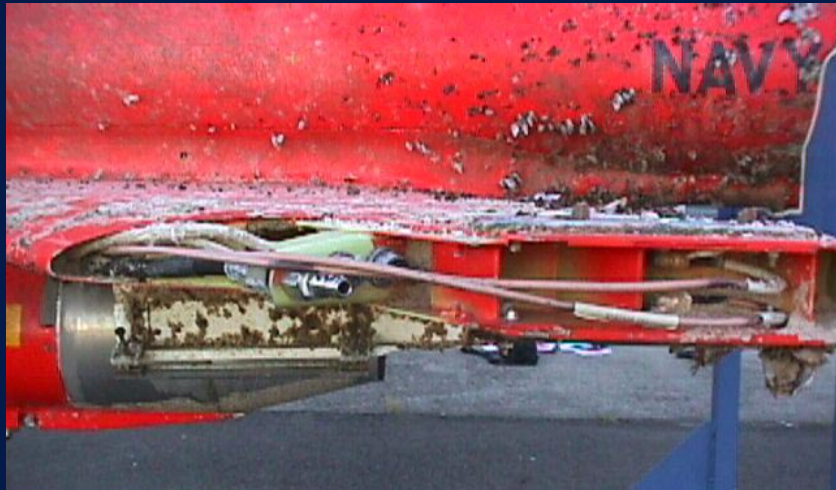
Inspection at Jervis Bay Range Facility (JBRF).

Marine growth showed which components departed when the incident occurred and which separated later when the aircraft beached itself.

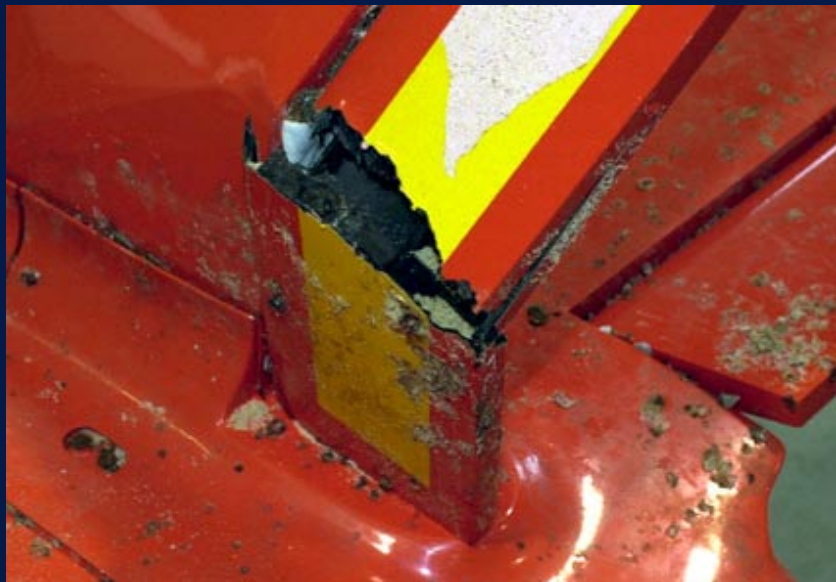
Absence of marine growth showed that the wing tip caps became detached and the rudder broken when the aircraft was beached.

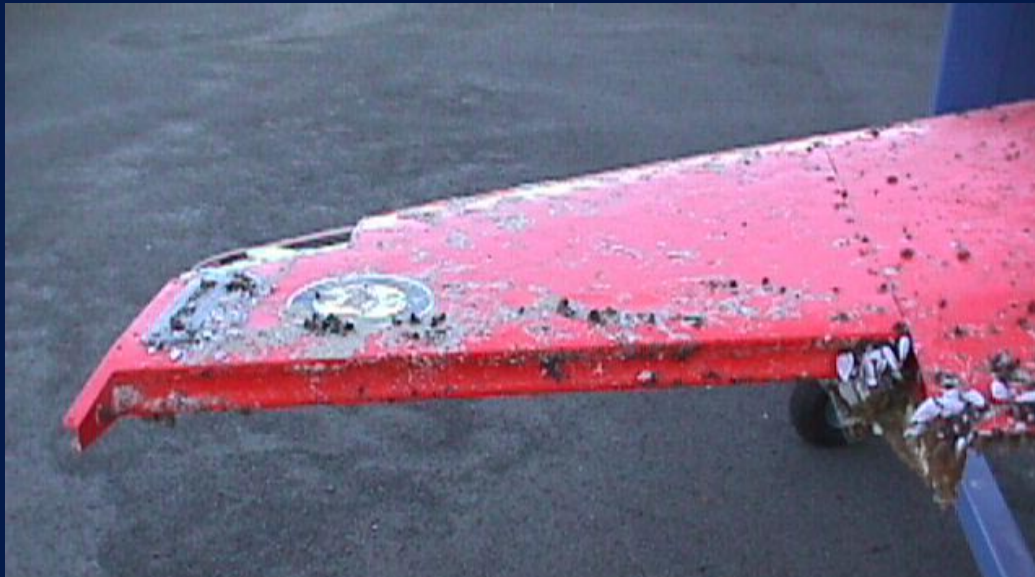
The area normally occupied by the port aileron had barnacles as large as any found elsewhere on the aircraft.

This indicated that the aileron detached at the time of the incident (possibly a significant event in the failure sequence).

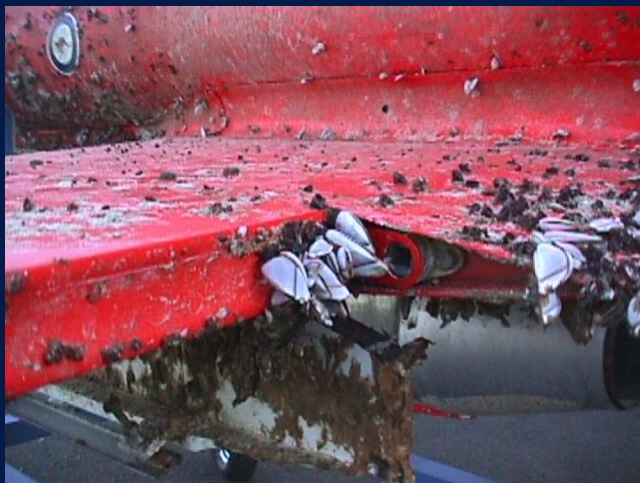
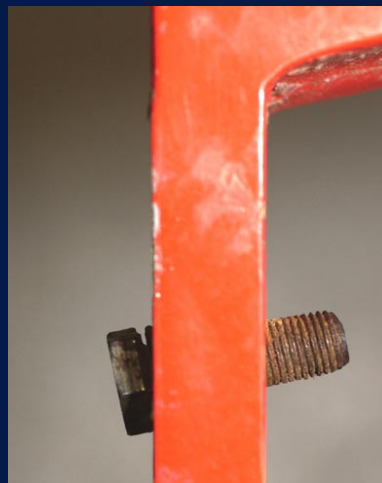
However, the aileron attachment bolt was still present

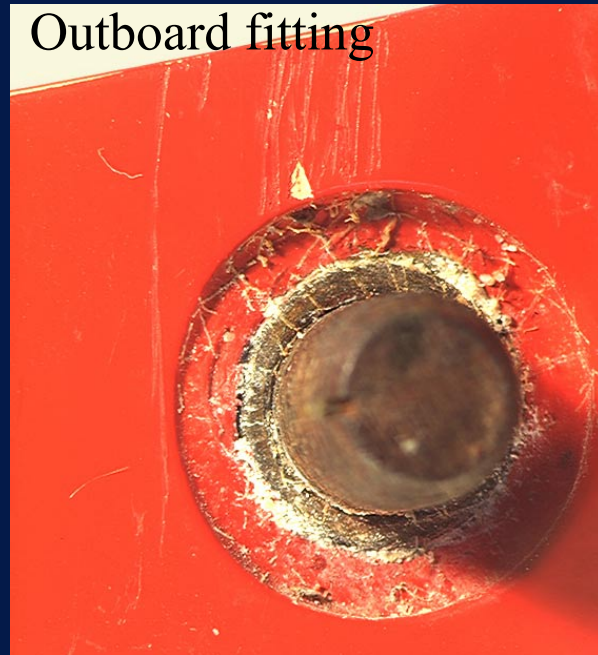
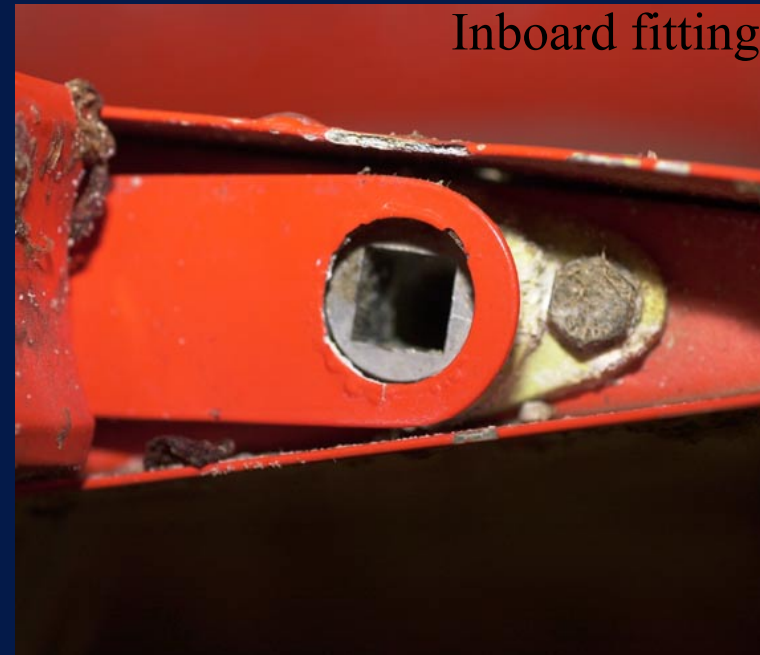
Witness marks (scratches) showed that the aileron first became detached at the outboard end (the attachment bolt end).

The aileron then moved outwards and upwards, pulling out from the inboard fitting where a square shaft that located the aileron caused damage.

No other damage marks were observed in this area suggesting that the aileron had departed intact rather than breaking up while the target was shot at.

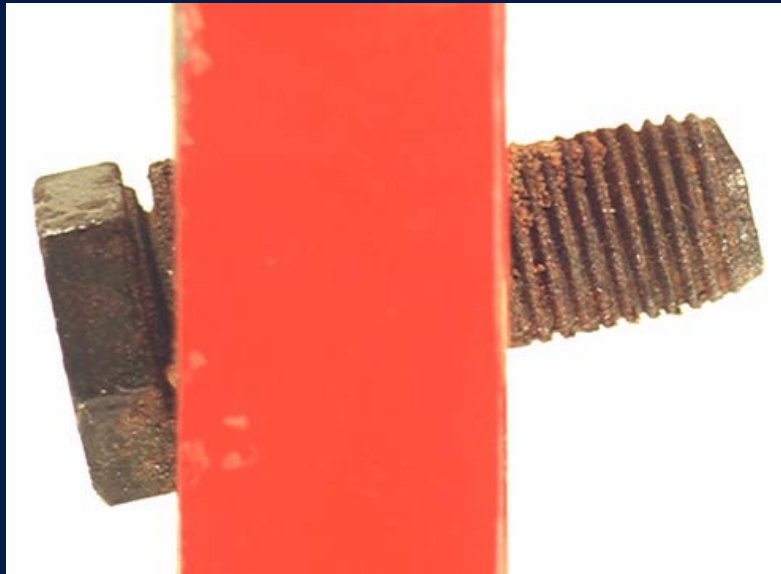
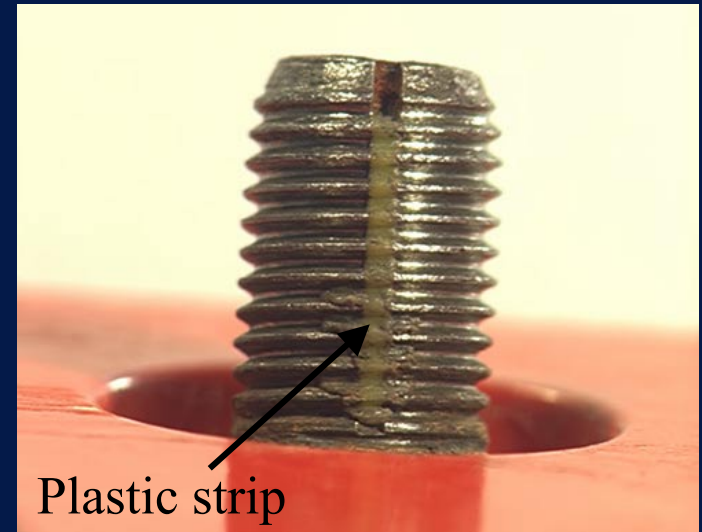
The aileron attachment bolt was present, but slightly displaced from its normal position

A plastic locking strip which locks the bolt to the aileron was clearly visible after the bolt was cleaned.

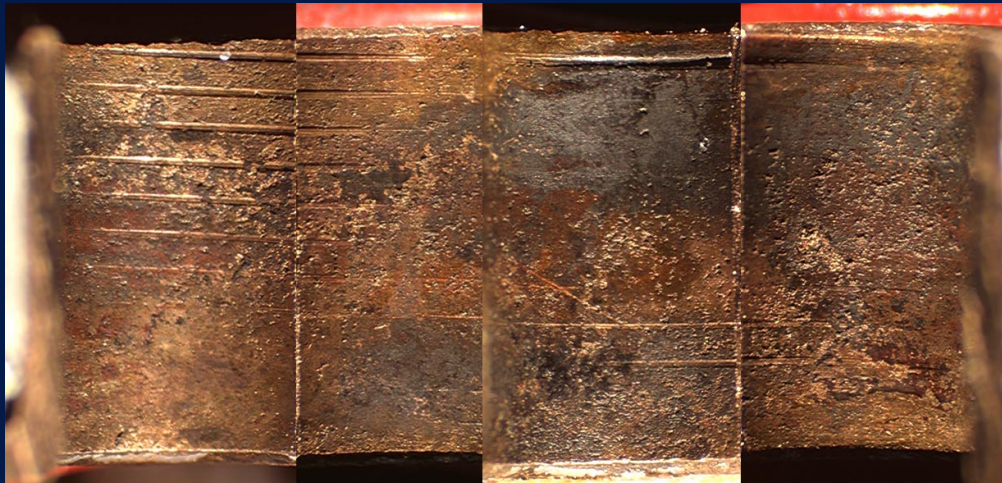
Port Aileron Bush
(missing aileron)

Port aileron bush - Aileron missing
Outer end of bush (collar) at bottom

There was a single set of thread marks on both the port and starboard bushes.

Thread marks are produced when a new bolt with undeformed locking strip is forcibly screwed through the bush.

This indicates that a new bolt was fitted only once, even though the aileron was removed several times.

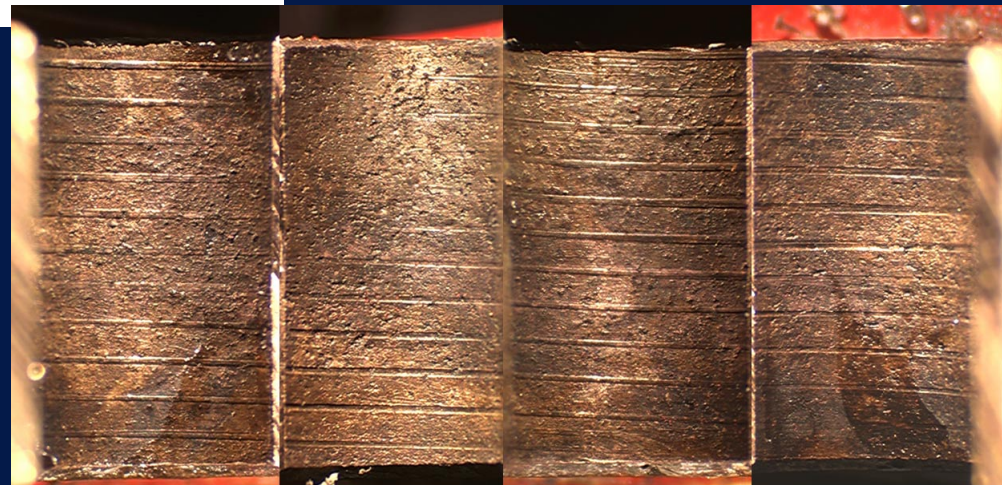
Starboard Aileron Bush
(aileron present)

Starboard aileron bush - Aileron present
Outer end of bush (collar) at bottom

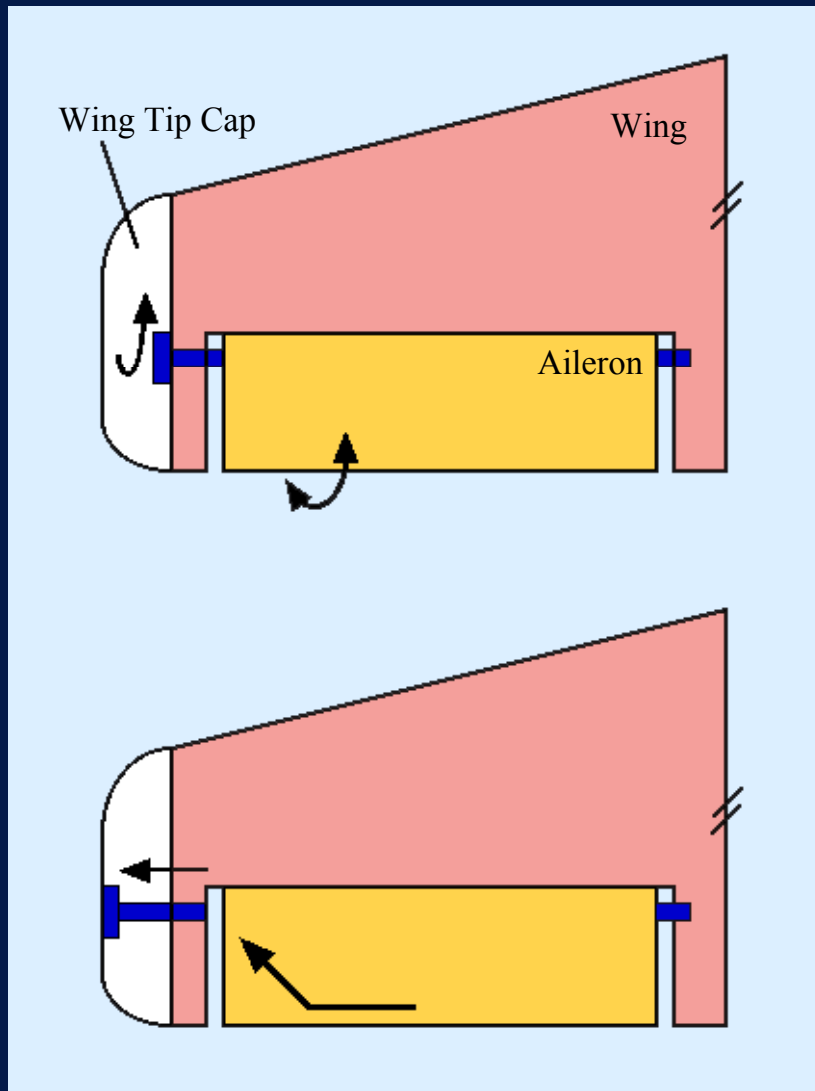
The multiple use of a “single-use” lock-bolt reduced its effectiveness, allowing the bolt to unscrew with aileron movement.

The bolt unscrewed until fully detached, allowing the aileron to depart in an upward and outward direction.

The plastic wing tip cap retained the bolt within the bush allowing it to fall back to near its original position, after the aileron had departed.
