Australian Transport Safety Bureau

ANZSASI Seminar, Glenelg SA

Fountain Head Road, Ban Ban Springs NT, 12 December 2006
(Thank you Larry Matters)

Major level crossing collision at Ban Ban Springs at 1356 on 12/12/06

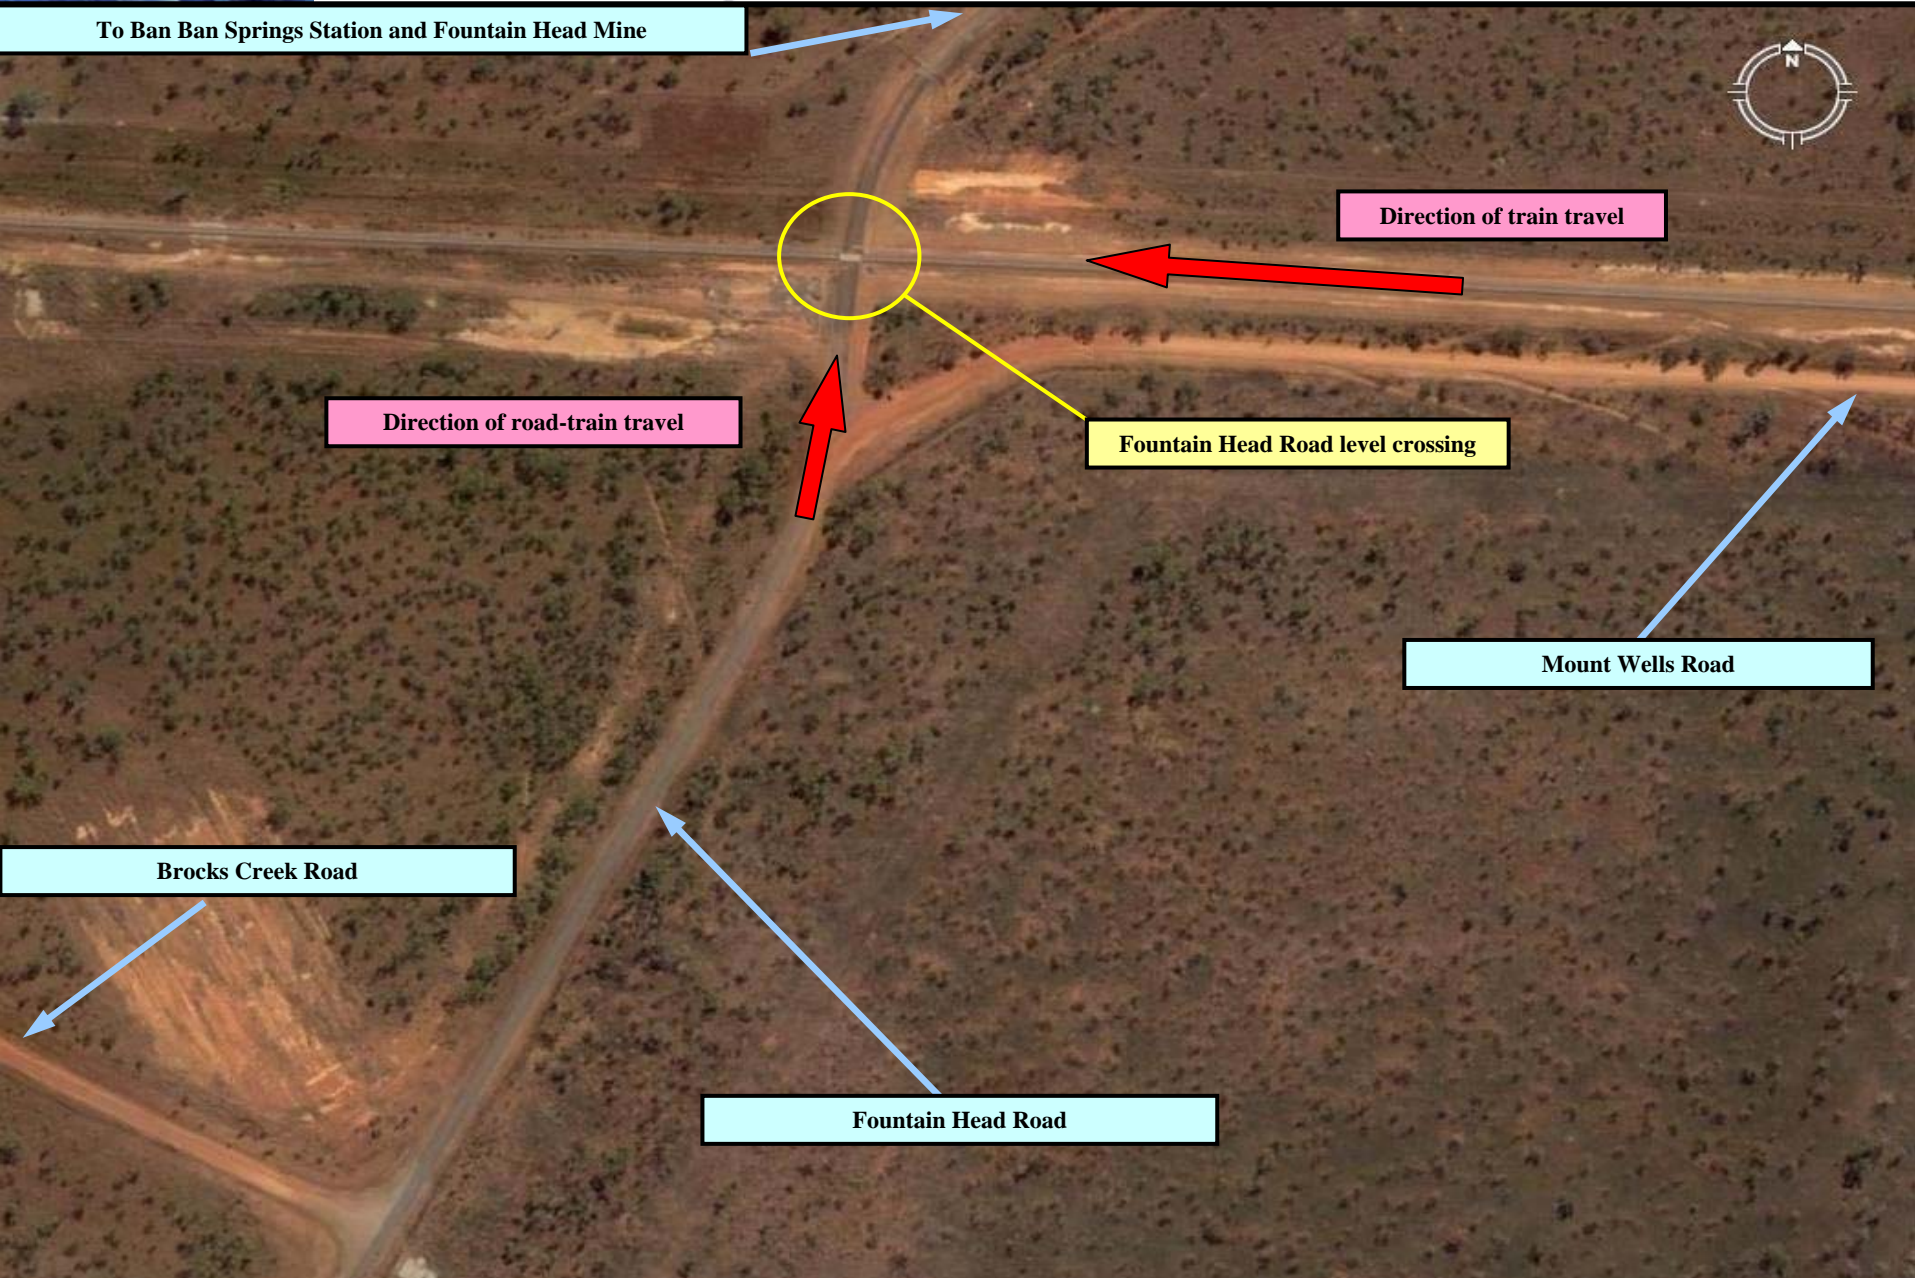
Fountain Head Road level crossing.

- Public level crossing
- Passive level crossing, controlled by 'Stop' signs.
- Fountain Head Road is oriented North - South, it intersects the rail line at 90 degrees
- Sighting distance from the Stop Line is about 1200 metres to the East and about 1000 metres to the West
- However, there is a mound of dirt and trees that prevents a driver of a northbound road vehicle from seeing along the track to the east until about 17 metres from the level crossing Stop sign. This is the direction that the road-train and *The Ghan* were travelling
- Although not as restricted, there is also a limited view from the opposite side of the level crossing along the line to the West.

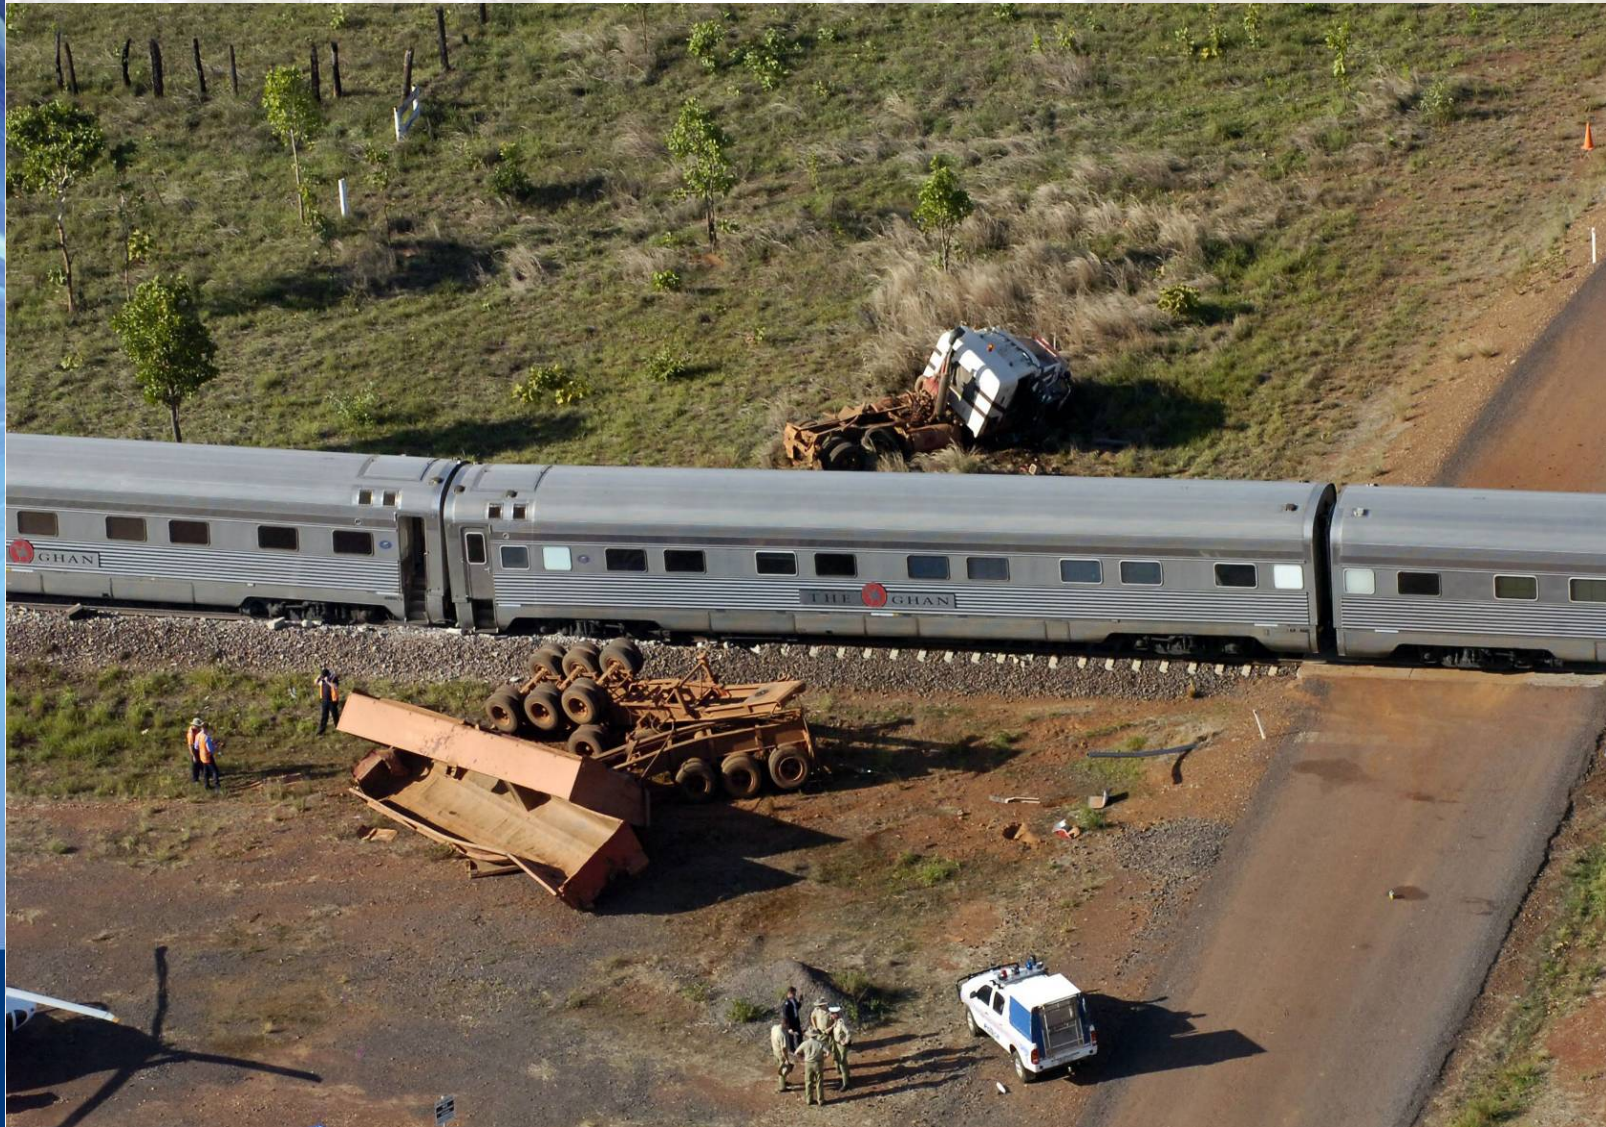
- Impact point was immediately behind the prime-mover cab
- Prime mover separated to the right of the track, the two trailers to the left of the track
- The lead locomotive broke away from the second locomotive and continued 440 metres with five of the six wheel-sets derailed
- Both locomotives, the motorail wagon and nine passenger carriages derailed
- Extensive damage to the locomotives
- Road-train truck written off
- Extensive damage to the track
- No major injuries.

Road-train separated either side of track

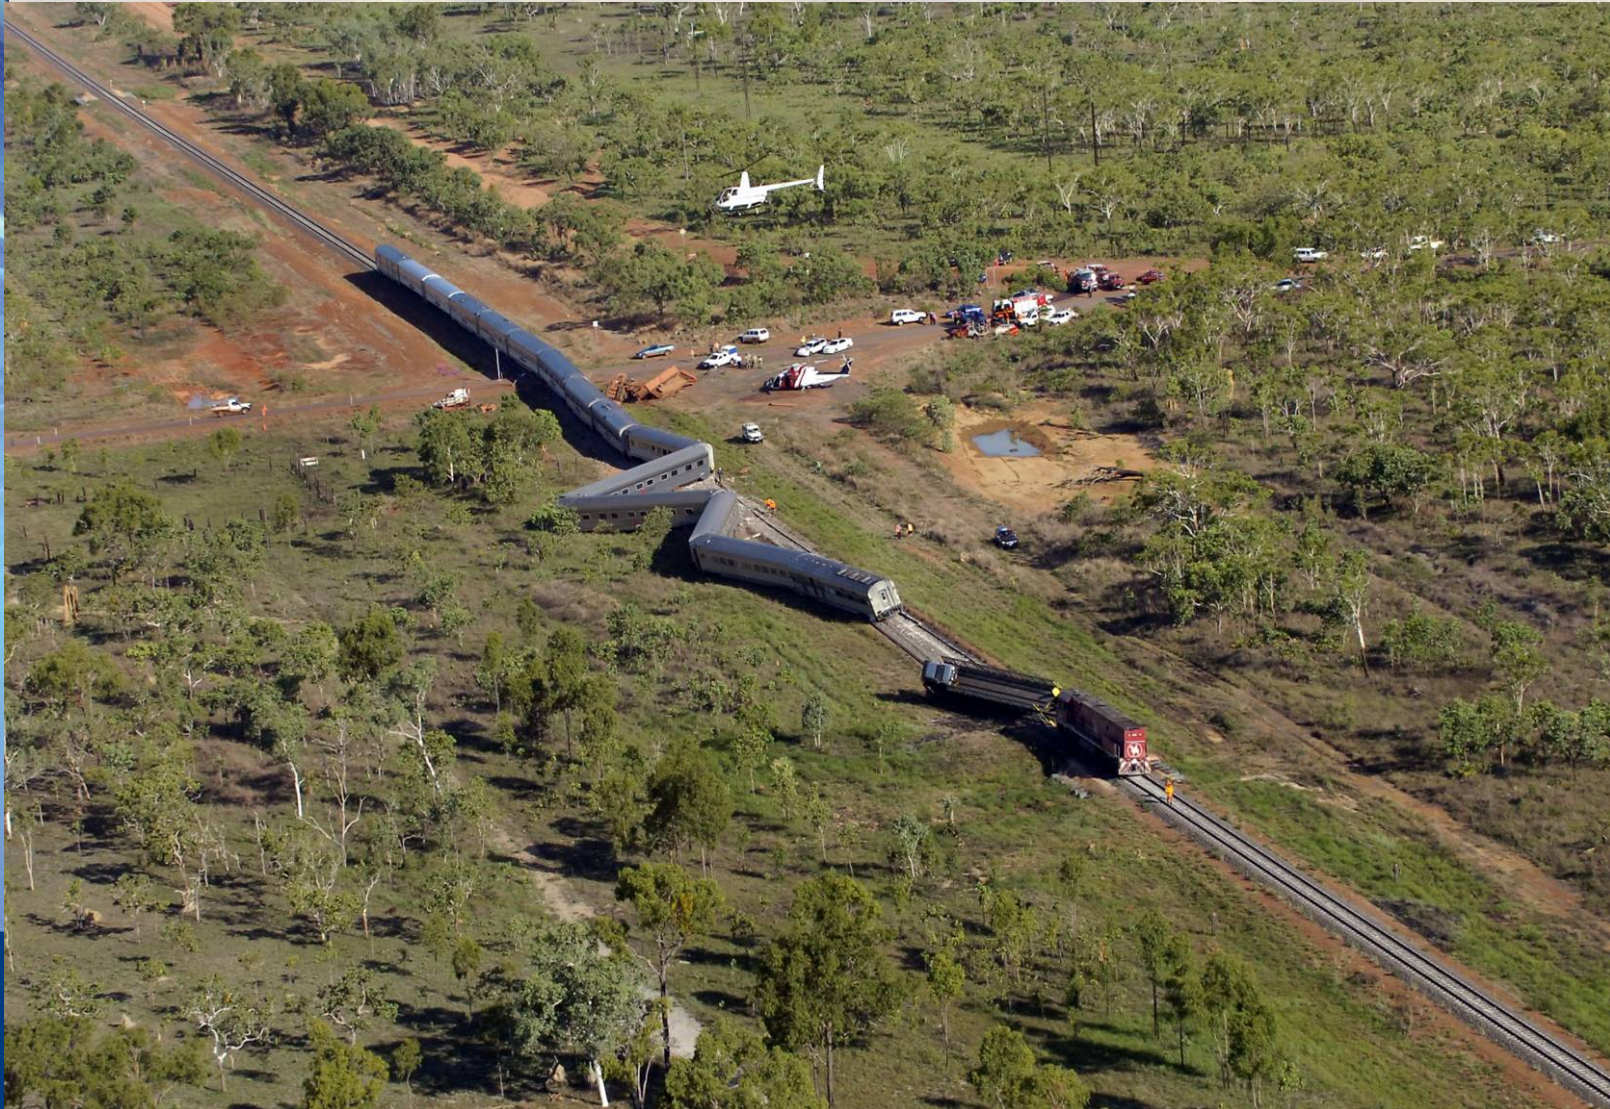
Accident site

- Both locomotives, motorail wagon and nine passengers coaches derailed as a result of the collision
- No fatalities
- Injuries incurred were mainly superficial, but a female passenger collapsed and lapsed into unconsciousness about 15 minutes after the collision. The unconscious passenger and the truck driver were the only persons admitted to hospital
- The road-train truck was damaged beyond repair
- The lead locomotive incurred extensive structural damage, two passenger coaches were damaged beyond repair
- About 280 metres of rail infrastructure was extensively damaged.

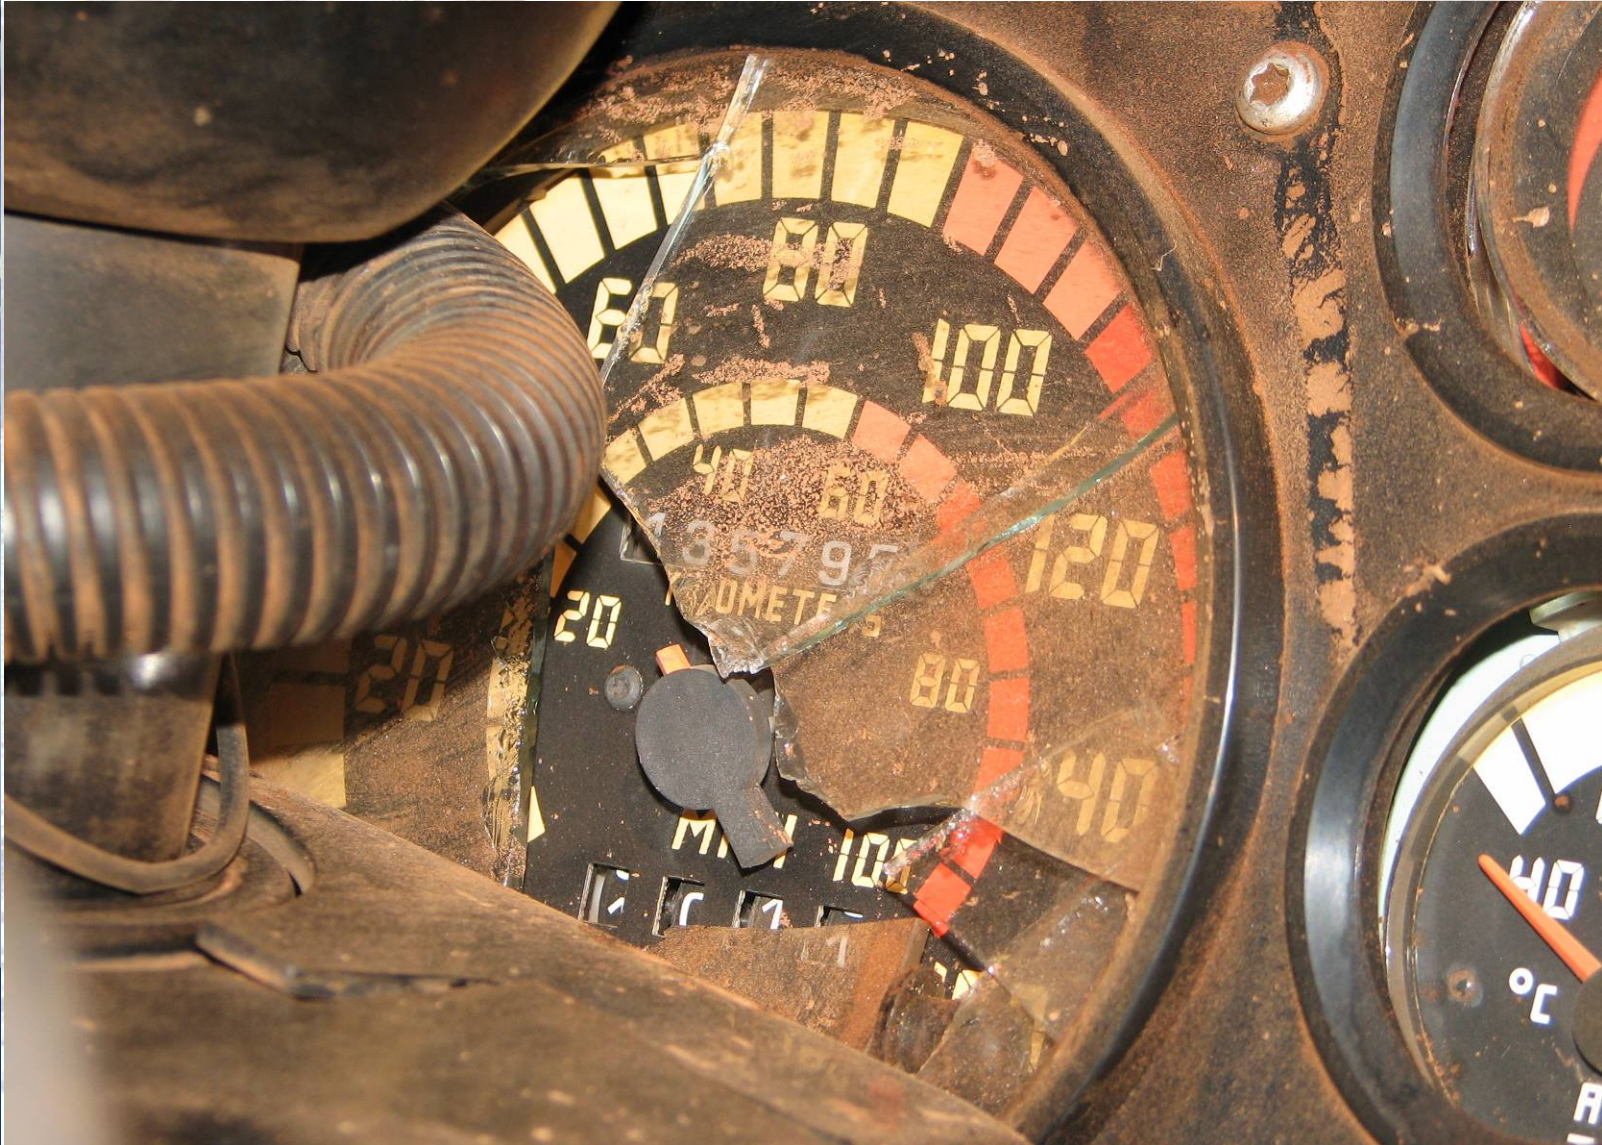
Road-train speedometer

- Train driver estimated he first saw the road-train when it was 100 metres from the level crossing, over a mound of dirt and scrub on the southern side of the level crossing.
- The train driver estimated the speed to be about 50 km/h
- The road-train driver said he had stopped 200 to 300 metres from the level crossing to close a door on the leading trailer. He said he then accelerated to the extent that he had just changed to the 'top box' gear range. He estimated his speed at the level crossing to be 20 to 30 km/h
- The road-train speedometer needle was stuck at about 50 km/h

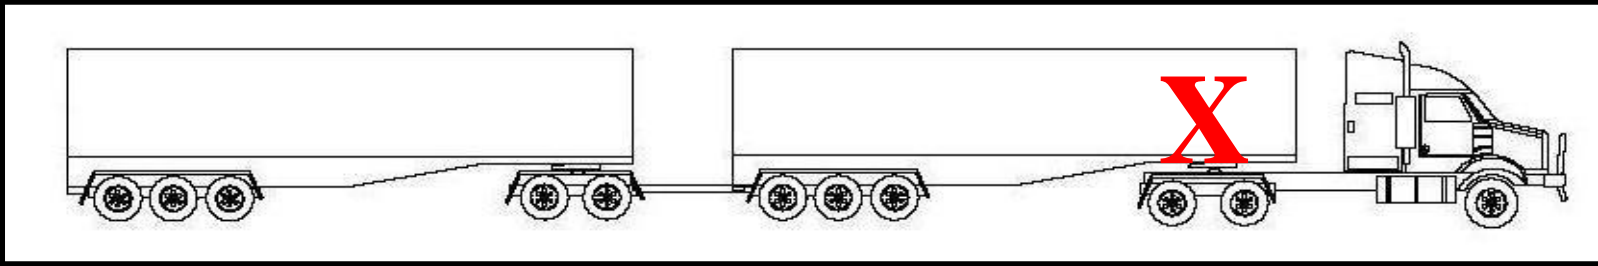
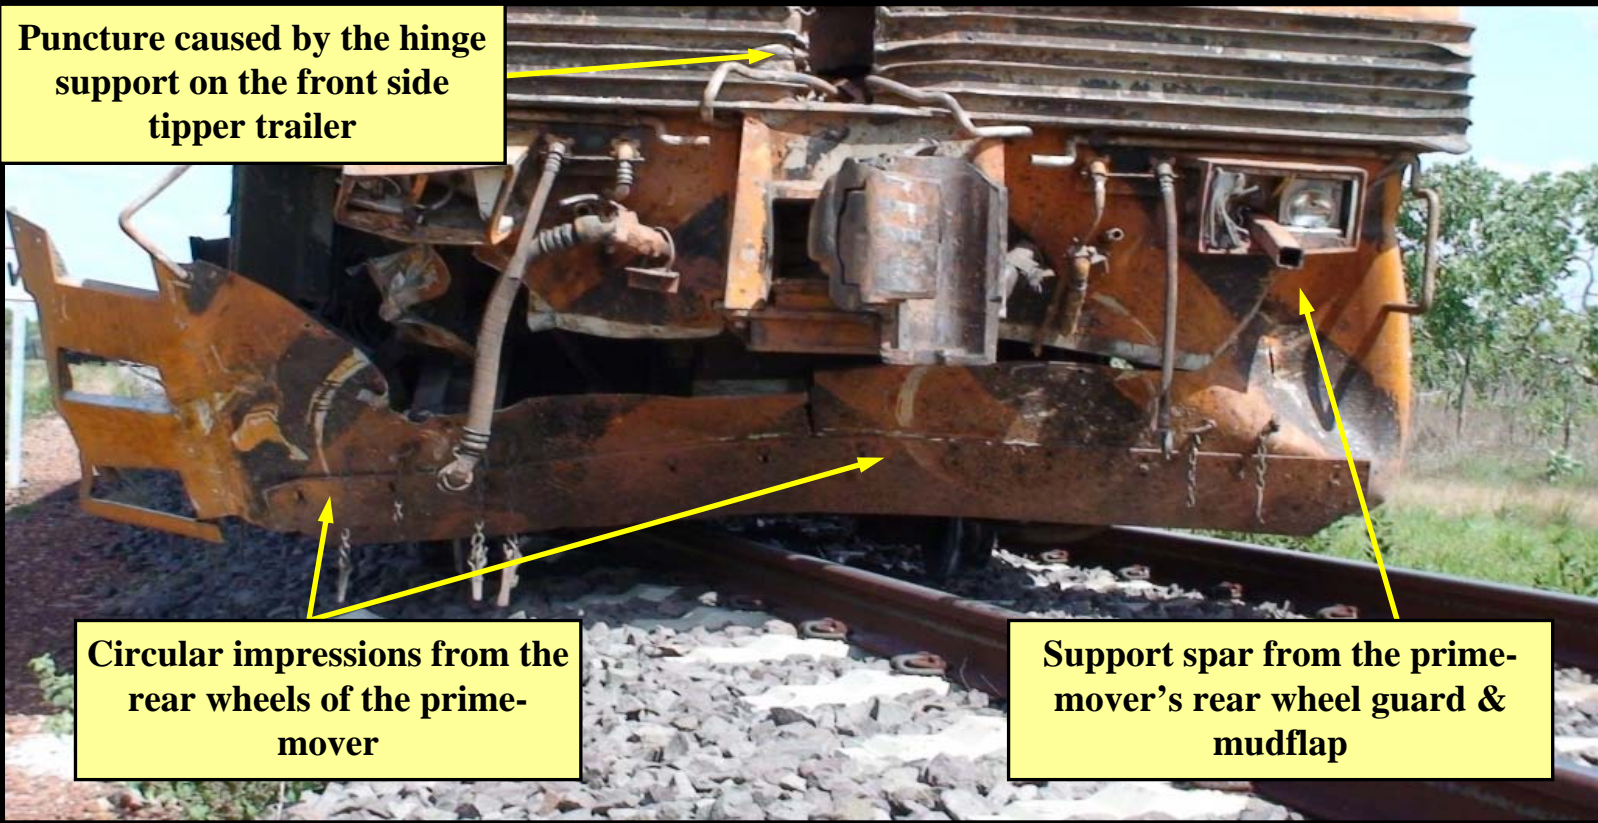
Point of impact

Puncture caused by the hinge support on the front side tipper trailer

Circular impressions from the rear wheels of the prime-mover

Support spar from the prime-mover's rear wheel guard & mudflap

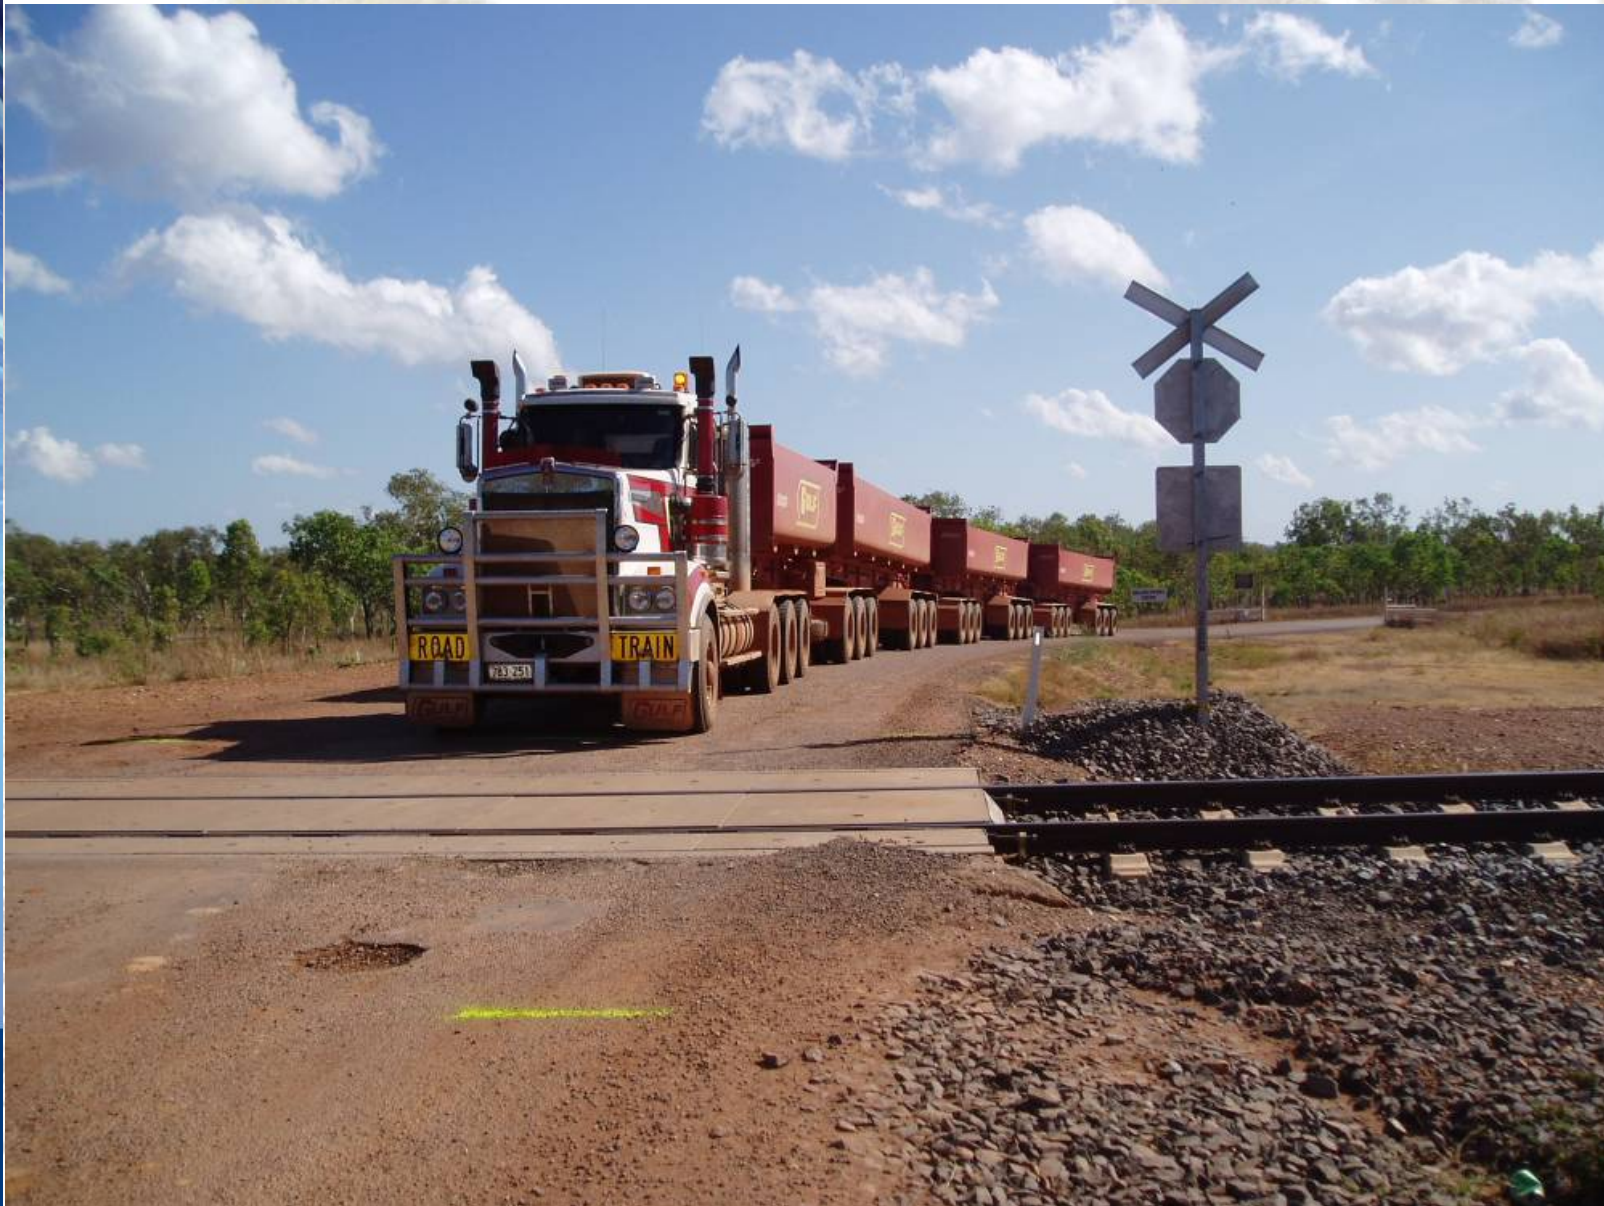
53.5 metre B+2A road-train

- Had heard that GBS Gold Pty Ltd had conducted some level crossing timing tests. The results were of concern
- The ATSB, accompanied by the NT DPI and other interested parties, conducted 12 tests with 53.5 metre road-trains on 29 August 2007
- Results ranged from 33.25 seconds to 71.25 seconds
- Biggest disparity was between when gears were held to when gears were changed (The USA and Canada do not allow the drivers of heavy vehicles to change gears on a level crossing)
- ATSB released a supplementary report in August 2007

- Members of the Standing Committee On Transport note the ineligibility of the road-train driver to hold an MC class licence due to hearing loss and that he had never been medically examined in conjunction with this licence
- State and Territory regulators consider the implications of the clearance times of the 53.5 metre road-trains
- Continued action by the NT DPI regarding enforcement and education of motorists at railway level crossings
