# Multi Linear Events Sequencing

Dr Dmitri Zotov, MBE, PhD, MA, FRAeS

## A Case Study

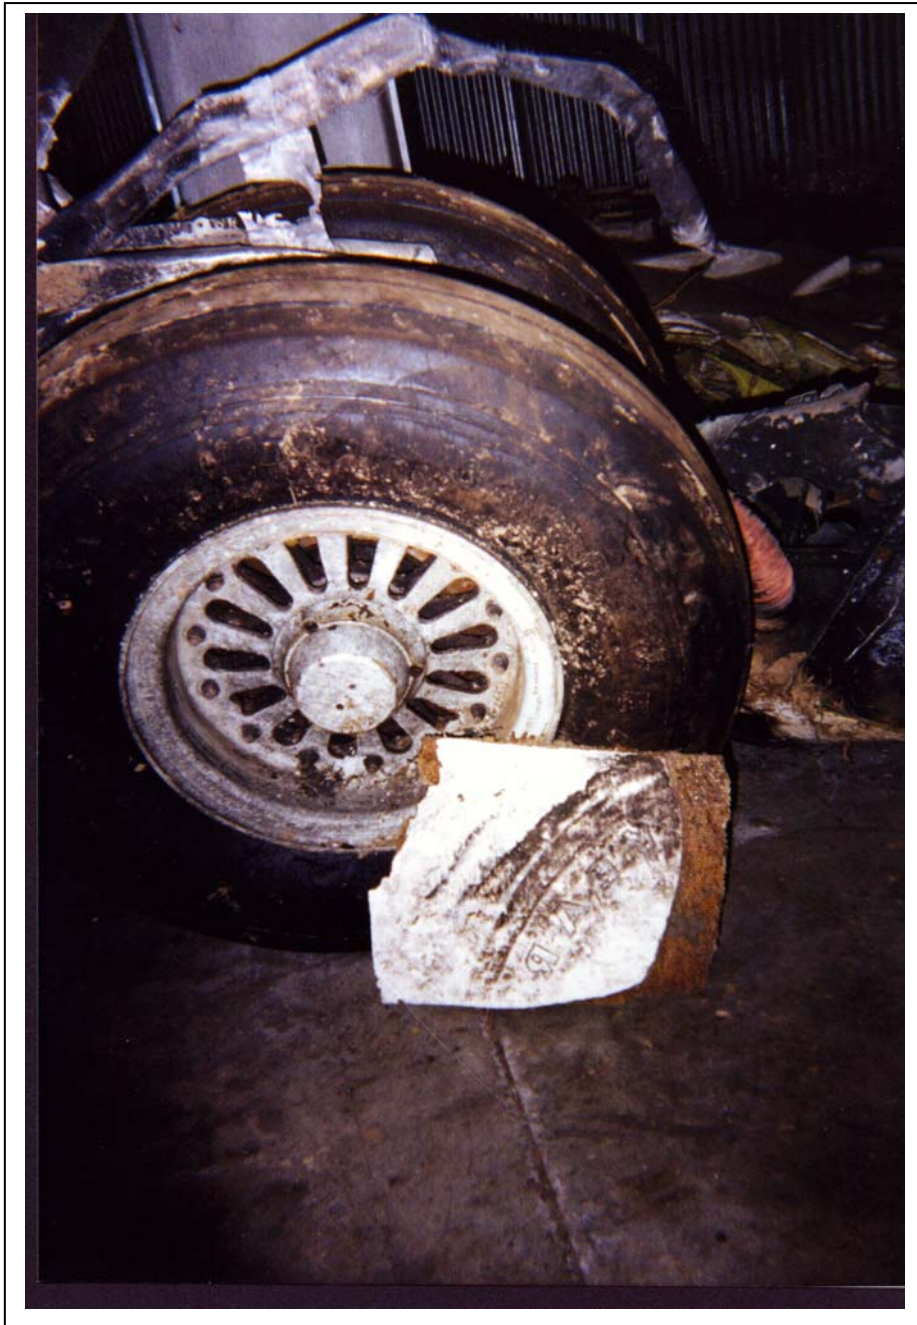
Figure 17. Witness mark on part of right hand undercarriage door.

The first unresolved point on the MES graph of the impact sequence is whether the right hand undercarriage was unlatched or not. The question is relevant in determining whether the indentation on the undercarriage latch was entirely due to wear, or whether it might have been, in part, due to impact from the retaining roller during the impact sequence. This point should be easily resolved by examination of the undercarriage doors, since immediately after release of the undercarriage the wheel would pass between the doors; subsequently the undercarriage leg would be between the doors. If the undercarriage had started to descend, there should be witness marks on the doors, i.e. marks made by contact between the doors and the undercarriage, showing what position the undercarriage was in relative to the doors when the marks were made.

Figure 17 shows part of the interior of an undercarriage door, alongside a tyre. The tyre manufacturer's name is embossed on the side of the tyre, and the witness mark is a mirror image of that name, impressed on the inside of the door by contact between the tyre and the door. To make the mark in this position, the wheel had to be partly descended, its sidewall being parallel to the door, at the moment of impact. Accordingly, the uncertainty is resolved: the undercarriage was unlatched, and the wheel had partly descended, when the engine nacelle struck the ground.

The report by the manufacturers of the undercarriage, Messier-Dowty (cited at 1.16.13, p. 46), stated that it was not possible for the manufacturer to determine whether all of the depression measured in the uplock hook was due to wear, or whether some might have been due to impact loading (1.16.13). Since the leg was partly extended, the uplock roller was not in proximity to the hook, and all of the measured depression was due to wear. The MES graph shows that there was an unresolved issue here. Had the investigators been using this method of data display and manipulation, their attention could have been drawn to the deficiency, and the matter resolved.

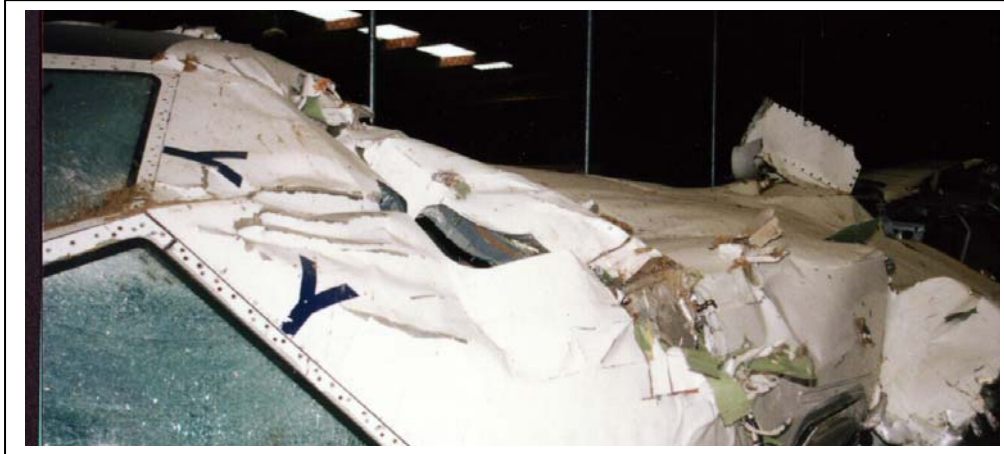
The photograph on p. 4 of the report shows the aircraft looking from the front (shown in Annex A, for convenience). The upper part of the cockpit roof has been flattened. Figure 18 shows that this crushing is continued as a line along the aircraft skin, along

the cabin roof and more or less parallel to it. This line is termed a 'crush line': it shows where structure has been crushed in, and has then rebounded to something like its original form. Earth is ingrained in the roof area. The only way to produce such crushing is for the aircraft to strike the ground or other solid object, with the part which has been deformed. In other words, the evidence from the photograph on p. 4, and figure 18, is that *the aircraft struck the ground inverted, in a slightly nose-down attitude.*

Figure 18. View from front of fuselage, showing crush lines and ingrained dirt.

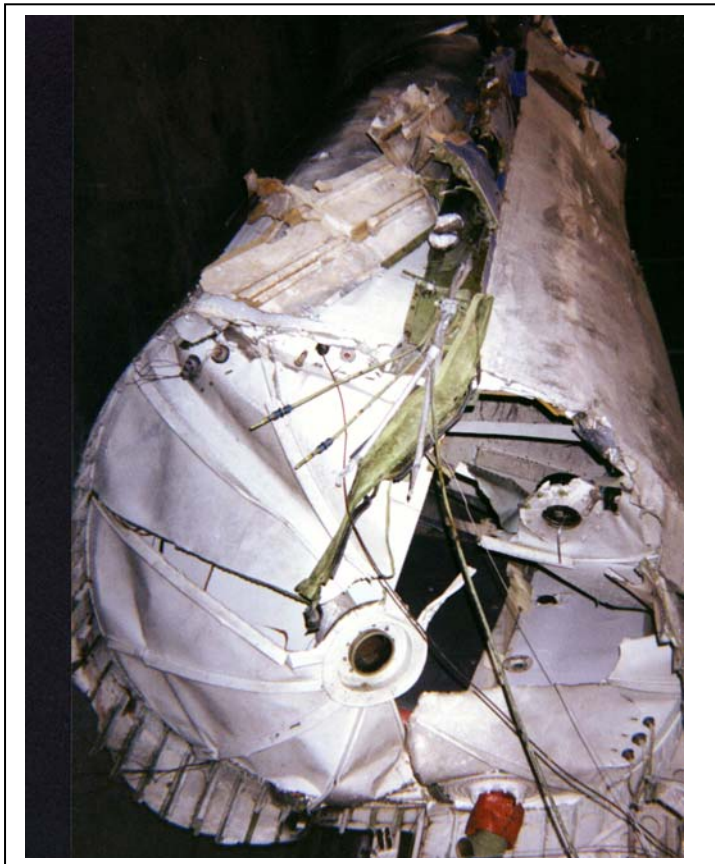
Figure 19. View from rear of fuselage, showing crush line, and torsional damage to rear bulkhead.

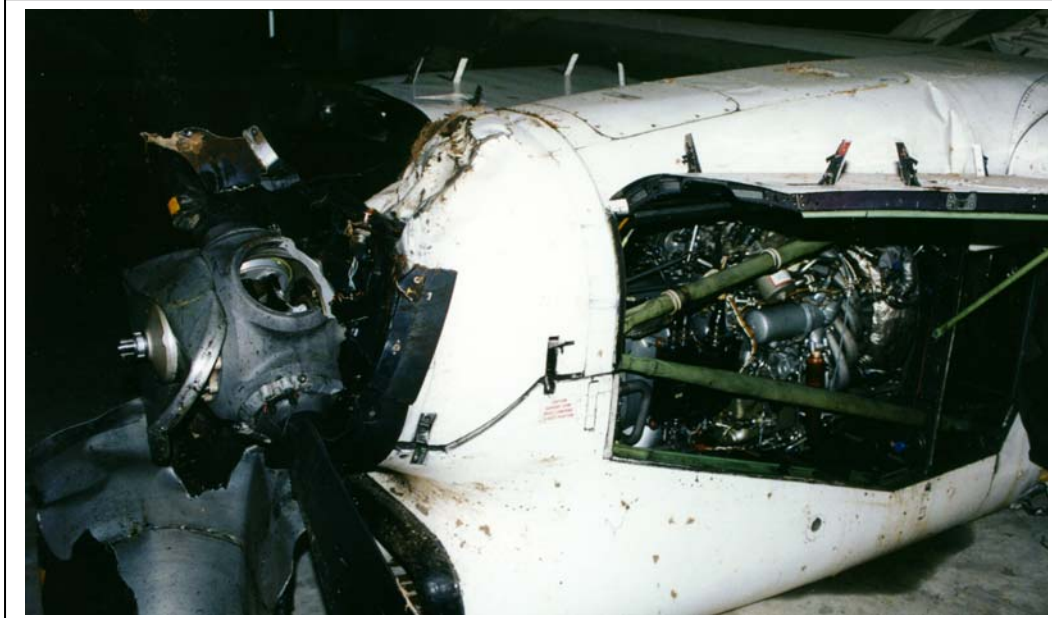
Evidence supporting the inverted impact is the lack of damage to the left undercarriage leg, which remained intact and extended throughout (photograph of the accident site, report p. 2 and Annex A), and the absence of damage to the underside of the left engine nacelle (Figure 20). Further supporting evidence is the crush damage to the front top of the engine nacelles made (like the damage to the cockpit roof) by an inverted impact in a somewhat nose-down attitude. Figure 21 emphasises the pronounced flattening on the top of the rear fuselage.

Figure 20. Left engine nacelle, showing lack of damage to underside, and inverted ground contact. Damage to the propeller shows that it was in this position, and rotating, when the nacelle struck the ground.

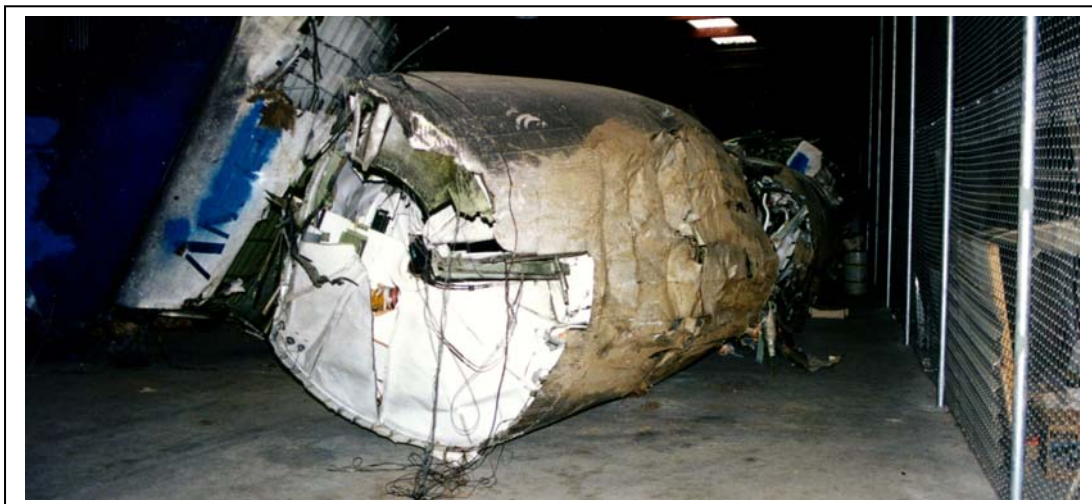
Figure 21. View from bottom rear of fuselage. Impact damage is ahead of rear bulkhead. Note flattening at top of rear fuselage.

Clearly, the first major impact (after the touch on the grassy knoll) was upright: there was nothing which could have caused the aircraft to roll inverted. This initial upright impact is consistent with crush damage to the belly of the aircraft (Figure 21). There

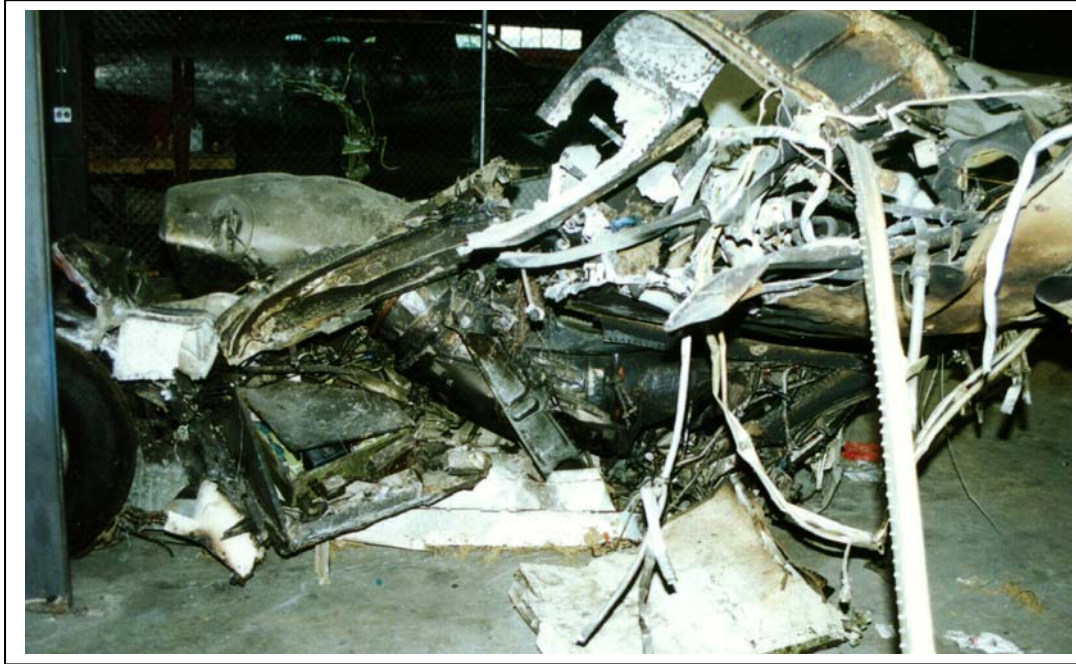
However, what *was* visible were two indications of in-flight explosion: the wing skins had been forced outward on both sides of the break; and bellling of the spar web, where pressure has forced the web rearwards between the stiffened areas. This suggests that an explosion must have been initiated while the structure was still intact, as otherwise the pressures necessary to deform and tear the metal could not have been generated. (The best photograph available is Figure 22. Unfortunately, attempts to photograph these features were unsatisfactory: they were black features against a black background, in a dimly lit hangar, and no special lighting was available. Ansett Airlines were permitted to destroy the wreckage before this evidence could be properly documented).

Figure 22. Starboard wing outboard of nacelle. Downward deflection of lower surface; spar web pulled away from spar caps. There has been no loading of the web in shear.

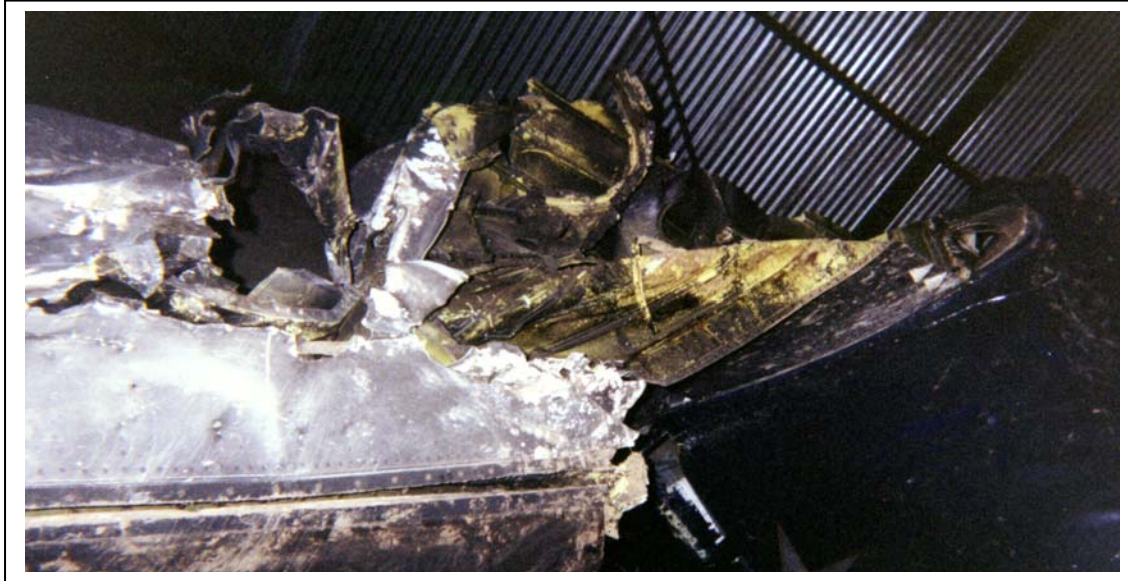
The position of the outer wing portion in the wreckage trail can be accounted for if the wing panel was loosely retained by a small portion of the structure, until it was finally torn off as the aircraft rolled. Such a portion, distorted in a manner consistent with such action, is visible in Figure 22, and some of the damage to the right tailplane is consistent with impact from the wing (Figure 23).

Figure 23. Damage to upper skin of starboard tailplane. The square hole has extensive sooting inside; the deflection damage has very little sooting.

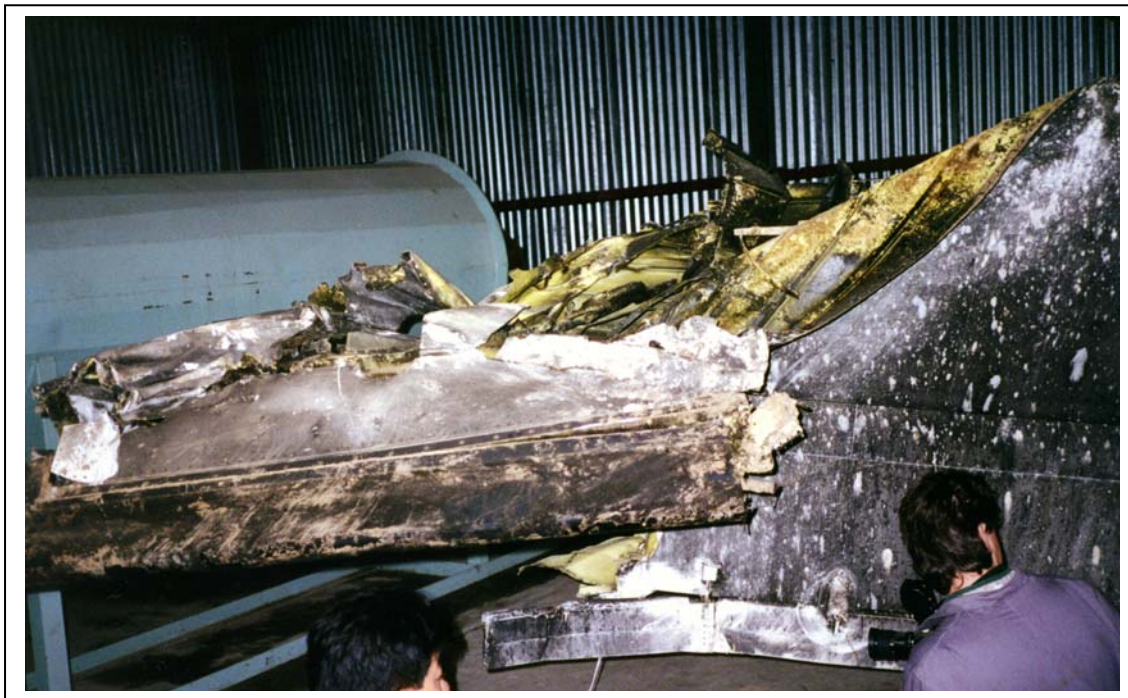
Figures 22 and 23, later, show that the sooting patterns around the rivets are consistent with a static fire. (There was also evidence of in-flight fire, consistent with the first flash fire). Since the static fire could only have occurred after the empennage came to rest, and there was no source for this fuel other than droplets already on the tailplane, it may be inferred that this second fire was a static fire rather than a flash fire. This matter will also be addressed when the post-impact diagrams are amalgamated.

Figure 24. Damage to leading edge of fin and upper surface of tailplane. There was no corresponding damage on the outer portion of the right wing. Soot deposits around rivets are fairly even, suggesting static fire.

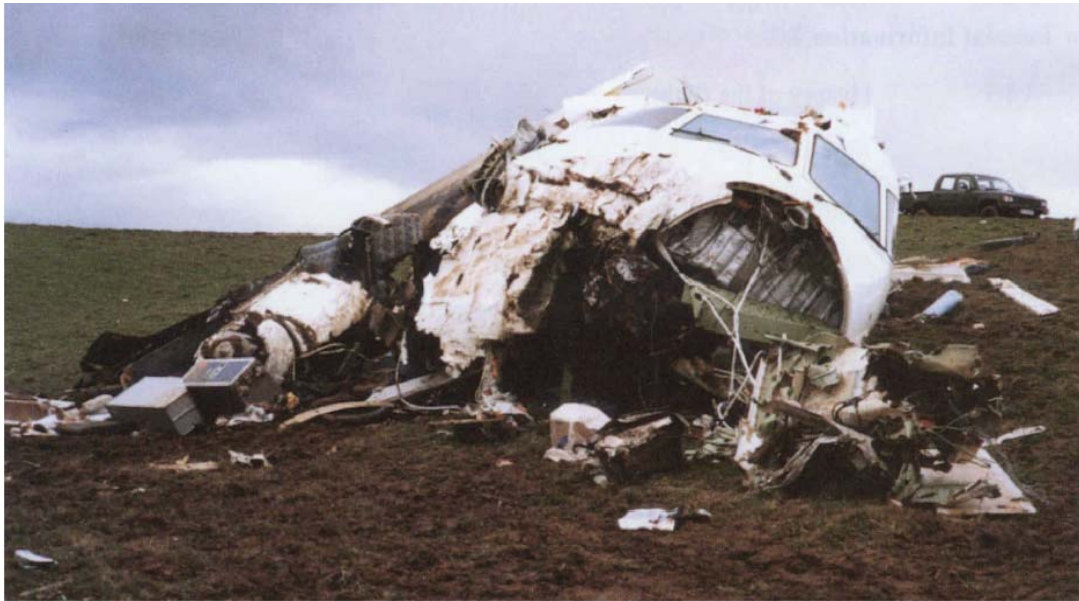
## Cockpit Exterior

The pilots suffered head injuries. They were restrained by full harnesses. How, then, could their heads come into contact with the cabin structure? The photograph from the front of the aircraft (report, p. 4 and Annex A) shows that the top of the cockpit was crushed in by the inverted impact, to an extent greater than subsequently found when the wreckage was examined. Since the occupiable space in the cockpit was significantly reduced as found (report Figure 6b, p. 42 – see Annex A), it may be concluded that the pilots' head injuries were due to transient lack of occupiable space, while the structure was crushed in by the inverted impact.
