Metro III

Undercarriage failure

New Zealand Transport Accident
Investigation Commission (TAIC)

Undercarriage failure & subsequent wheels-up landing

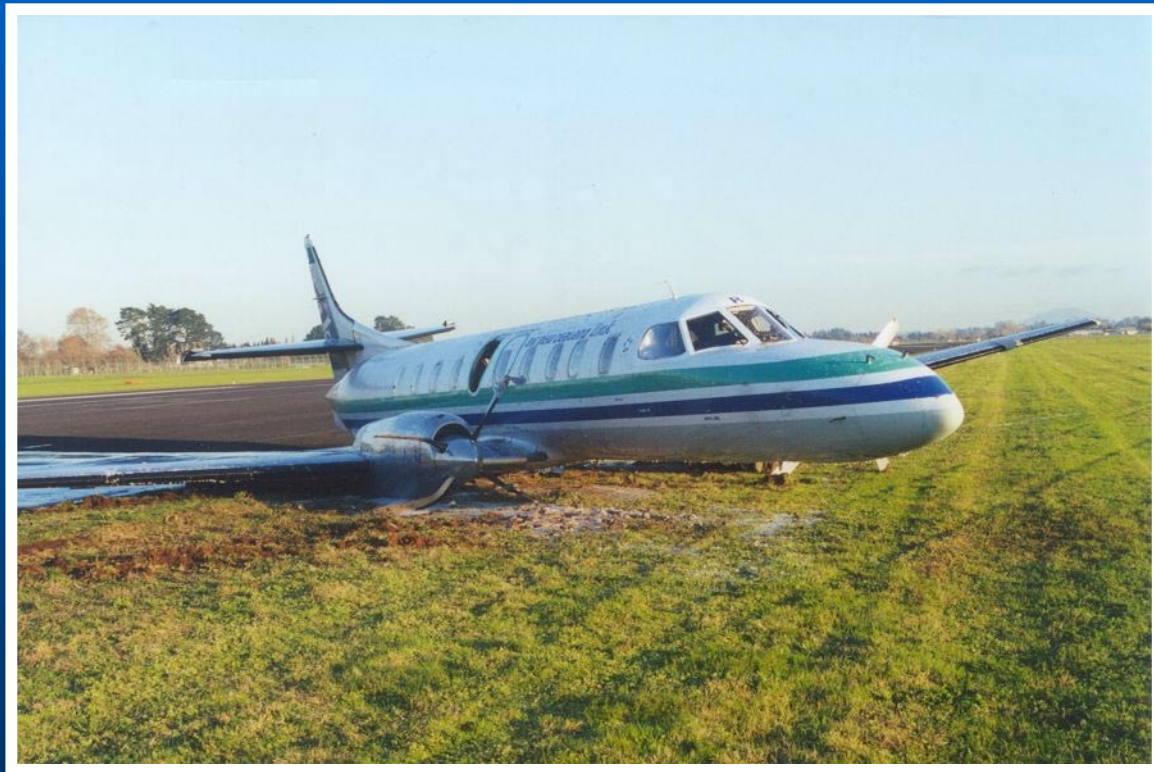
Following wheels-up landing

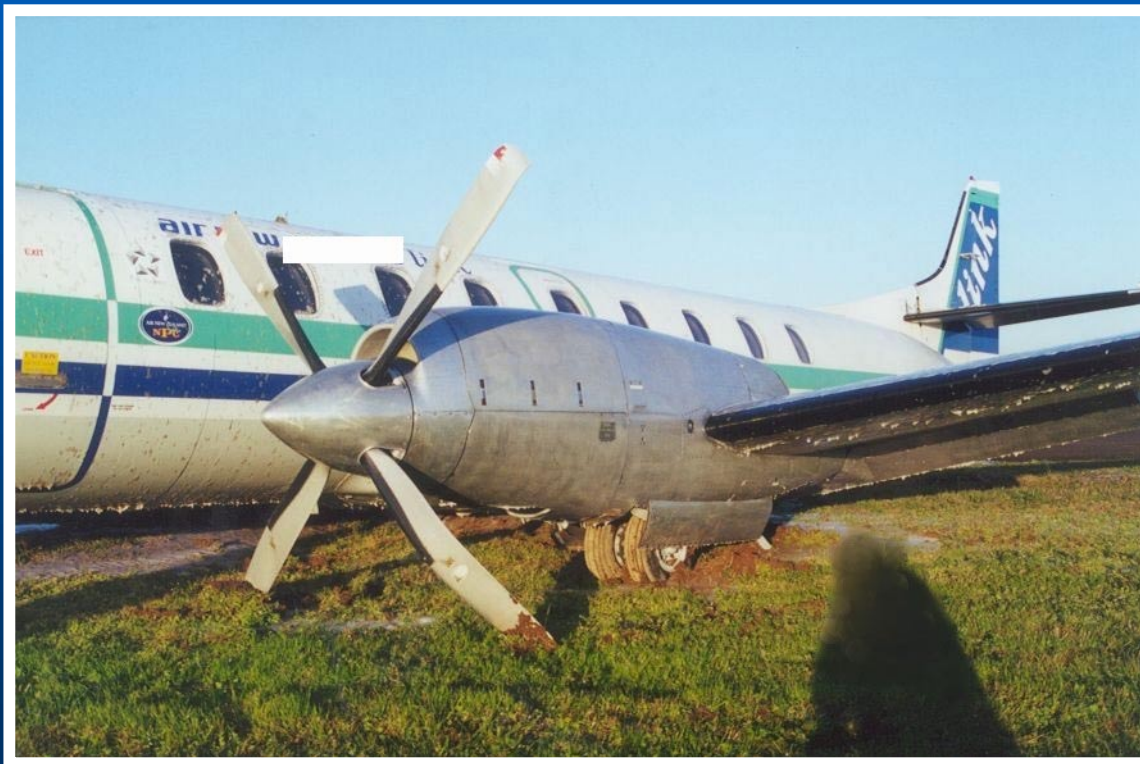
After wheels-up landing

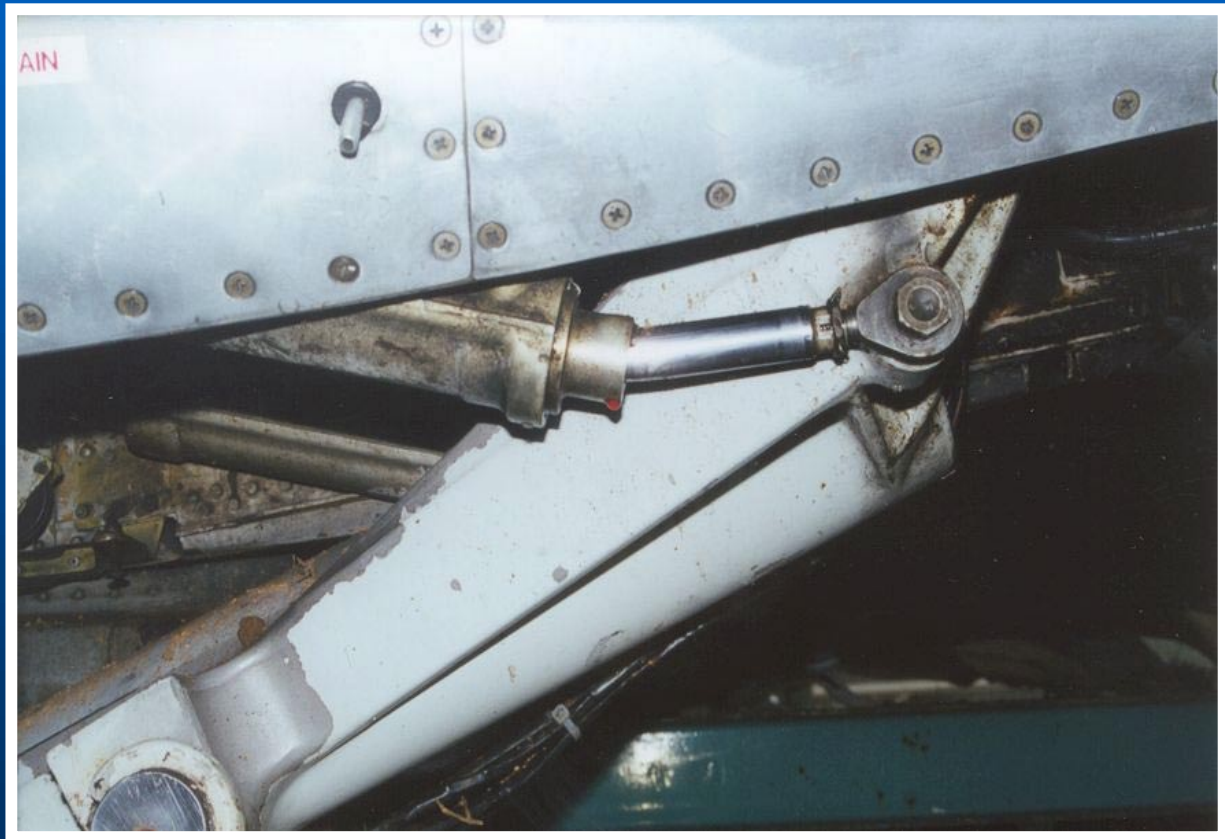
Bent hyd actuator arm

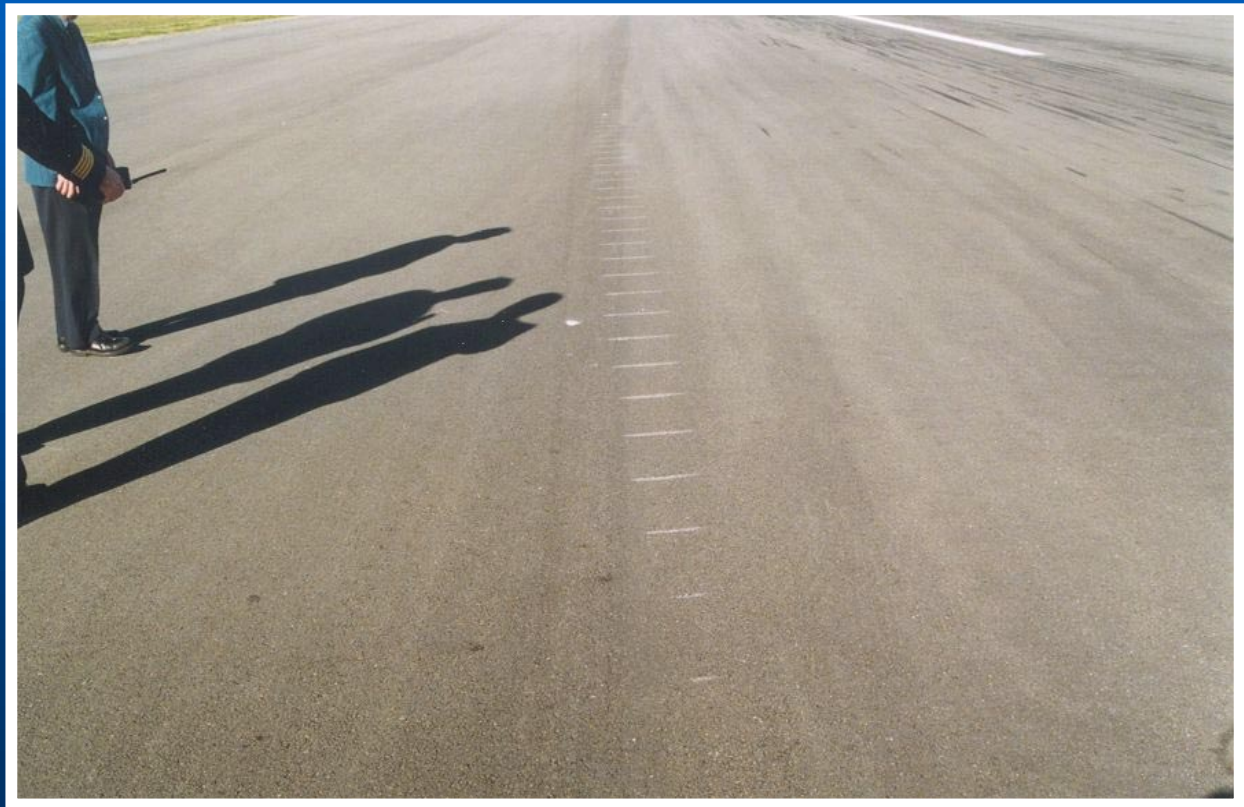
Rwy prop strikes

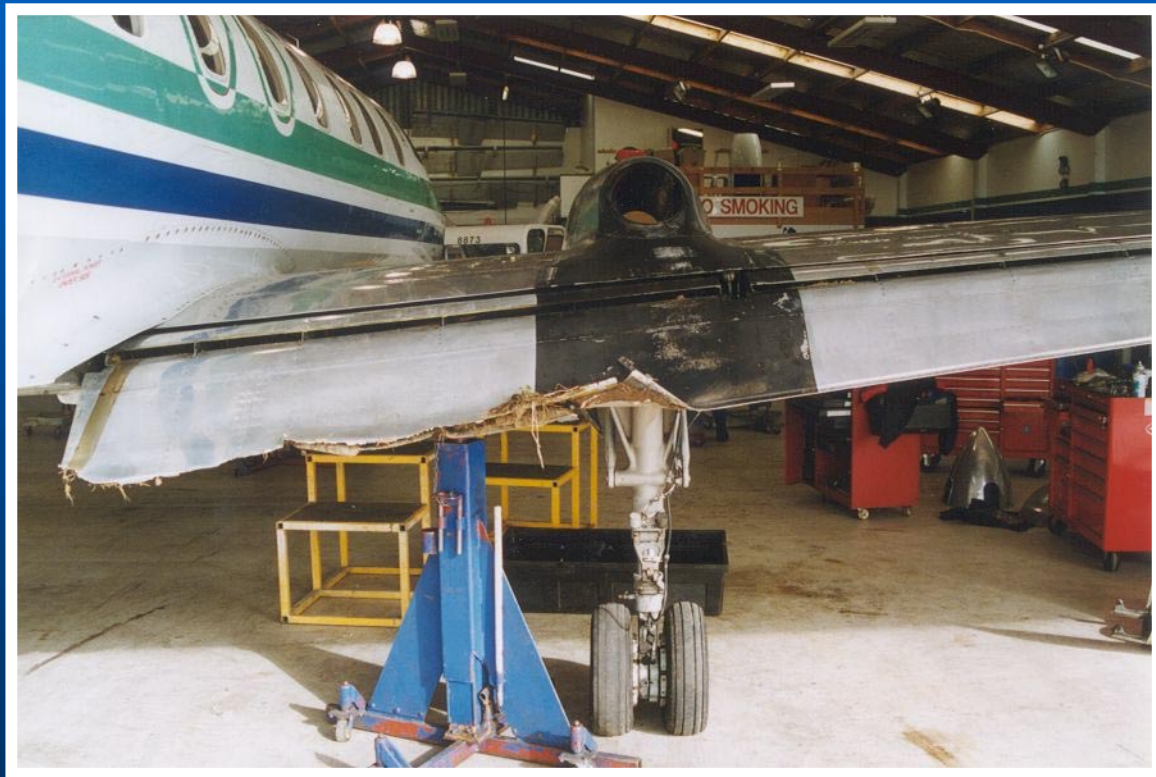
Some damage

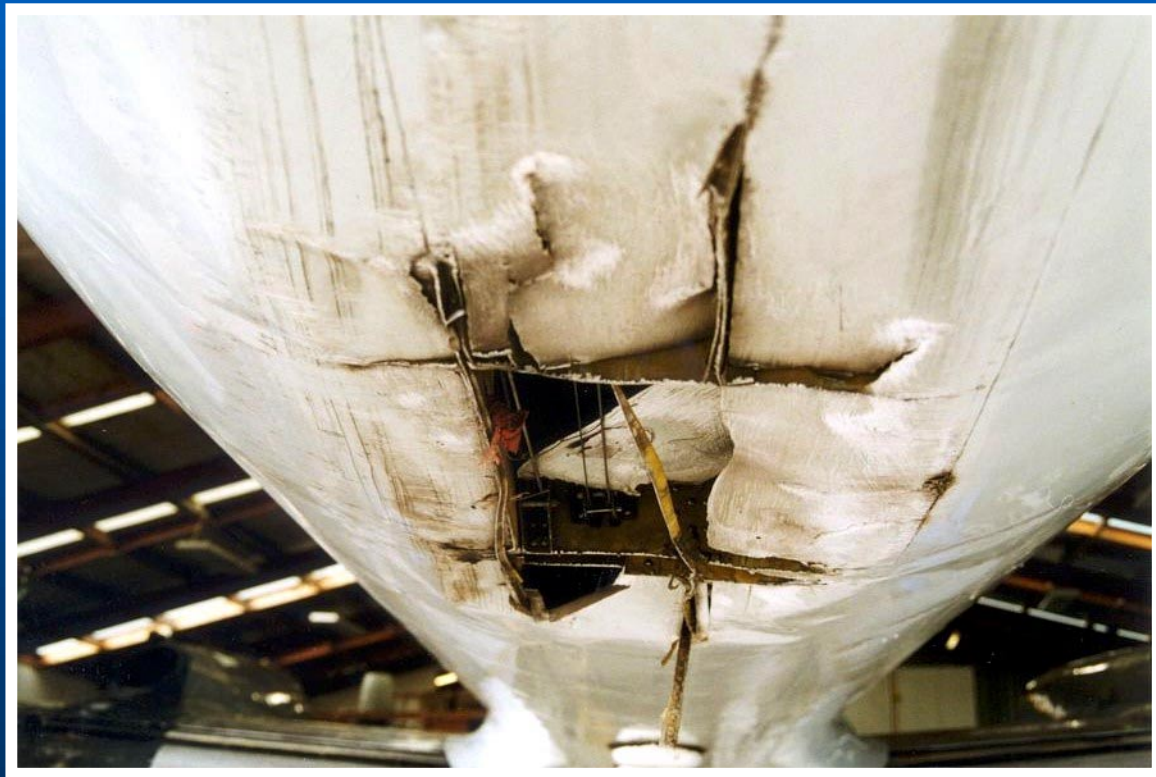
Some further damage

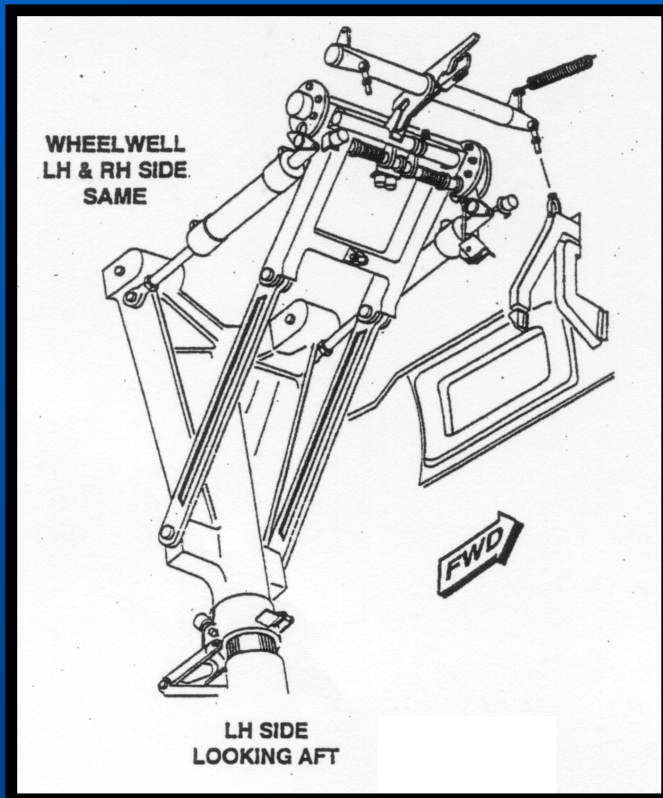
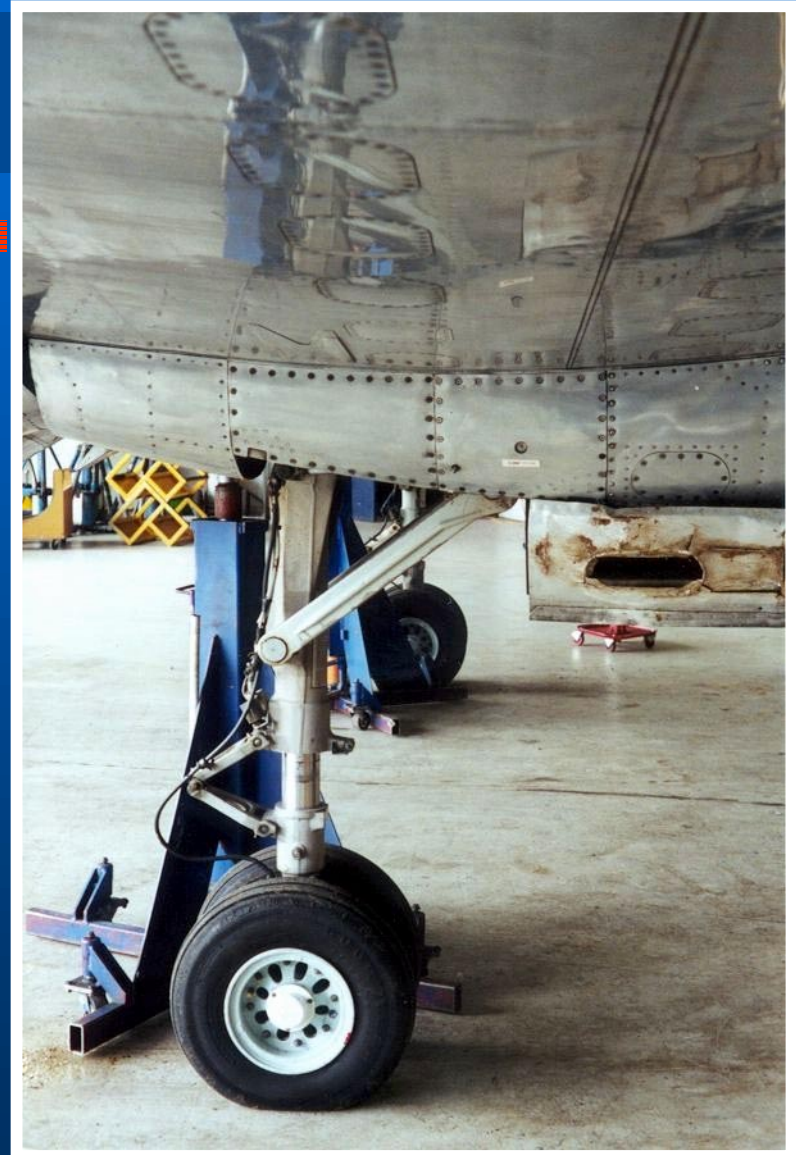
Drag braces

- Left u/c outboard drag brace failed near the point where it attached to the u/c leg, through its grease fitting recess
- Load transferred to the inboard drag brace
- Inboard drag brace failed in overload in similar position to outboard drag brace
- Left u/c leg moved aft past its normal vert down & locked position
- Consequently a/c swung left after t/d and prop struck the rwy

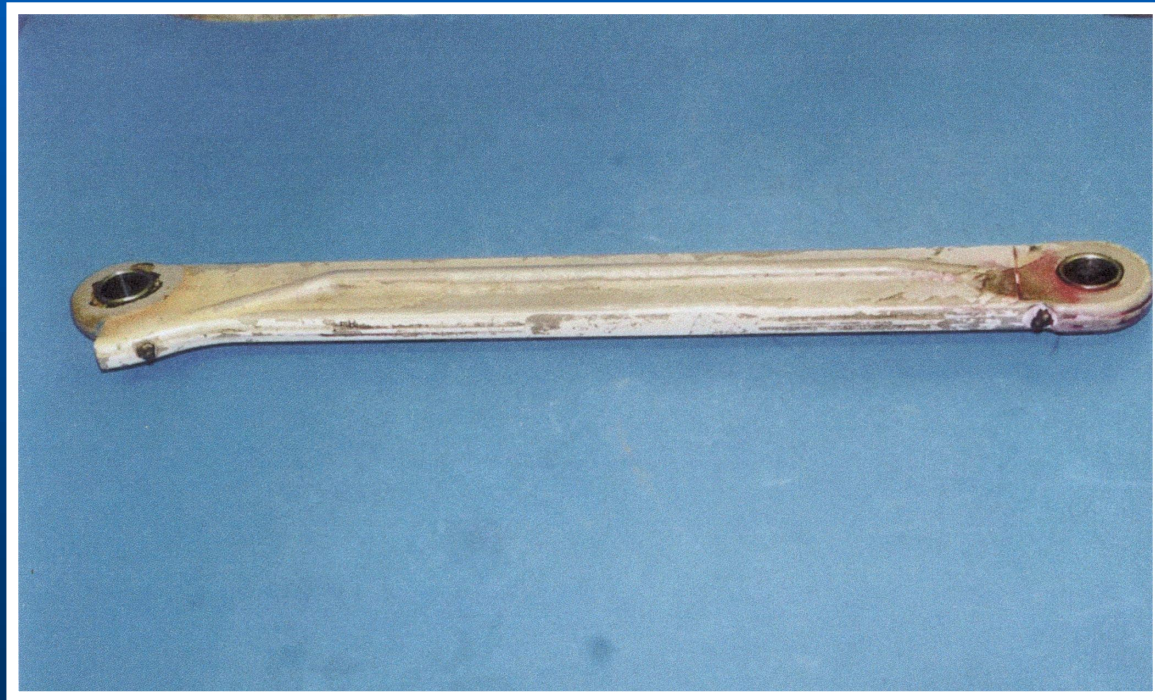
Cracked drag brace from another a/c

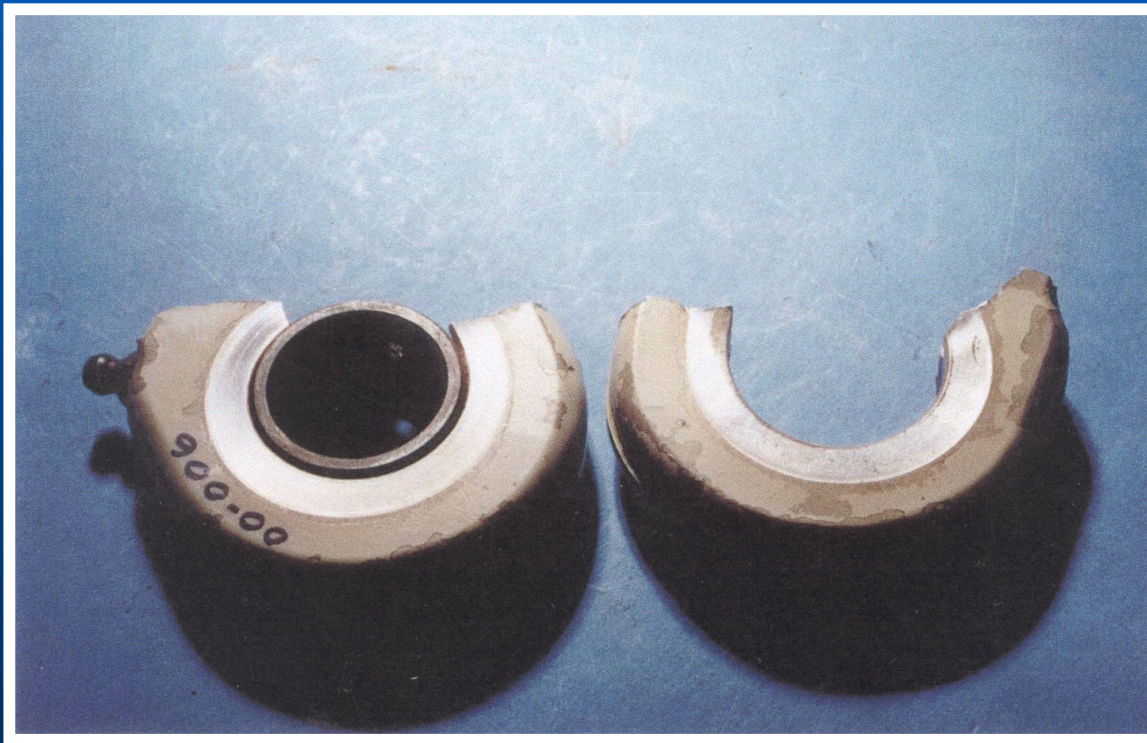
- A fatigue crack had started and propagated in the drag brace's machined grease fitting recess
- Load was transferred to the other drag brace, which failed in overload
- Each landing cycle caused the crack to grow
- Crack was growing rapidly
- Drag braces under tension during Idg & taxiing
- Crack propagating for some 15 000 Idg cycles
- Machined recesses had square edges acting as stress concentrators

The 2 failed drag brace end pieces

- Overseas authorities advised of the problem
- No reports of cracking in Metro a/c outside NZ
- The manufacturer issued 2 Service Bulletins and highly recommended compliance
- The NZ CAA issued an AD
- The manufacturer advised it was changing the drag brace material to a tougher material; braces to be machined rather than forged; grease fitting surface to be machined flat or with a smooth radius

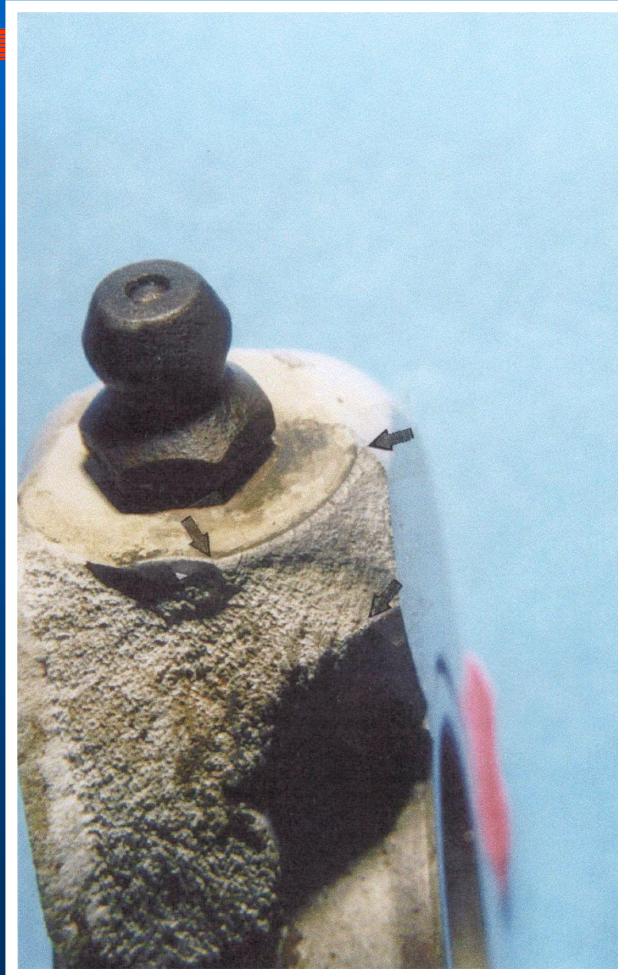
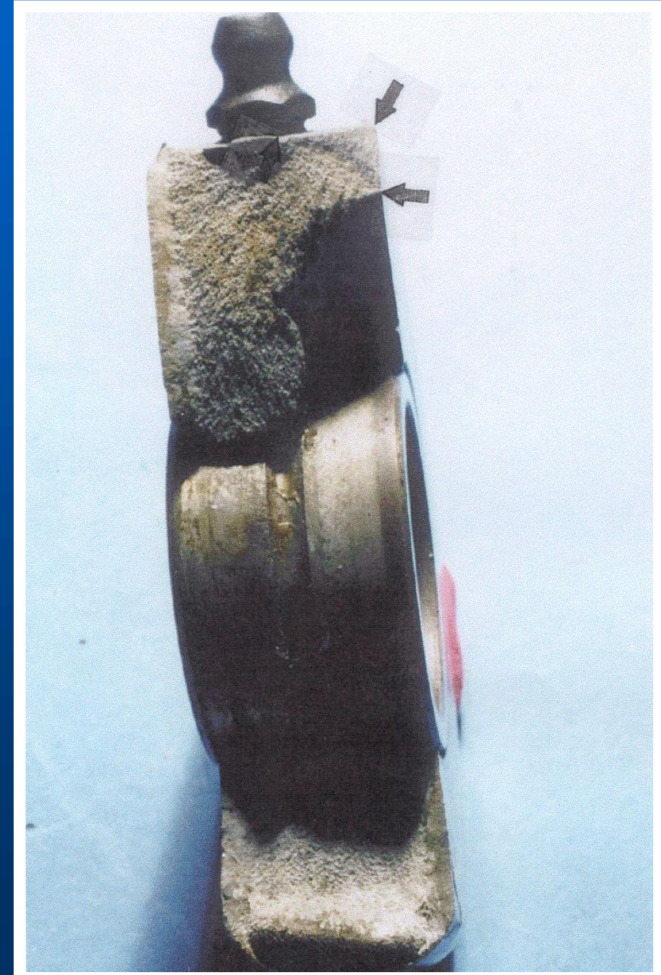
Fatigue crack and overload section

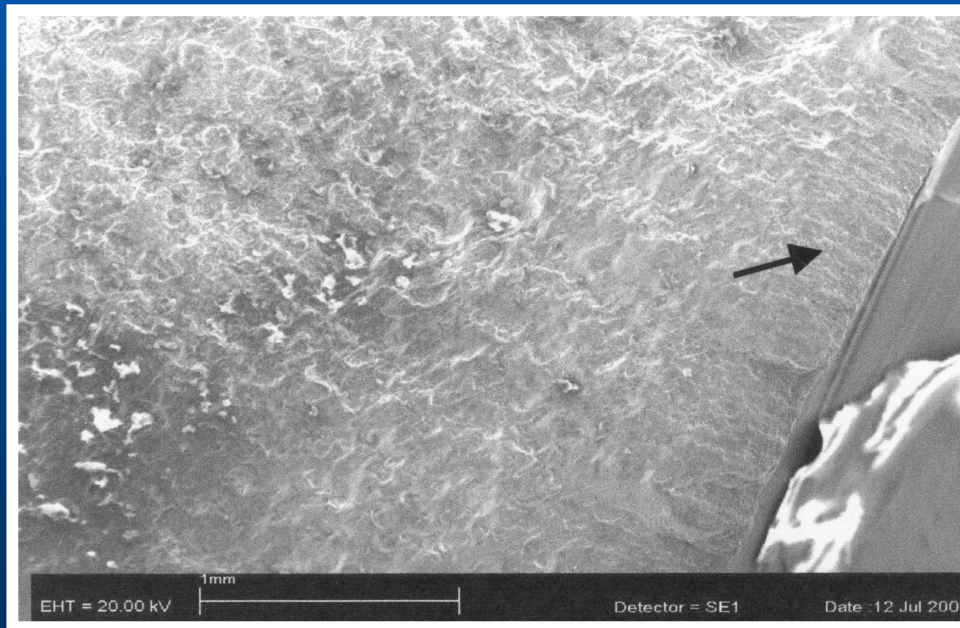
SEM showing fatigue crack & multi origin castellation

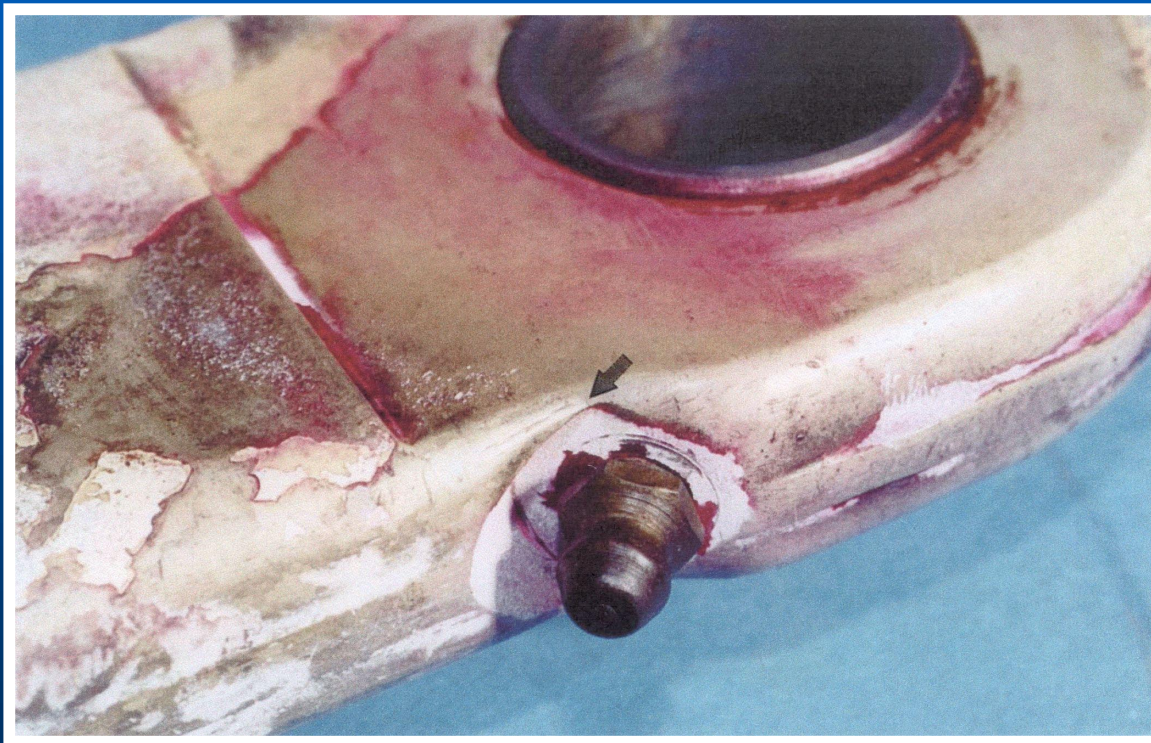
Square machined recess & crack in other a/c brace

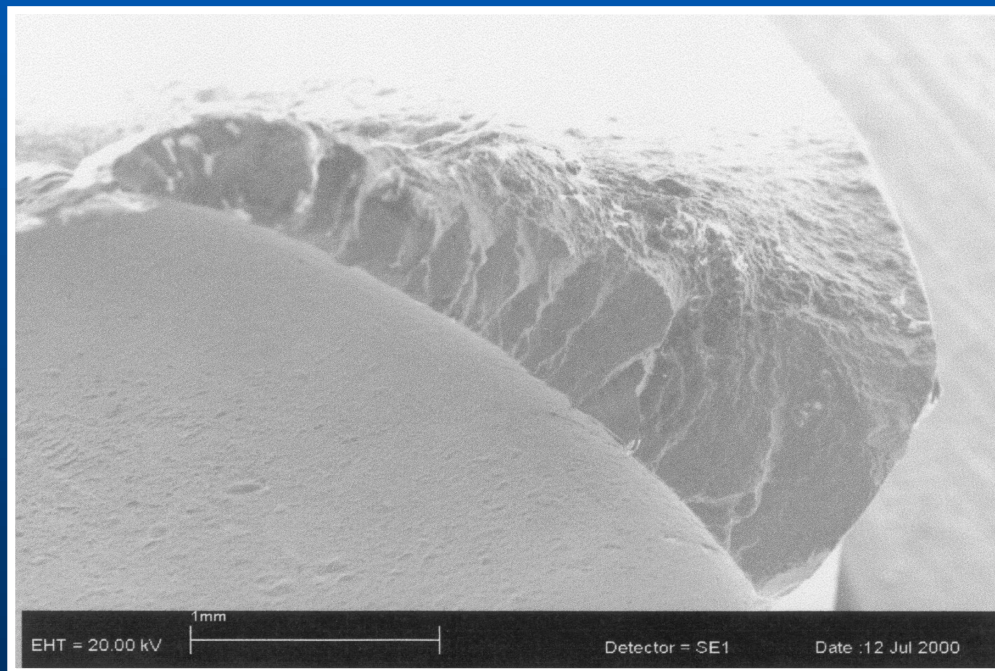
SEM showing fatigue crack in other a/c drag brace
