# Oxygen Fire in an EMS helicopter

Presented by Ron Heitmann  
Investigator  
Australian Transport Safety Bureau  
Brisbane Field Office

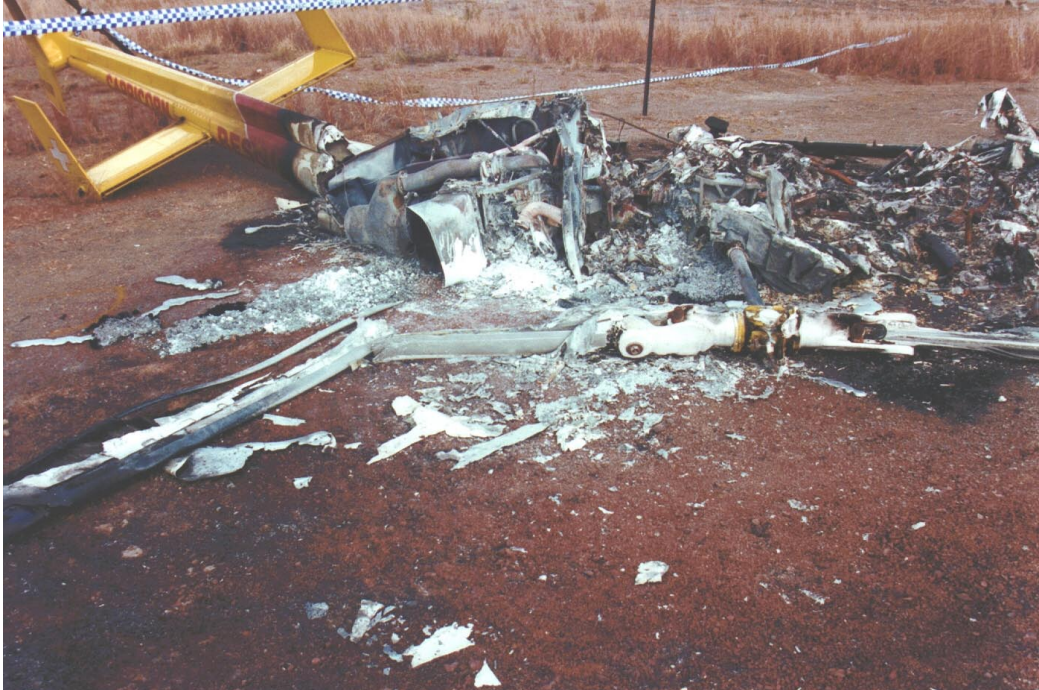
The helicopter was extensively burned. Rivulets of different metals began running down the slope near the rotor blade.

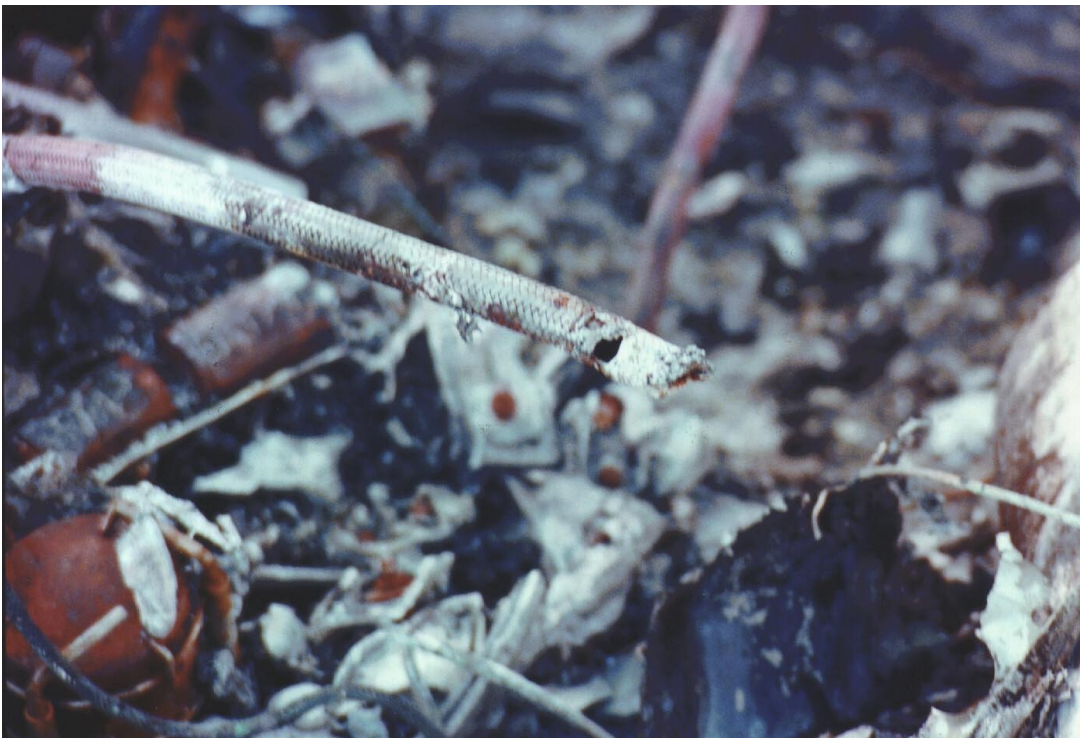
The end of a braided hose was melted. The rest of the hose was missing.

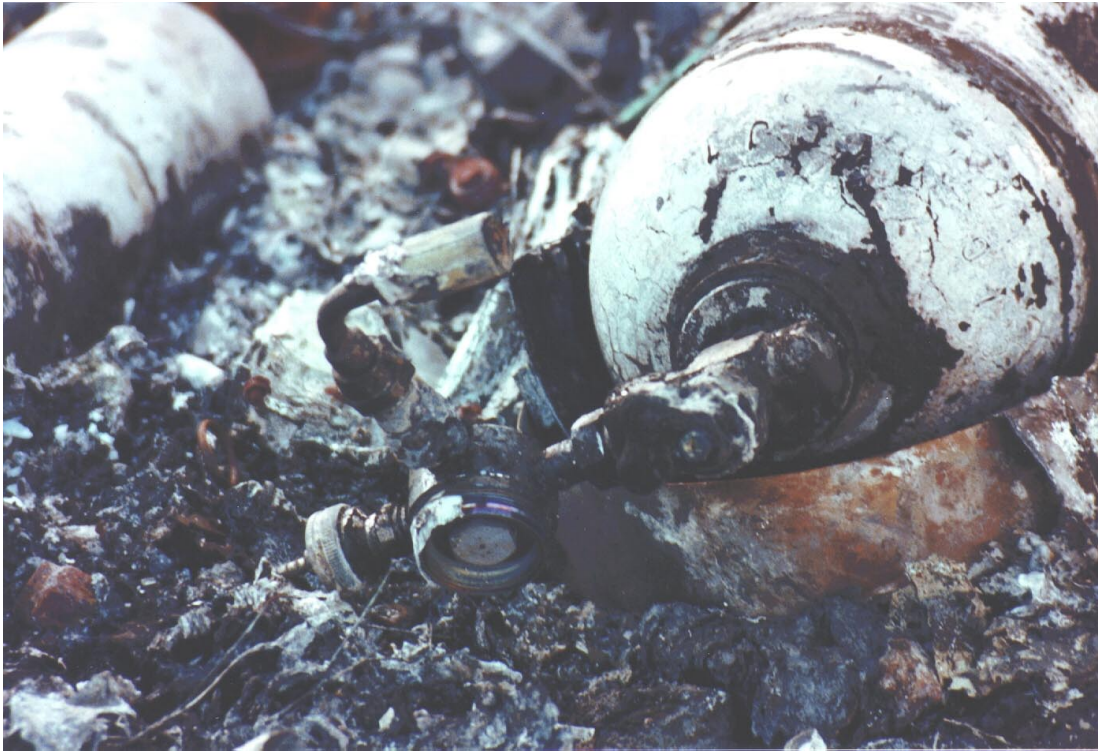
The beginning of the hose was attached to the regulator of the large bottle. A second bottle and regulator were the portable system, which had also had oxygen burning from it.

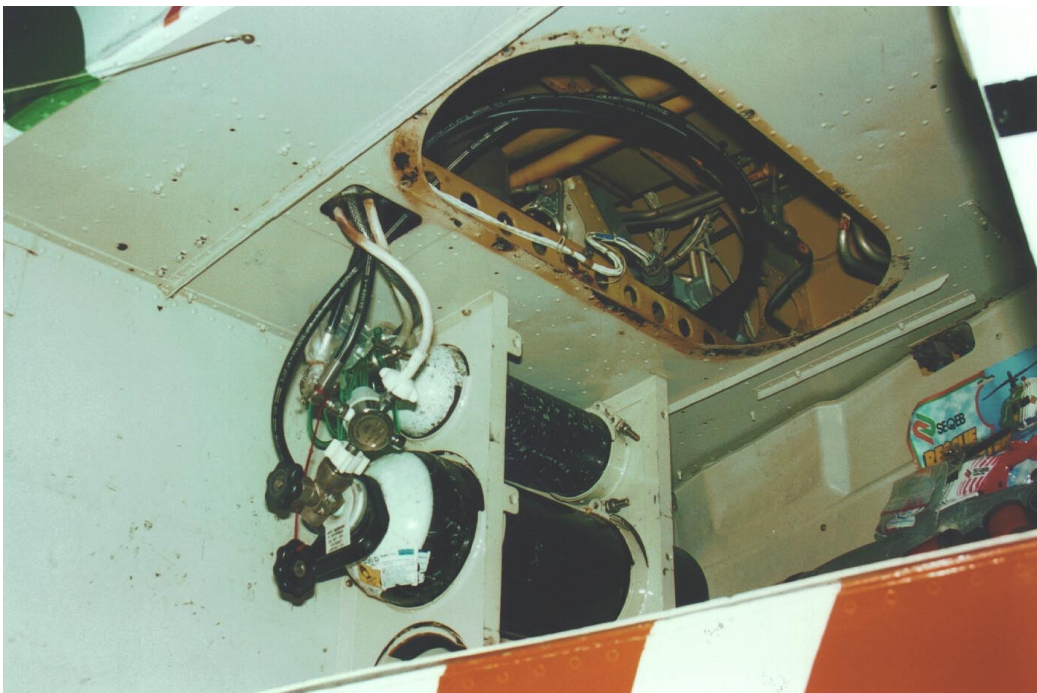
It was necessary to gain an understanding of the installation before the fire. This one was similar, but this one had two bottles permanently fixed. Note the loops of hose visible where the cover has been removed.

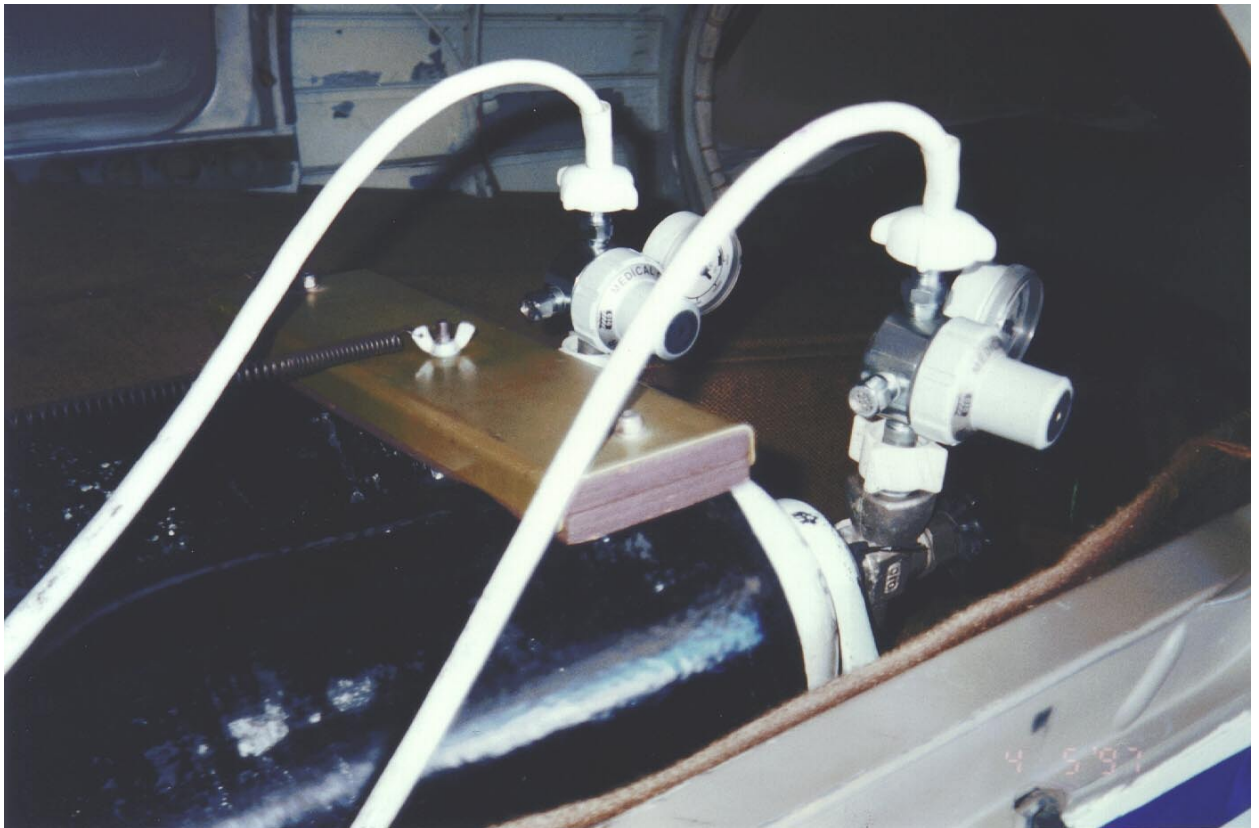
A fixed wing aircraft was found with an unsafe installation of oxygen bottles and hoses in the nose locker. There was no way to turn these bottles off from inside the aircraft.

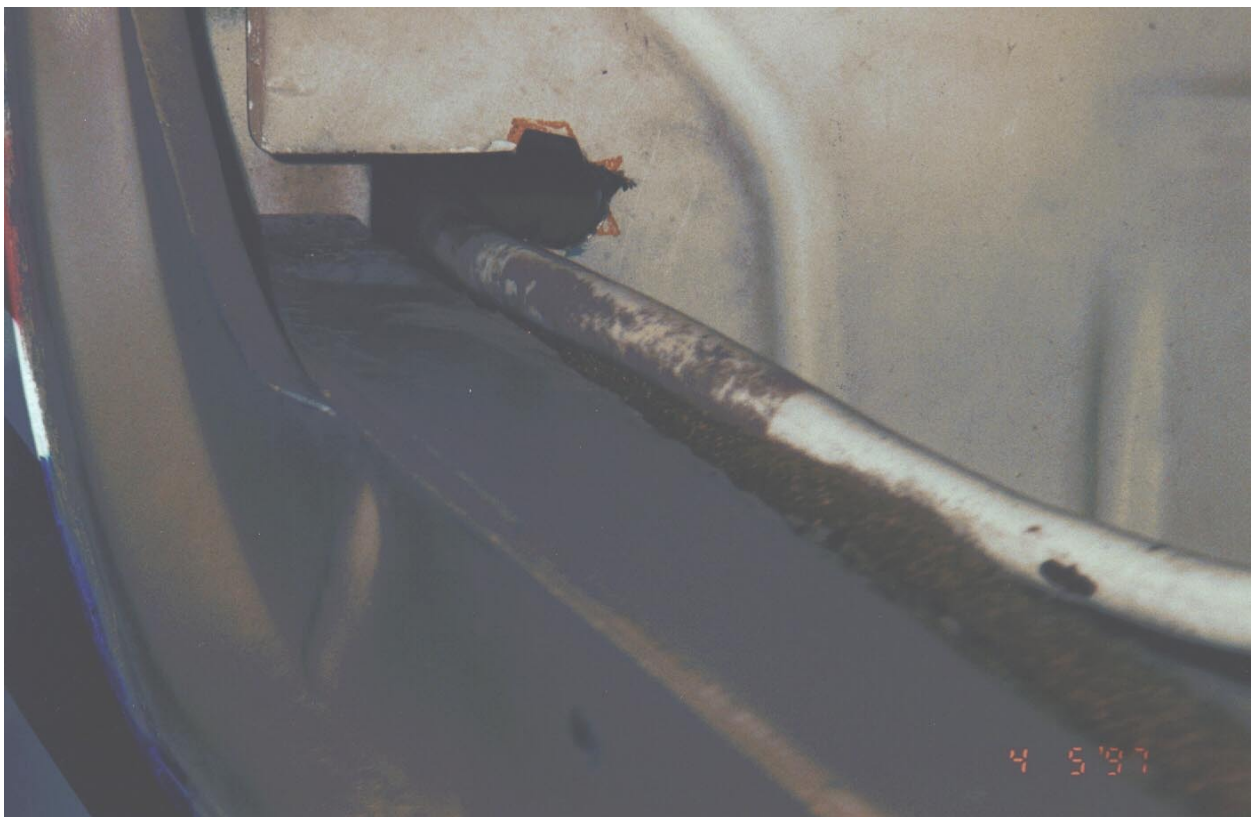
The hose running into the cabin was not restrained, nor protected from chafing, or cutting.

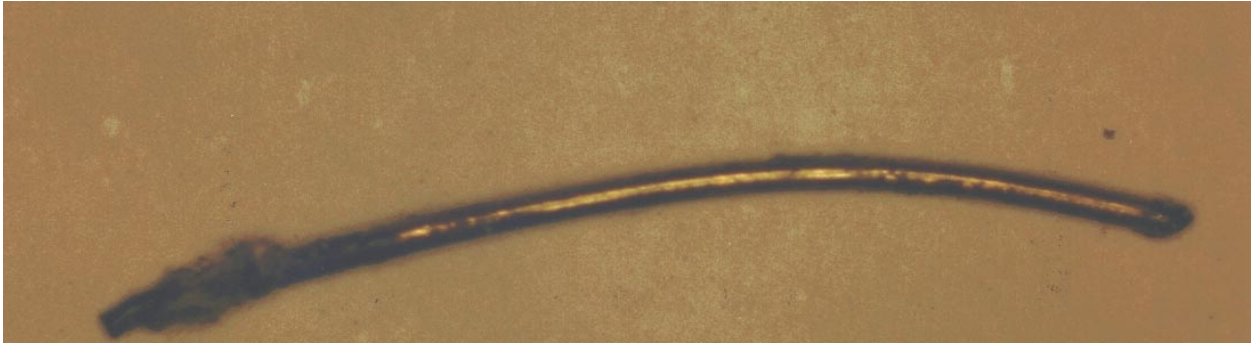
Pieces of wire braid were extracted from the pilot's flying suit and neck. The ends of the steel wire had melted.

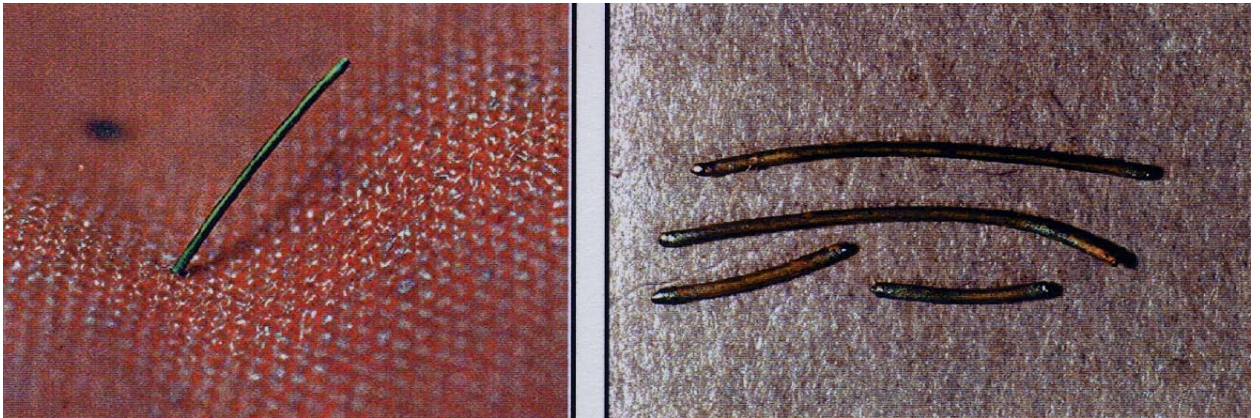
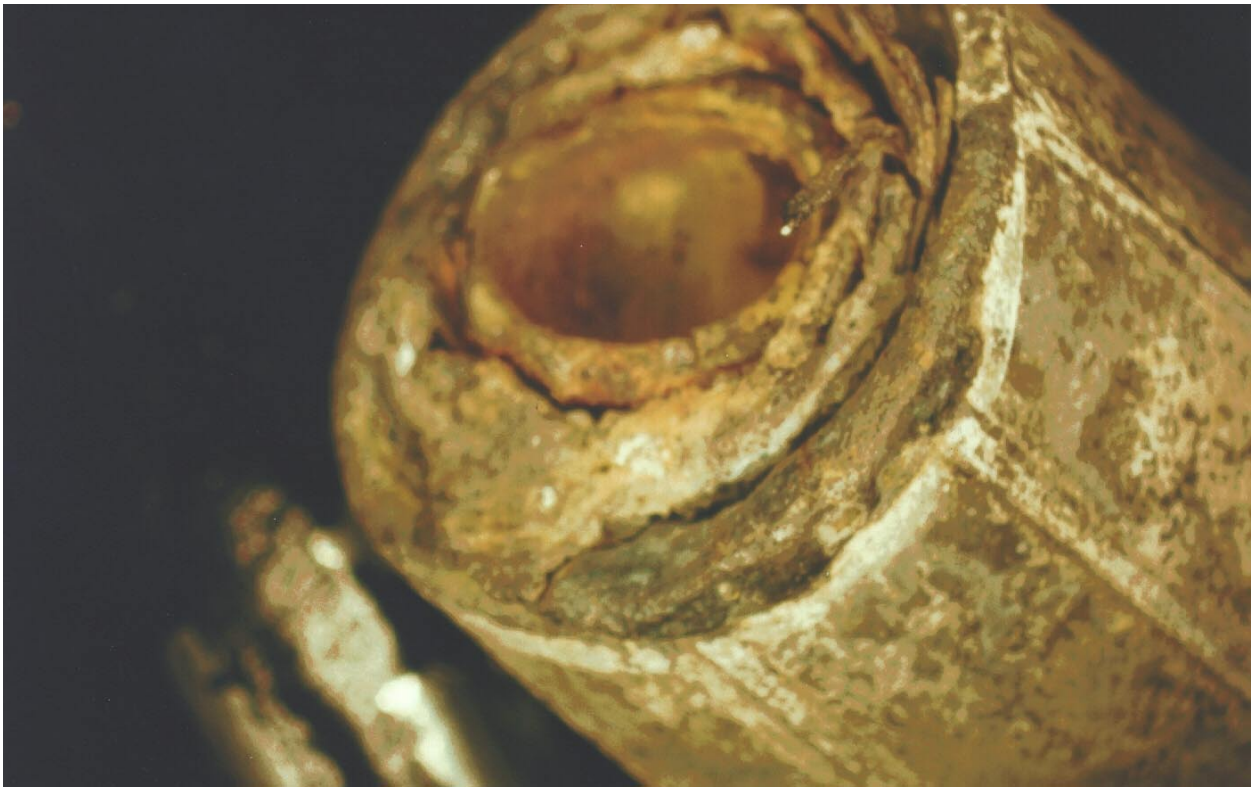
The hose fitting at the regulator was solid enough to stop the oxygen fire before the regulator. Some melting took place. Remember that all of the oxygen fire occurred in about 0.3 seconds.

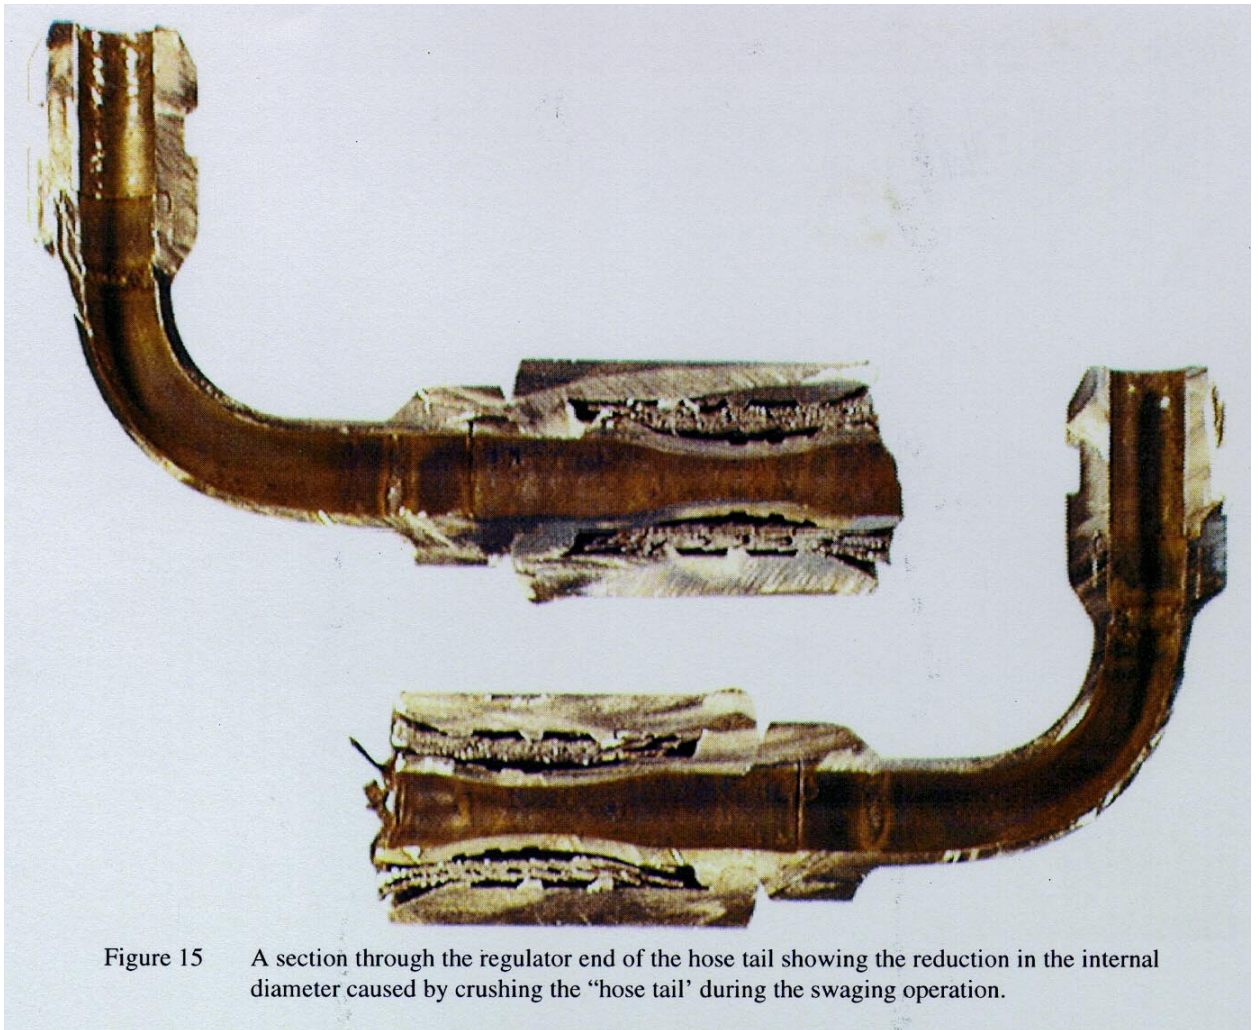
The crimped fittings had been over-crimped, creating venturis to accelerate particles in the gas flow.

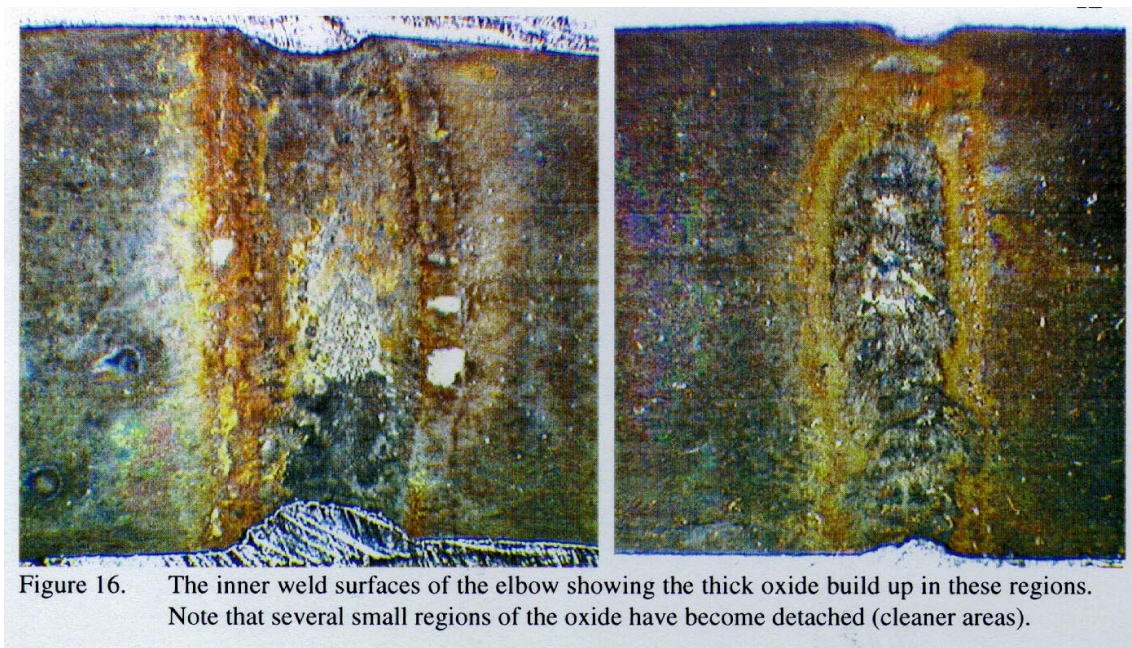
Welding flux broke off the inside of the welded fittings, which were industrial, not aircraft quality.
