Bombardier Q300 nose landing gear incidents

Peter R. Williams
Transport Accident Investigation Commission

ANZSASI Regional Air Safety Seminar
Christchurch, June 2013

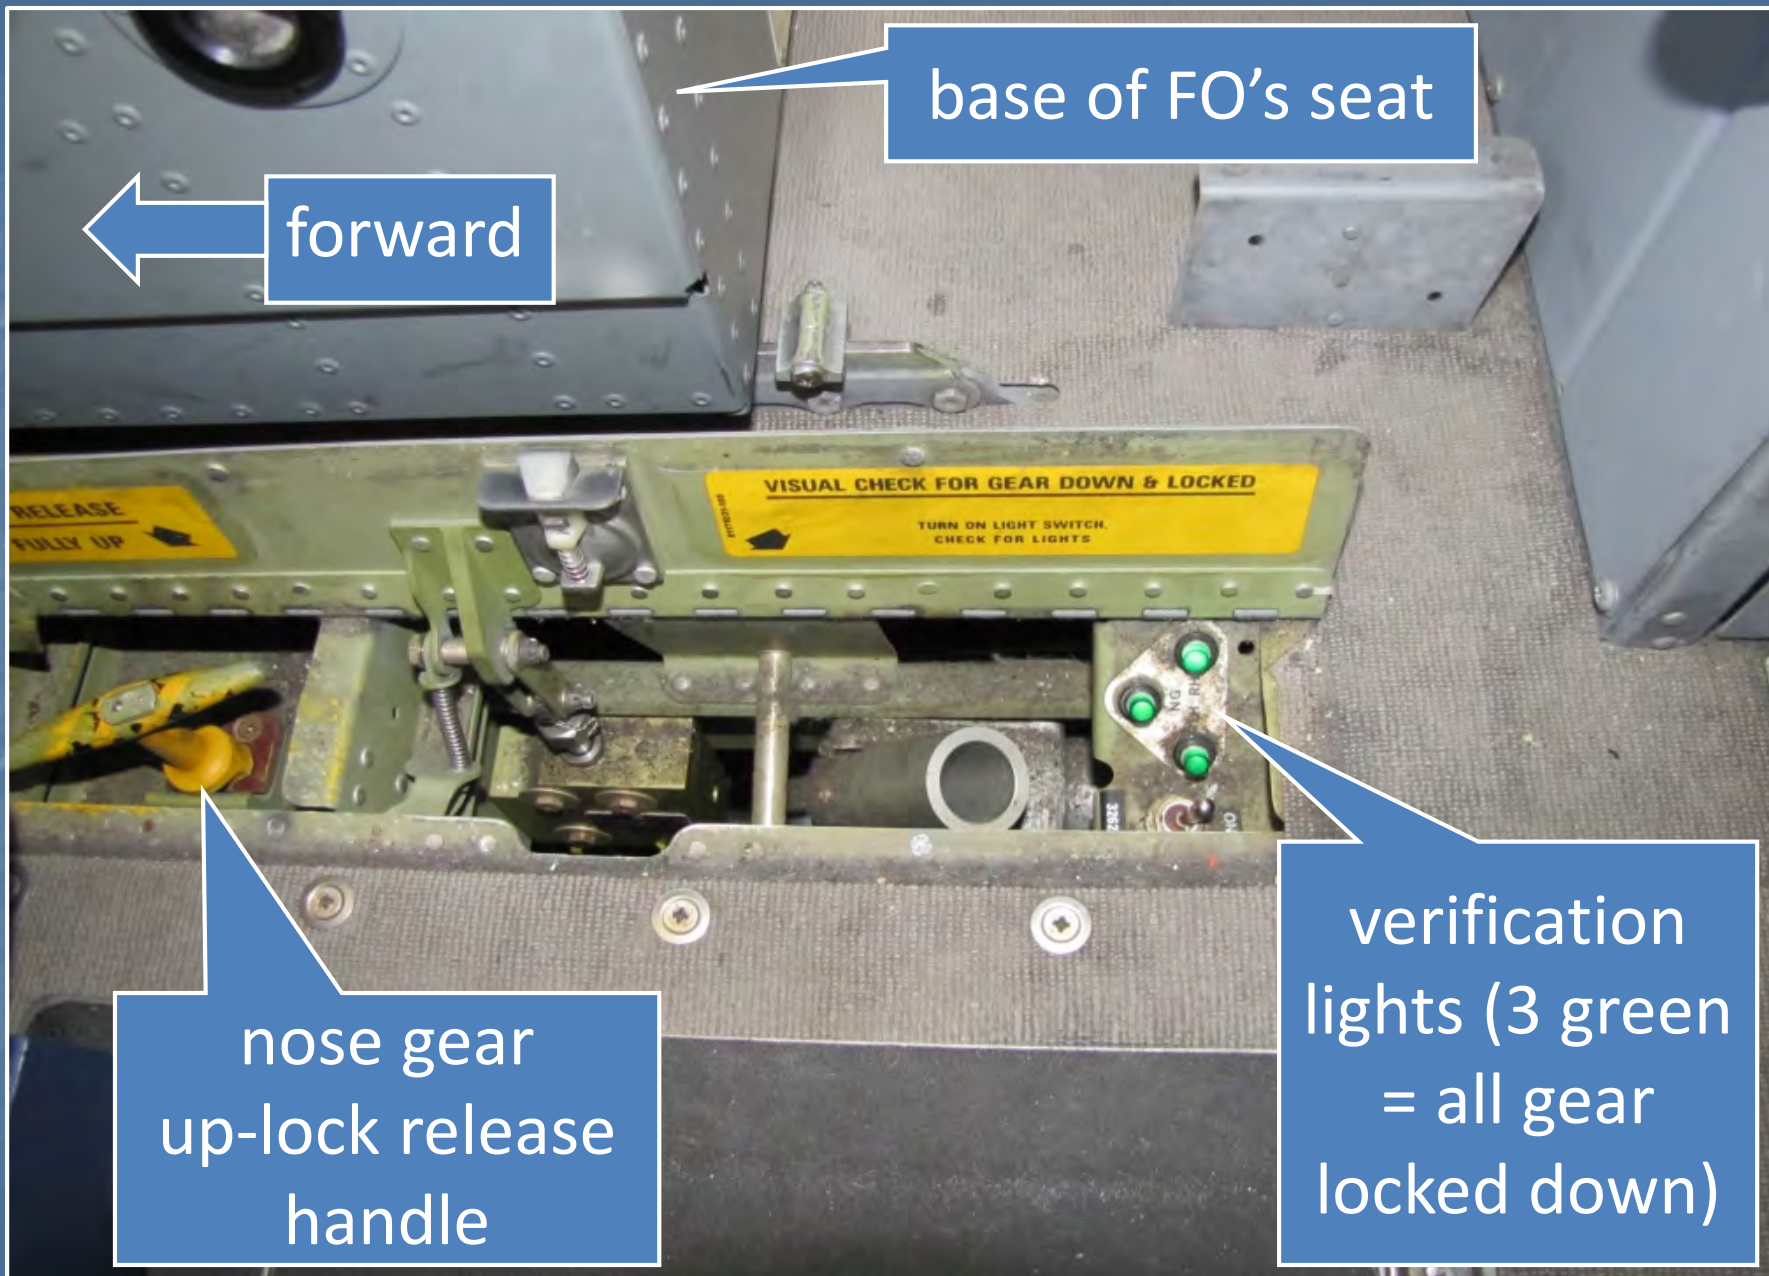
base of FO's seat

nose gear
up-lock release
handle

verification
lights (3 green
= all gear
locked down)

VISUAL CHECK FOR GEAR DOWN & LOCKED

TURN ON LIGHT SWITCH.
CHECK FOR LIGHTS

RELEASE
FULLY UP

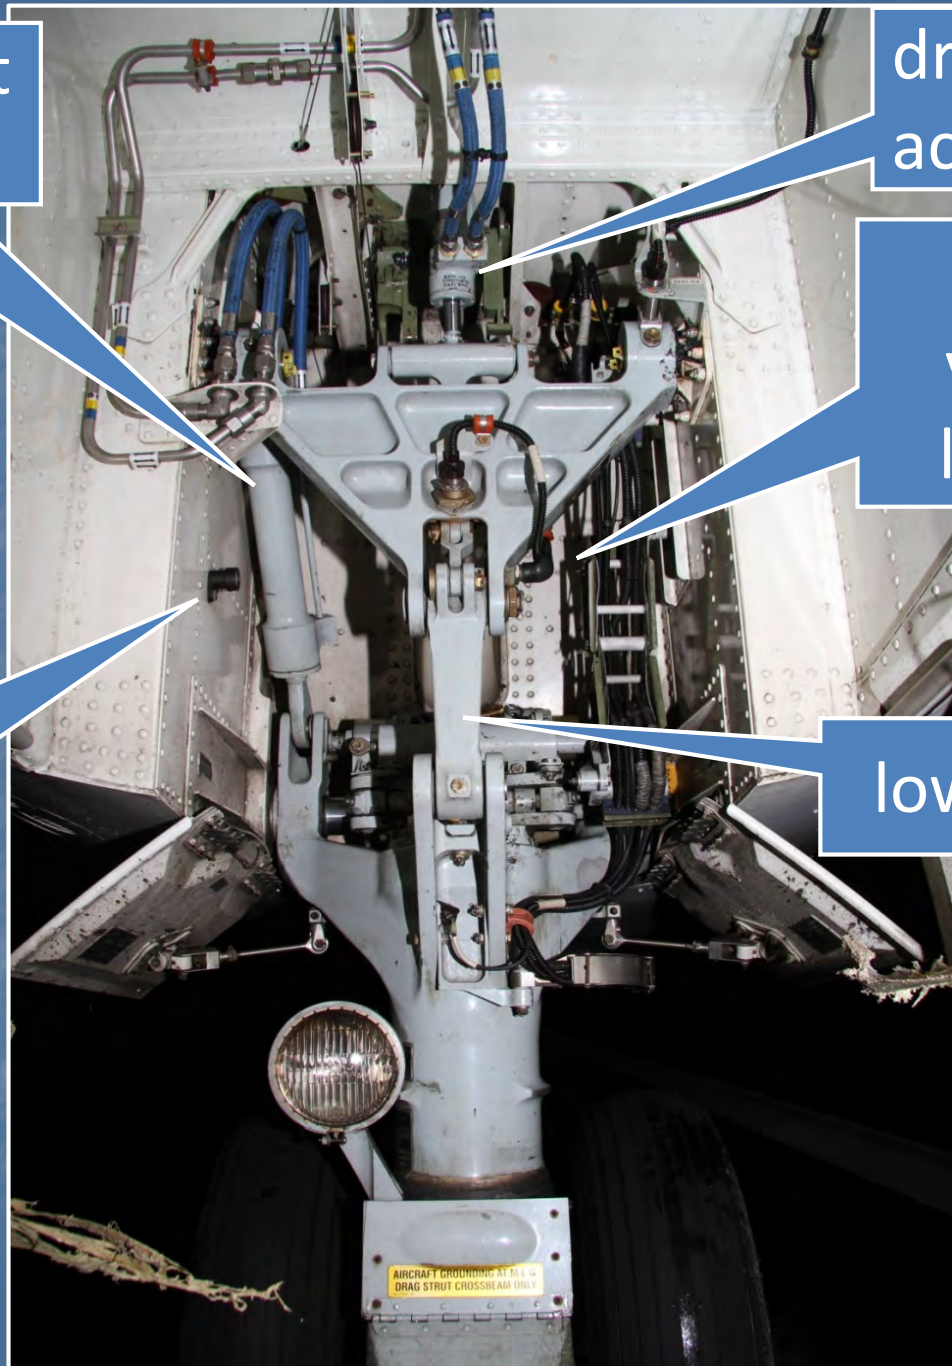
extend/retract
actuator

drag strut
actuator

down-lock
verification
light source

down-lock
verification
sensor

lower drag strut

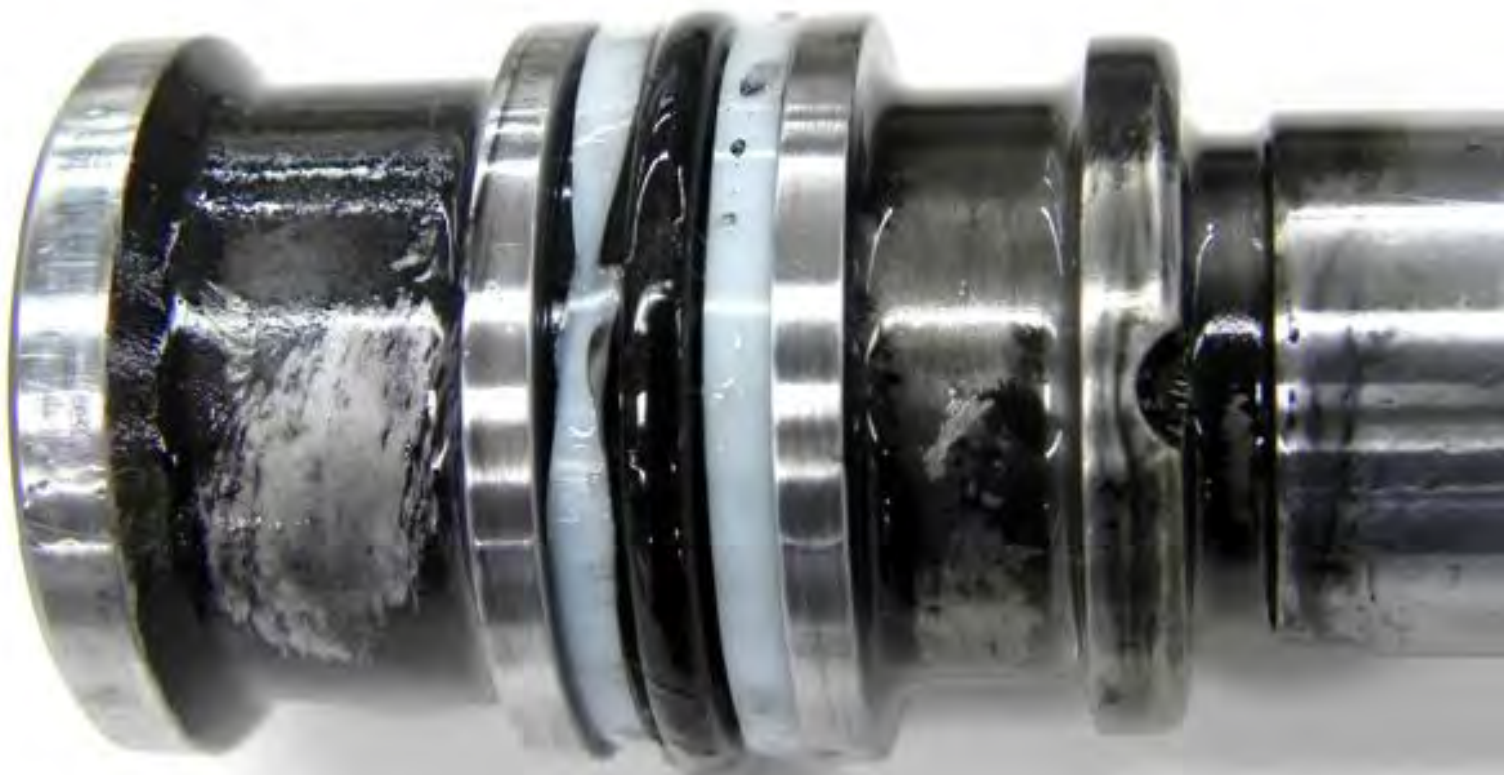
2011-4504
AIRNELSON LTD
(failed packing)

- What caused nose gear to not extend? **Seal debris in actuator ports**
- Damage at manufacture or assembly?
- Damage worsened by other debris in fluid, possibly from door actuator
- Alt extension drill unlikely to have succeeded; cycling gear might have
- Previous symptoms not resolved

light axial
scoring

undamaged
back-up ring

damaged back-up ring

damaged elastomer
seal

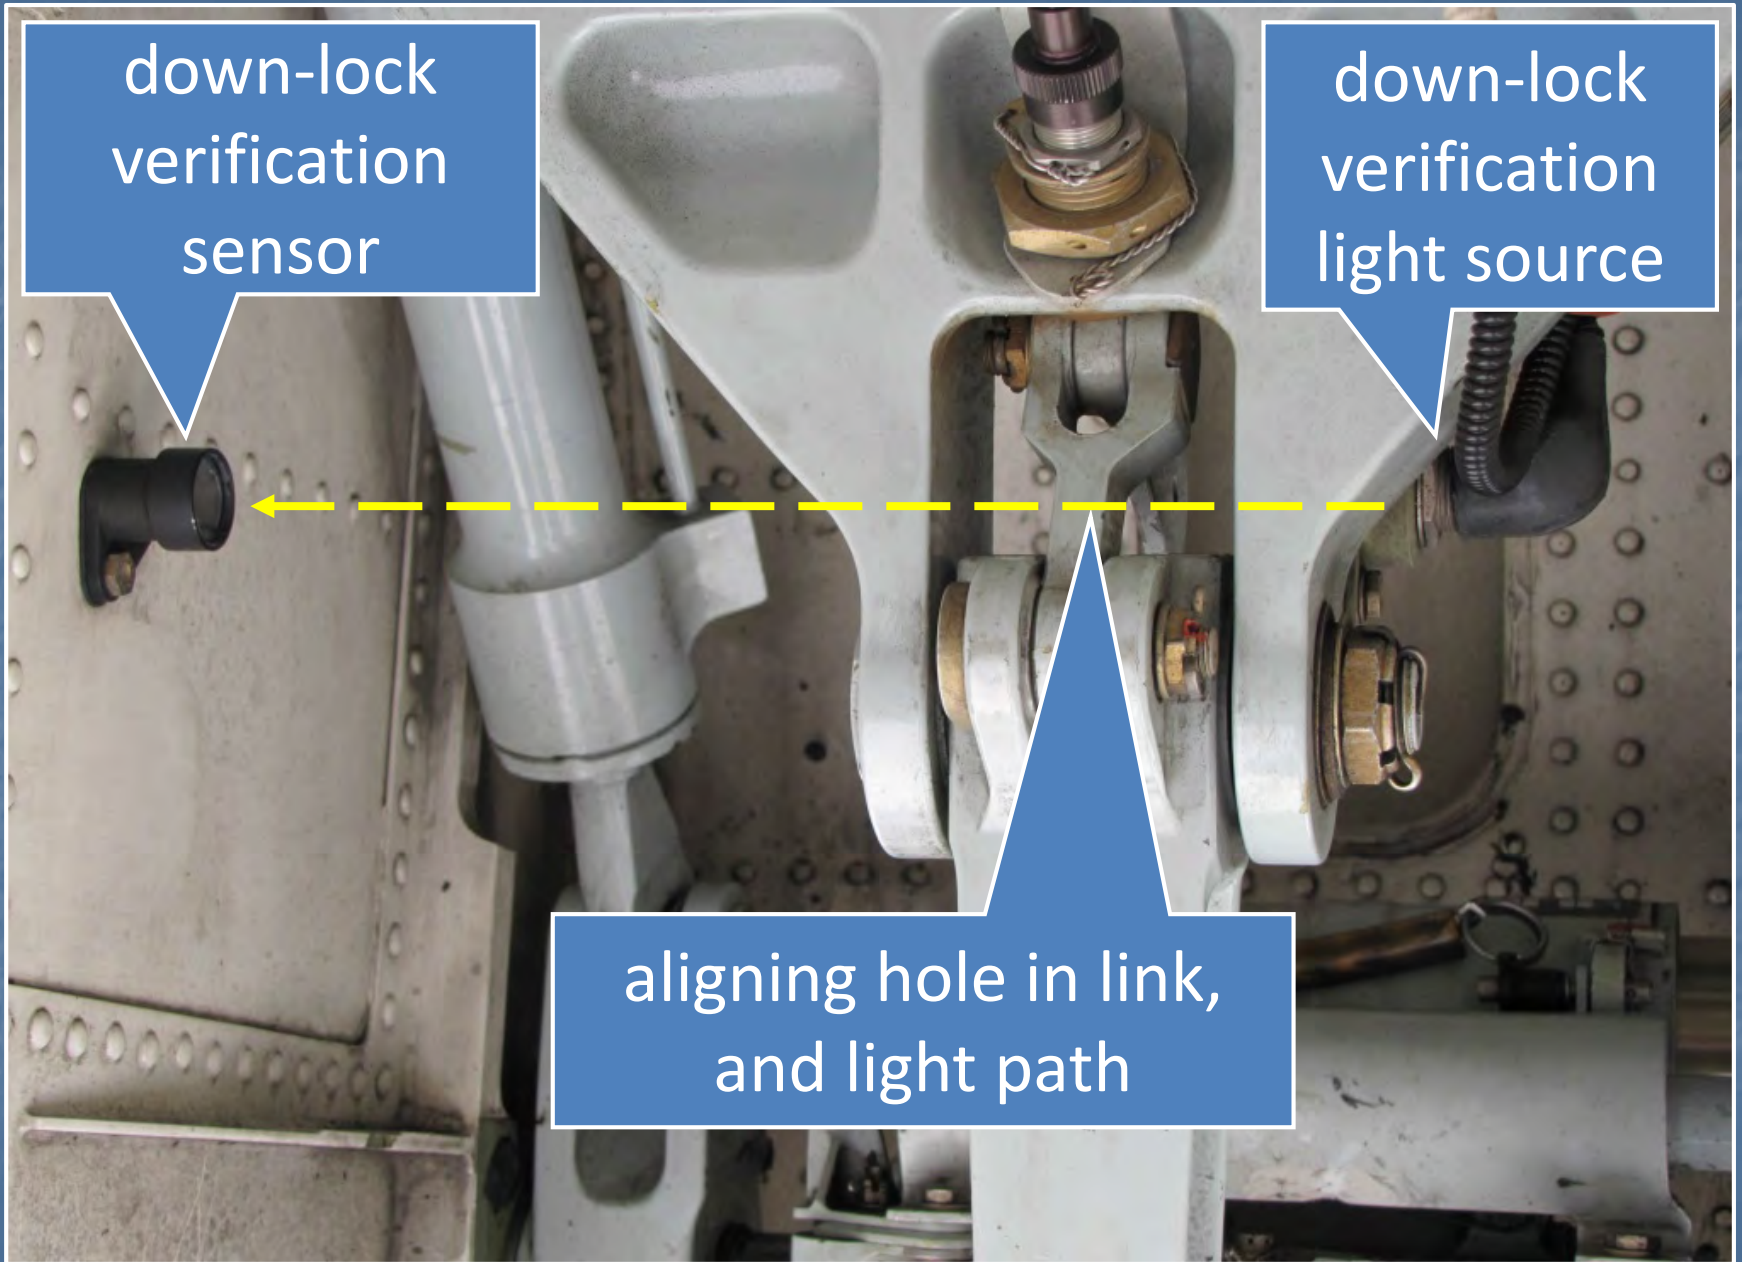
- Why the erroneous verification?
Verification system was deficient
- Taxi light had to be off during check of verification system
- Sensors prone to water ingress

down-lock
verification
sensor

down-lock
verification
light source

aligning hole in link,
and light path

- SLs dealing with alternate gear extensions and situations beyond scope of QRH (overlap with Feb 2011 incident)
- Check alt verification with taxi light off
- Cycling not recommended, unless alt extension procedure unsuccessful
- Special Inspection of alt indication system
- Re-design of alt verification system

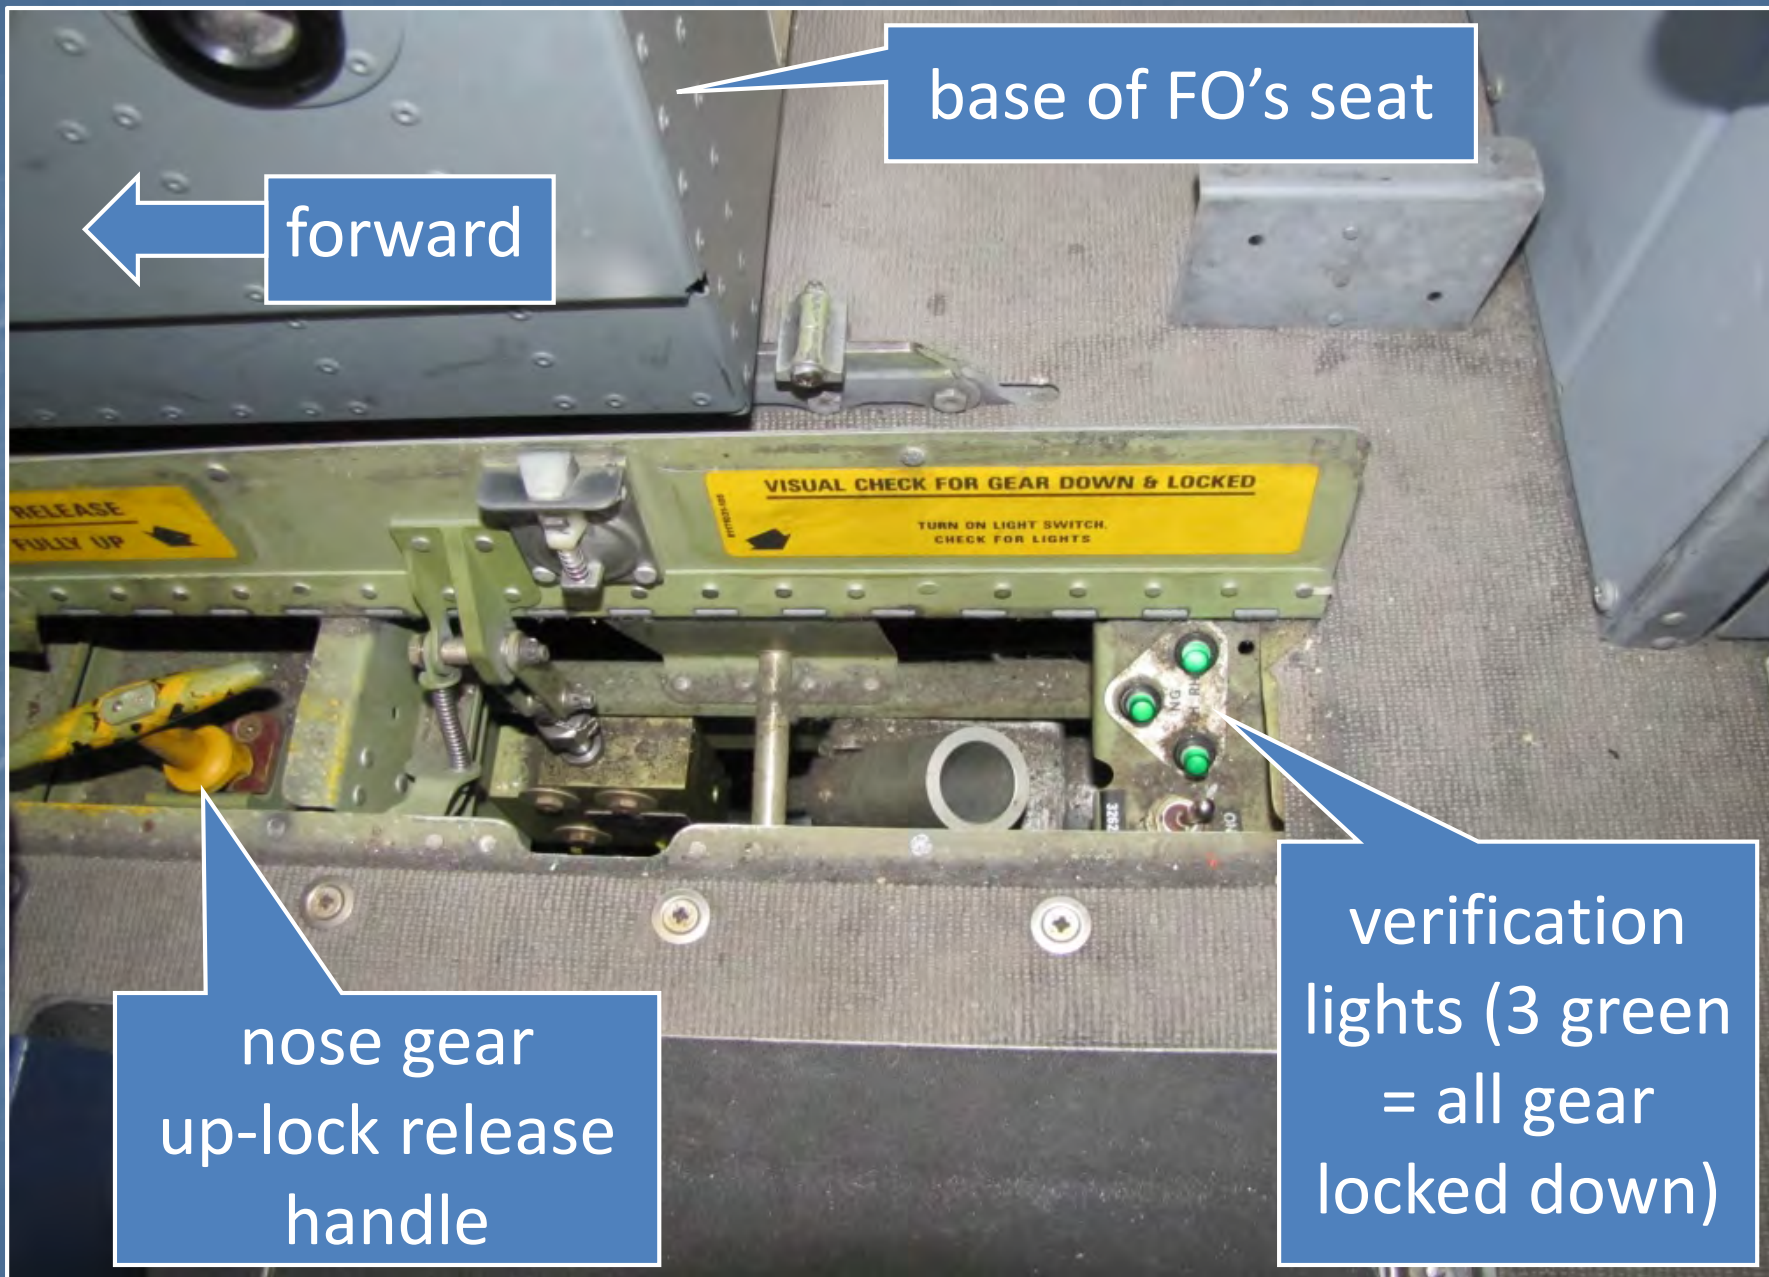
base of FO's seat

VISUAL CHECK FOR GEAR DOWN & LOCKED

TURN ON LIGHT SWITCH.
CHECK FOR LIGHTS

nose gear
up-lock release
handle

verification
lights (3 green
= all gear
locked down)

- Why didn't NLG extend under alt system? **There was no defect with alt system - FO didn't pull hard enough or hold tension for long enough**
- Bombardier noted high forces in its AFM and SLs, but not in its QRH. Air Nelson training and custom QRH did not include that information.

- Revised landing gear system training
- Revised QRH format and content
- Modified simulator NLG uplock release force
- Revised alt gear extension method – pause after doors unlocked.

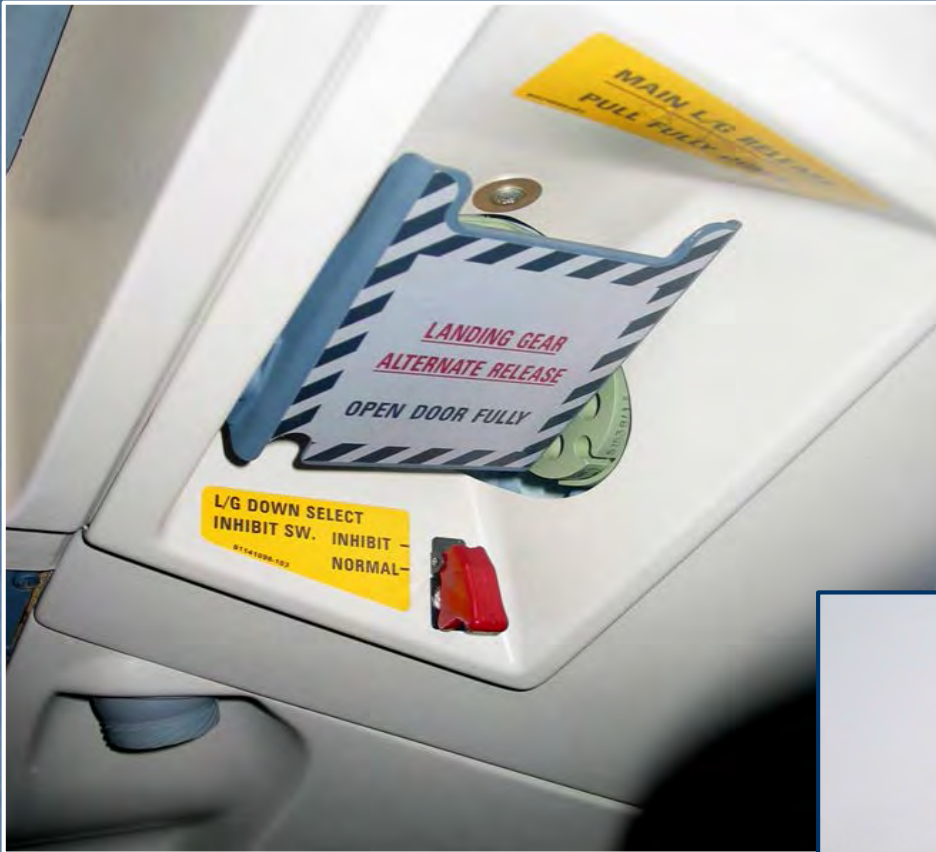
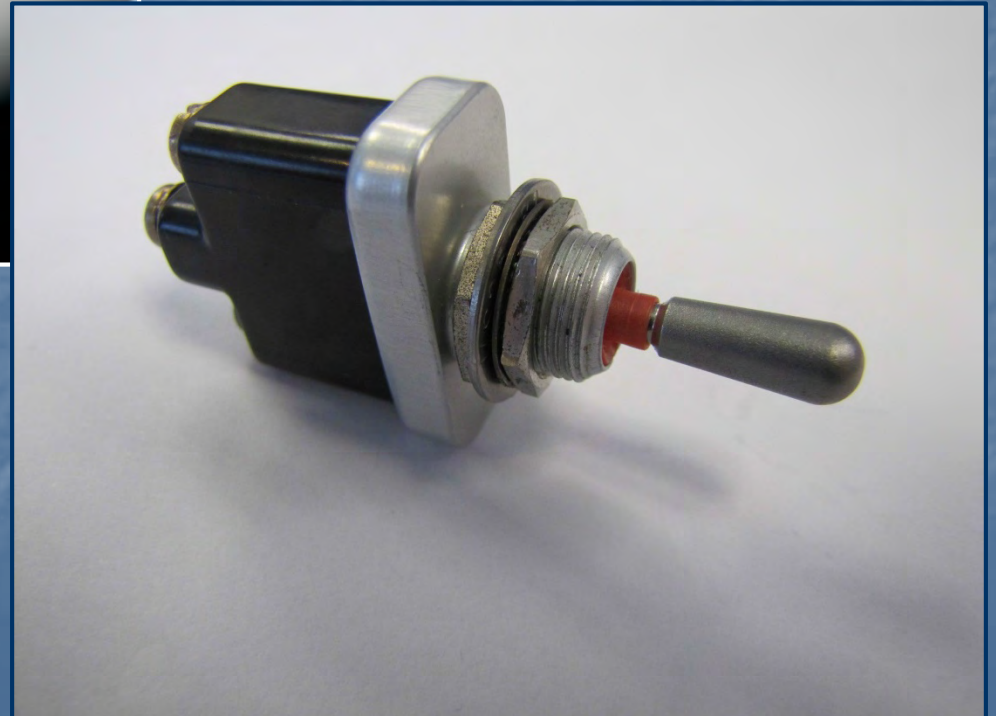
- What caused normal gear extension to fail at Wellington? **Faulty 'landing gear down select inhibit switch'**

- This was also cause of nose wheel steering defect at HLZ. Both systems get hydraulic pressure when the gear is selected DOWN
- MEL for NWS didn't consider role of landing gear supply pressure

- Amended MEL for NWS, to require confirmation of hyd pressure
- Issued SL giving more technical info on landing gear, alternate extension, and further non-normal options
- Repeated some information from Sep 2010 incident
