In-flight fuselage rupture and depressurisation QF30, 25 July 2008

A presentation to the 2009 ANZSASI Regional Air Safety
Seminar

VH-OJK B747-438 Depressurisation 25 July 2008

AO-2008-053

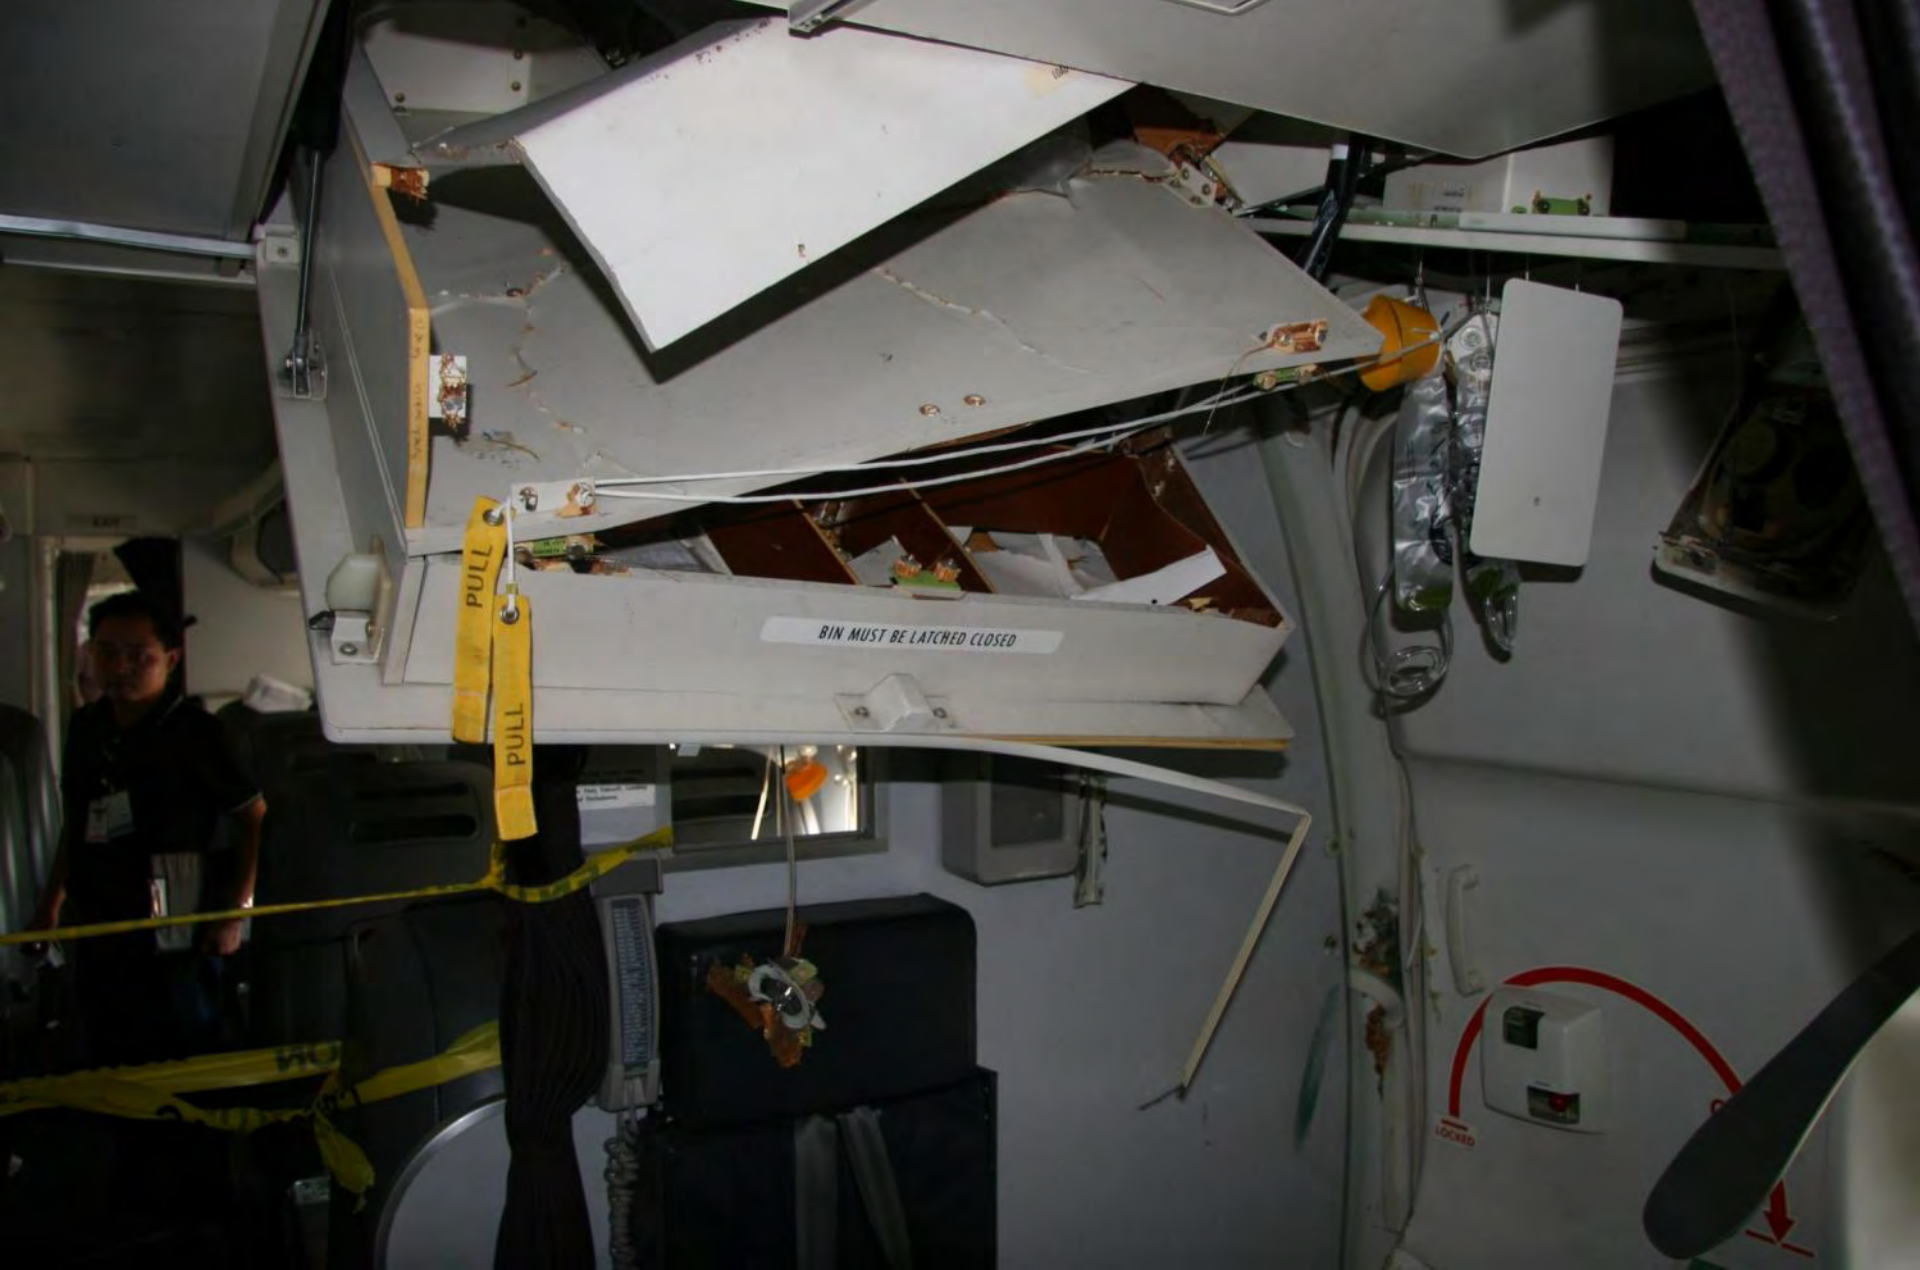
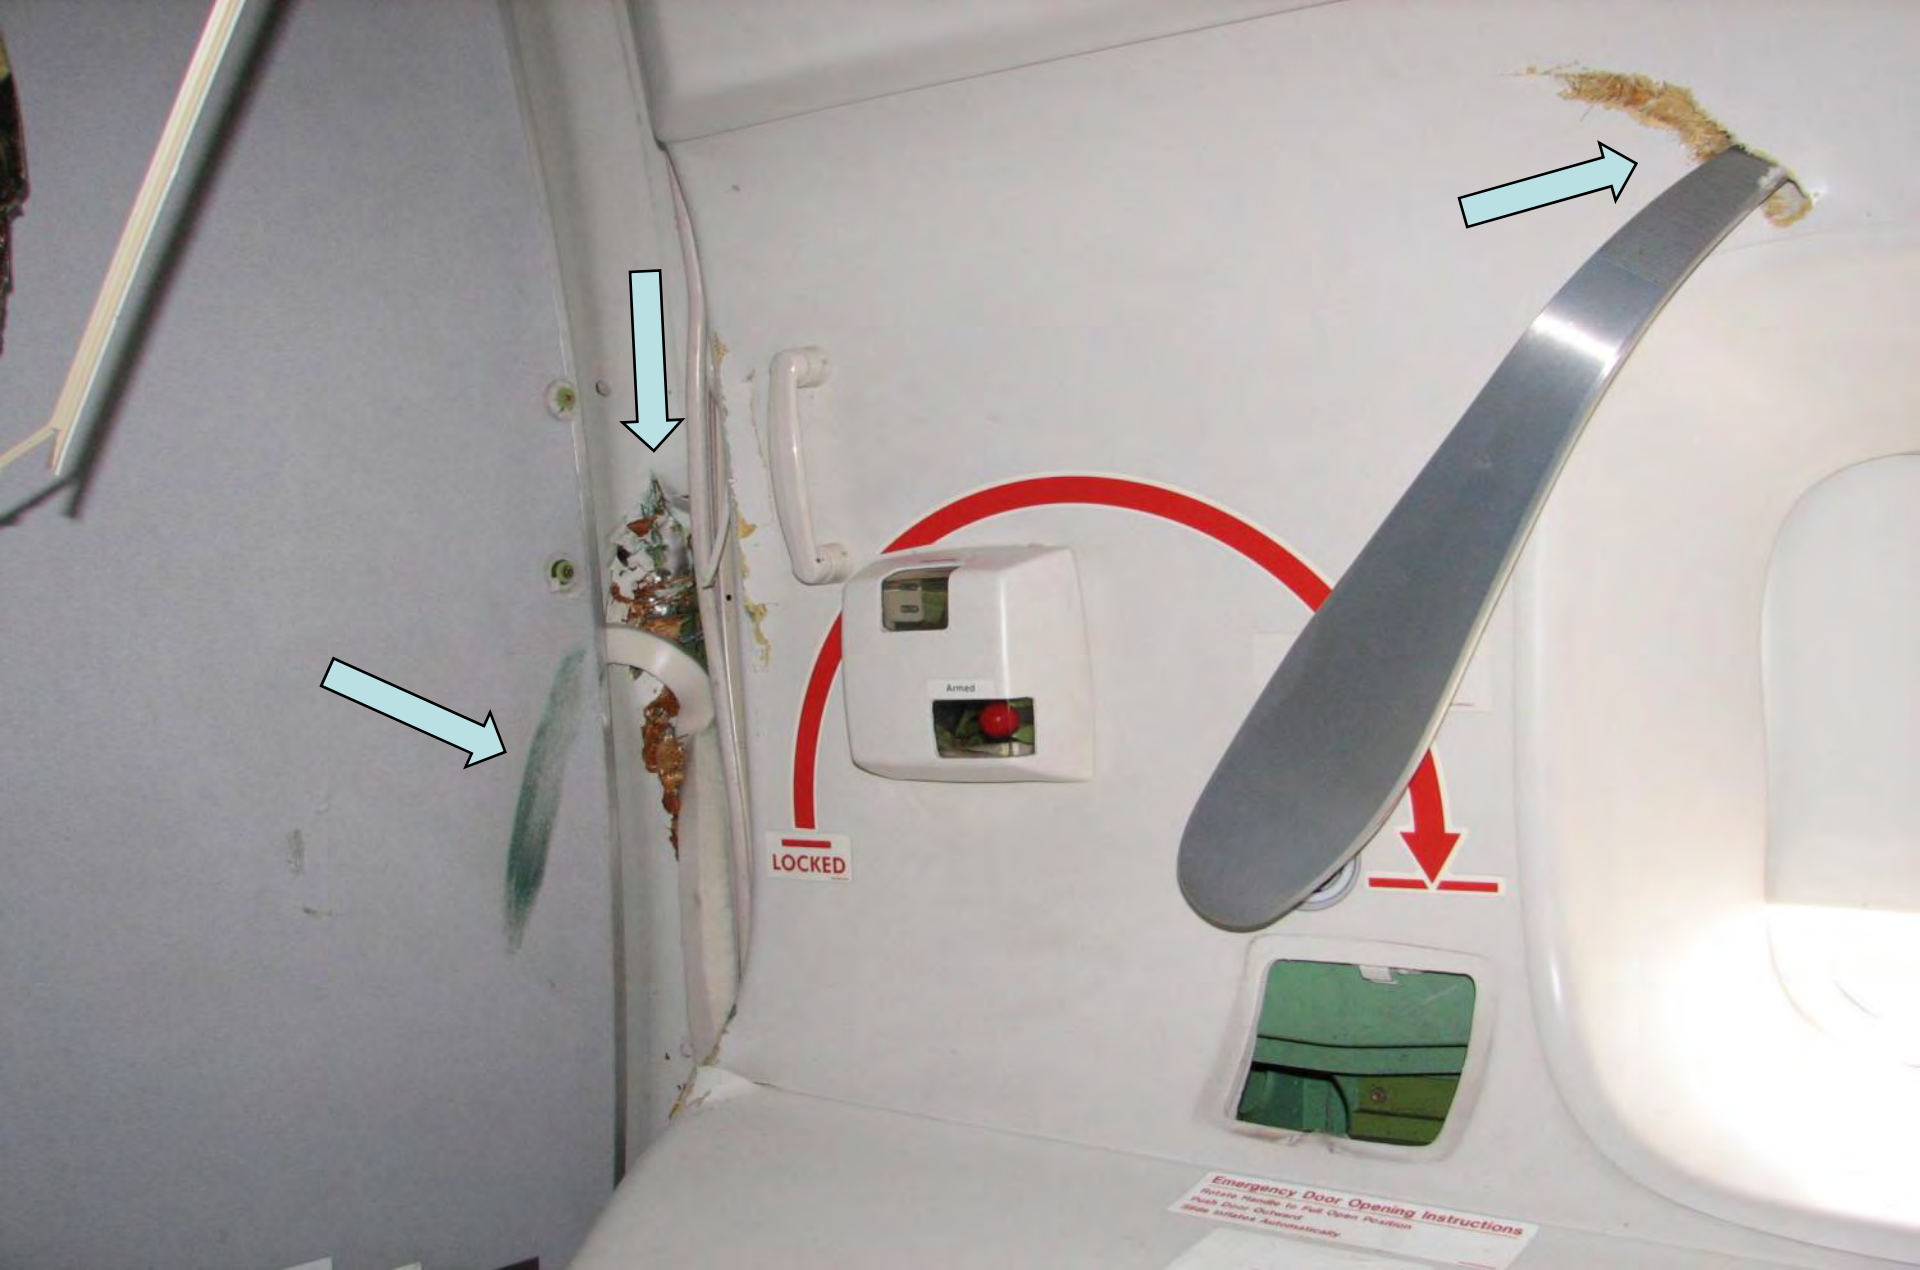
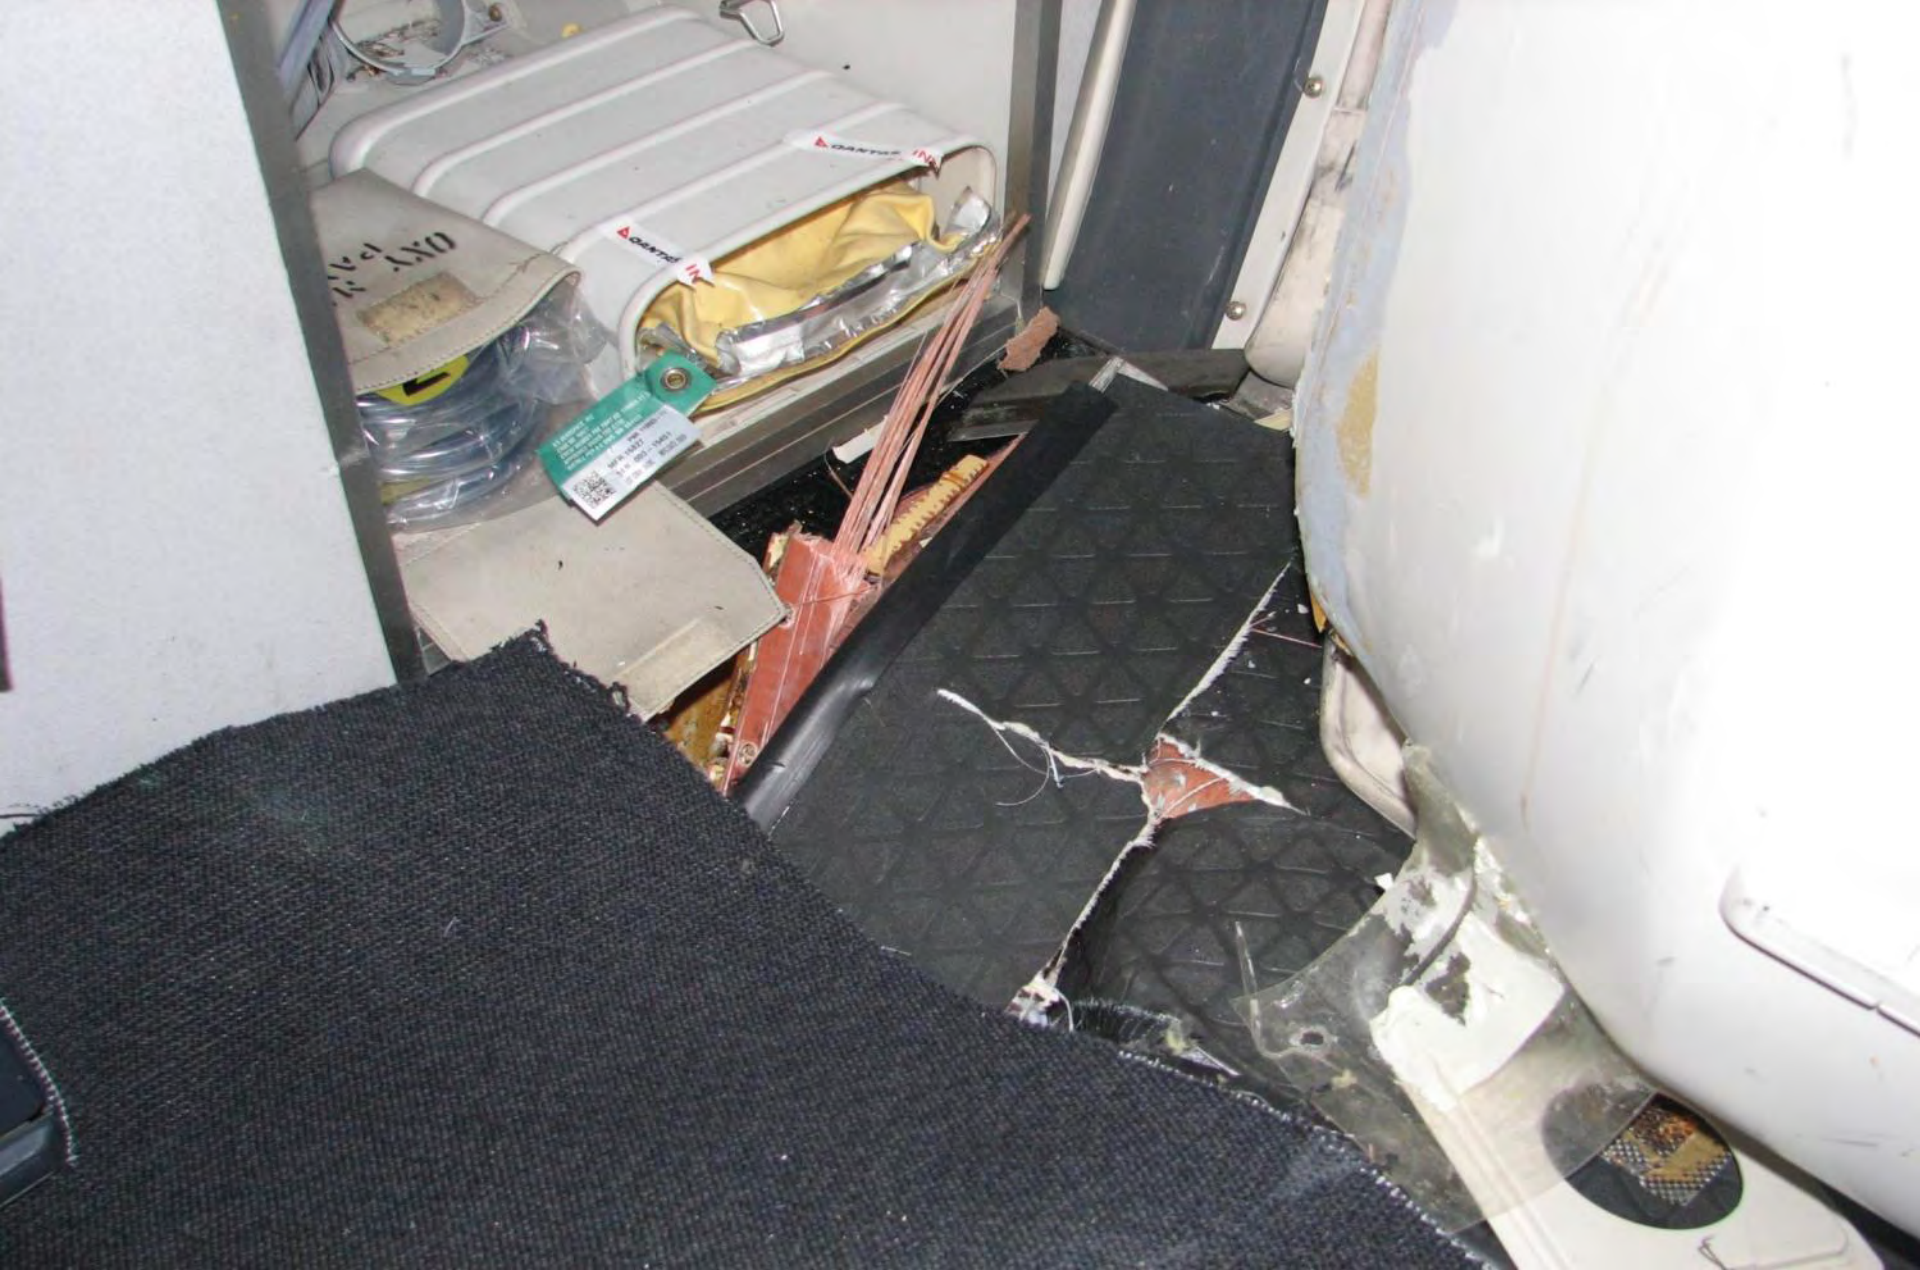
- During the diversion to Manila, cabin crew informed the flight crew of a significant degree of damage to the cabin around the R2 door, including, disruption of the floor, damage to overhead panelling and damage and movement of the door handle.
- The cabin crew member assigned to the R2 door position was assisting with a meal service and was not at their door station at the time of the event.
- Crew members reported that the automated Passenger Address system did not function during the depressurisation. The system alerts passengers to the need to use oxygen and instructs them on necessary actions, including mask use.
- None of the passengers aboard the aircraft reported any physical injuries to the cabin crew immediately following the depressurisation event, or to the operator's staff upon arrival in Manila.

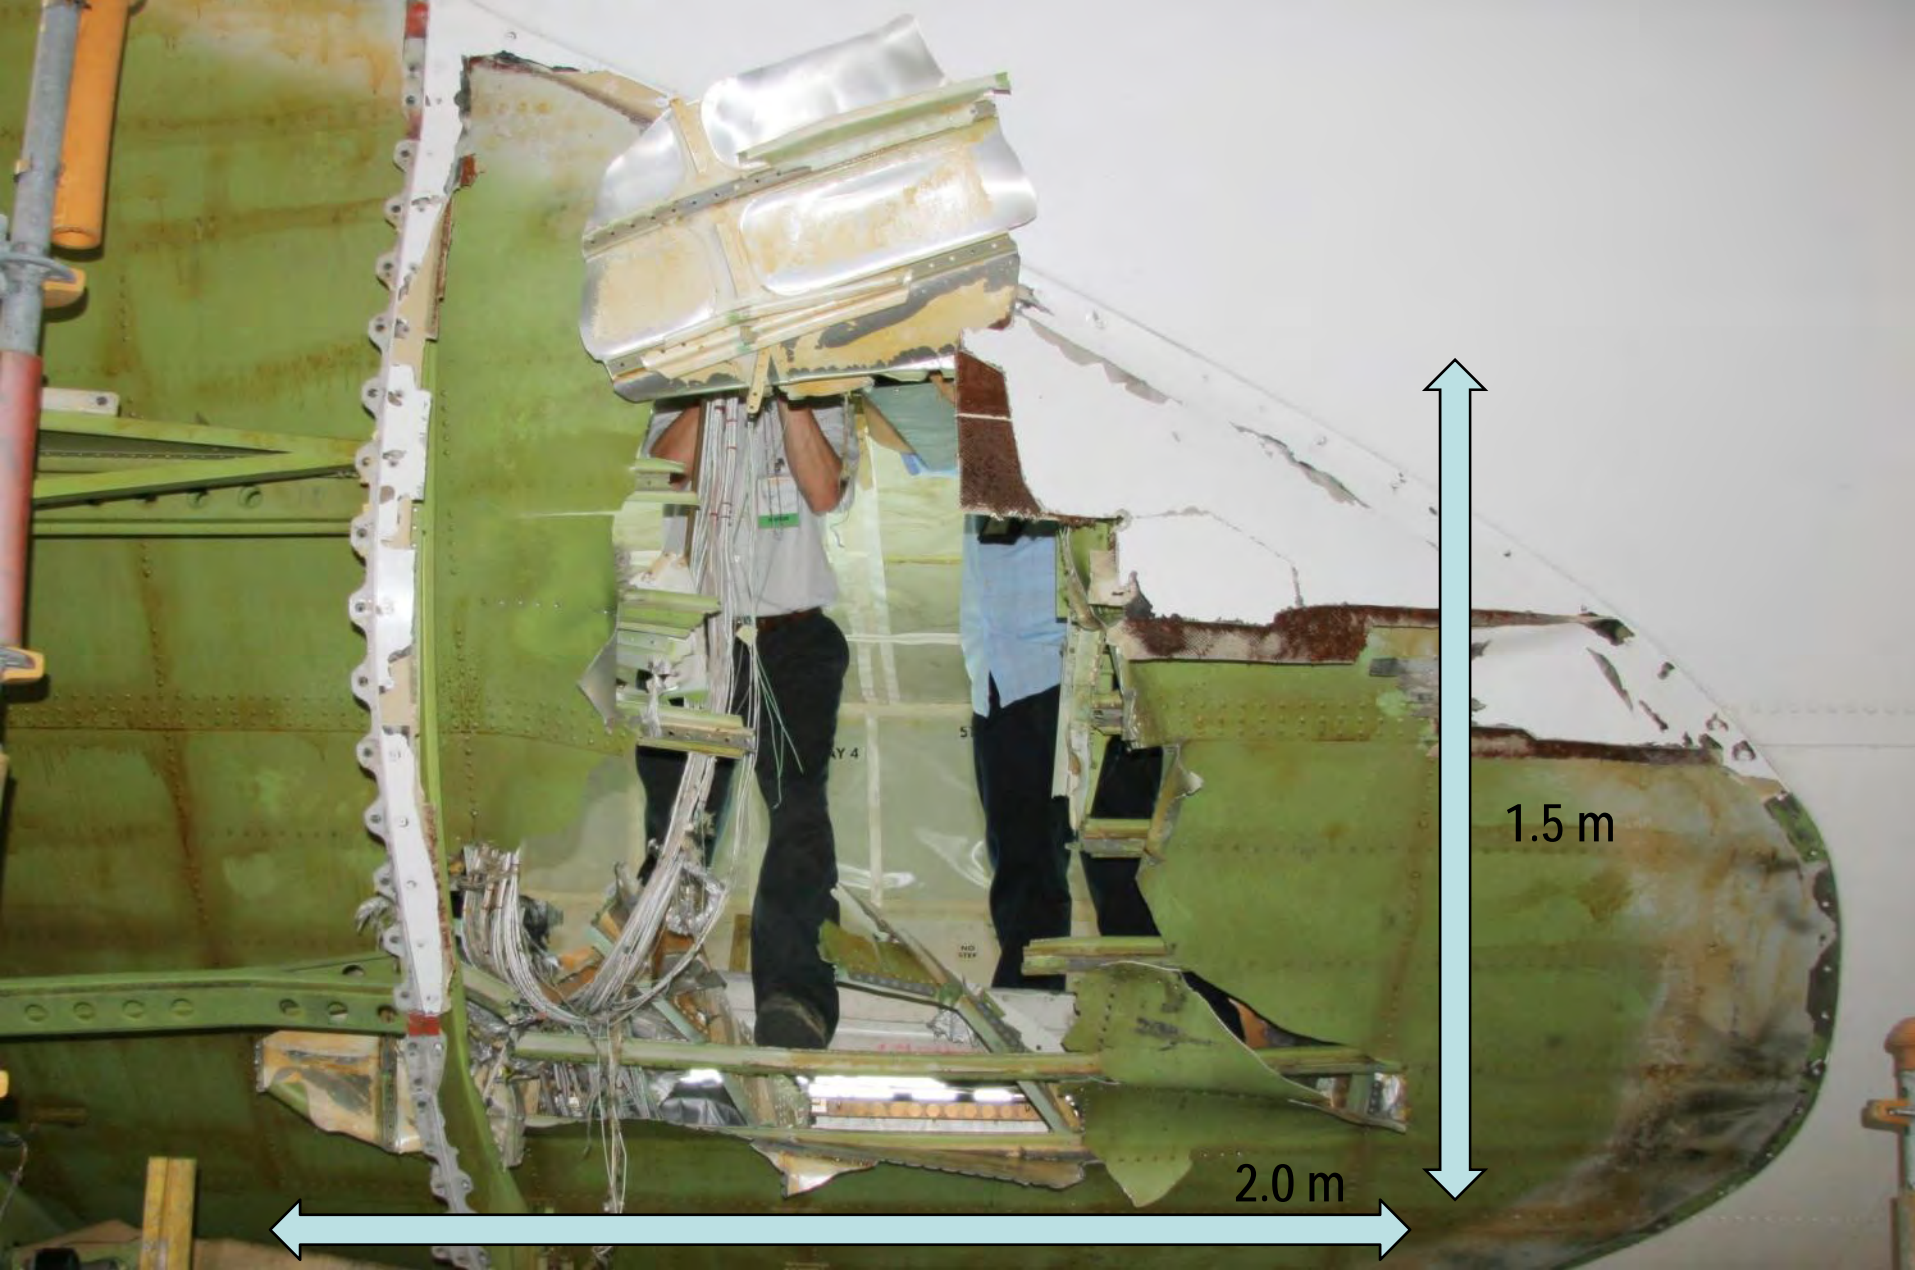
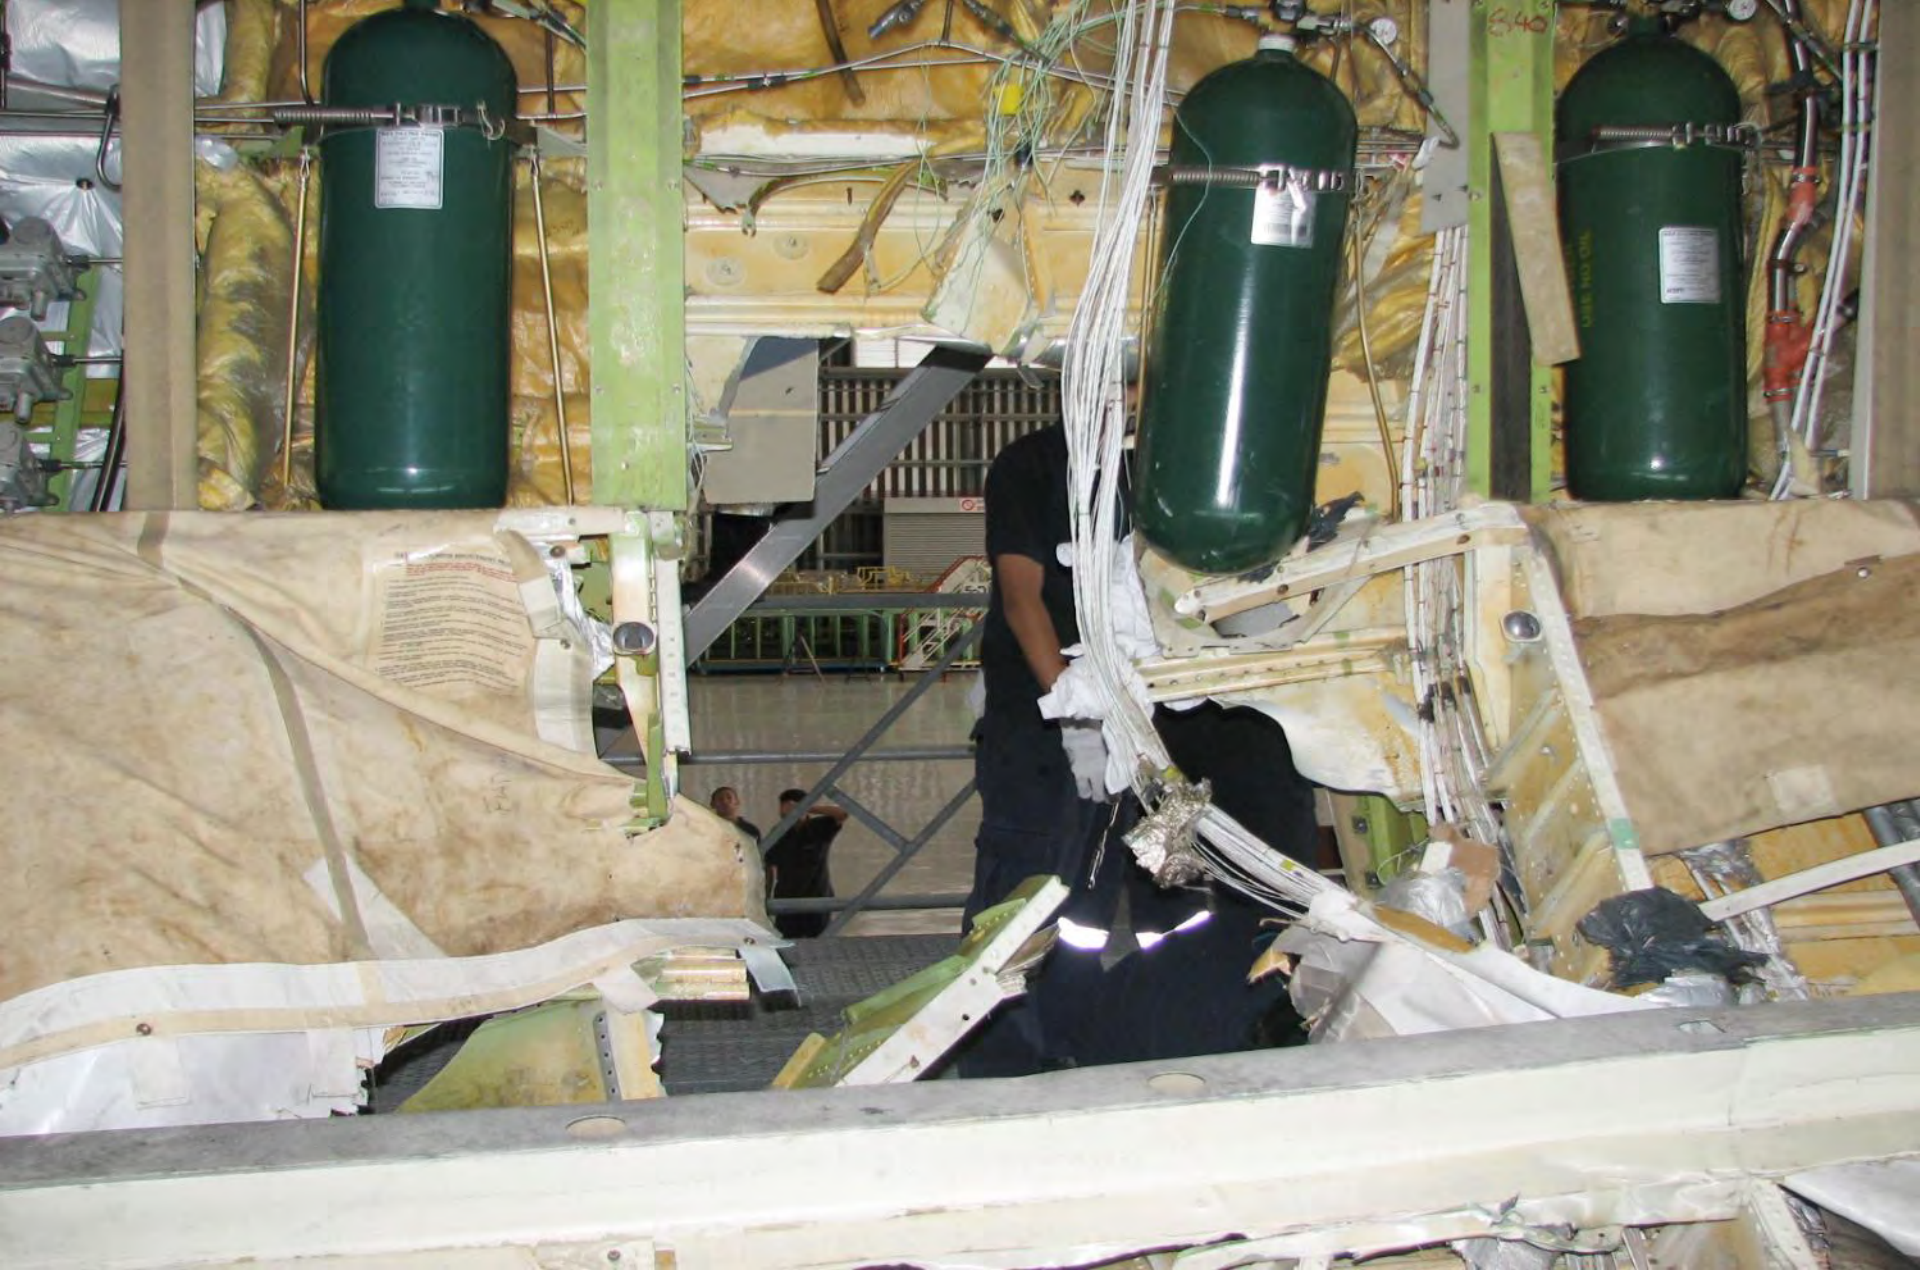
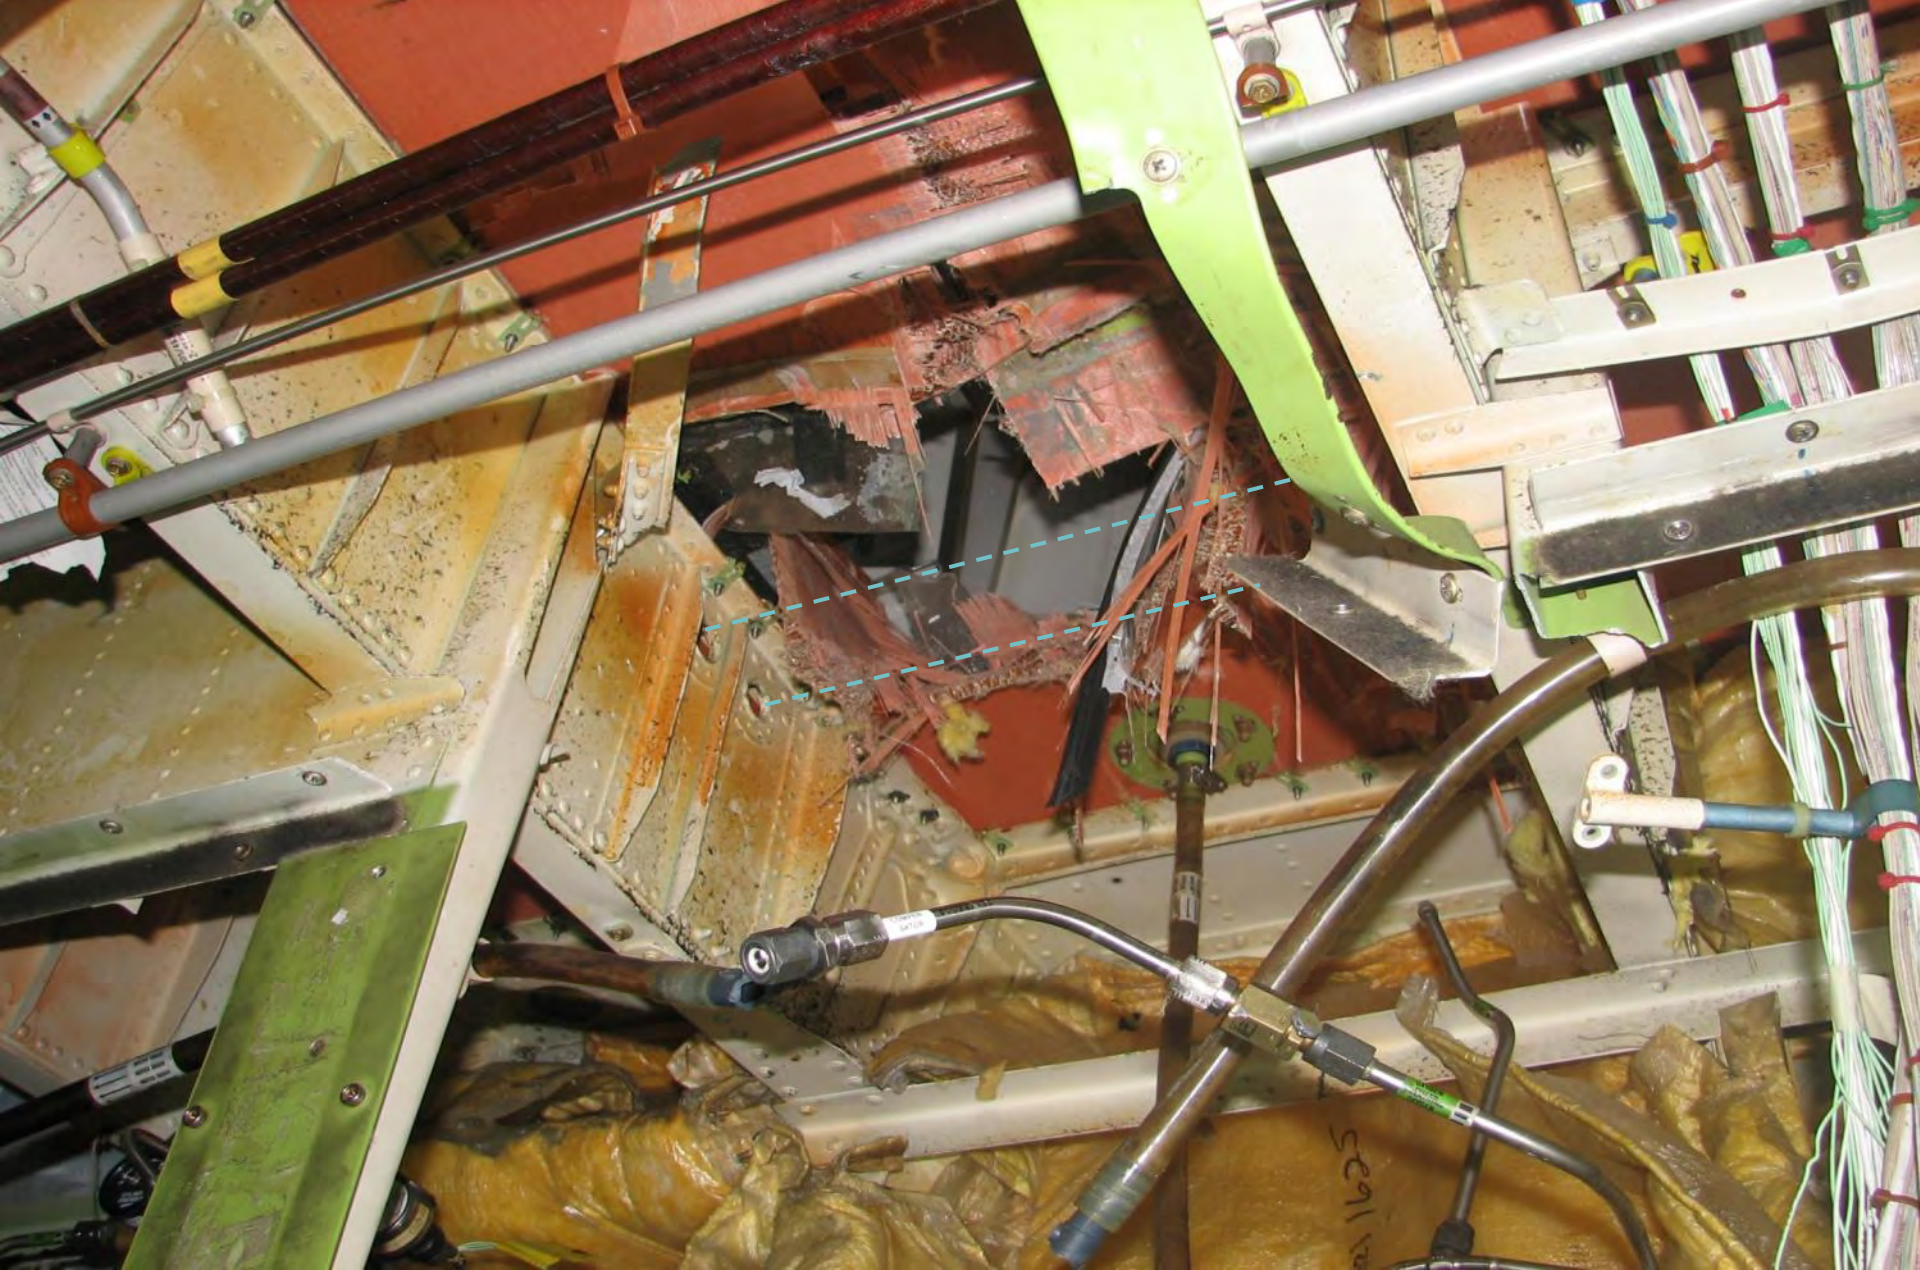
- Stripping of the body panels revealed the full extent of the rupture – 2 m wide x 1.5 m high, in an inverted T shape. Approximately 1.7m² total exposed area.
- Several fractured transverse frames and longitudinal stringers, but no evidence of associated cracking, corrosion, seam-line failure or other potential pre-existing defects.
- One missing passenger oxygen cylinder (number-four from the bank of seven) along right side of cargo hold – immediately above ruptured area. Oxygen line connections broken away in overstress from the valve fittings. Remnants of the cylinder valve recovered from within the cabin near the R2 door.
- No part or remnant of the number-four passenger oxygen cylinder recovered – presumed lost during depressurisation.
- Circular hole in cabin floor immediately above number-four cylinder location.
