In-flight fuselage rupture and depressurisation QF30, 25 July 2008

A presentation to the 2009 ANZSASI Regional Air Safety
Seminar

VH-OJK B747-438 Depressurisation 25 July 2008

AO-2008-053

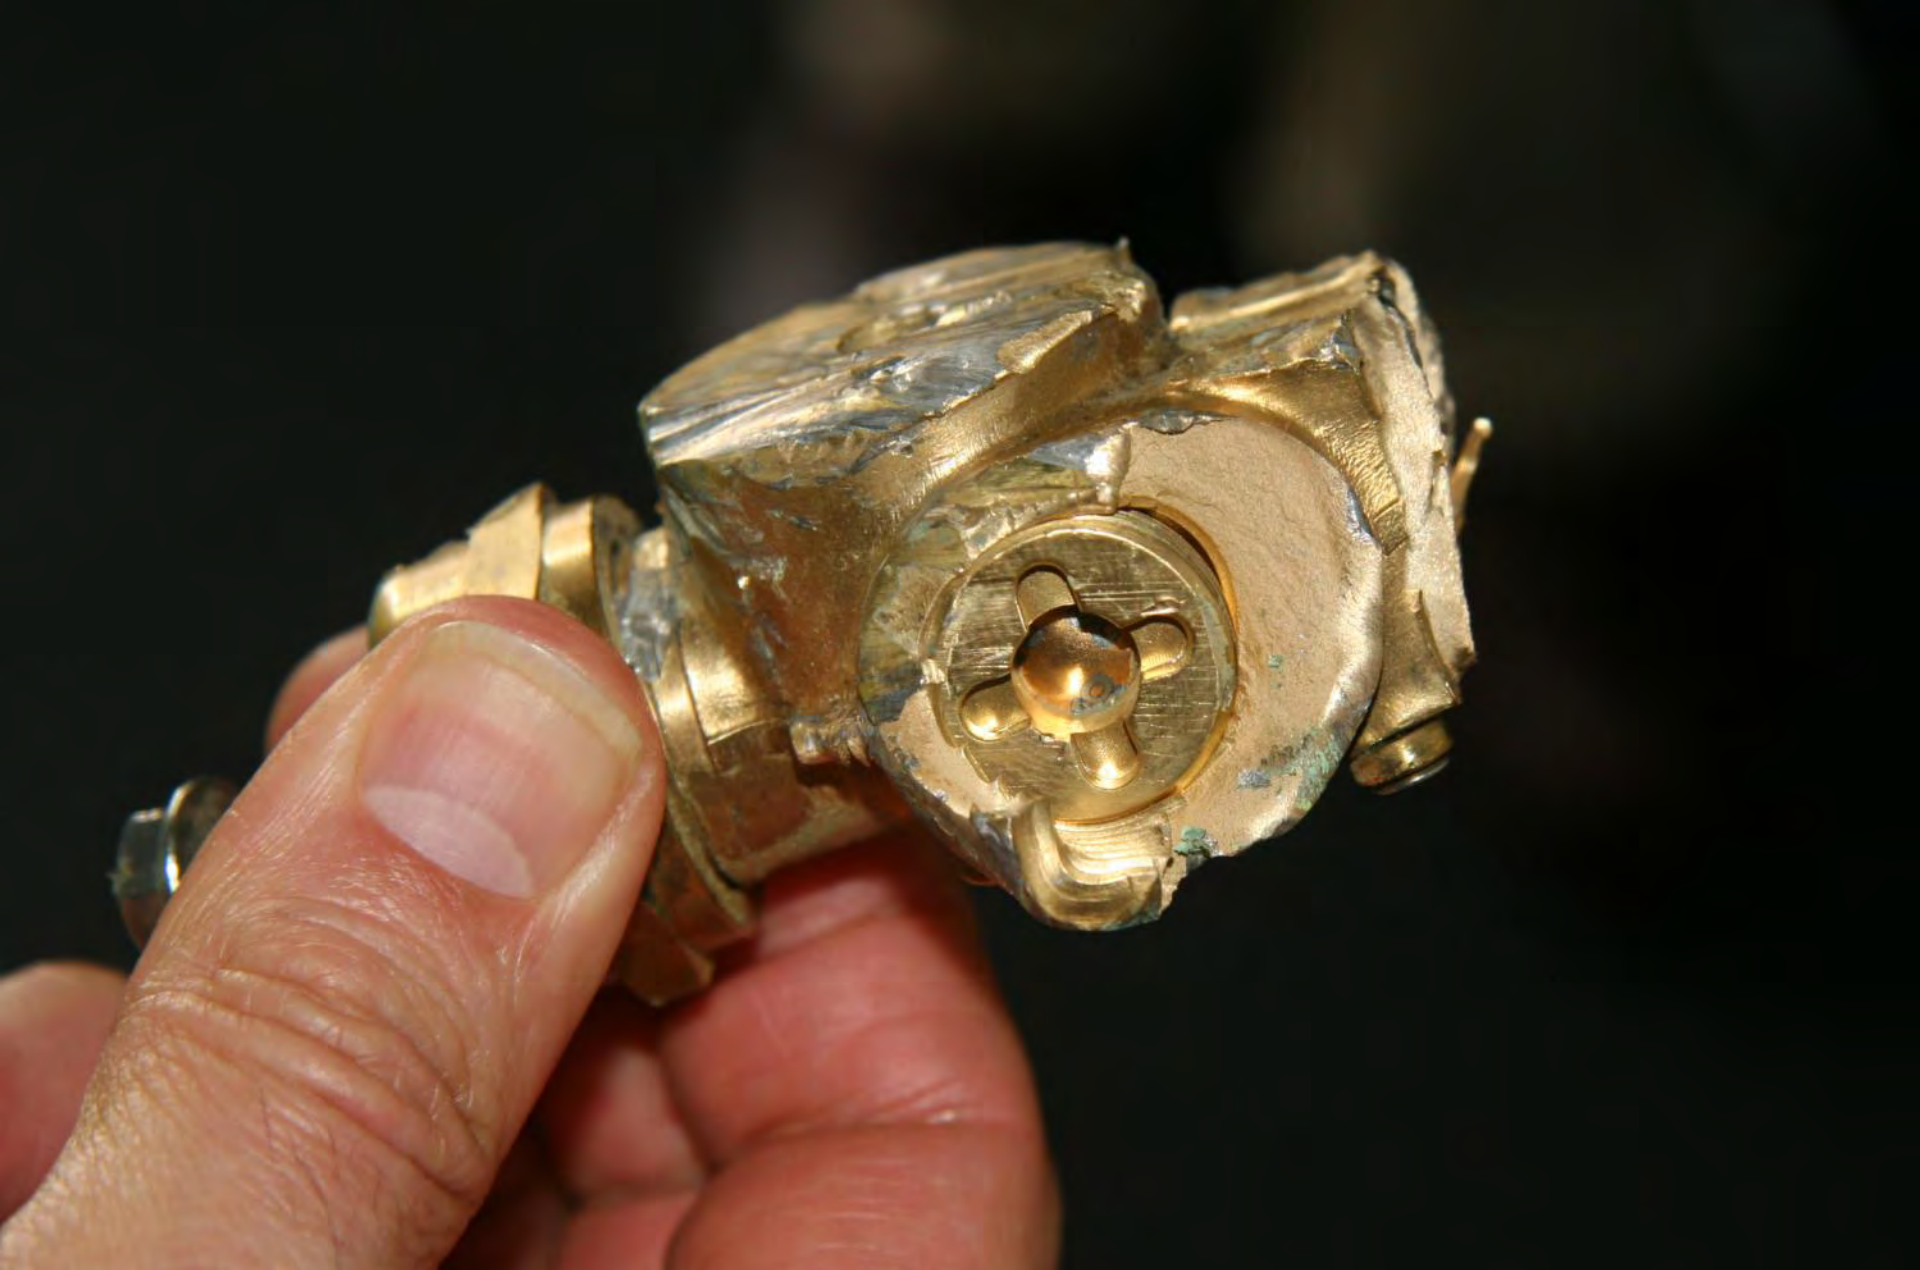
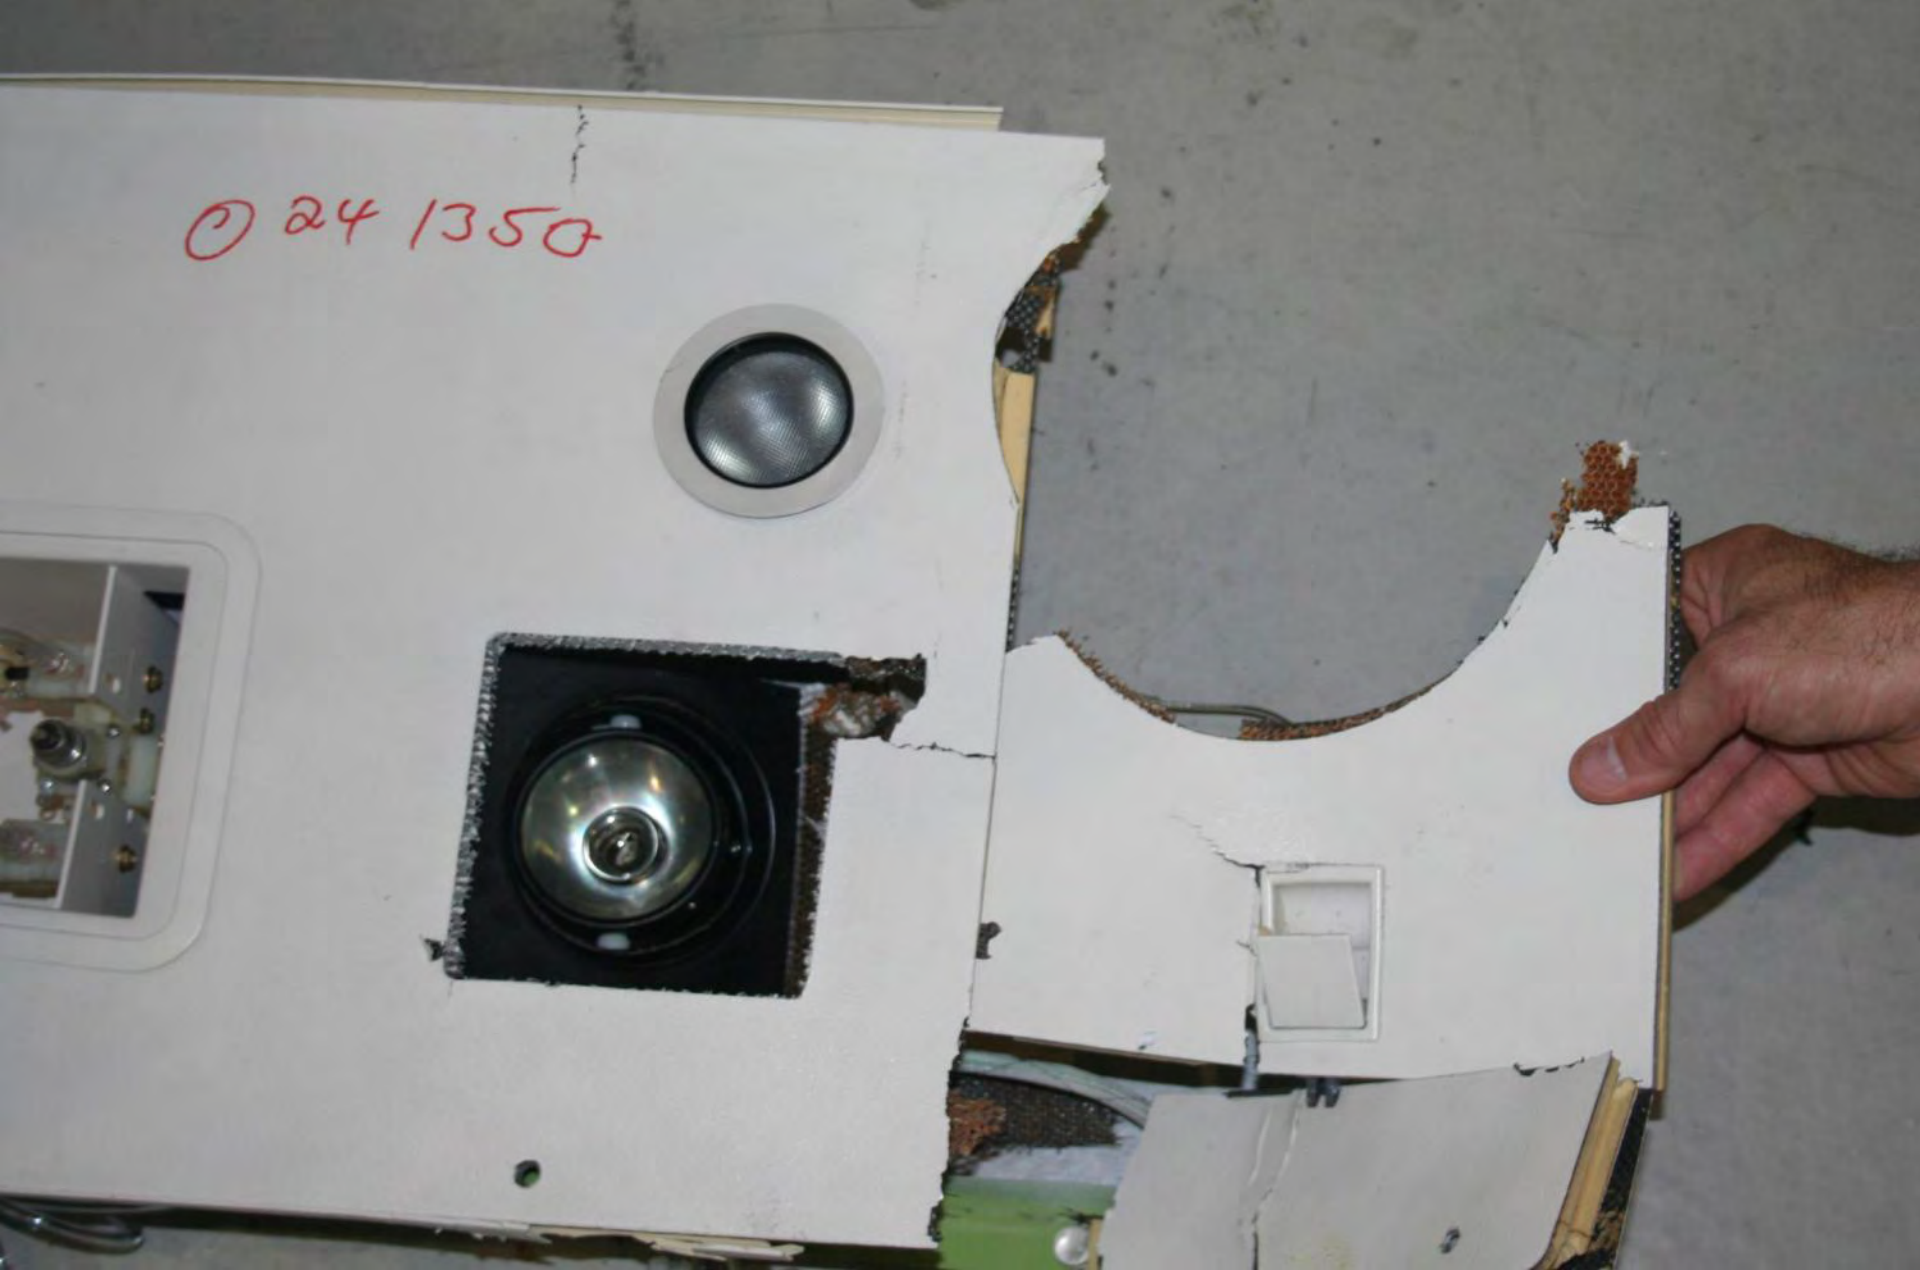
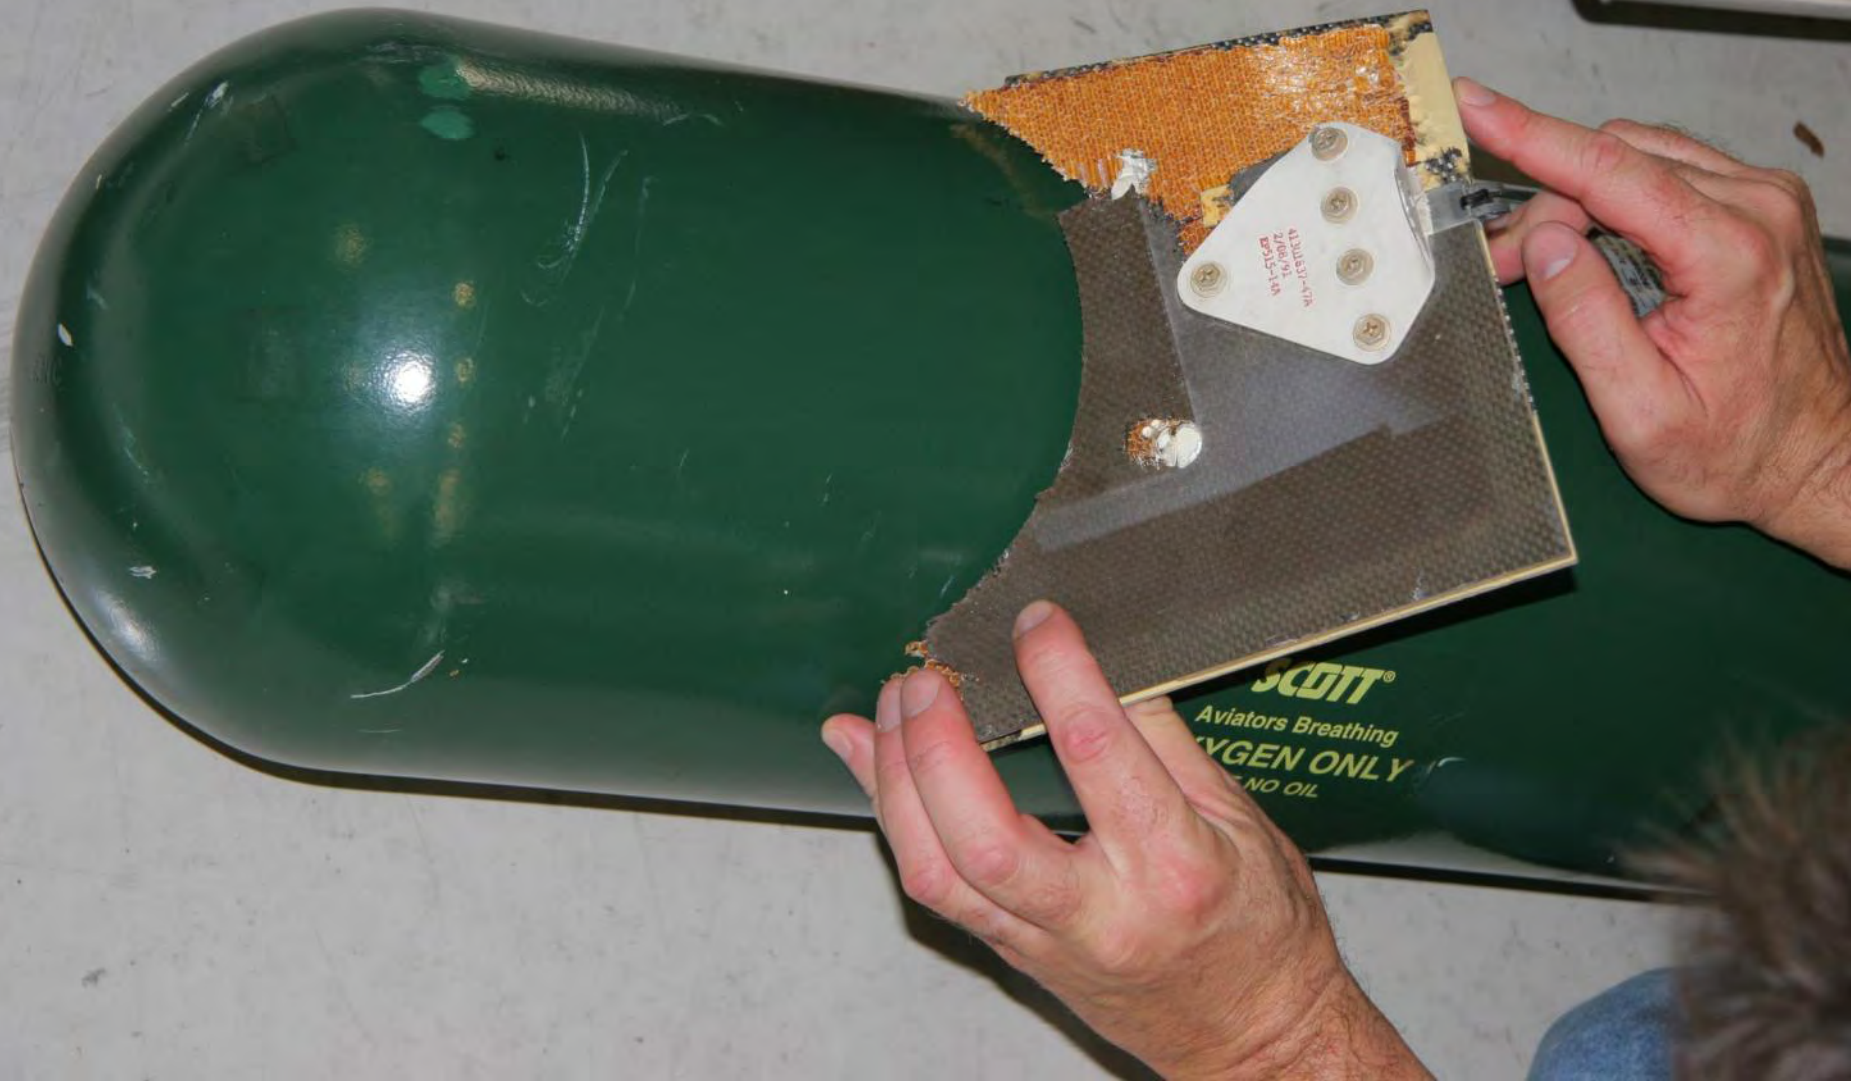
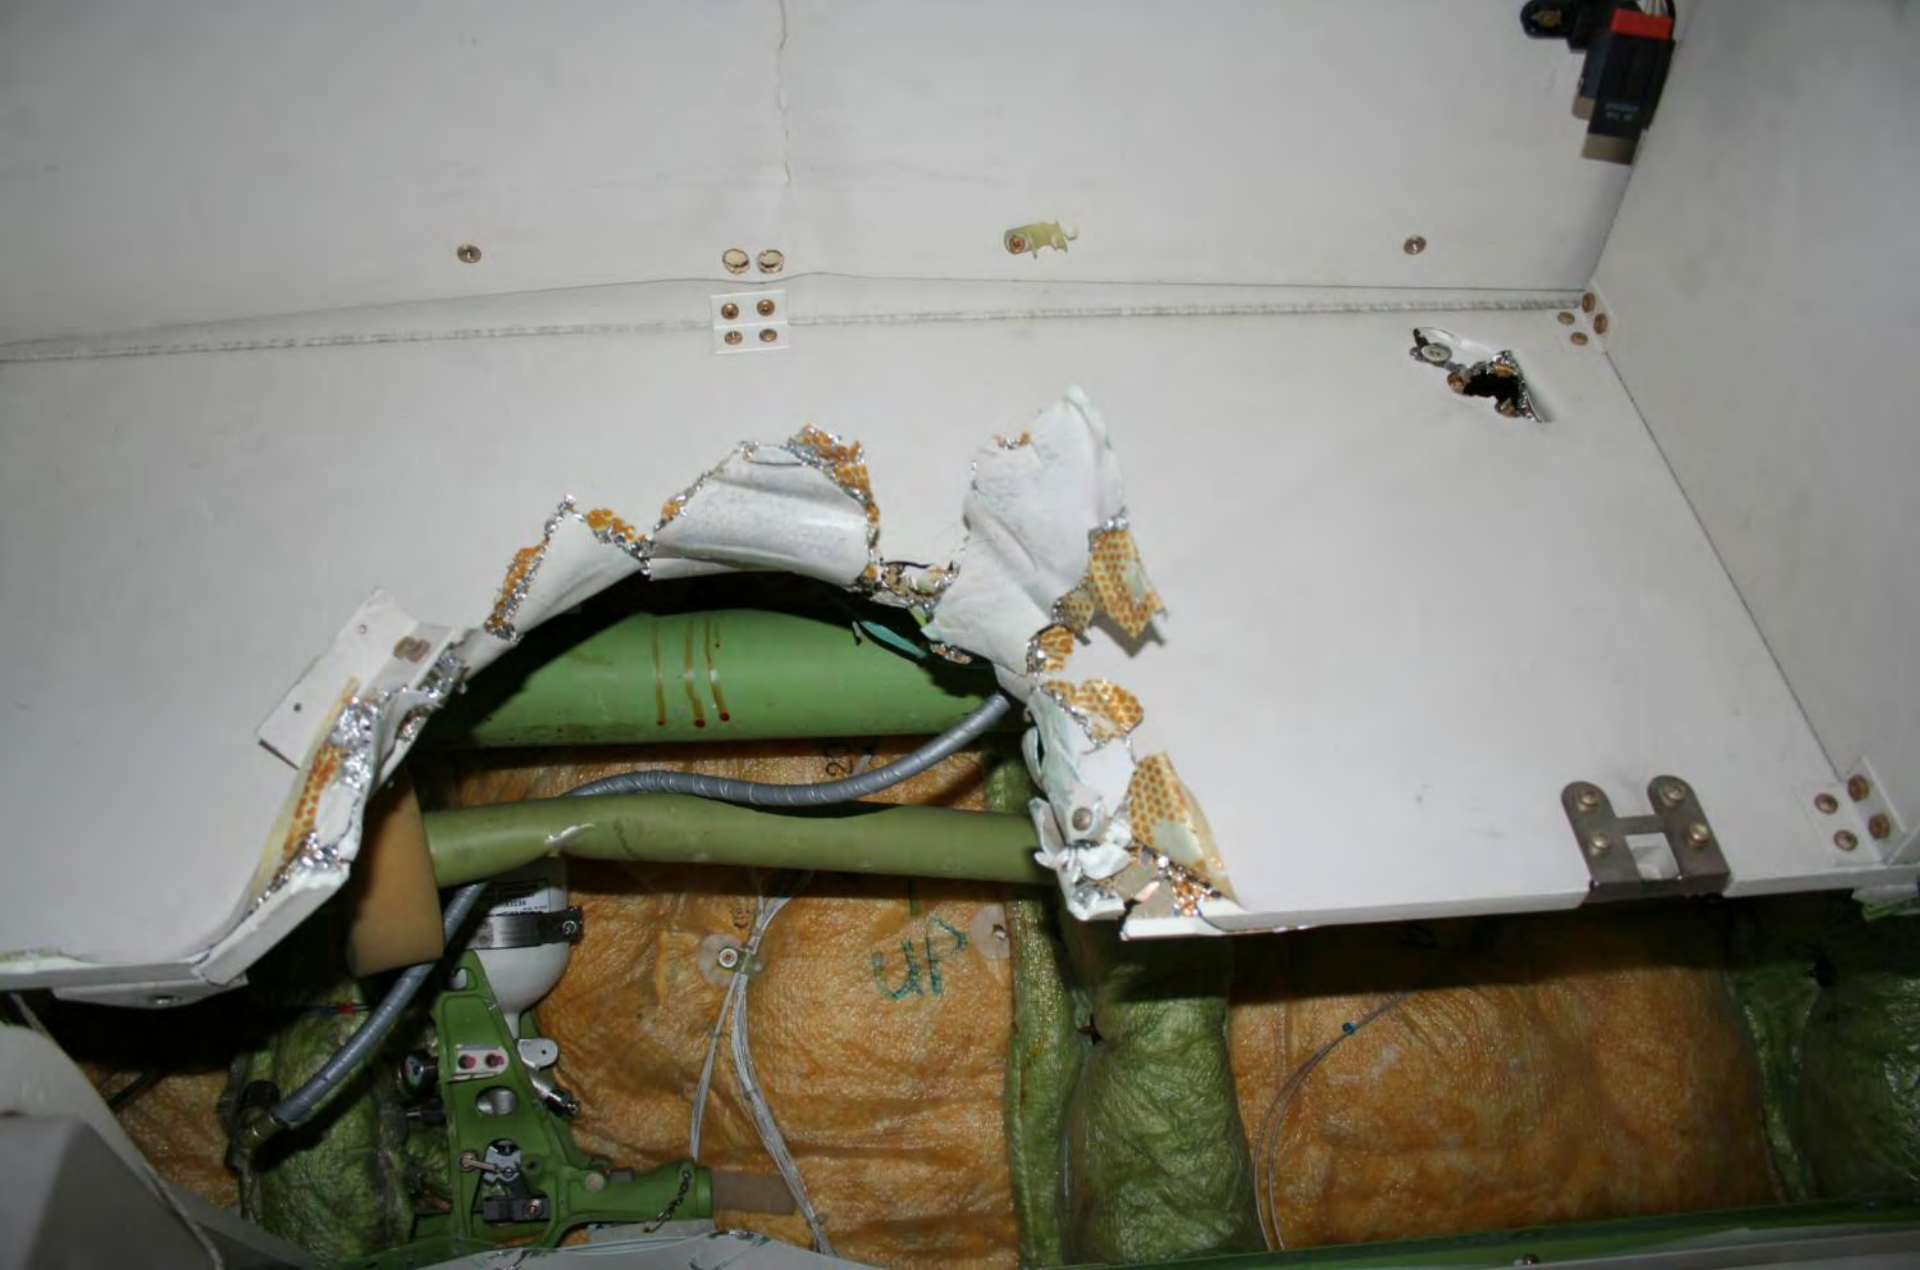
- Hole in cabin floor above missing cylinder.
- Unusual 'green paint' abrasion marks on cabin partition and door panelling.
- Cylinder valve body and handle fragments located within cabin.
- Valve body fragment recovered from within damaged area on door frame.
- Circular 'cut-out' within overhead panelling near R2 door – matches cylinder diameter.
- Semi-circular crushed area in compartment partition – diameter matches cylinder.

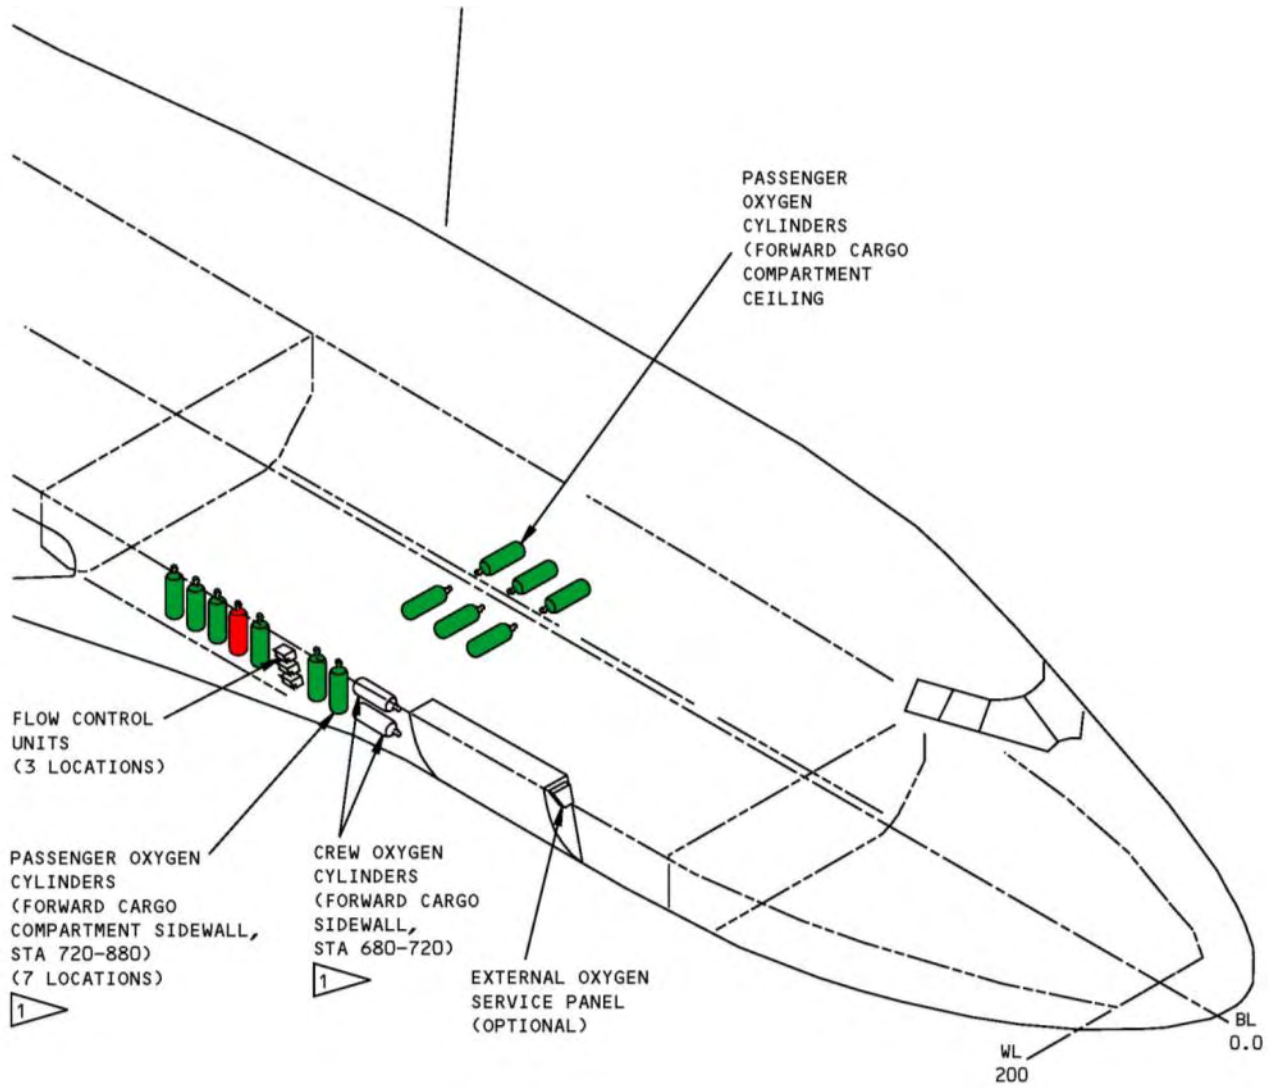
- Aircraft damage consistent with circumferential rupture of the number-four passenger oxygen cylinder; compromising the fuselage below and propelling the upper part of the cylinder through the cabin floor.
- Aviator's breathing oxygen cylinder – manufactured as a deep-drawn and forged item from a single blank of AISI4130 Cr-Mo alloy steel; heat-treated.
- Produced to the US DOT 3HT specification - nominal wall thickness is around 3.2 mm – no welded seams or end caps.
- Operating pressure 1,850 psi. Cylinders re-certified every 3 years by internal visual inspection and hydrostatic pressure testing to 3,080 psi.
- The failed / missing cylinder was manufactured in Feb 1996 and had been re-tested four times; the last being around two months before the failure.

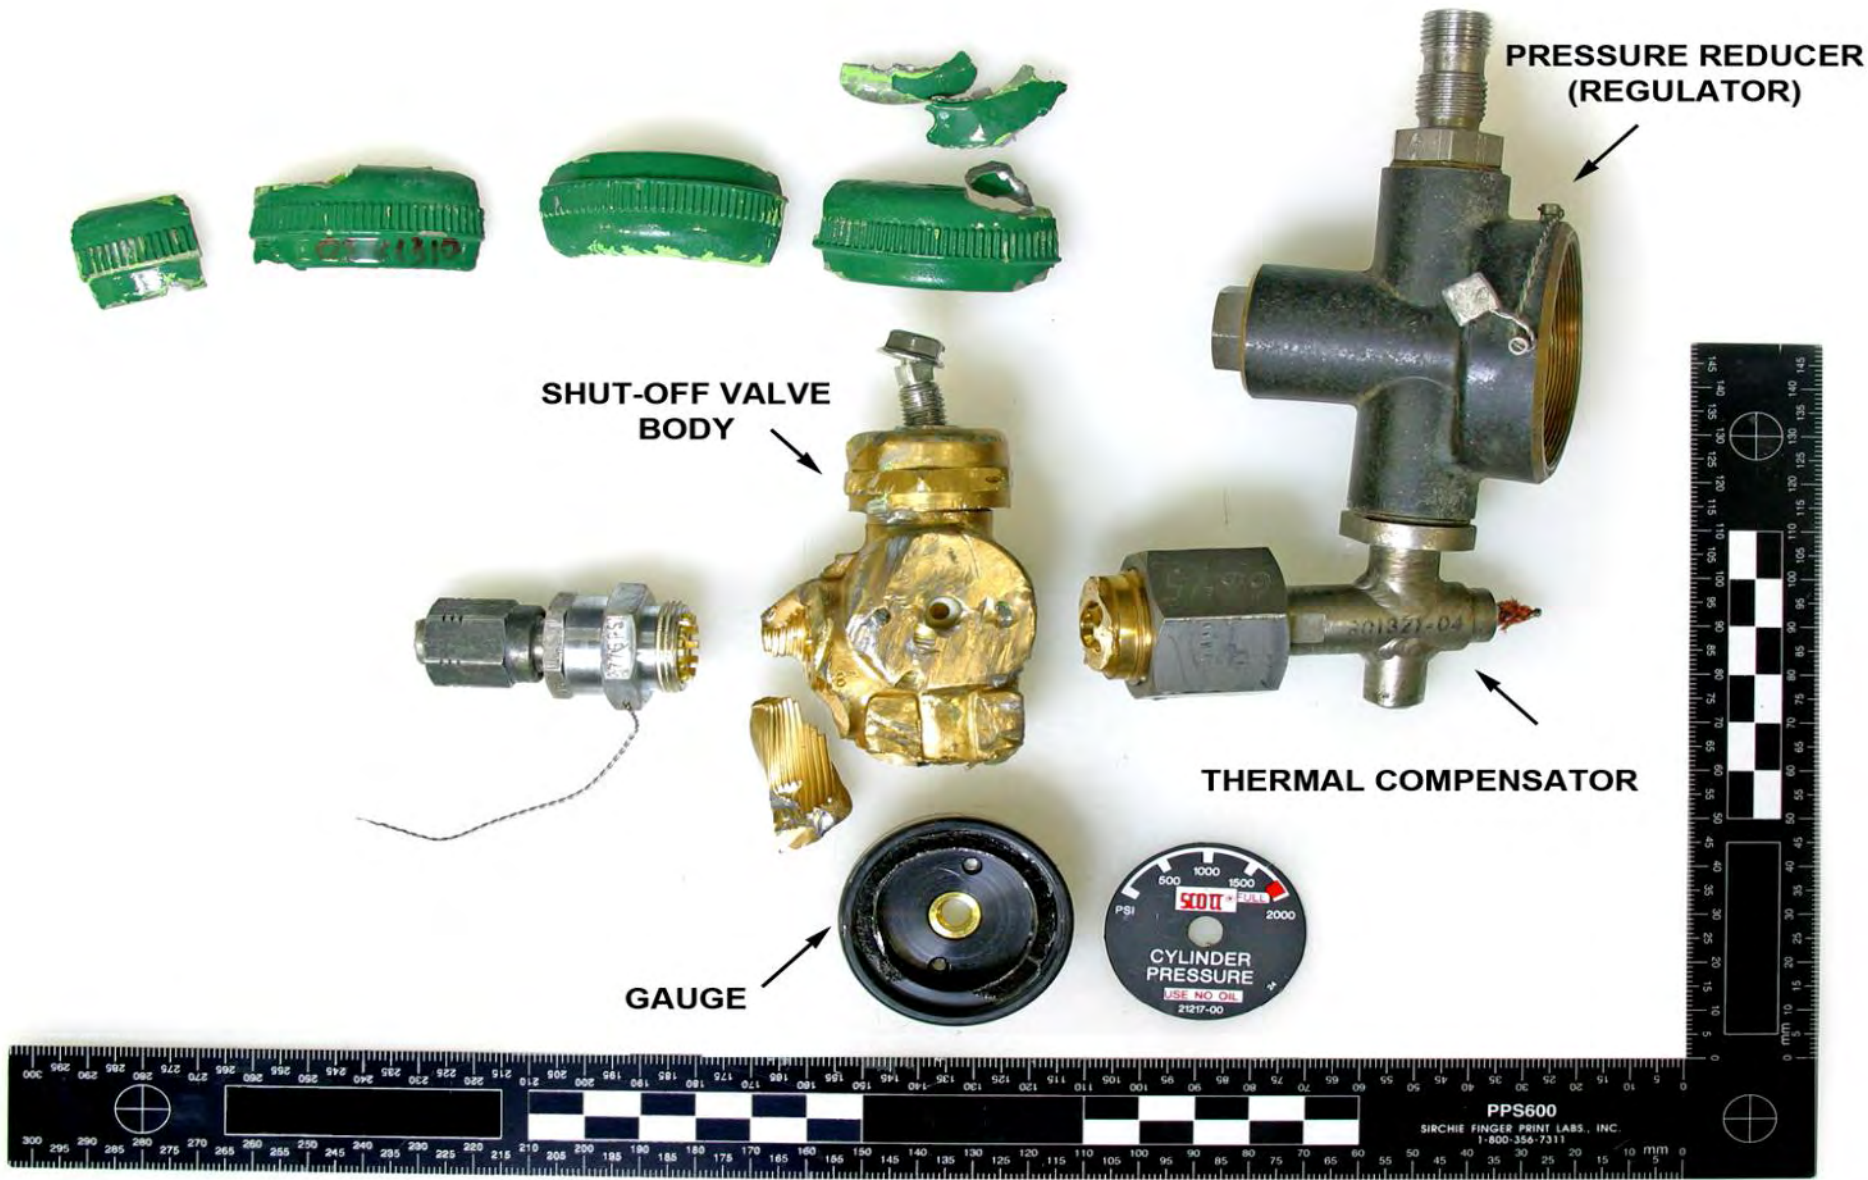
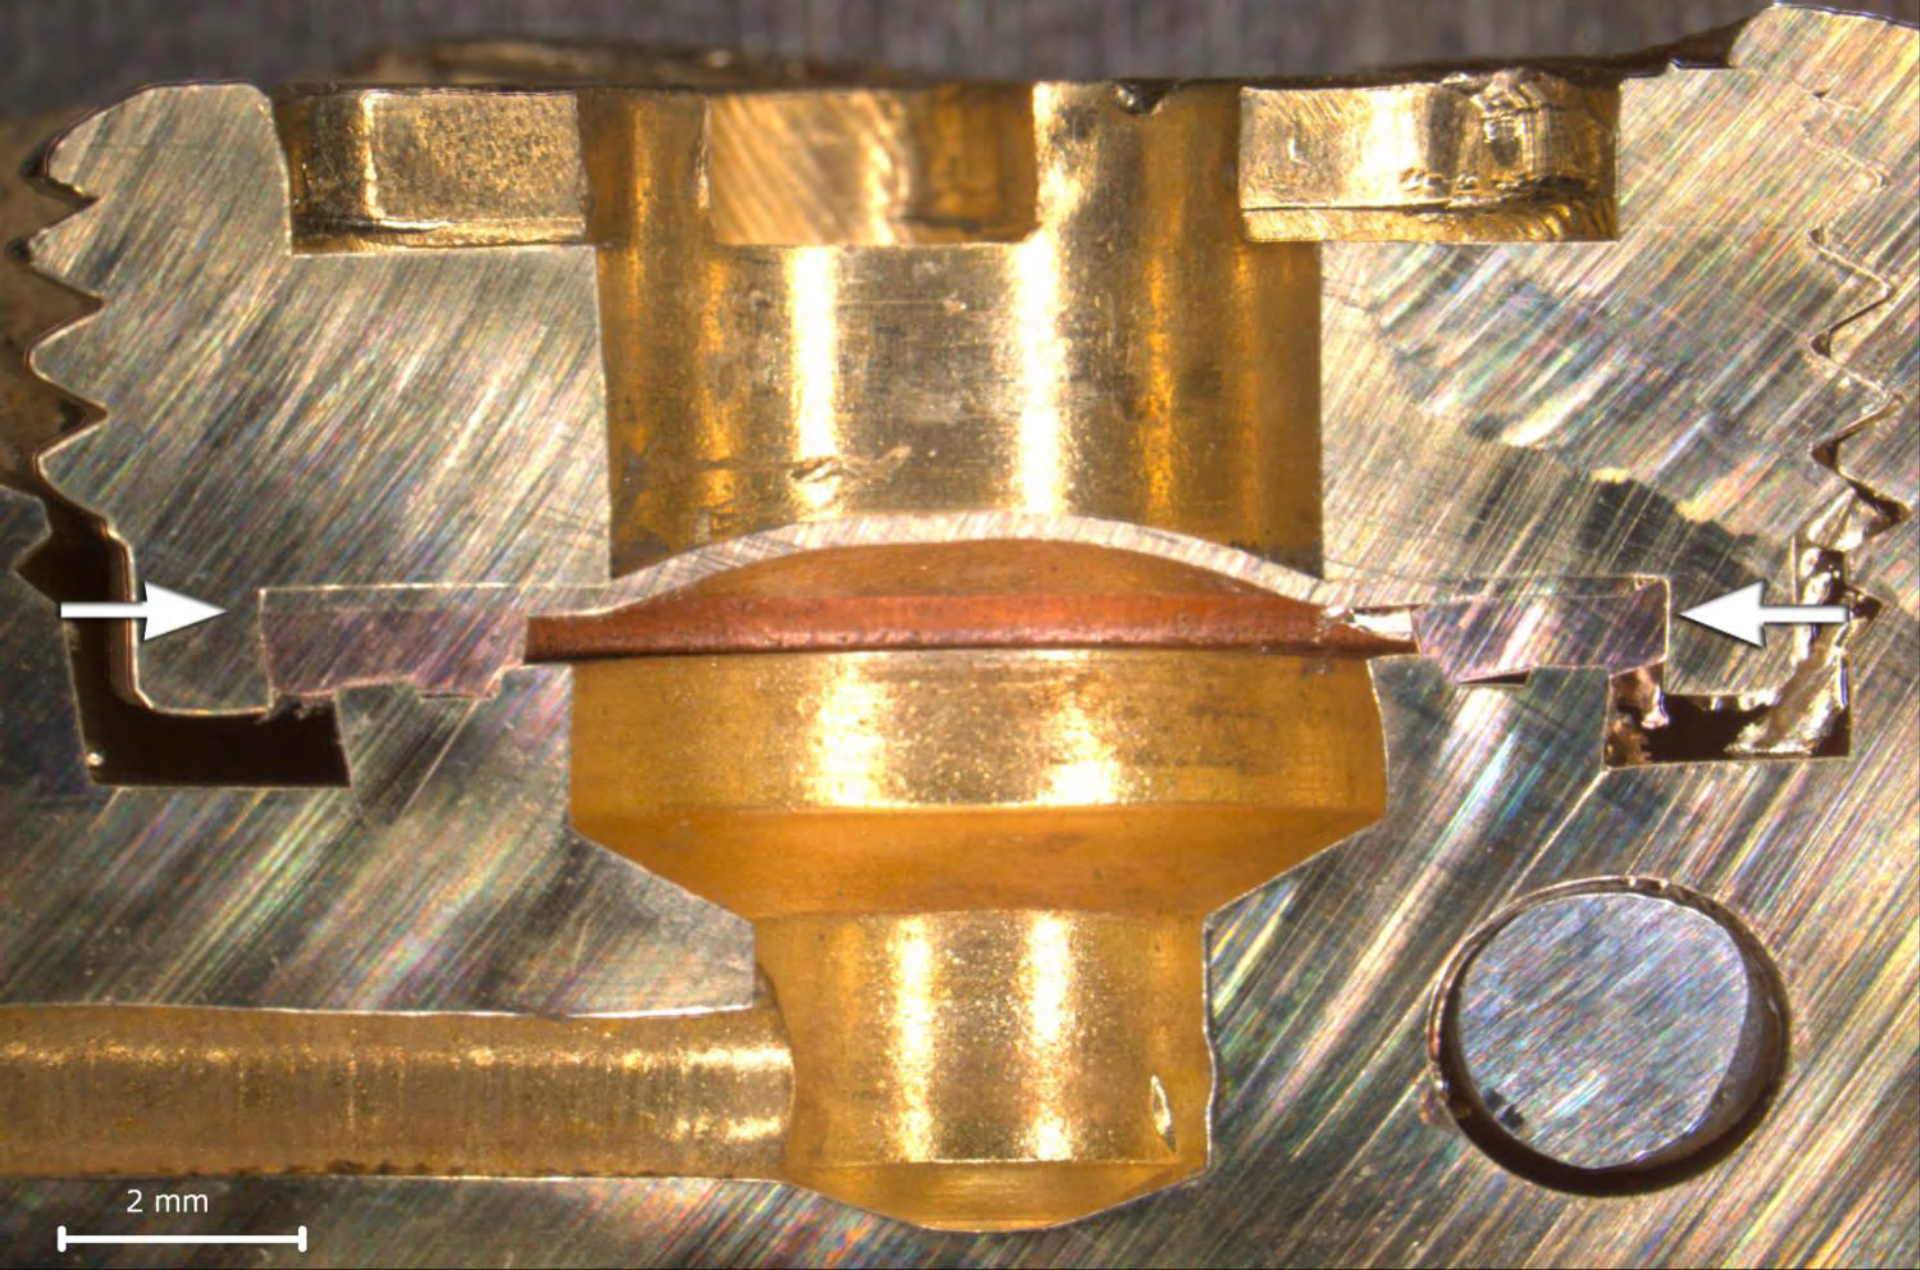
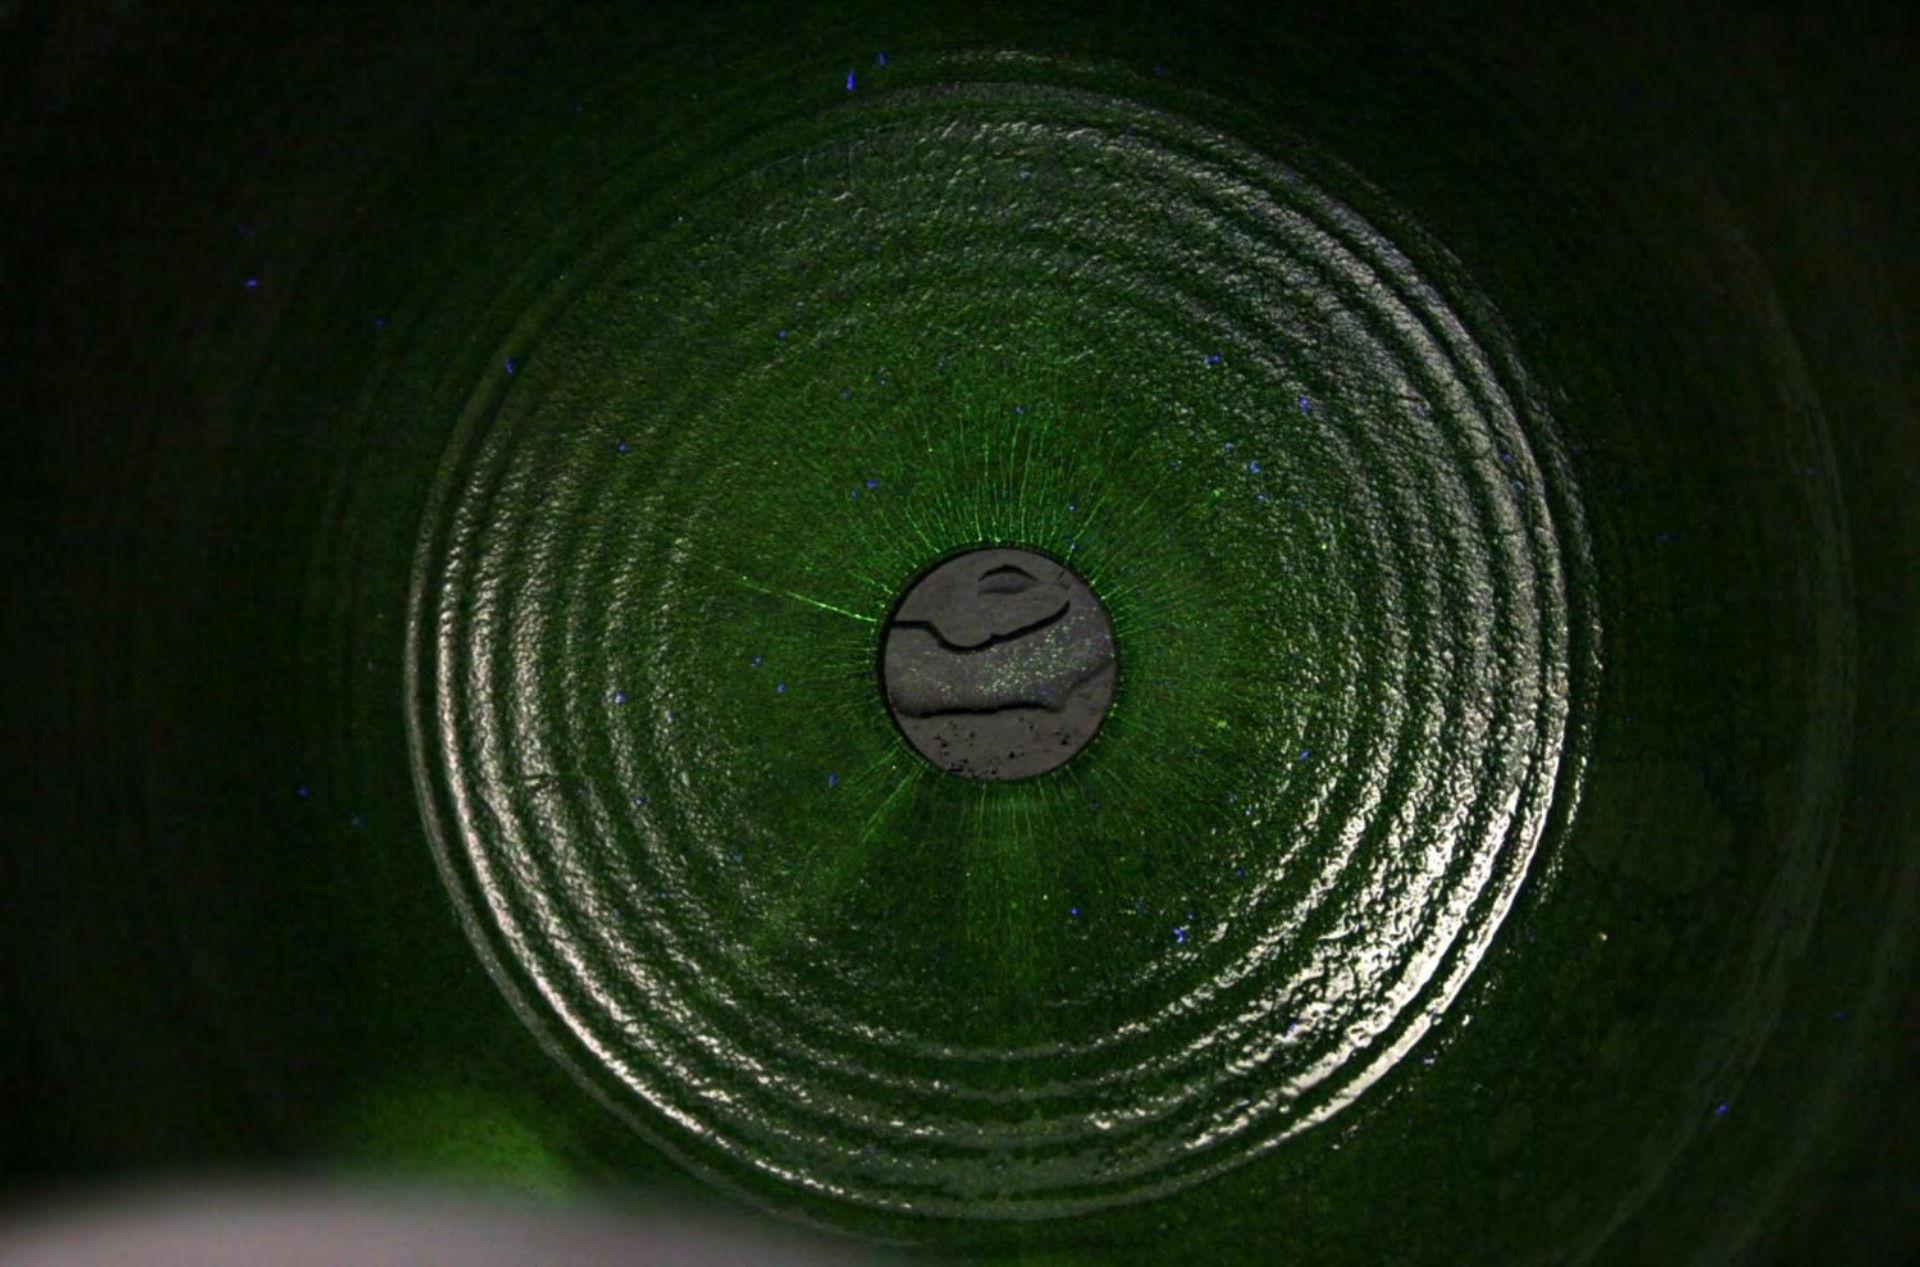
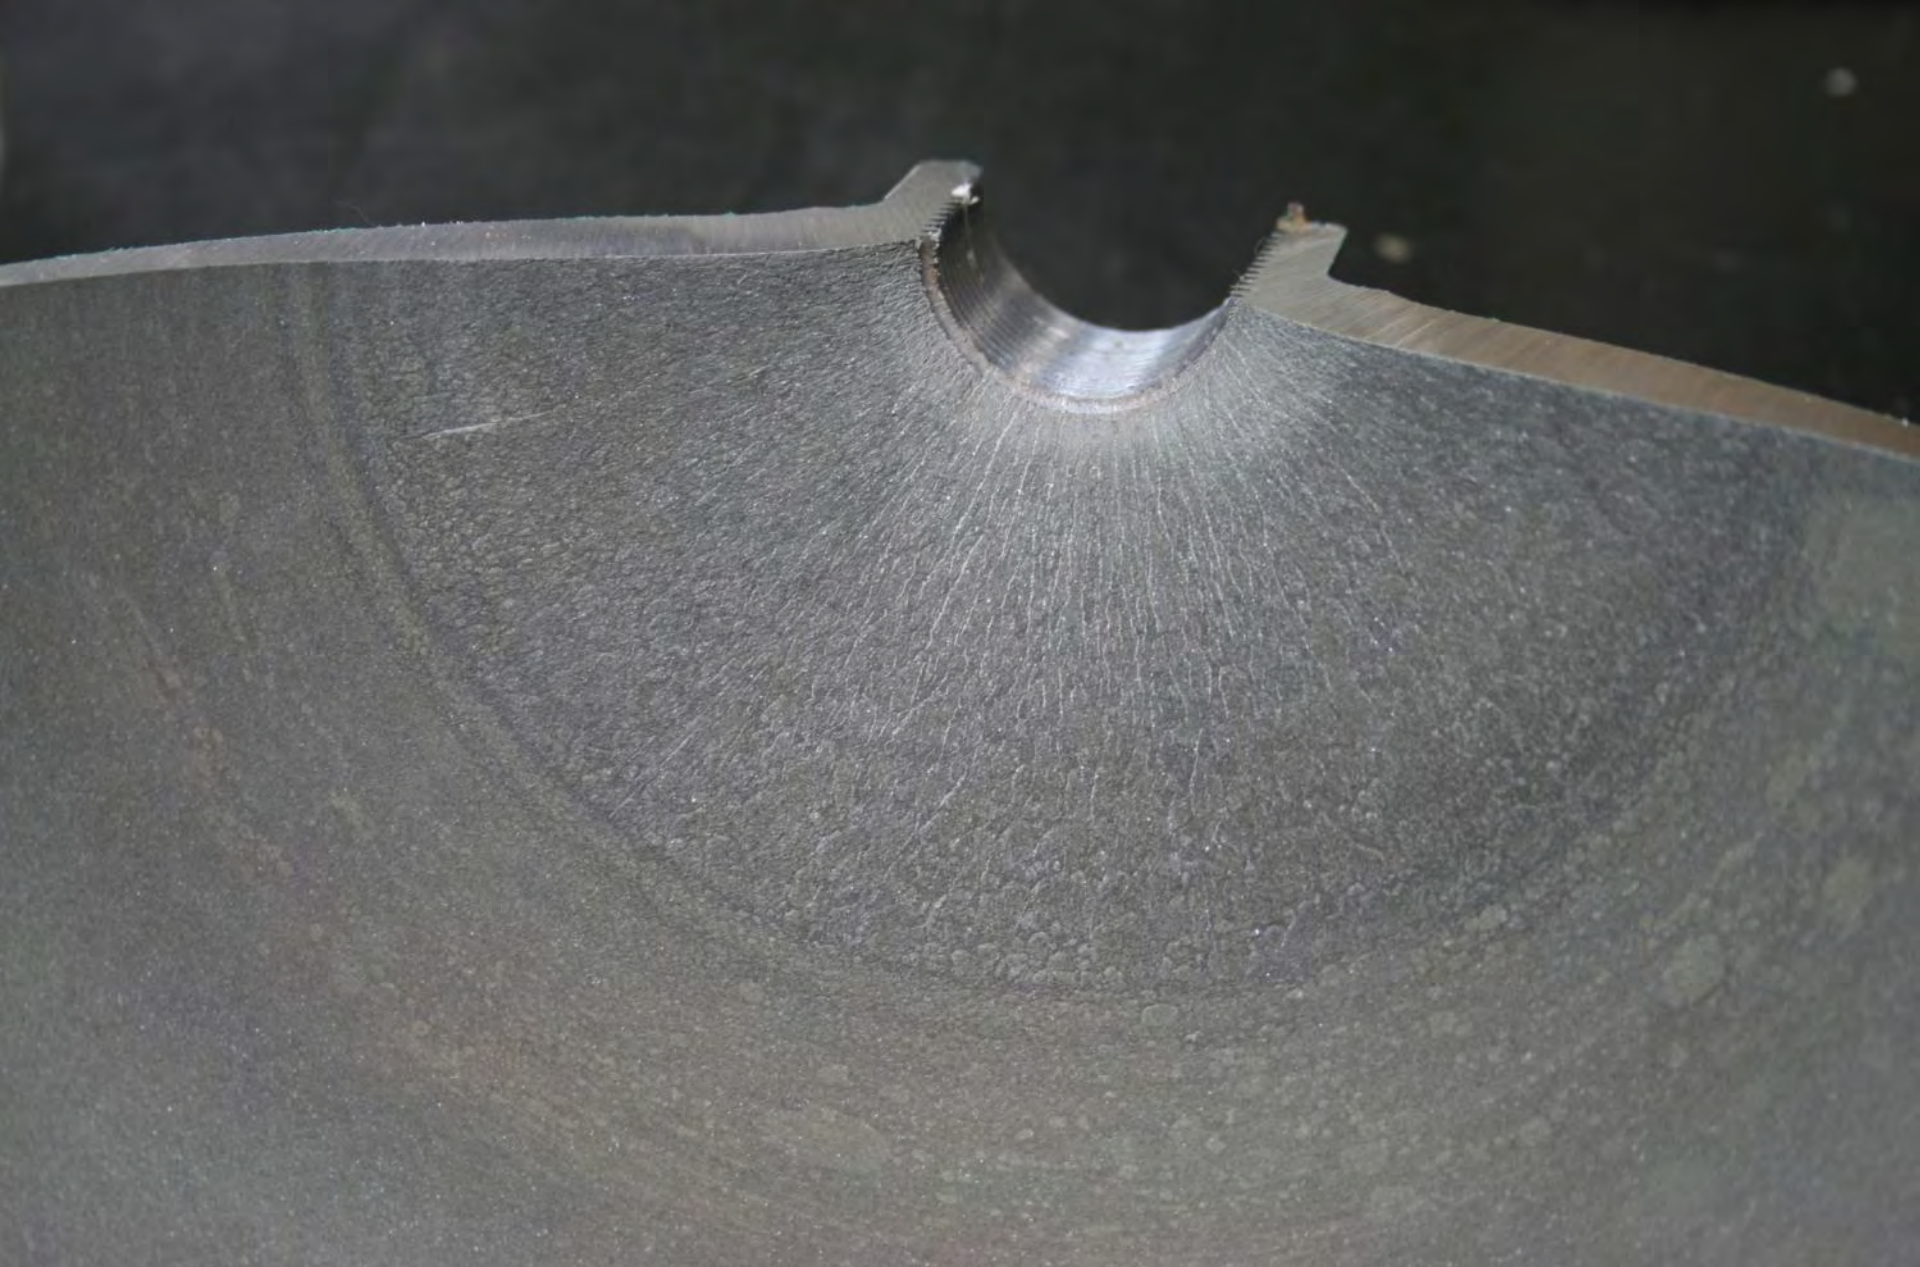
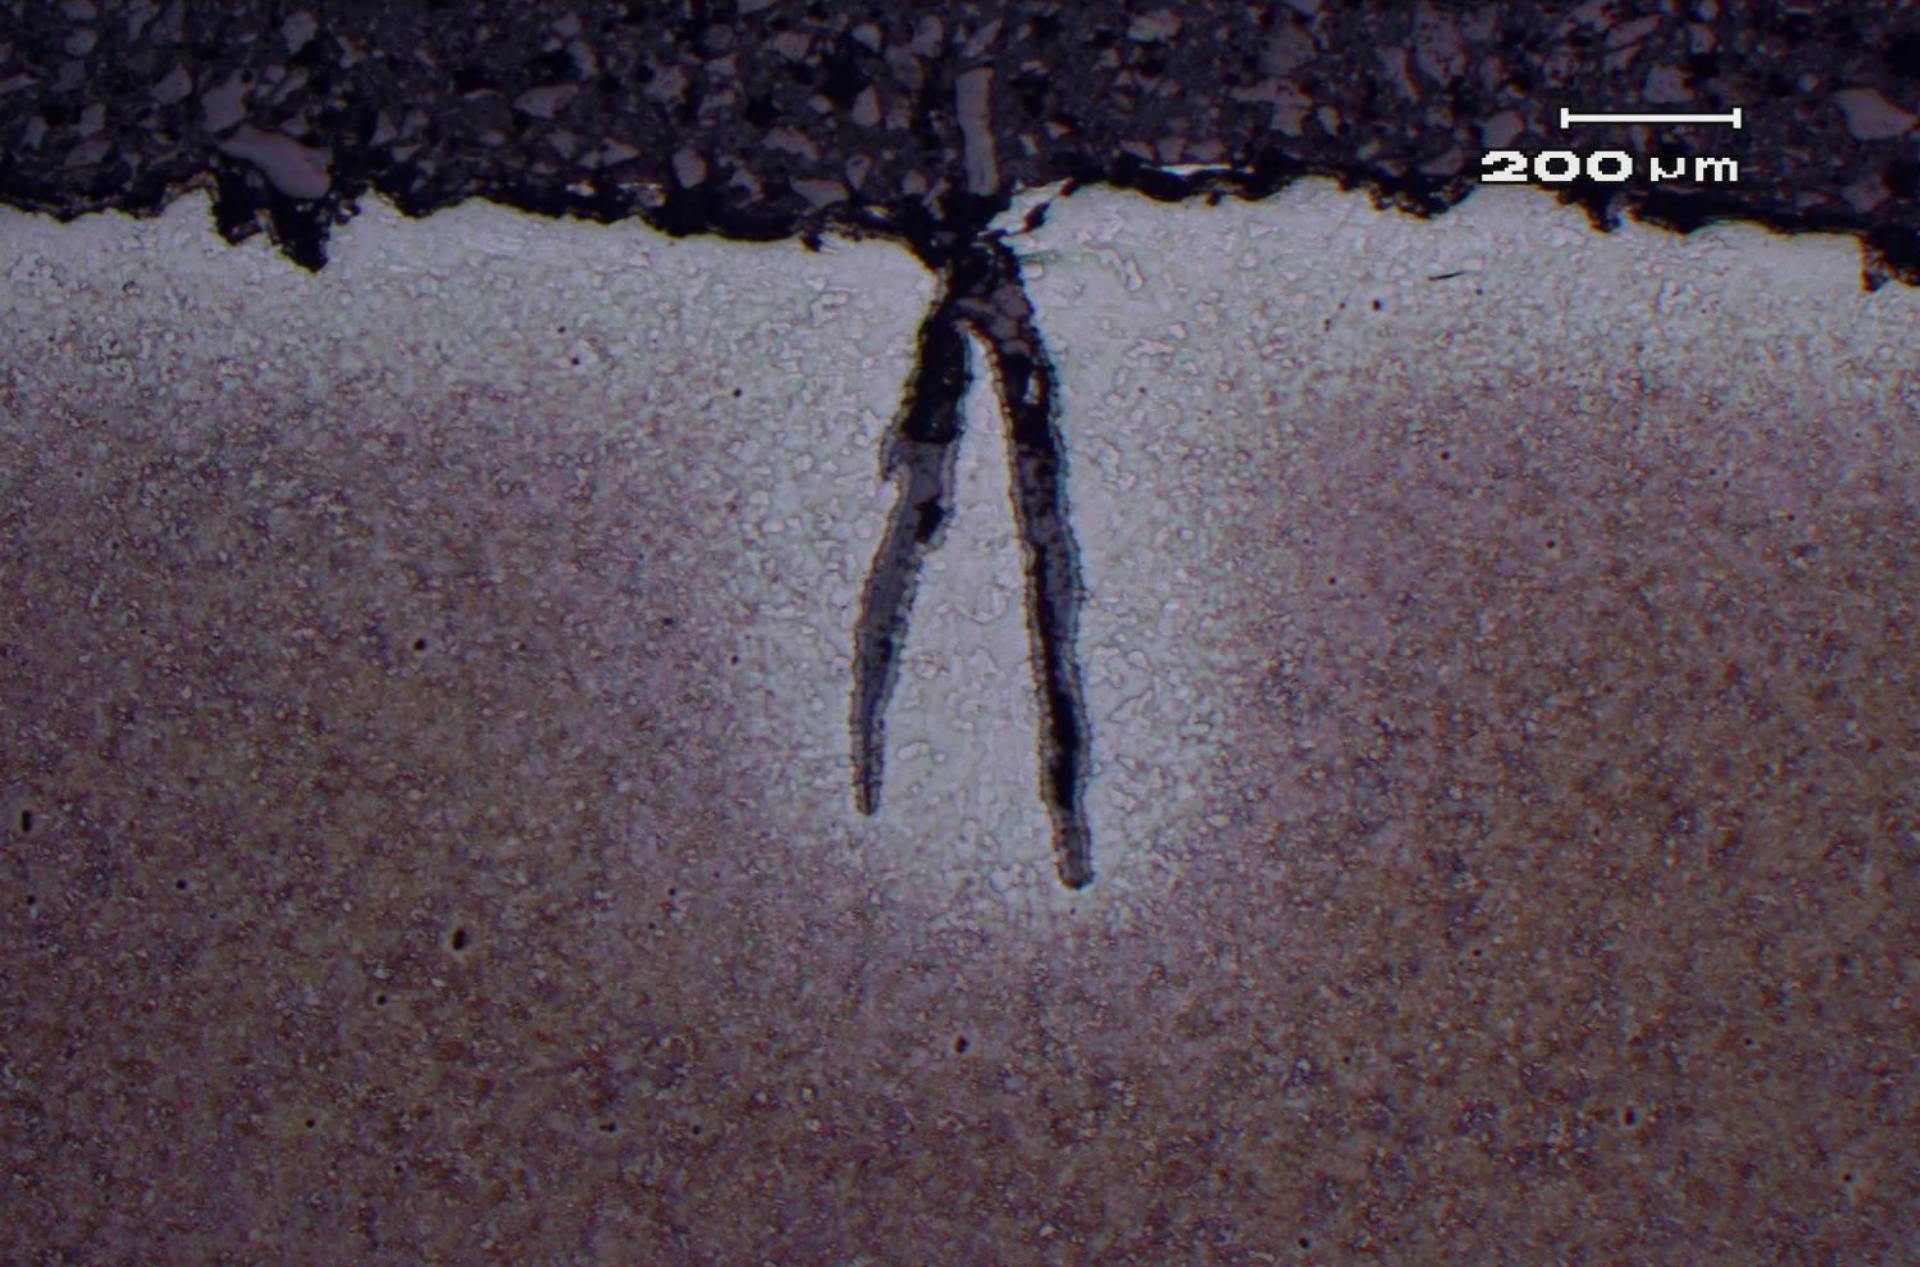
- The cylinder valve remnants were closely examined for any evidence of a combustion event – negative.
- The cylinder valve protective burst-disk was closely examined – found intact and typical of other similar disks in other cylinder valves.
- With assistance from Boeing, six other cylinders from the same production batch were located world-wide, and obtained by the ATSB for scrutiny.
- Those cylinders have been intensively examined, including repeating all of the original design certification tests, including material analyses, metallographic study, mechanical, non-destructive and pressure tests.
- No evidence of any deficiency in the cylinder design or manufacturing processes has been identified.
