In-flight fuselage rupture and depressurisation QF30, 25 July 2008

A presentation to the 2009 ANZSASI Regional Air Safety
Seminar

VH-OJK B747-438 Depressurisation 25 July 2008

AO-2008-053

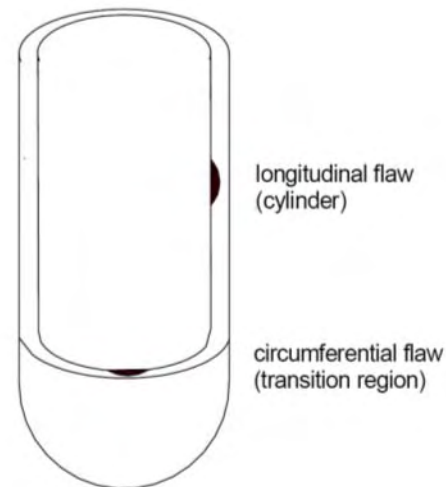
- A finite element model was created to ascertain the stresses developed within the cylinder under internal pressure.
- Linear Elastic Fracture Mechanics (LEFM) methods were used to numerically estimate the size of a cylinder shell defect that could cause unstable fracture at both the cylinder service pressure (1,850 psi) and re-test pressure (3,083 psi).
