# **ANZSASI 2003: THE OBVIOUS CAUSE!!**

## **Case Study: Report 01-011 - History of the flight.**

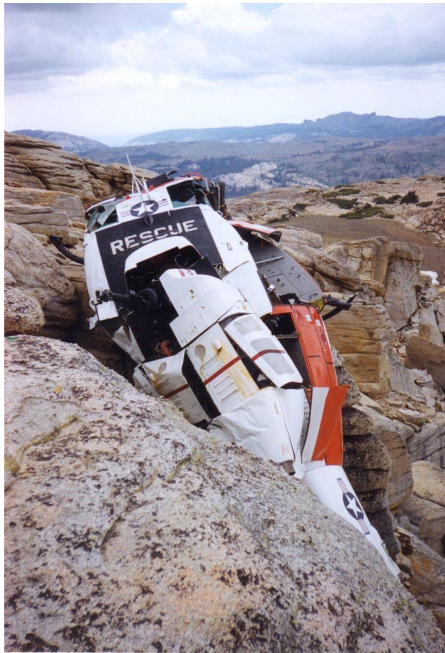
Photo 1: Would they have been unlucky to have been killed in this low speed accident?

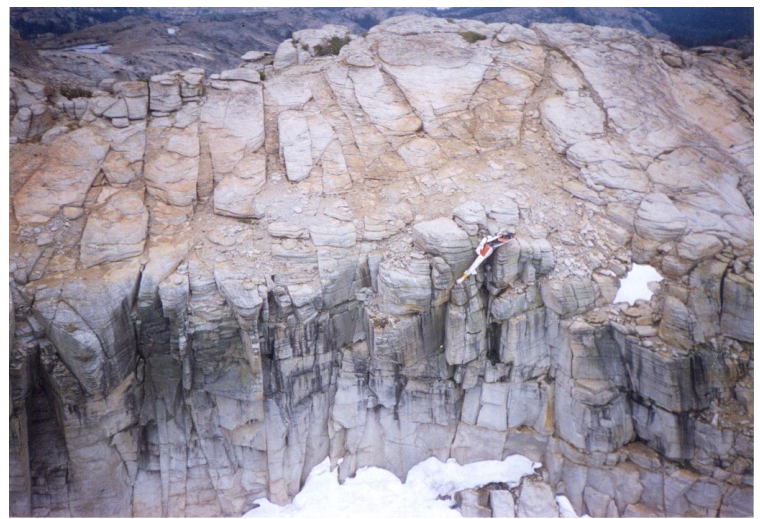
Photo 2: Or were they lucky to have survived?

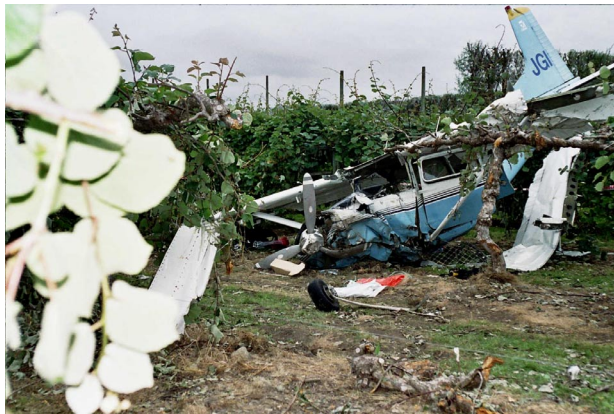
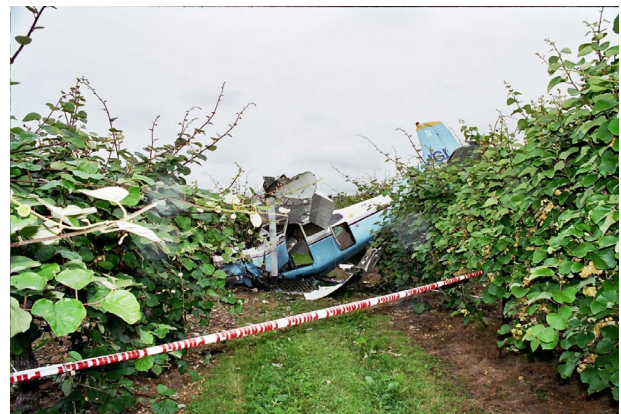
The 3 parachutists on the right side were ejected through the parachuting exit door – ending up on the ground next to the aircraft. The others remained in the aircraft. The pilot's seat broke free from the floor mountings and the pilot's face impacted the instrument console. The tandem master seated behind the pilot was able to assist his rider clear of the aircraft before giving initial first aid to the pilot and checking the other 3 parachutists. Assistance arrived within 5 minutes and the most serious were evacuated to hospital by helicopter. All survived.

The pilot and a parachutist were critically injured, 3 seriously and one with minor injuries. Due to the severity of the injuries sustained by the pilot, he was unable to be interviewed until some 3 weeks after the accident. The other occupants reported the pilot's hands moving around the cockpit and warning them to prepare for a crash landing.

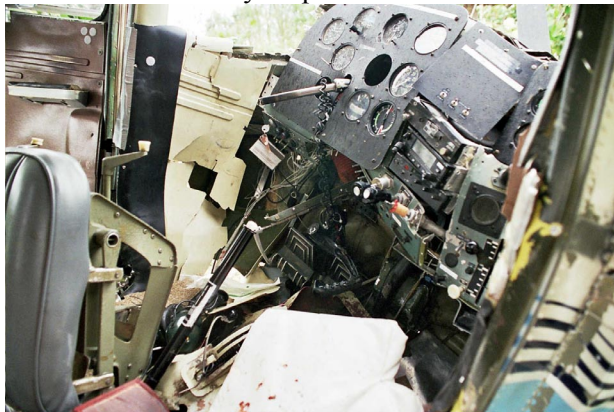
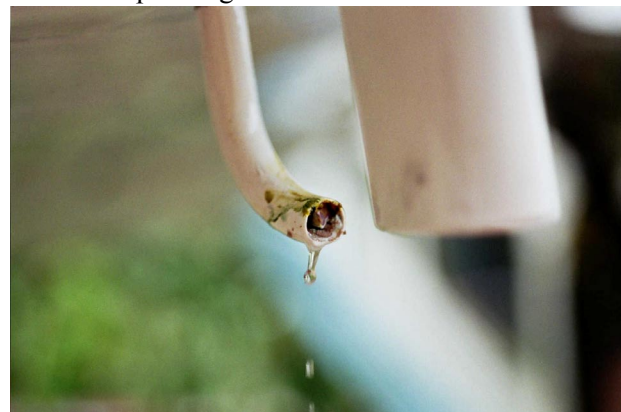
The aircraft was destroyed. The damage to the propeller was indicative of slow or no rotation at the time the aircraft struck the ground. Fuel was seeping from the right fuel vent, which was nearly fully blocked by a red substance. **(First obvious possible cause; fuel blockage?)** The flaps and flap lever were in about the full flap position. The power controls were in the fully forward position. The fuel shut-off valve was in the fully on position and the fuel tank selector was pointing towards the rear.

The fuel system was examined and a good fuel flow to the collector tank was possible. **(Delete fuel blockage as a cause.)**

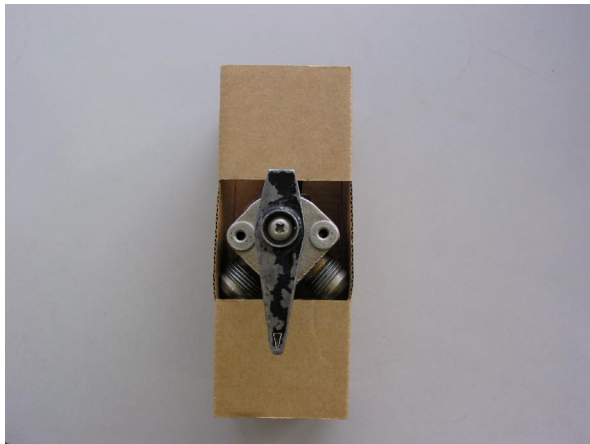
The selector cover or plastic moulding that surrounds the fuel selector cover was not present. A modified Perspex cover had recently been installed to prevent inadvertent interference with the lever during parachuting operations. With the selector cover absent it was possible to rotate the selector to the rear and shut-off the fuel. **(Second possible obvious cause; selecting the fuel Off?)** But did the pilot, or someone else, deliberately select fuel to Off before or after the power loss?

Position of the selector as found on ZK-JGI.

The pilot was eventually able to confirm that while preflighting the aircraft he had observed the fuel selector to be on the right tank – possibly related to the blockage in the right tank vent. He then rotated the selector 90° clockwise with the intention of selecting Both. This in fact shut off the fuel flow and left sufficient fuel in the collector tank to get the aircraft airborne, but little more. **(Delete broken fuel line as a cause.)**

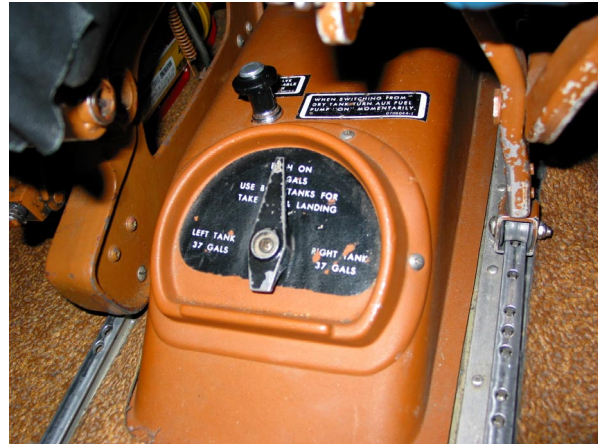
Cessna 185 fuel selector with the cover and labels.

The selector cover had been absent since the importation of the aircraft from Vietnam in 1995. The initial certification of the aircraft, including a type conformity check, failed to record the absence of the cover and the change in function of the fuel selector from a 3-position lever to a 4-position lever that included

an Off position. The use of sticky labels to identify the tank selection was inadequate as they did not last long.

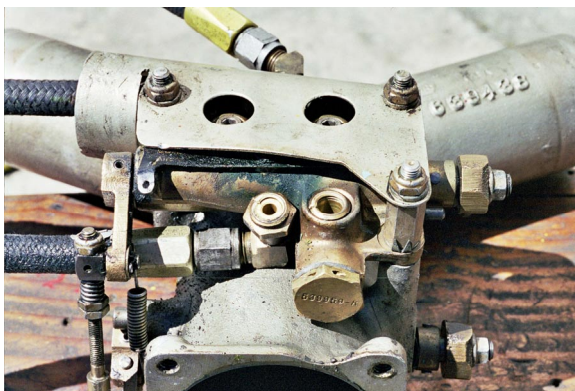
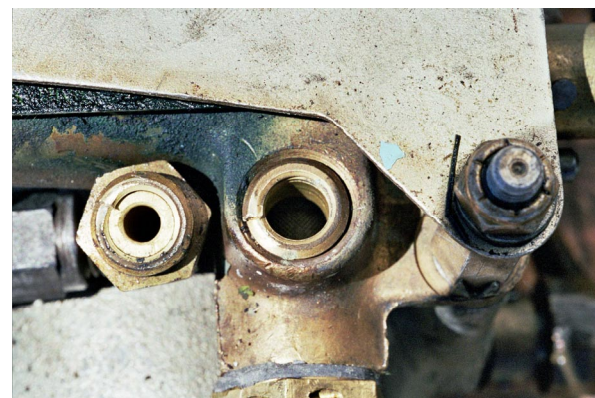
The engine was removed for inspection. No evidence found of obvious mechanical failure or blockages that could have caused the total power loss. However, during the inspection the fuel control unit displayed significant fuel staining and a broken fuel line leading from the engine driven pump to the fuel control unit. The break was at an elbow joint and about ½ of the diameter displayed indications of fatigue. **(Third possible obvious cause; broken fuel line?)**

Further examination determined that a sufficient fuel flow was still possible while the line was attached though a small seepage would have been evident. But did the separation of the line occur before or after the impact?
