# Tiger Moth in-flight break-up investigation

**Presented by Eric Blankenstein**  
Senior Transport Safety Investigator  
Australian Transport Safety Bureau

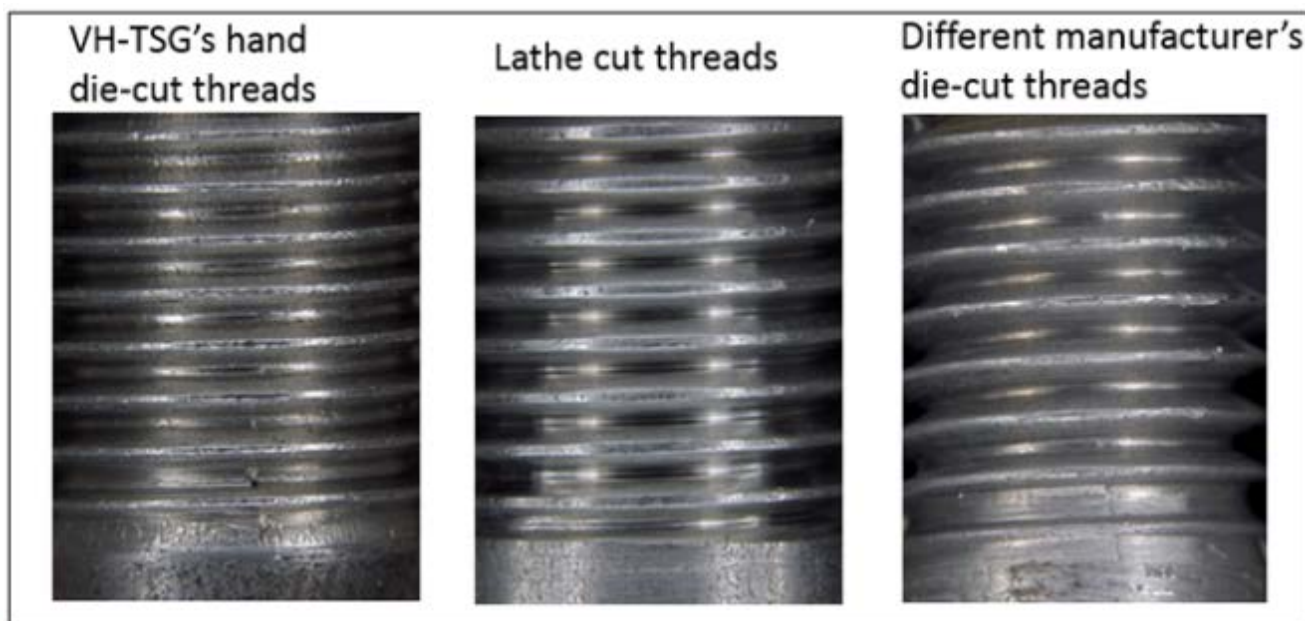
# Surface finish

- VH-TSG's tie rods had a rough surface finish when compared to other tie rods from the same manufacturer and others.
- Rough finish appeared to be due to the method utilised to form the thread (hand die cut). As opposed to lathe cut and Coventry die cut.

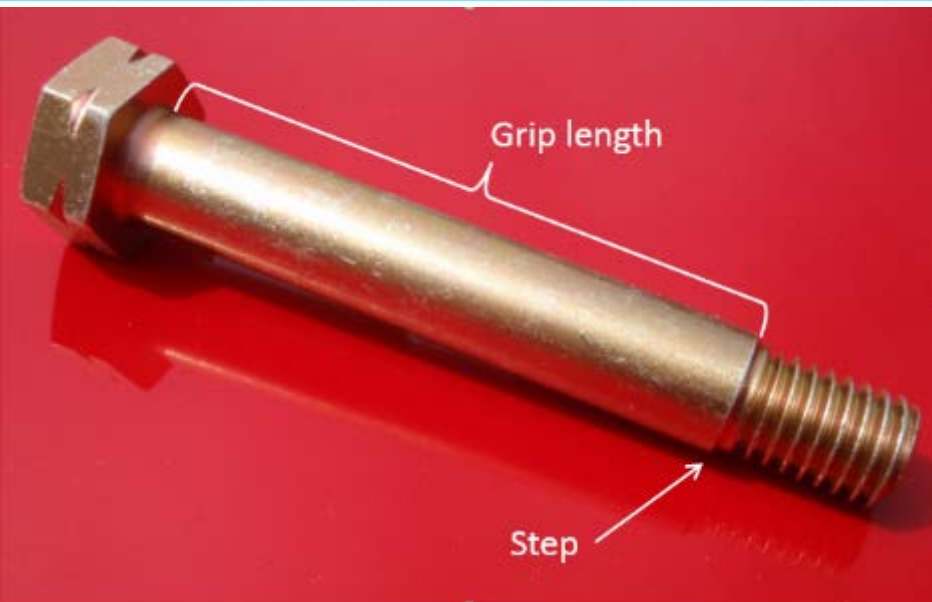
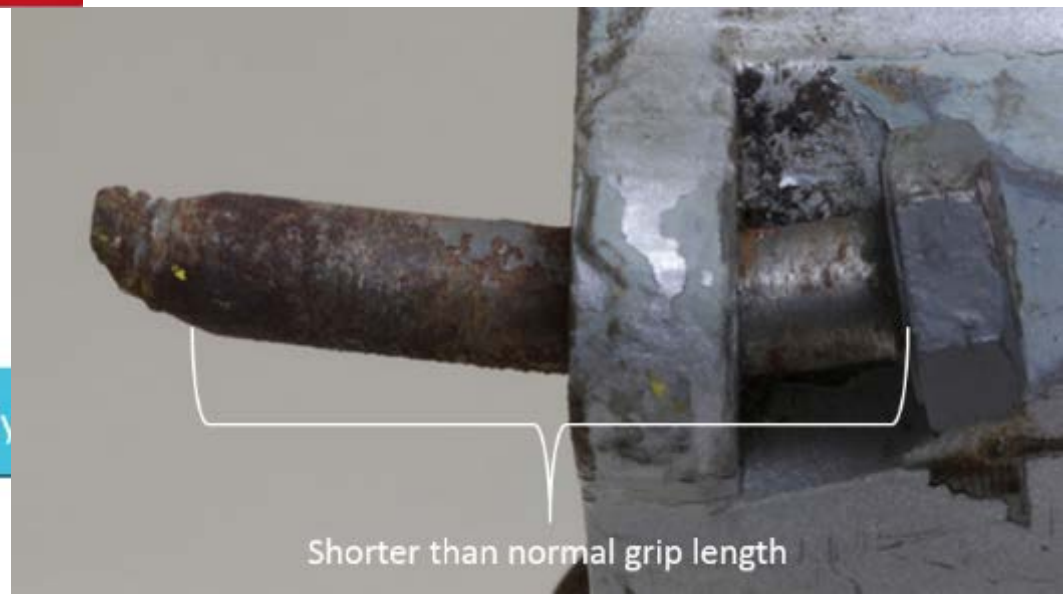
# Upper attachment bolts

The upper attachment hardware was a close tolerance bolt specifically designed for Joint H.

VH-TSG had non-standard parts of unknown origin.

Two of the three retained Joint H upper attachment bolts had a shorter than normal grip length
