# **UH-1H MAIN ROTOR BLADE FATIGUE**

**Patrick Conor, Alan James, Michael Hollis**

**Defence Technology Agency  
New Zealand Defence Force  
Auckland**

*ANZSASI Queenstown, June 2005*

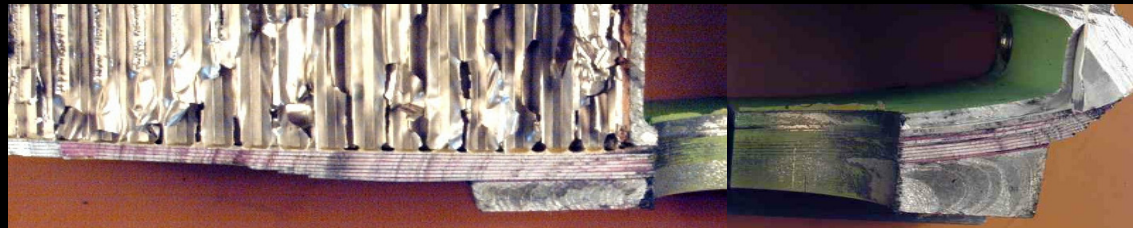
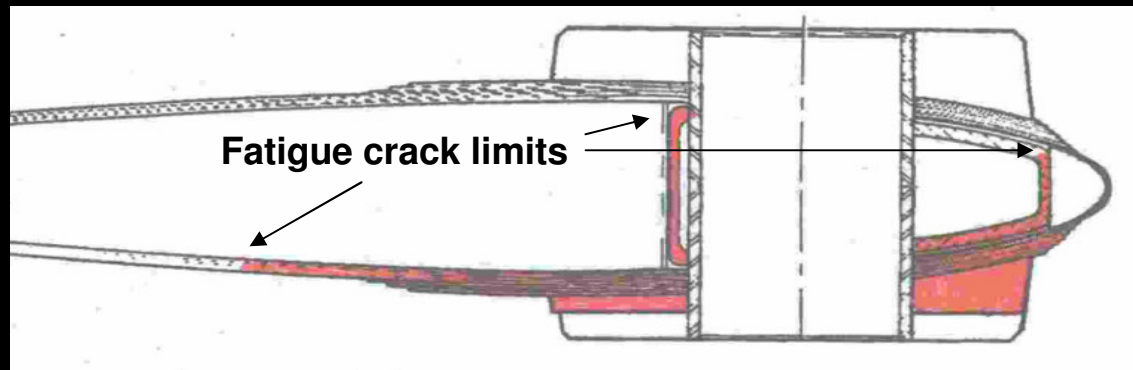
## FRACTURE SURFACE

CHORDWISE C/S

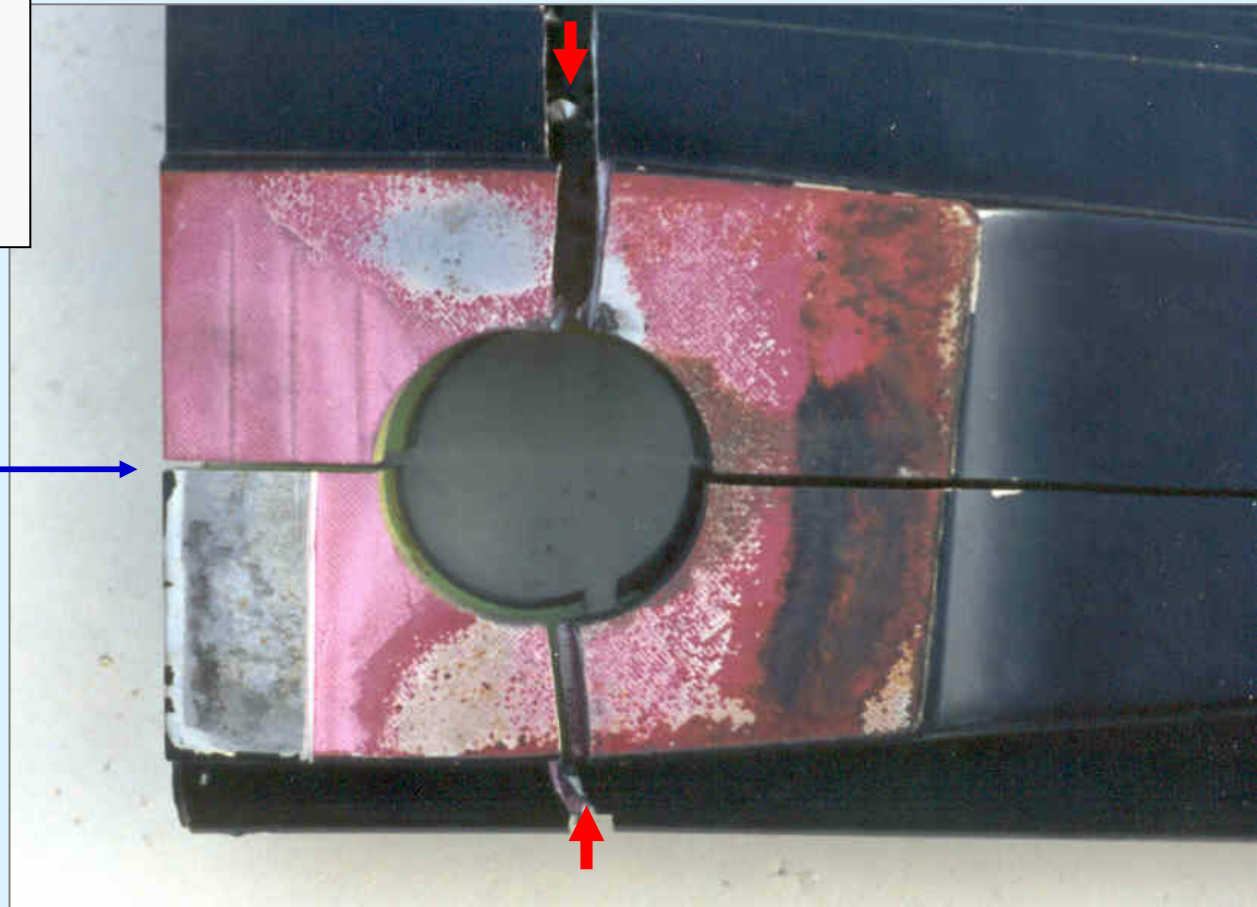
UNDER-SURFACE  
OF CRACKED  
BLADE

SAW CUT

GRIP PAD REMOVED  
AND BLADE CUT UP  
FOR FRACTURE  
SURFACE ANALYSIS

FATIGUE CRACK

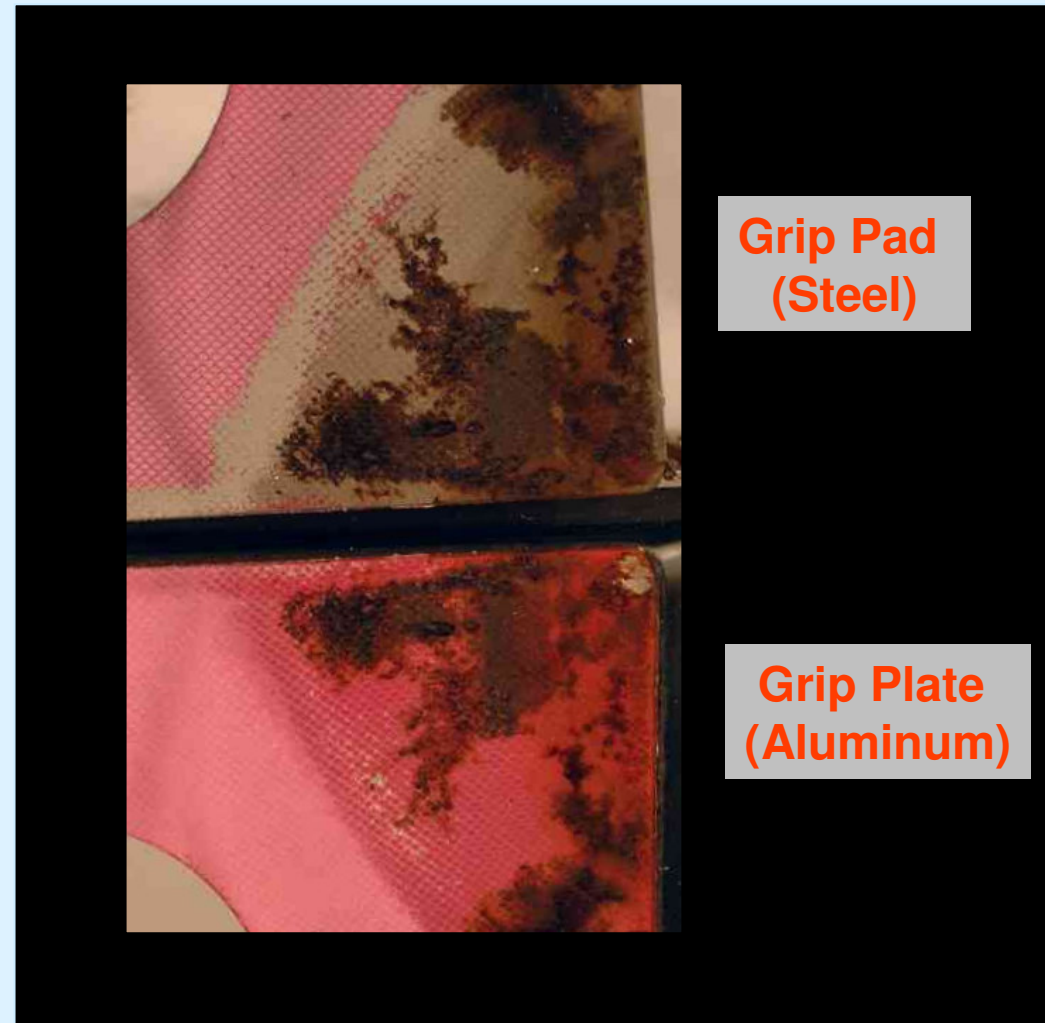
DISBONDING FOUND IN A  
BLADE REJECTED FOR  
OTHER REASONS AFTER  
1100 HRS IN SERVICE -

- **LARGE DEFECT WAS NOT  
DETECTED BY EITHER:**

- BONDLINE VISUAL  
INSPECTION (IN A LAB  
ENVIRONMENT)

- COIN TAP-TESTING

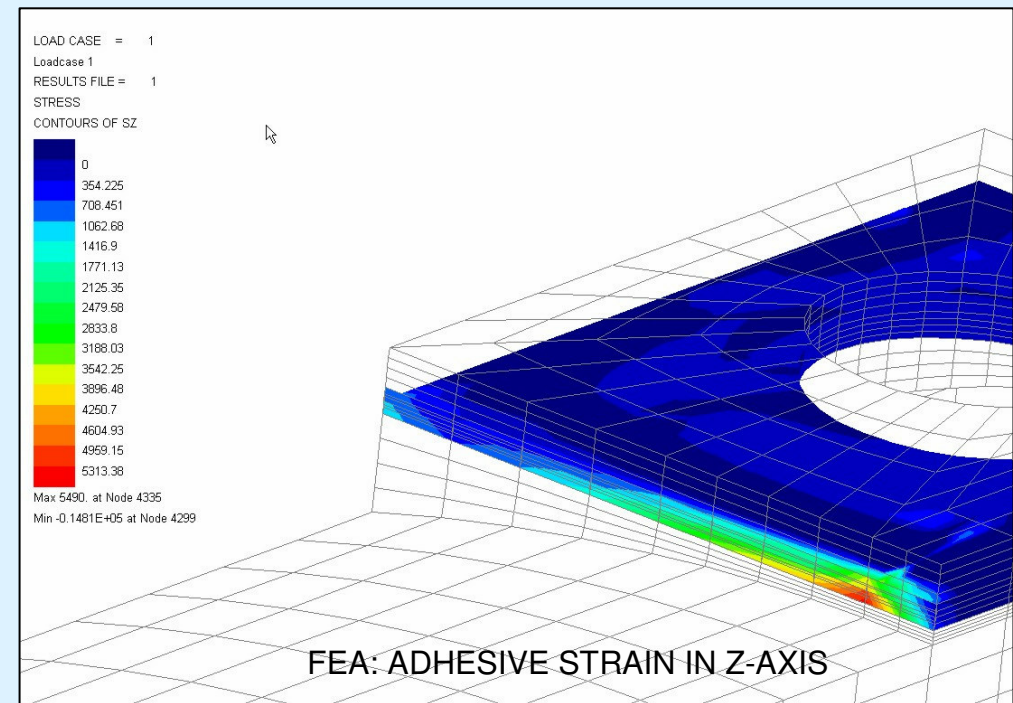
- HIGH PEEL STRESS IN THE ADHESIVE
- DEMANDING LOADS SPECTRUM?
