Case Study: Metroliner Trim Runaway

#### IMPROVING SMS – LESSONS LEARNT METROLINER TRIM RUNAWAY

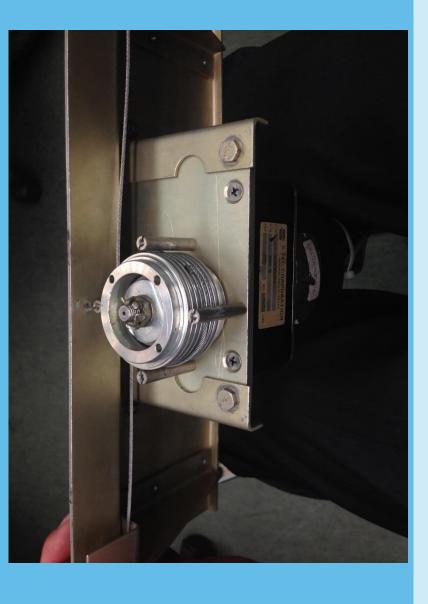
- Late 2014
- Routine flight, freight only, single pilot
- Auto pilot engaged ALT HOLD, resulted in trim down runaway
- Trim was operating in reverse sense

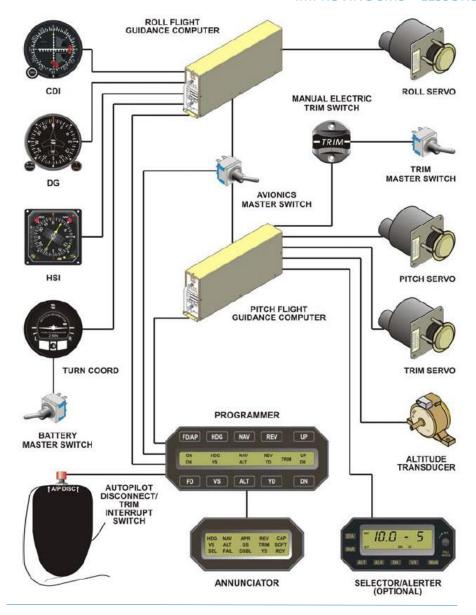
The servo actuator is supplied from the factory with the clutch set at 5in lbs or less, and wired to cause the capstan to rotate in a **counter-clockwise direction**, when system voltage is applied to Pin 3, and Ground to Pin 4 of the **servo connector**. Prior to installation in the aircraft, the servo clutch must be adjusted and the direction of rotation established as called out below.

Note: If the servo direction needs to be reversed from CCW to CW, reverse the corresponding wires on the servo connector.
