## AO-2018-026 Loss of control and collision with water involving Eurocopter (Airbus) EC120B, VH-WII, Hardy Reef Qld.

Presented by  
Angela Andrews  
Manager Transport Safety

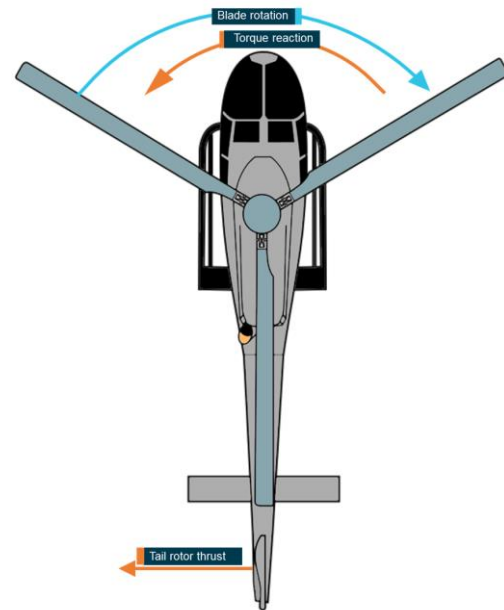
- Main rotor of the EC120B rotated clockwise, this is mostly the same in European manufactured helicopters
- Helicopters manufactured in North America rotate the opposite way

**Manufacturers provided guidance in both 2005 and 2019 explaining conditions to avoid and what to do if it occurs**

**Procedure when unanticipated yaw is experienced**

**Can be mistaken for LTE – ask Peter to explain (I did about 400 times)**

Apply full opposite sustained pedal

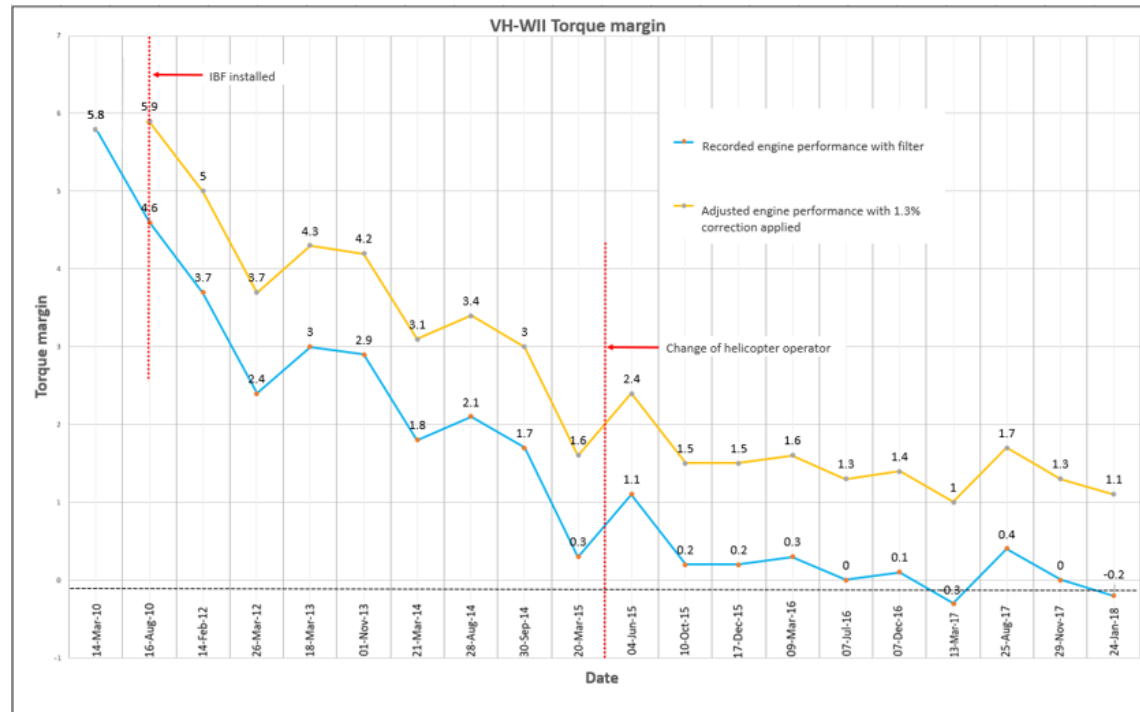
- Inlet barrier filter fitted
- Engine health checks were conducted by the operator on a regular basis, but this data was not used for trend monitoring
- At the time of the accident the engine was close to its lowest allowable limit

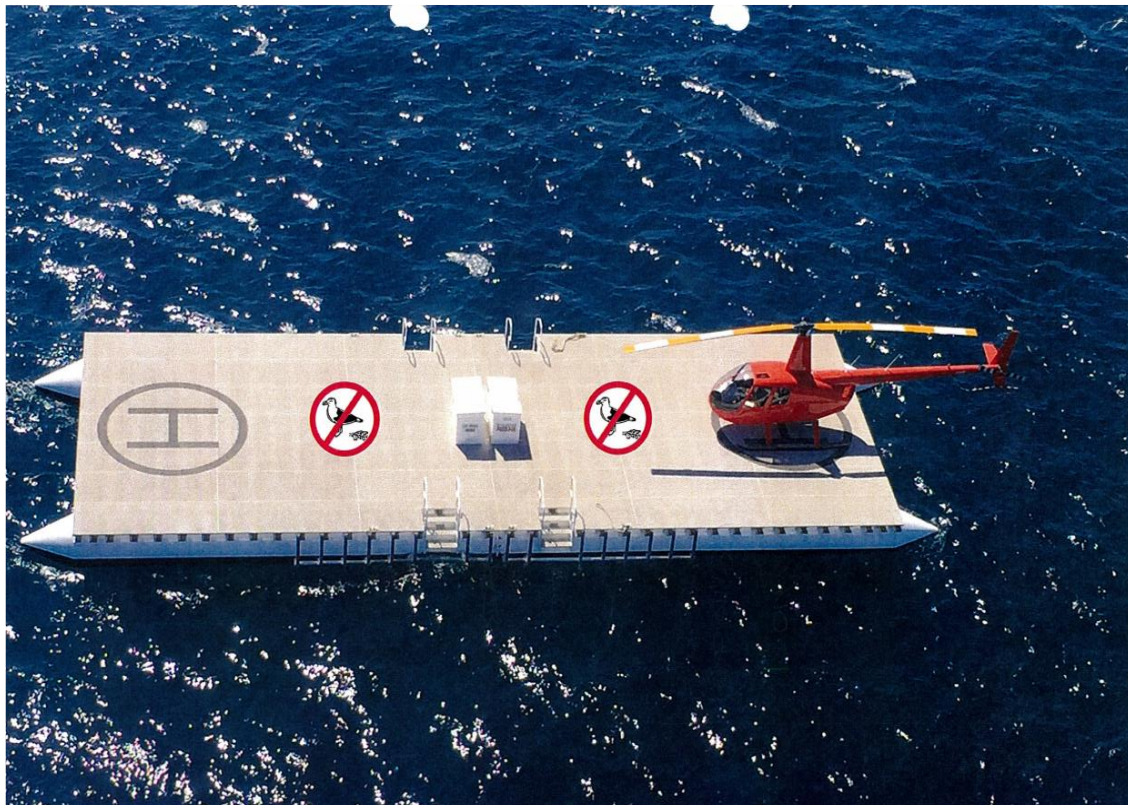
- Swing mooring – adjusts according to wind and tide
- Wooden and carbon fibre surface – mesh (allows the bird poo to fall through)

- Although being a suitable HLS, being a mesh surface over open water, ground effect would be reduced to a point that a pilot could not rely on it for performance

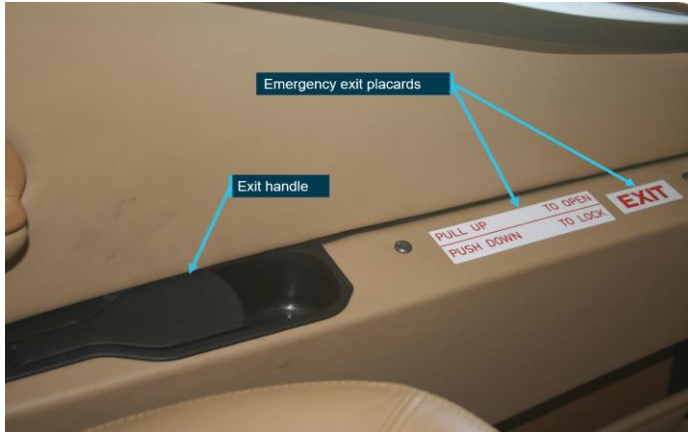
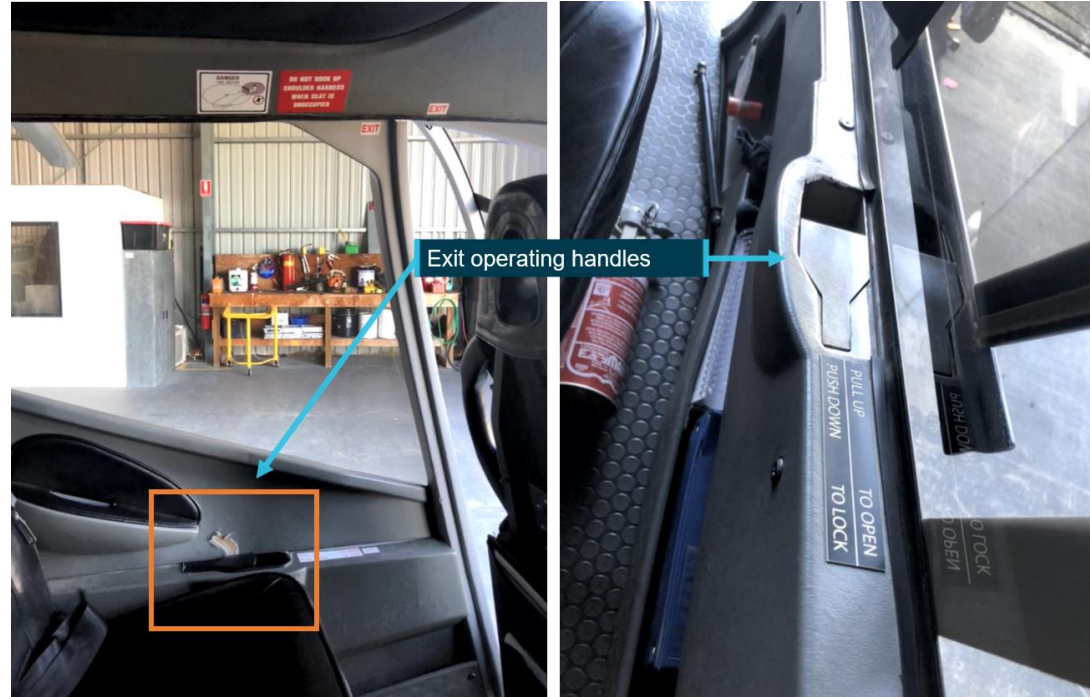
ATSB examined a number of EC120B

- Handle not obvious
- Inconsistencies with placards
- Three distinct actions for the rear left sliding door

- 2019 production of safety information notice (SIN) on unanticipated yaw
- Human factors review of the identification and use of the rear left sliding door
