## More than just VFR into IMC

Decision making and data analysis in accident investigation

**AO-2021-017 – In-flight  
breakup involving Van’s  
Aircraft RV-7A,  
registered VH-XWI**

90 km south of Charter  
Towers, QLD, 23 April 2021.

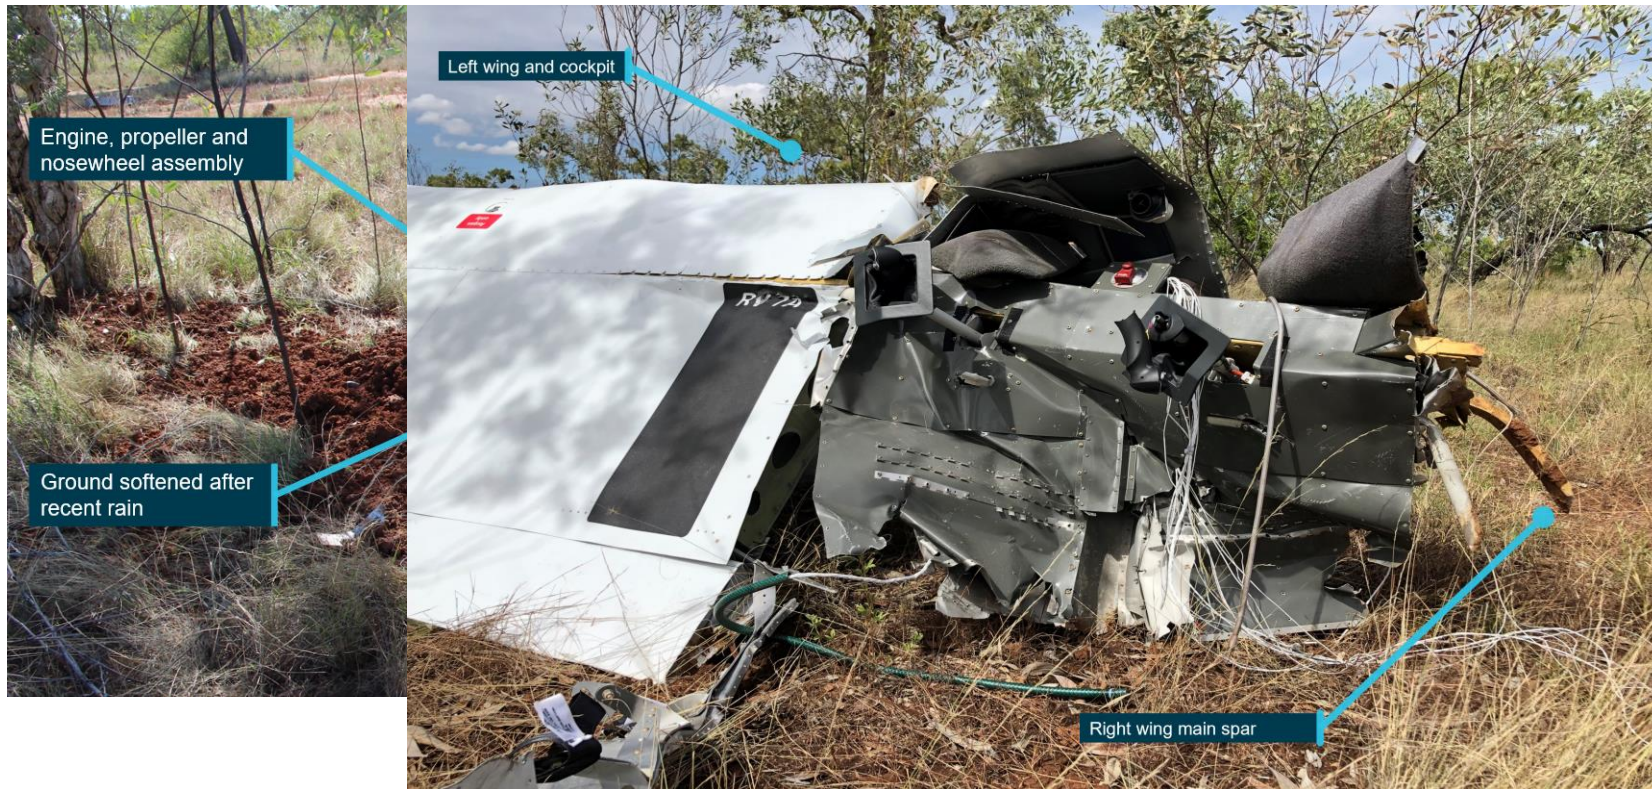
# Airframe in-flight break-up signatures

Engine, propeller and nosewheel assembly

Left wing and cockpit

Ground softened after recent rain

Right wing main spar

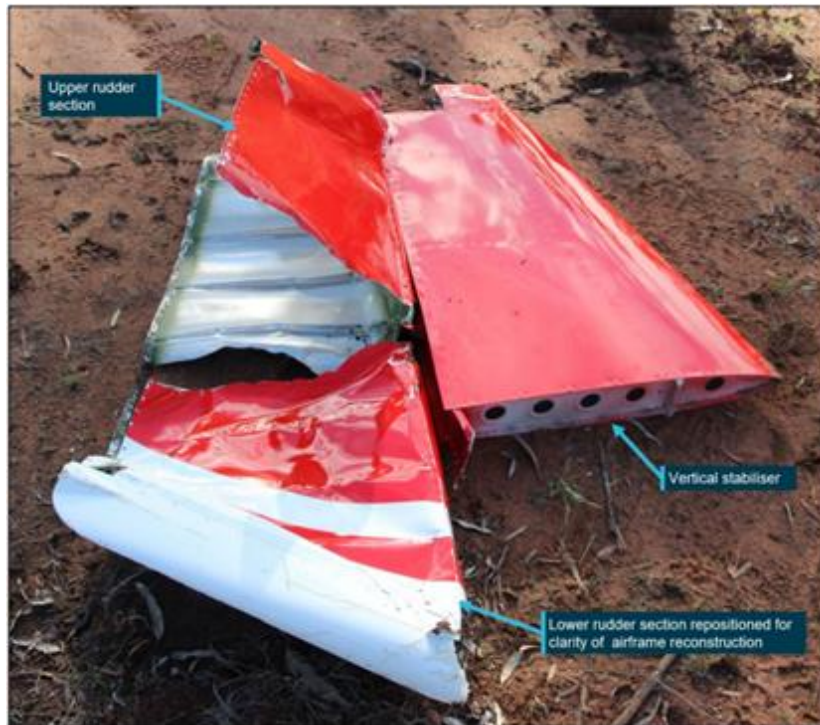
ZK-DVS

Two previous accidents involving Van's RV-7/A variants involved in in-flight break-ups involving high rates of descent and exceedance of Vne, these demonstrated similar airframe failure modes to that of VH-XWI.
