Australian Government  
Australian Transport Safety Bureau

# **AO-2023-001 Sea World mid-air survivability assessment**

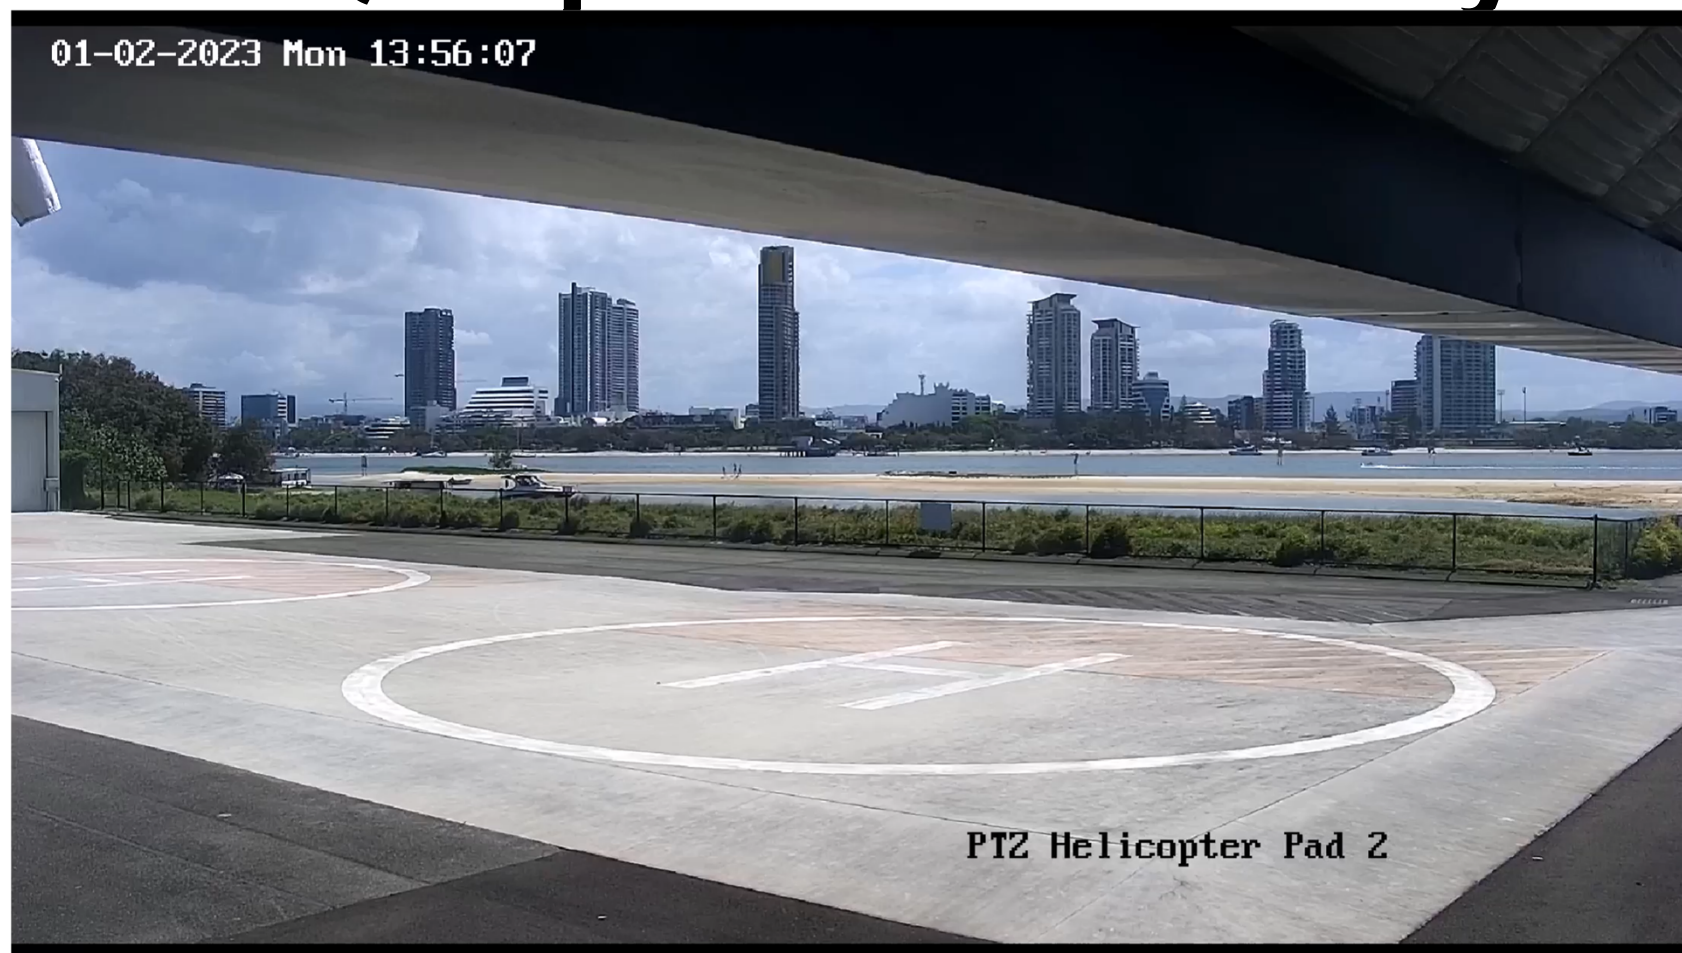
# VH-XKQ Impact video analysis

| | SeaWorld CCTV (25 fps) | GCSCN CCTV (25 fps) |
| Resolution | 0.085 m/pix | 0.026 m/pix |
| Analysis length | 11 frames | 8 frames |
| Vertical speed | 24.3 m/s | 24.8 m/s |
| Horizontal speed<br>(across the screen) | 14.2 m/s | 17.5 m/s |
| Apparent angle of impact | 60° | 75° |
| Travel angle out of plane | 34° | 67° |
| Impact velocity | 30.2 m/s | 30.3 m/s |
| Angle of impact | 55° | 55° |

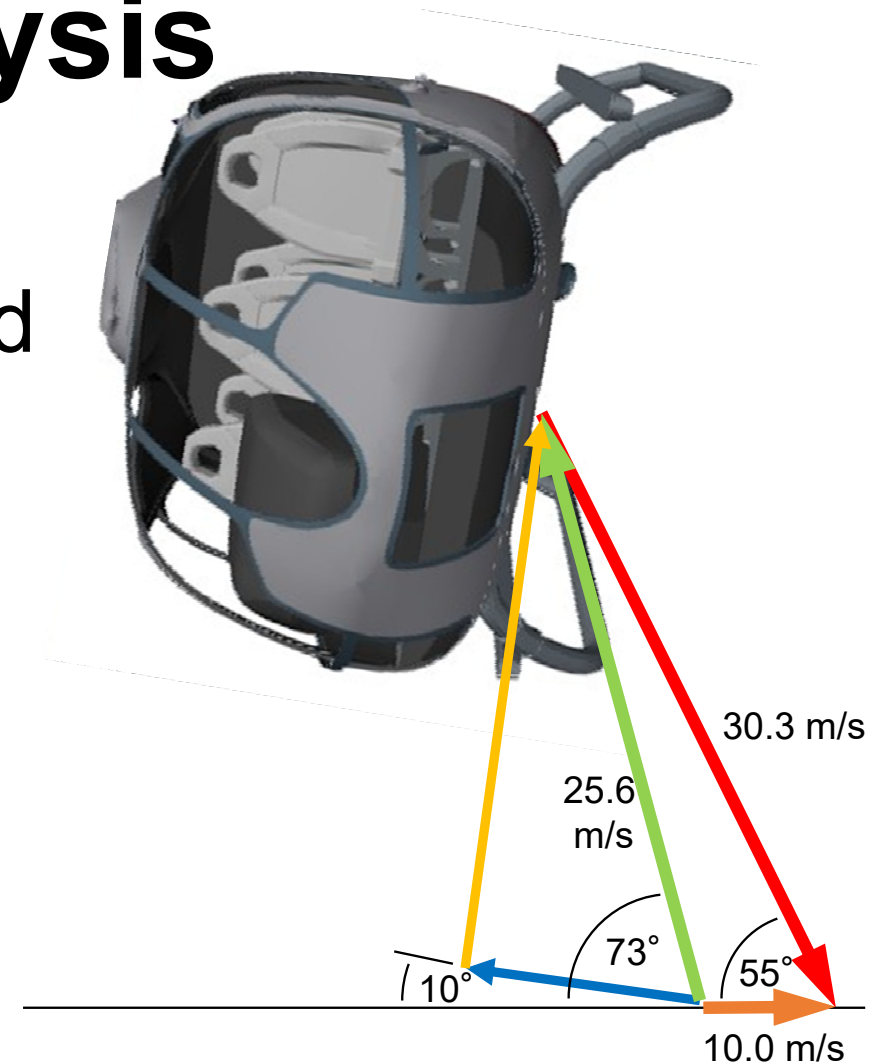
# Ground impact analysis

- Inbound vector known
- Outbound vector guestimated
- Reaction vector calculated
- Resolved to body axis
  - 11.6 m/s vertical
  - 22.8 m/s lateral
- Average acceleration
  - 14.8 g vertical
  - 29.0 g lateral

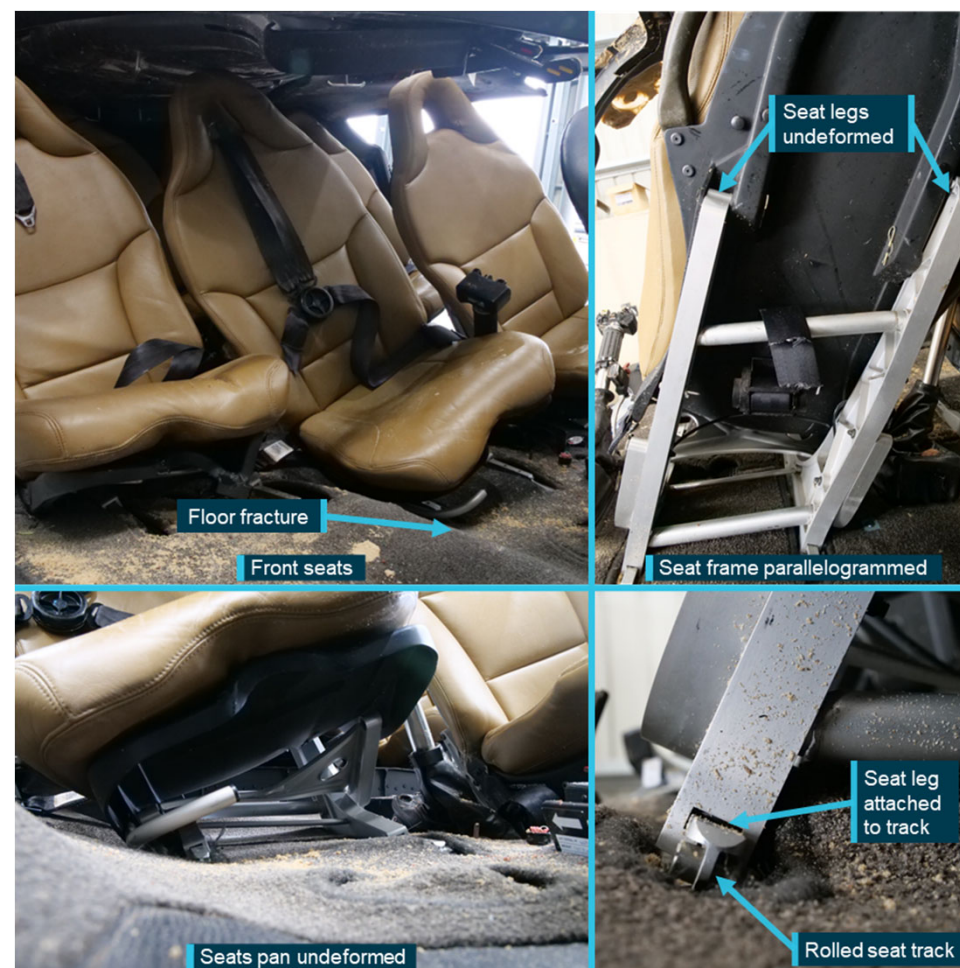
- Dynamic loading averaged 32 g (> 80ms), peak 50 - 60 g (well in excess of the 8g static certification load case)
- The seats were canted (parallelogrammed) substantially to the right.
- The seat legs were mostly undeformed.
- All seat legs remained attached to the seat tracks.
- All seat tracks remained attached to the floor (front row) or plinth (second row).

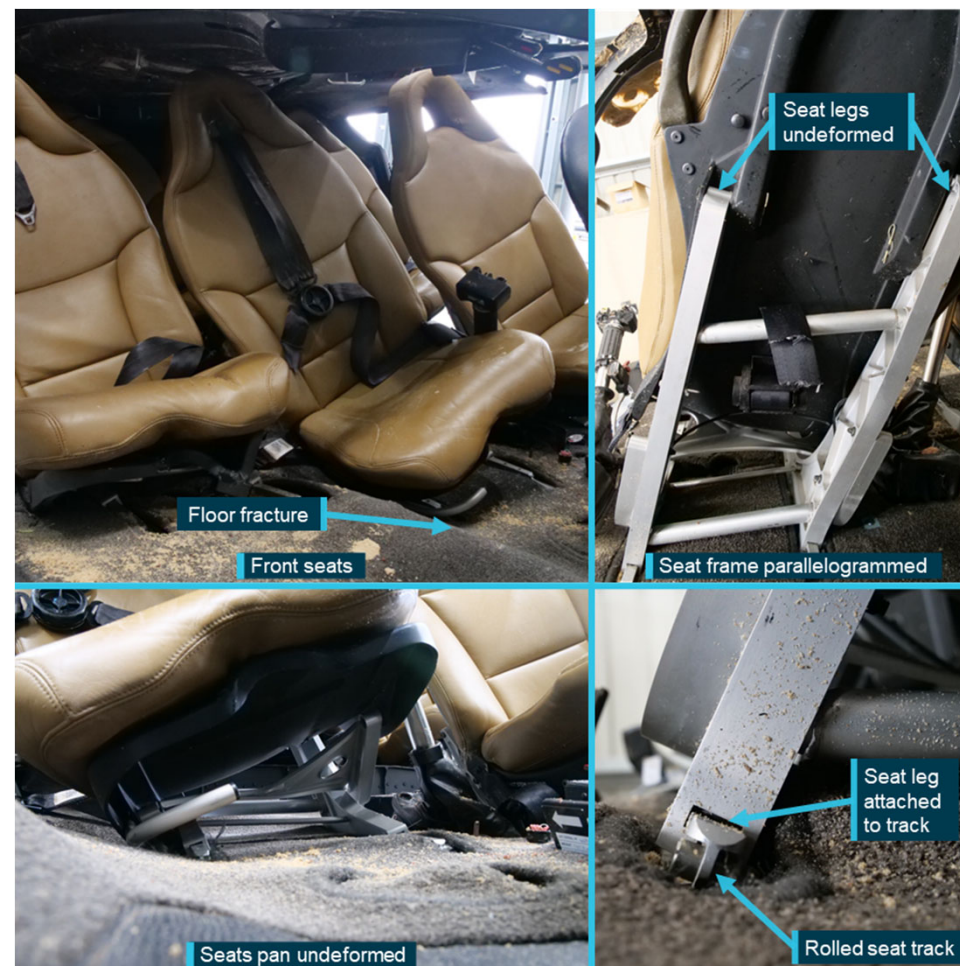
- Seat legs and integrated track slots rolled right with the seat track permanently set.
- The seat buckets stroked on one side.
- The composite seat buckets mostly intact and undeformed.
- Seat pan and seat back cushions in place and undamaged.
- The cabin ceiling had compressed onto the seats.

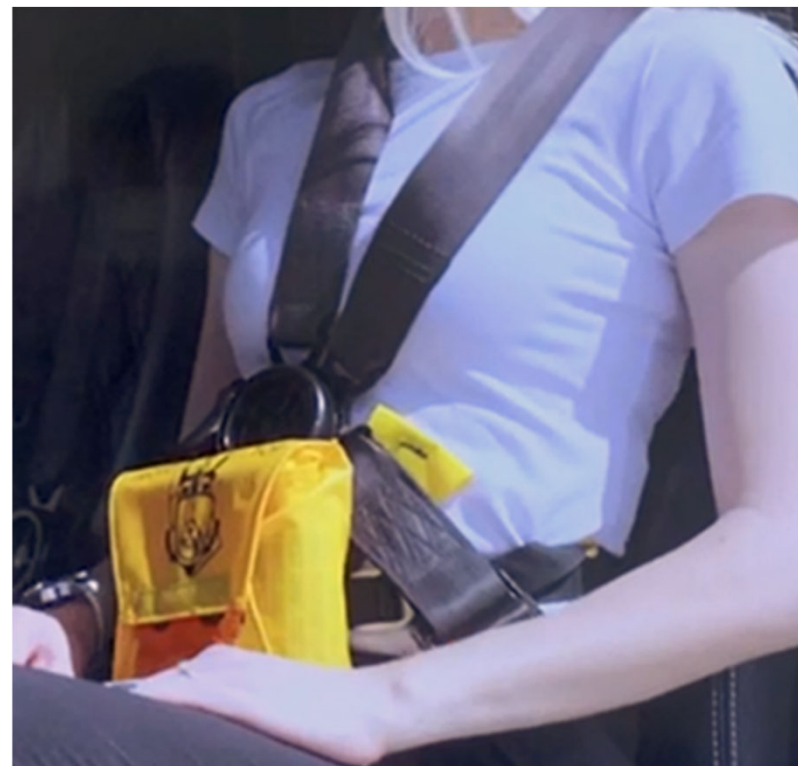
- Inconsistent and incomplete briefing material
  - Safety briefing video
  - Safety briefing card

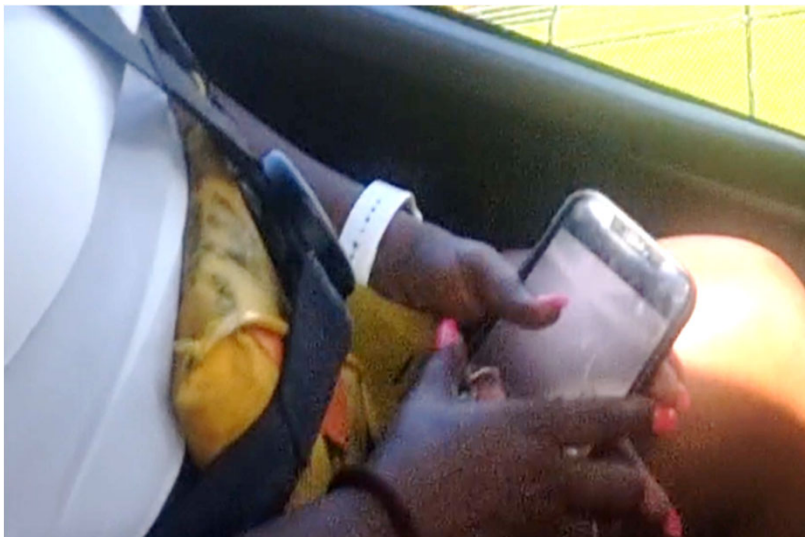
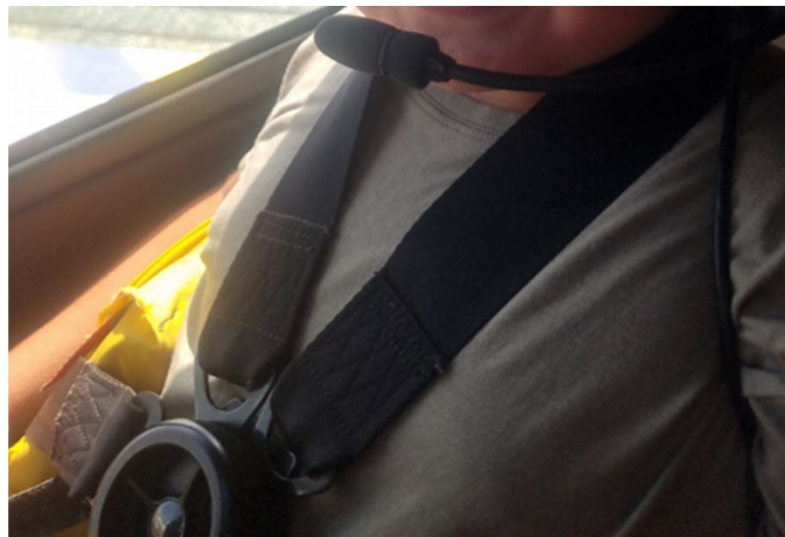
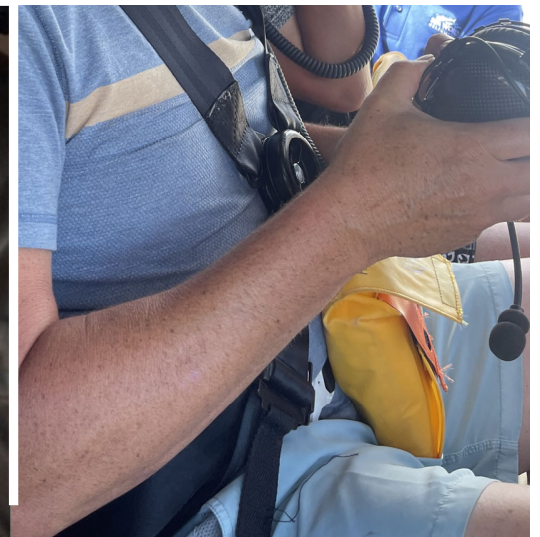
- Poor occupant restraint
- Equipment incompatibility
