Aviation Safety- Bail before you wipe out

ANZSASI Seminar – Sydney
June 2026

Transport Accident
Investigation
Commission

Aviation inquiry AO-2023-010
Kawasaki BK117 B-2, ZK-HHJ
Collision with terrain
Mount Pirongia
19 September 2023/

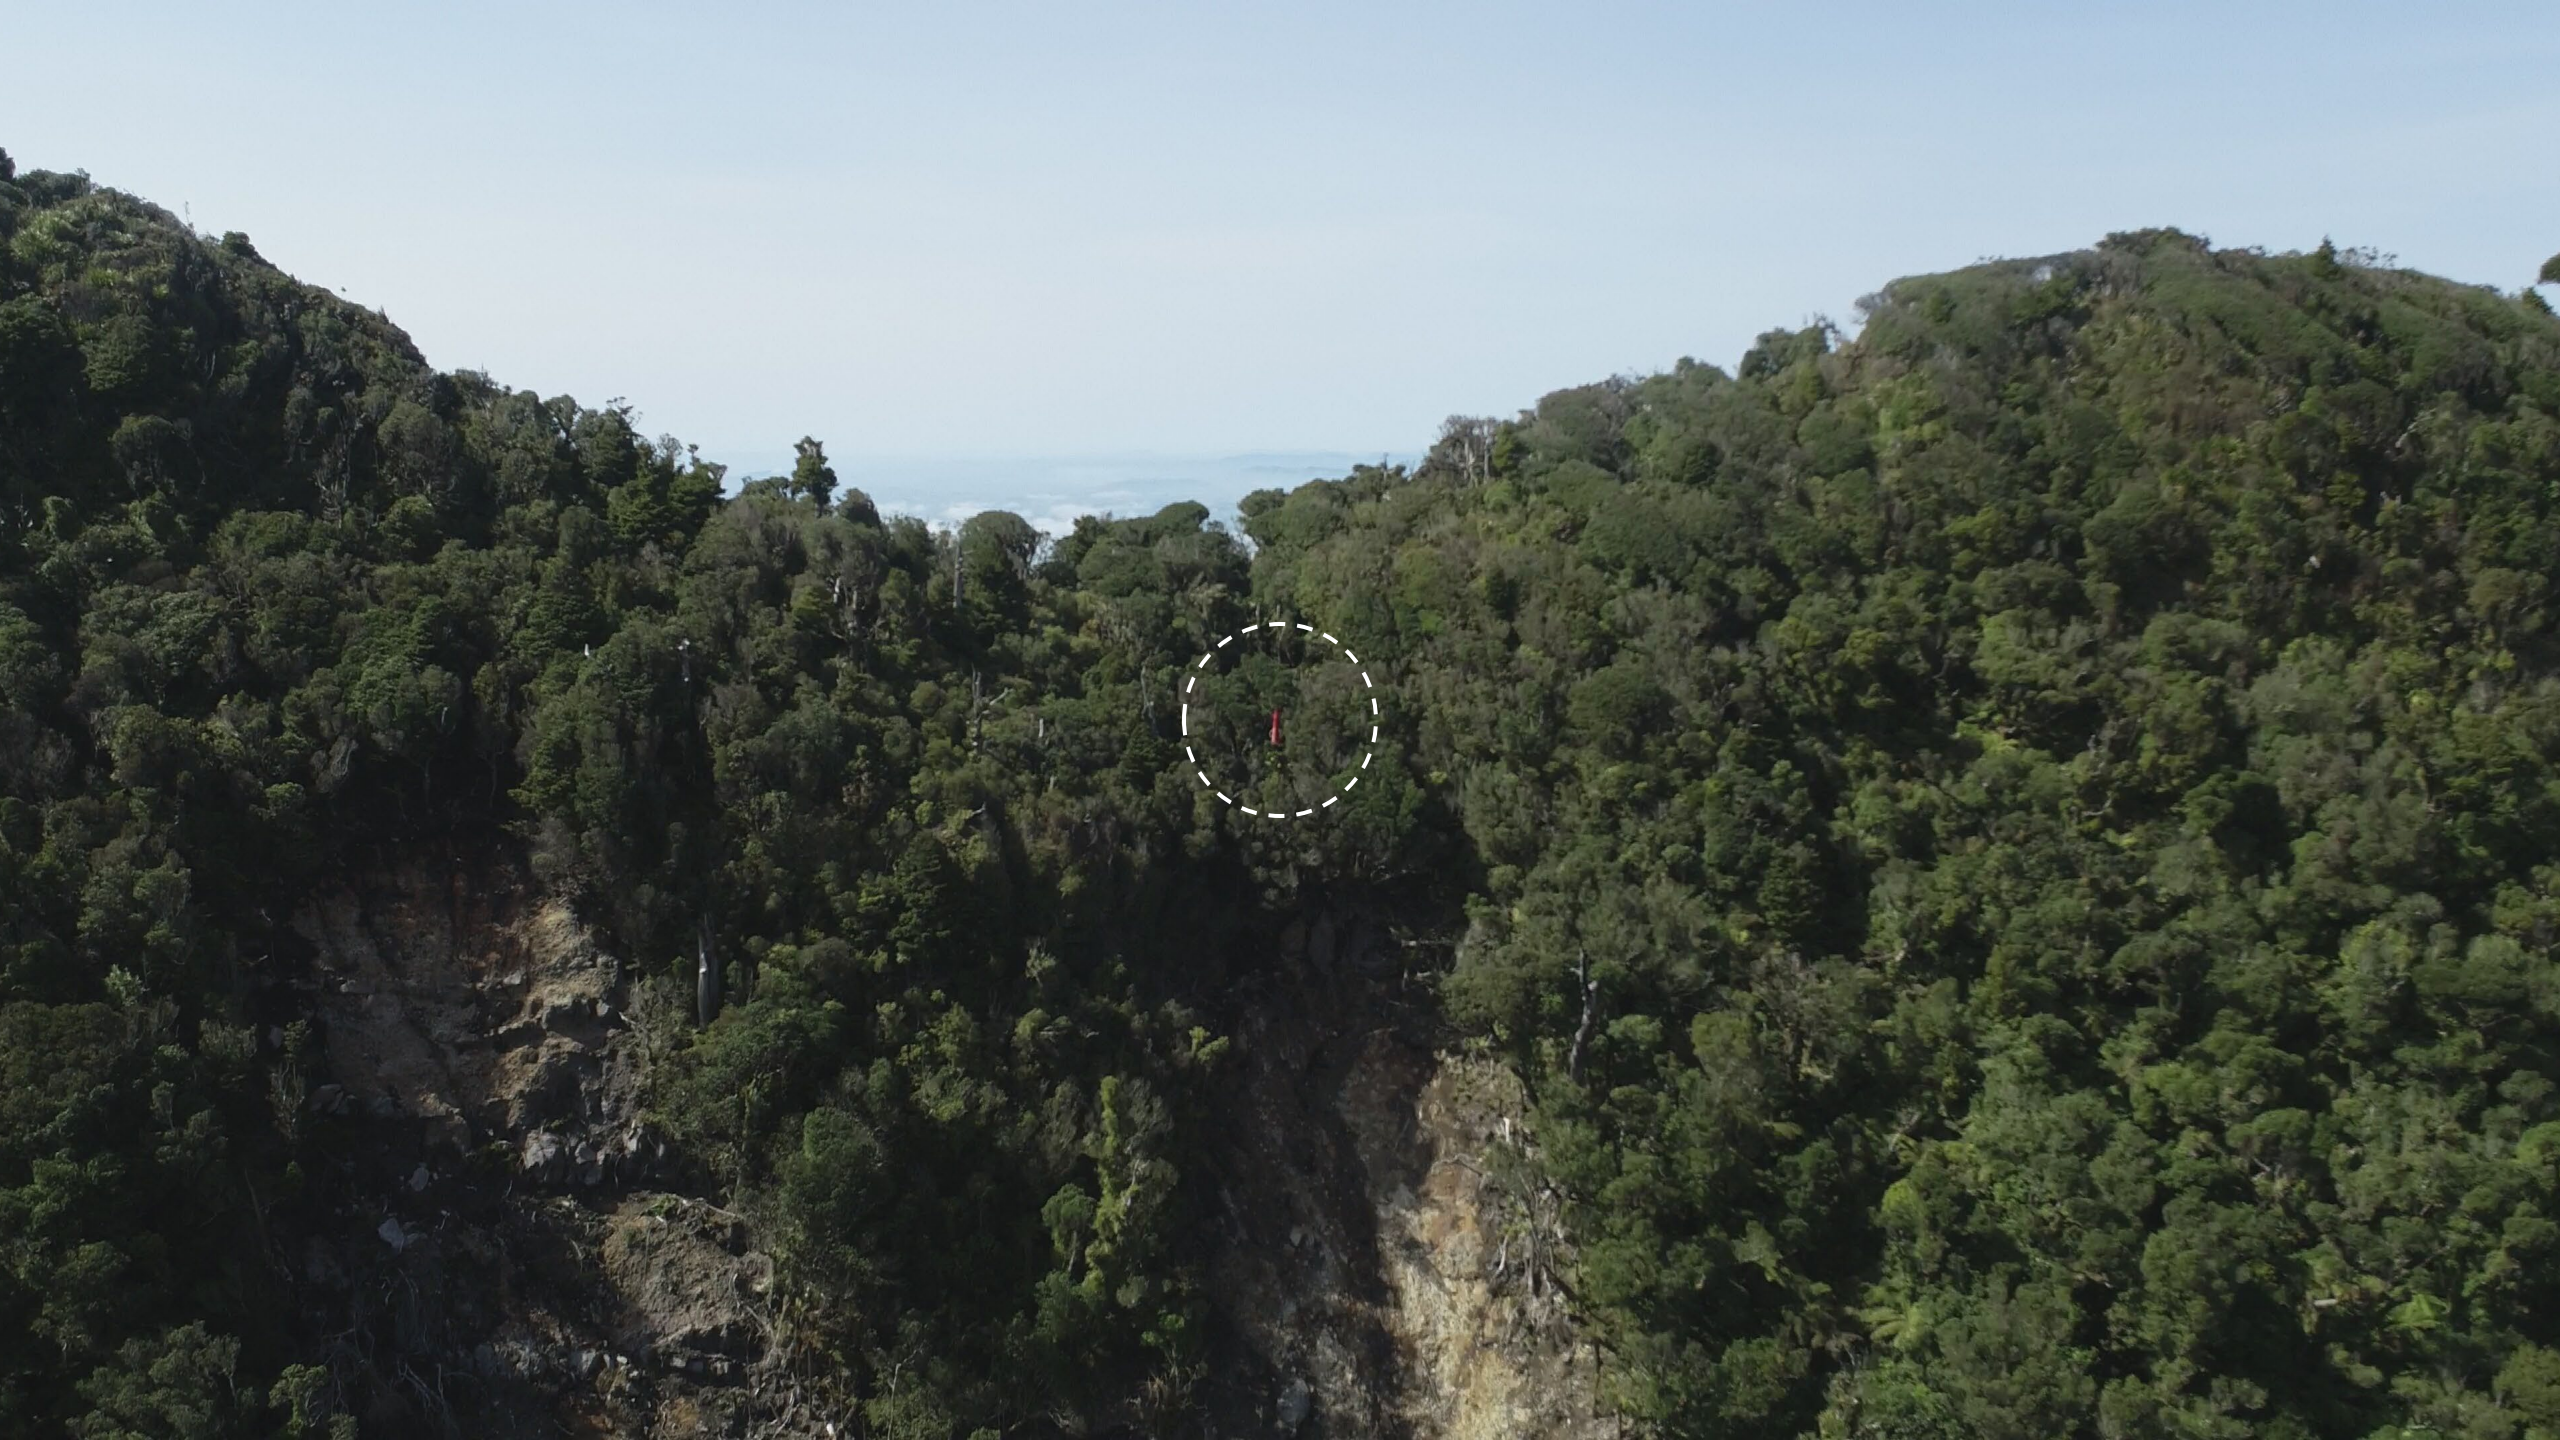
17:06:43
3000ft

17:06:51
19.5 degrees pitch up

17:06:57
-728 ft/min, 20 kts
9 degrees pitch up, 281 ft AGL

17:06:55
-649 ft/min, 26 kts
13 degrees pitch up, 291 ft AGL

17:06:59
-1050 ft/min, 18 kts
9 degrees pitch up, 252 ft AGL

17:07:03
-2145 ft/min, 9 kts

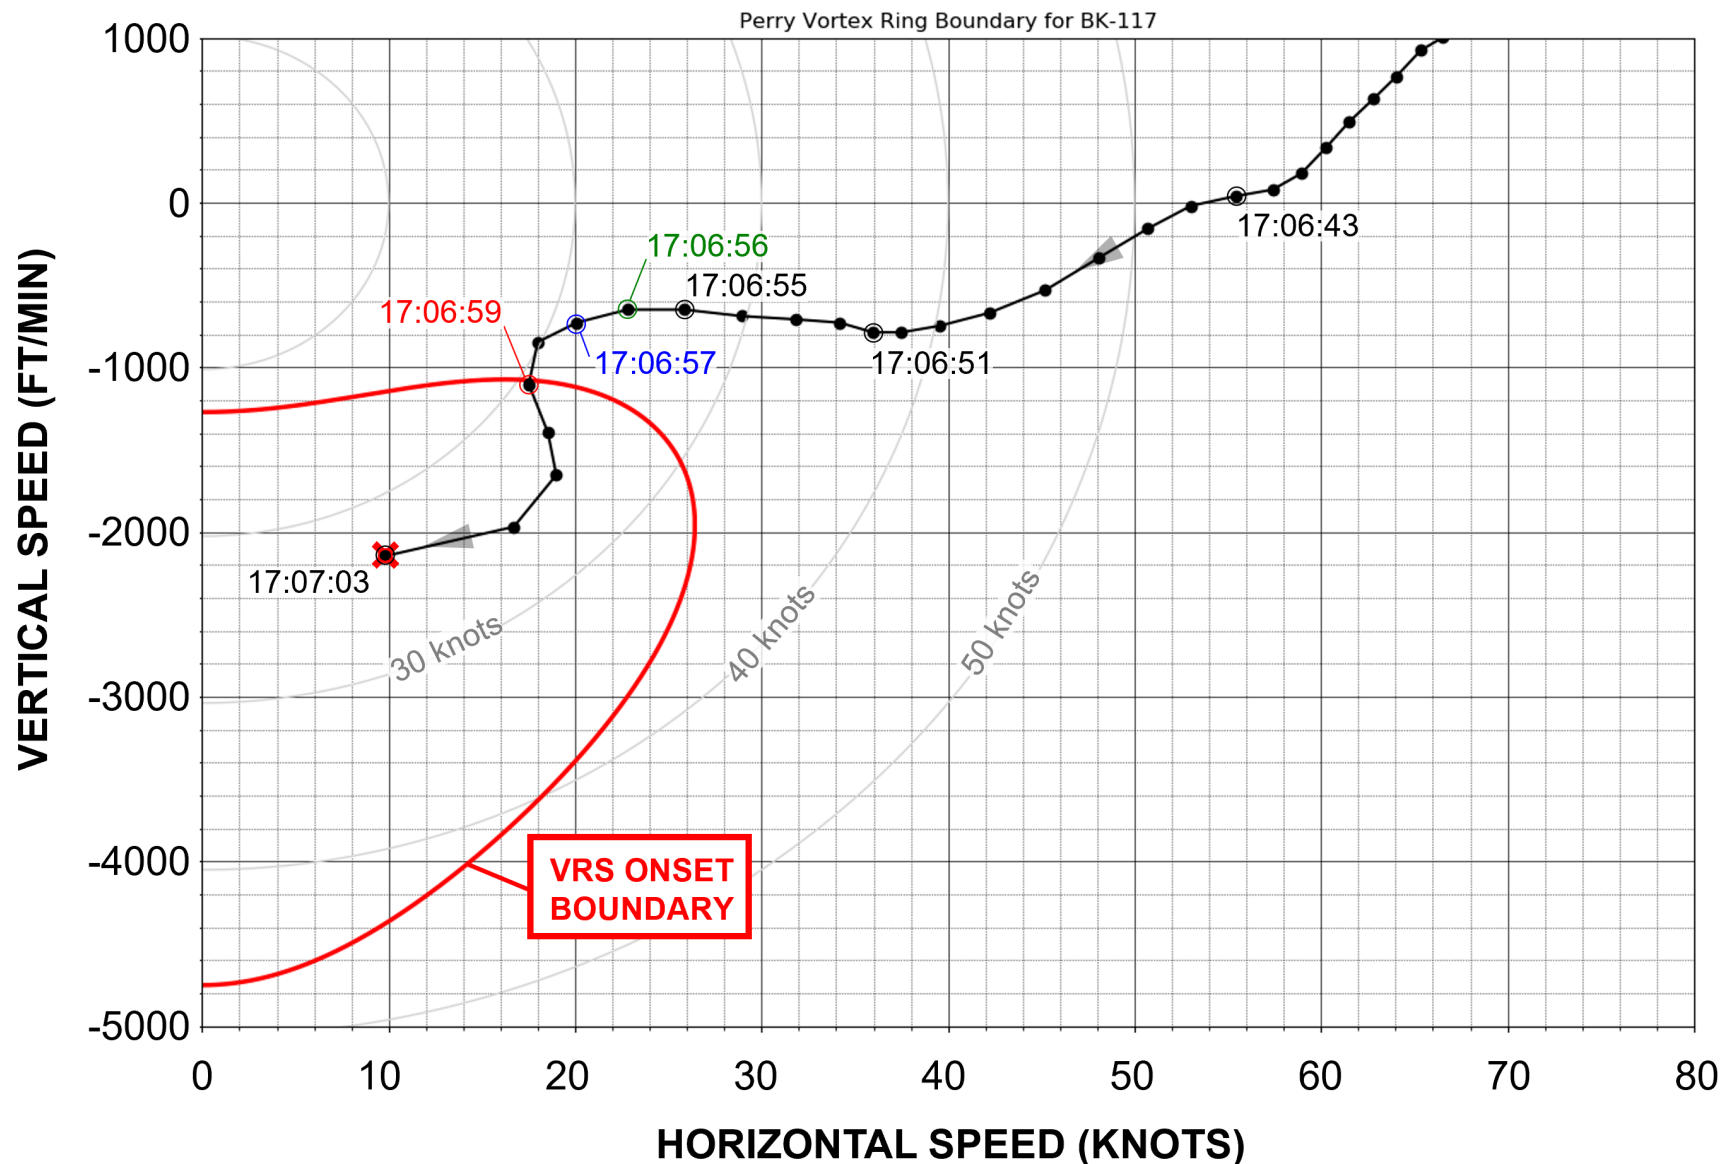
ZK-HHJ TRAJECTORY RELATIVE TO BOUNDARY FOR VRS ONSET

ZK-HHJ trajectory
superimposed on
VRS onset boundary

Black trajectory :
GPS trajectory (groundspeed)

Trajectory annotated with
New Zealand Standard Time
(UTC+12 in format hh:mm:ss)

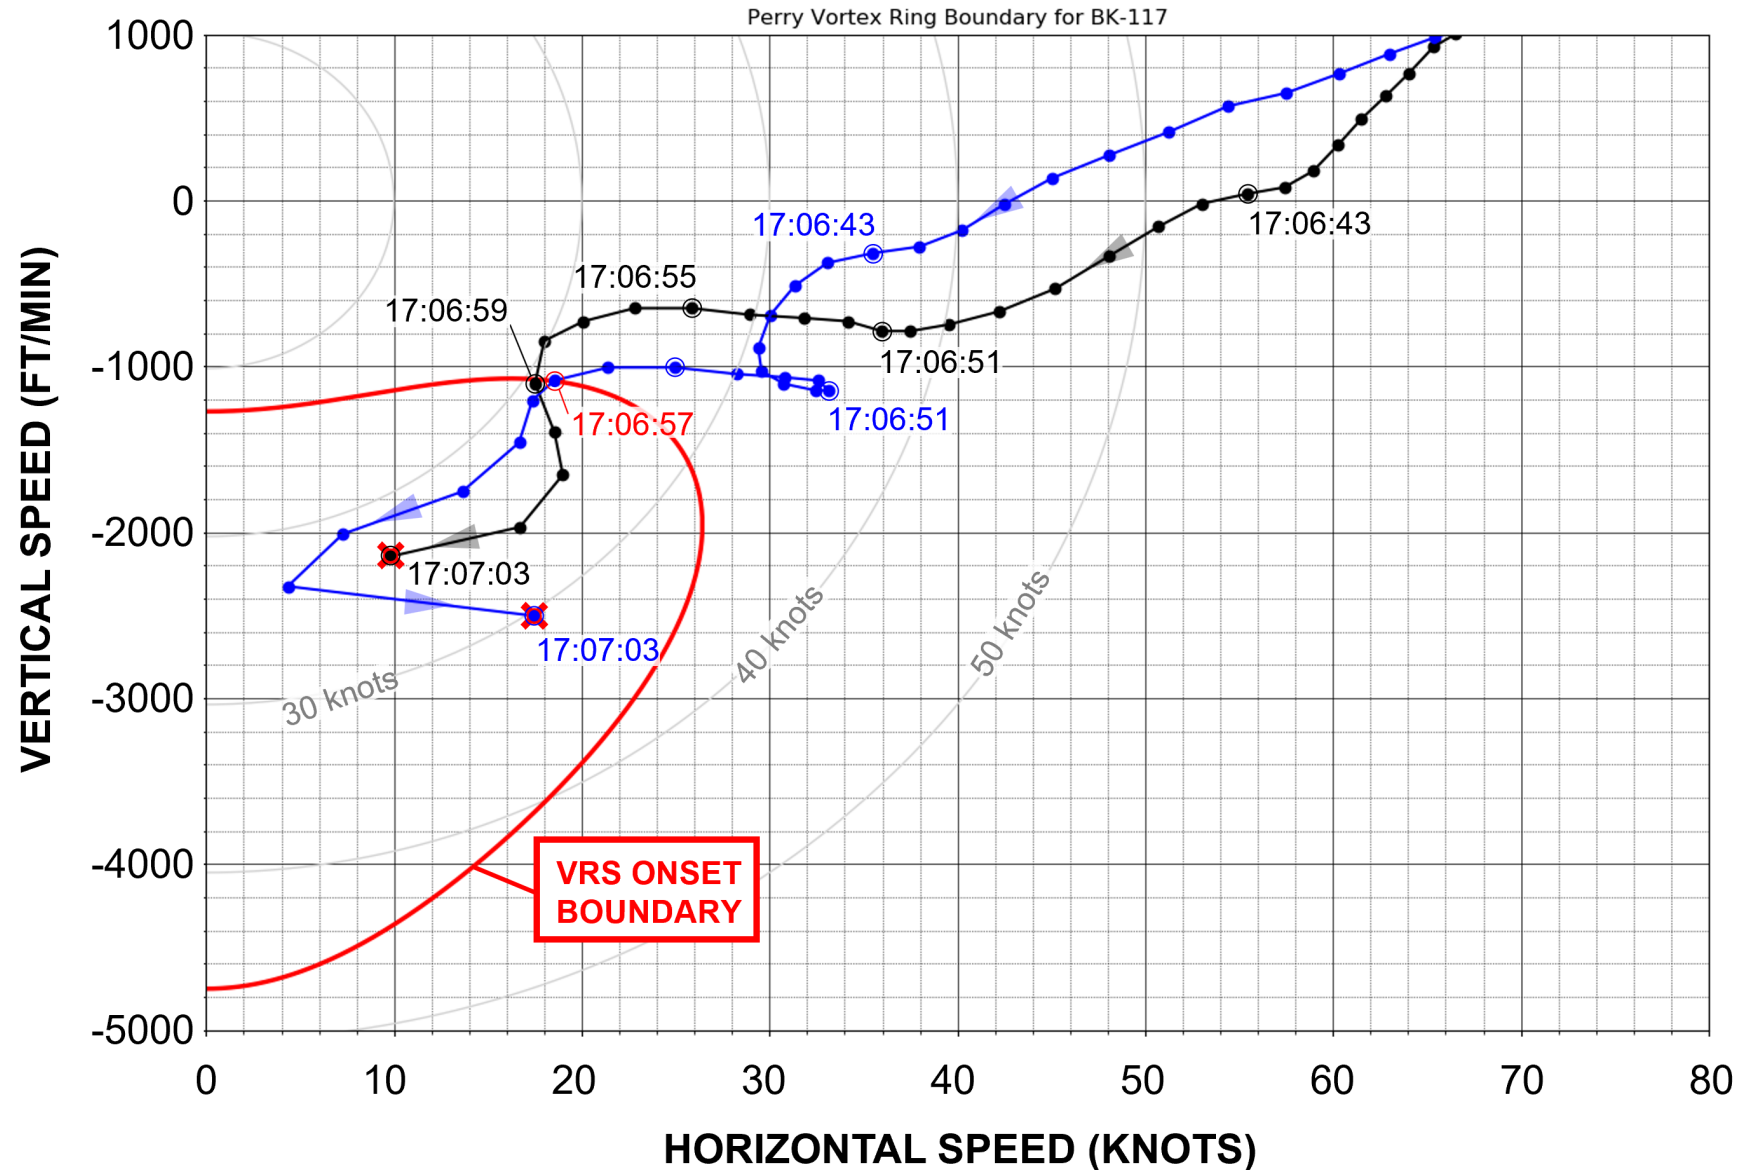
ZK-HHJ TRAJECTORY RELATIVE TO BOUNDARY FOR VRS ONSET

ZK-HHJ trajectory superimposed on VRS onset boundary

Black trajectory :
GPS trajectory (groundspeed)

Blue trajectory :
Airspeed accounting for

- 20 knot westerly wind
- 10 degrees orographic uplift

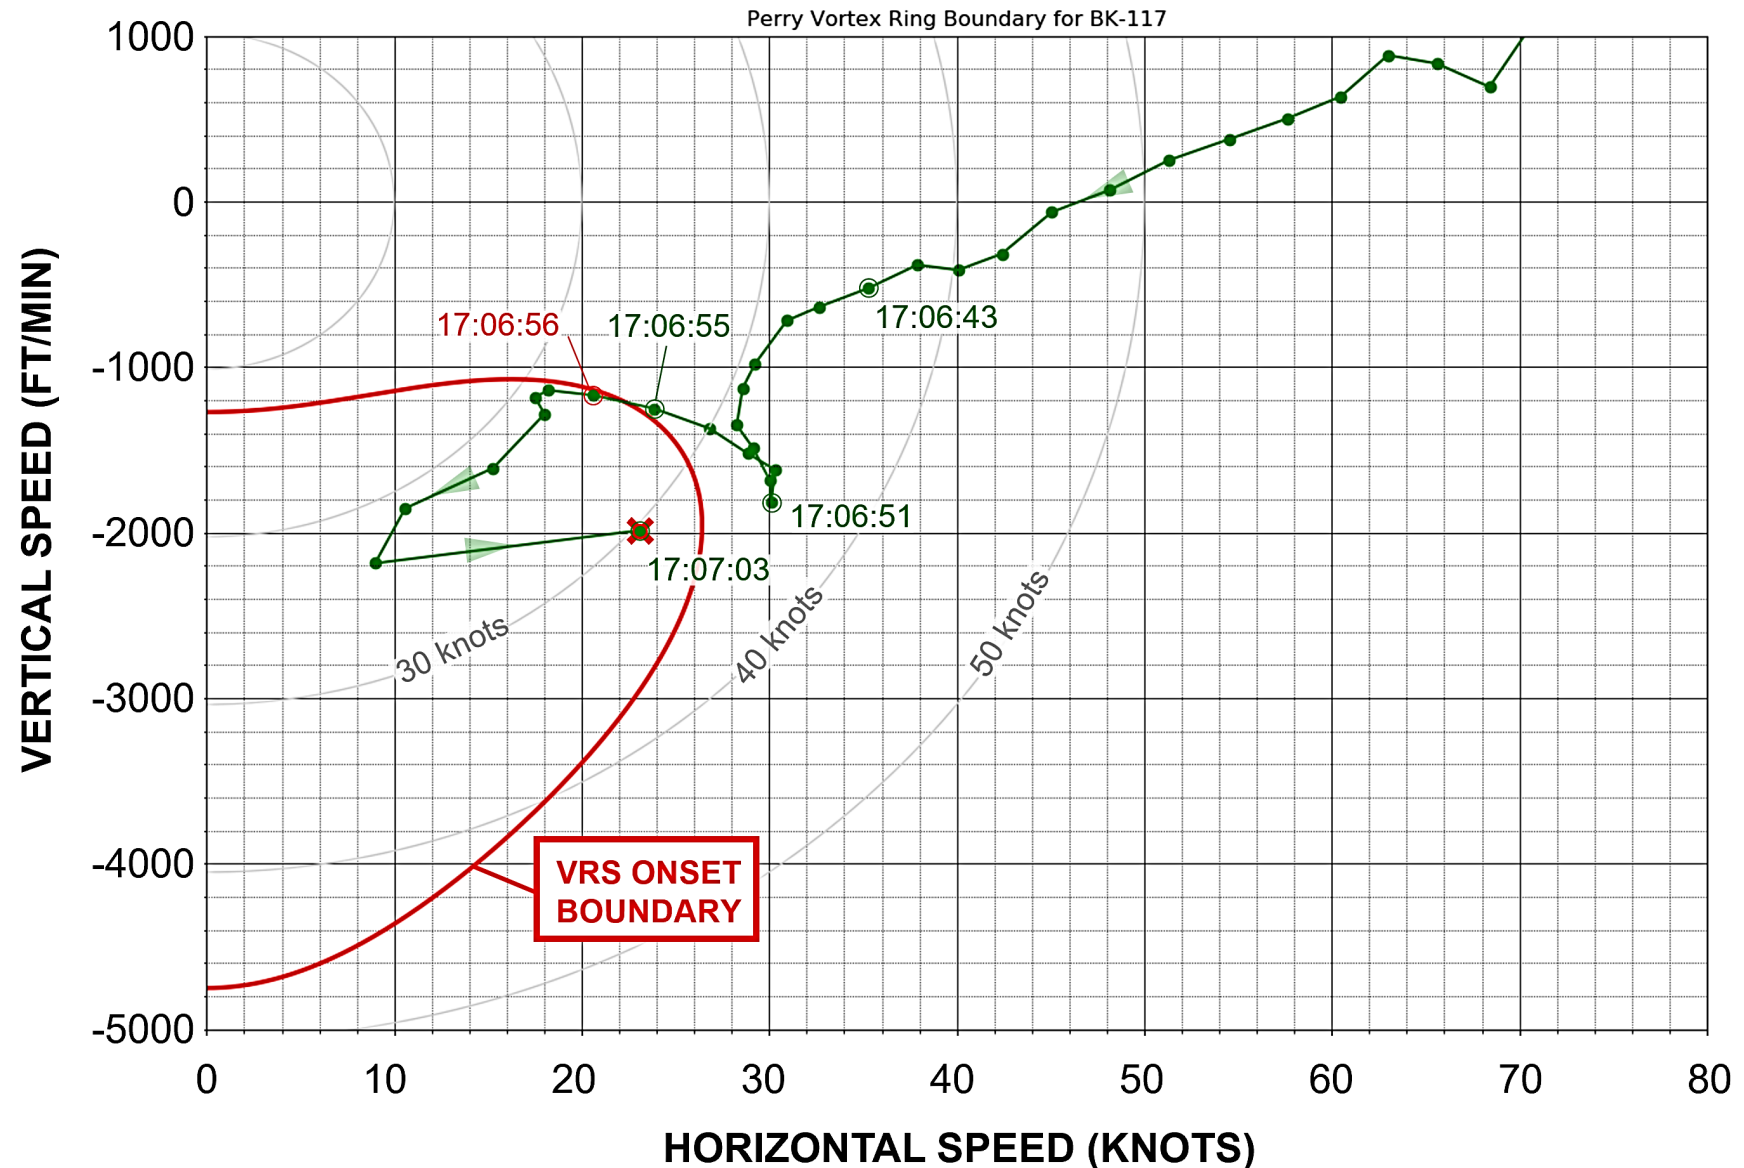
ZK-HHJ TRAJECTORY RELATIVE TO BOUNDARY FOR VRS ONSET

ZK-HHJ trajectory superimposed on VRS onset boundary

Green trajectory :

Airspeed accounting for

- 20 knot westerly wind
- 10 degrees orographic uplift
- aircraft pitch attitude
