## Surfing the unknown break- challenging the status quo

Runway incursion involving a Lancair, VH-VKP, and a Bombardier DHC-8-315, VH-TQZ, at Mildura Aerodrome, Victoria on 29 September 2023.

**Presented by**  
Lee Ungermann  
Manager Transport Safety

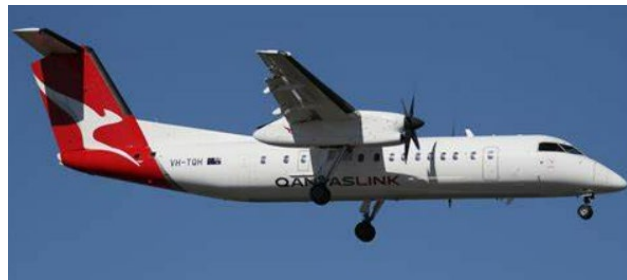
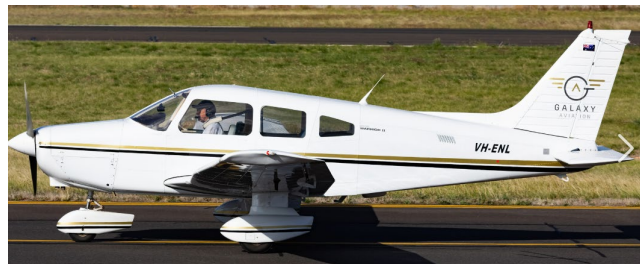
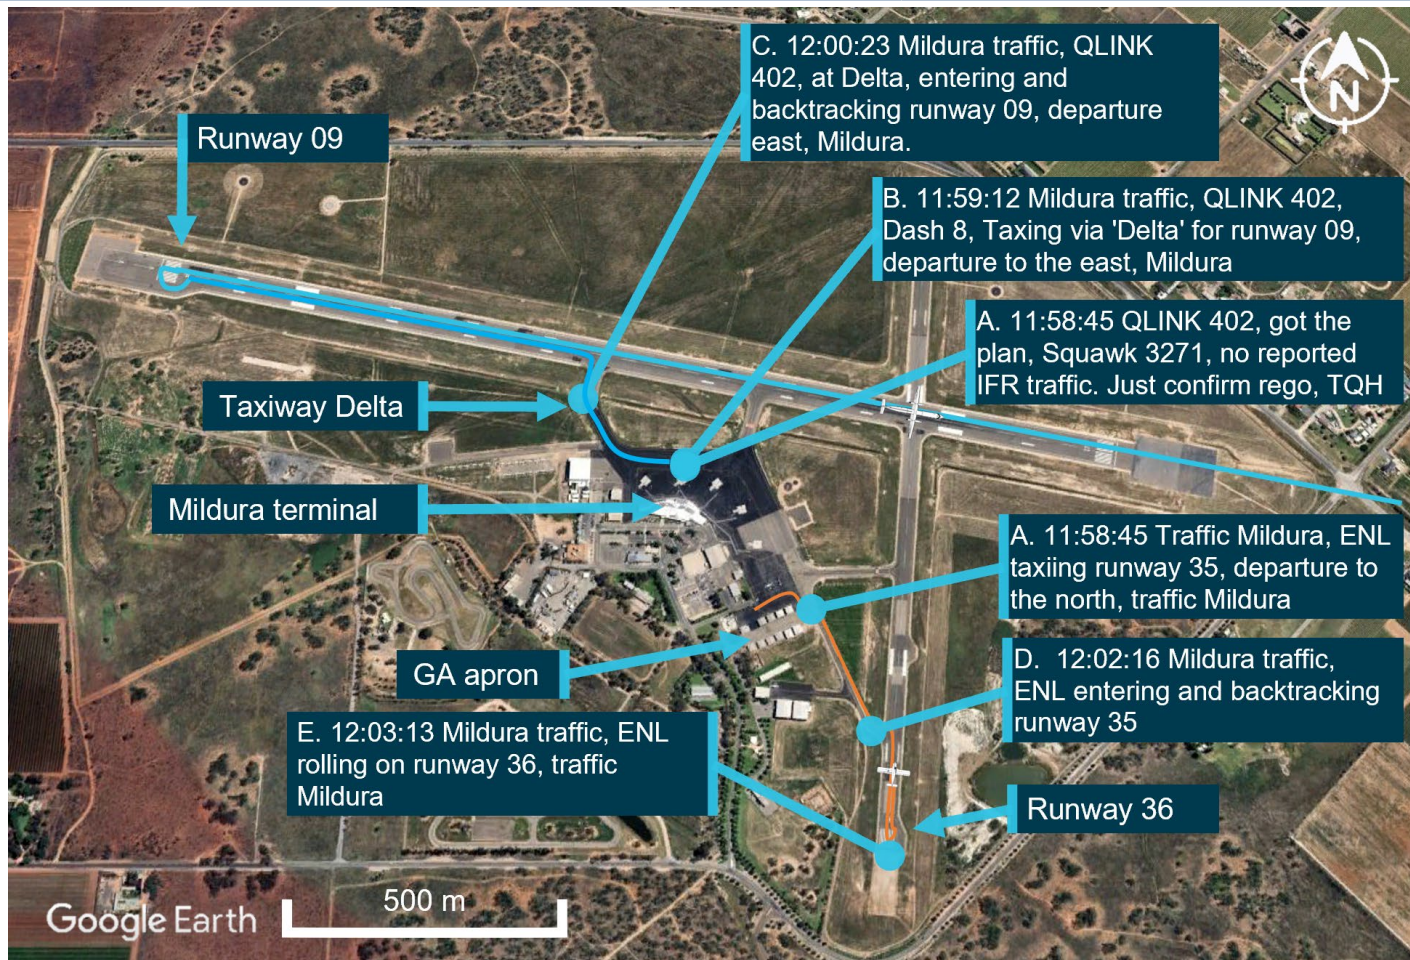
# Mildura 1 - What happened

- At about 1203 on 6 June 2023, QLINK 402, a Bombardier DHC-8-315, registered VH-TQH taxied runway 09 at Mildura for a regular passenger transport service to Sydney.
- The crew of VH-TQH commenced their take-off from runway 09.
- A short time later, the pilot of VH-ENL commenced their take-off from runway 36.
- At about rotation speed, the crew of VH-TQH identified a Piper PA-28-161, registered VH-ENL, becoming airborne on Runway 36.
- The pilot of VH-ENL observed VH-TQH airborne and climbing as it crossed runway 36 ahead of them.

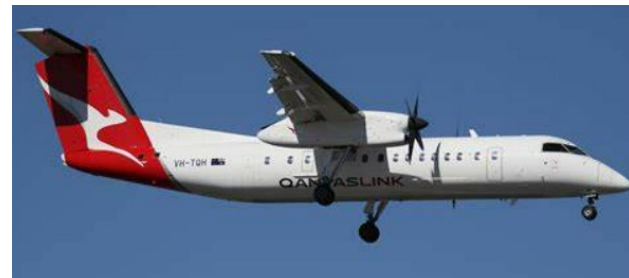
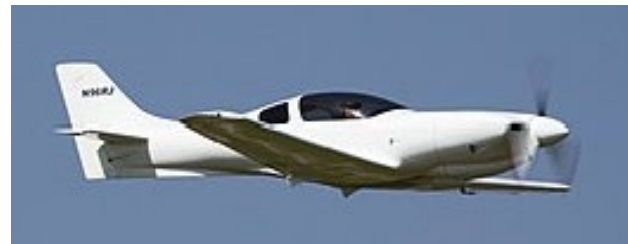
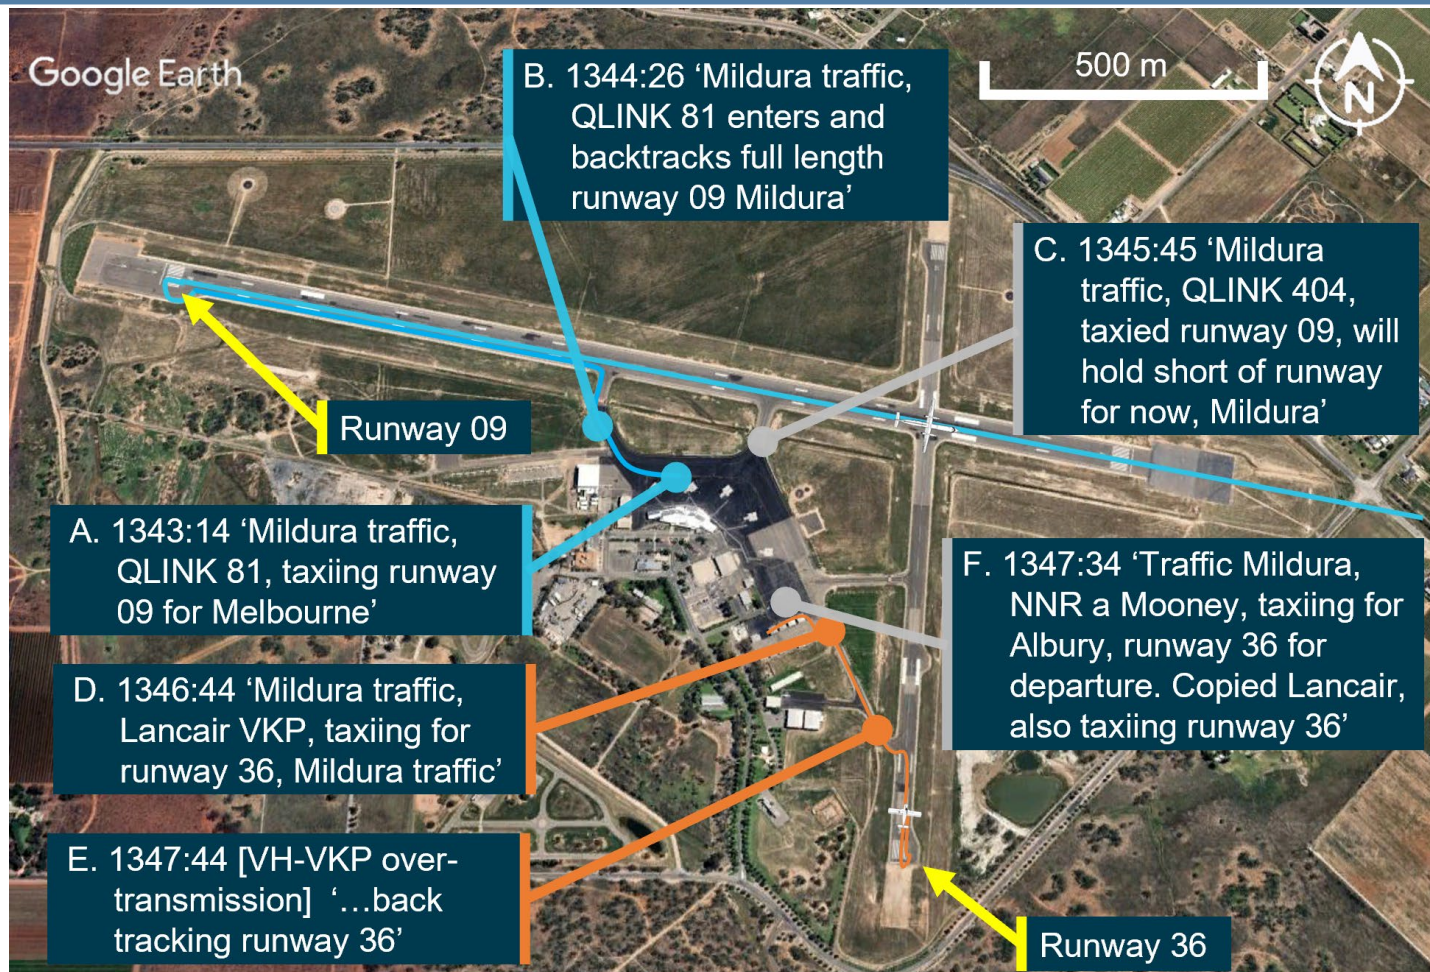
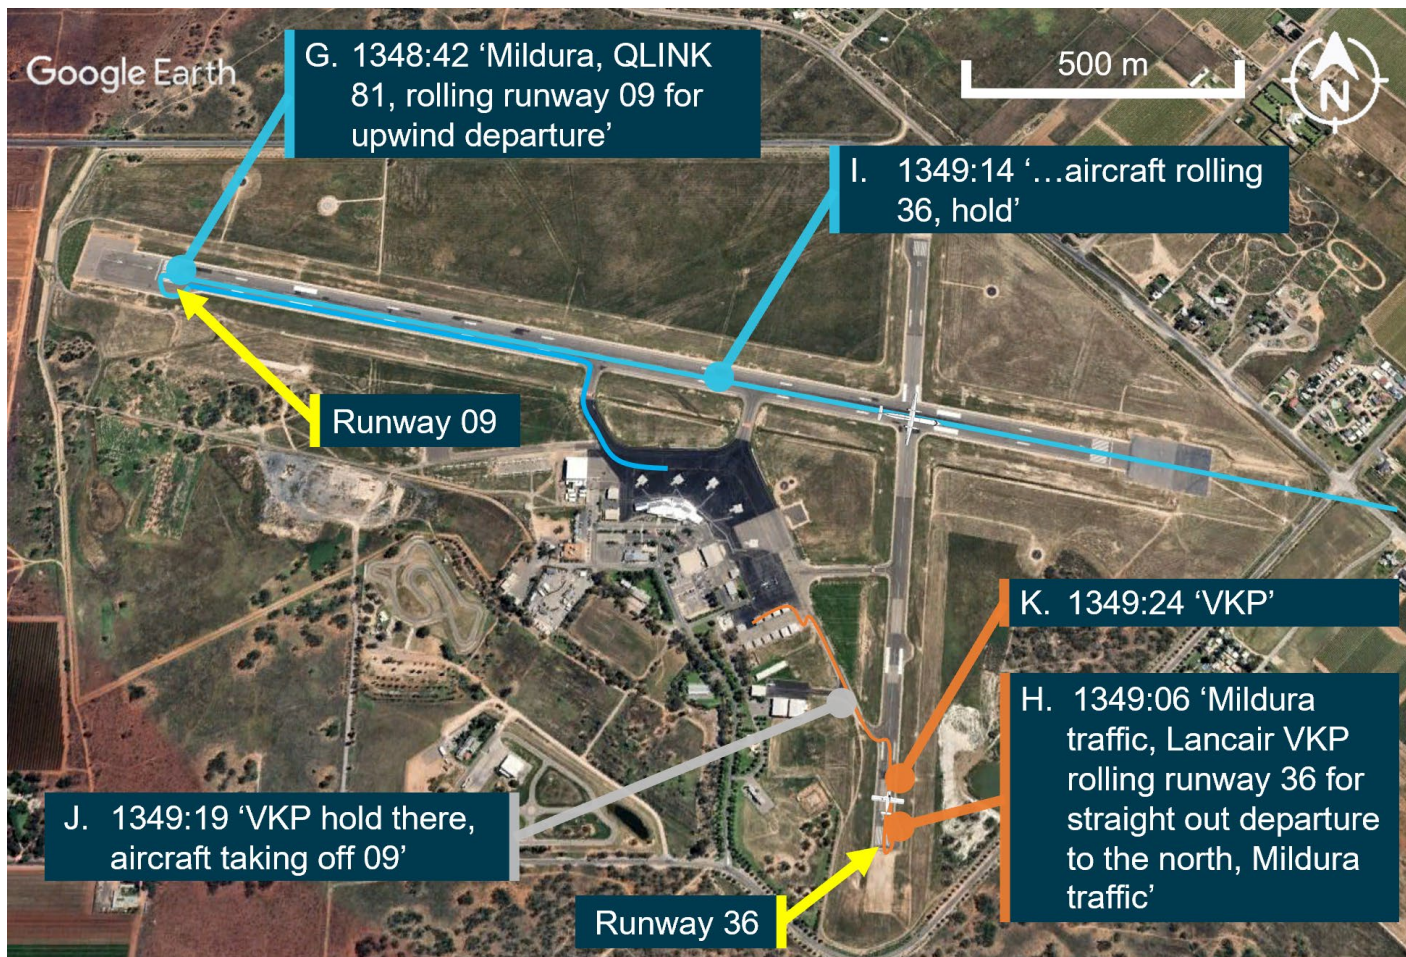
# Mildura 2 - What happened

- At about 1444 on 29 September 2023, QLINK 81, a Bombardier DHC-8, registered VH-TQZ taxied runway 09 at Mildura for a regular passenger transport service to Melbourne.

- The crew of VH-TQZ commenced their take-off from runway 09. A short time later, the pilot of VH-VKP gave a rolling call for runway 36. At about rotation speed, the crew of VH-TQZ identified the Lancair registered VH-VKP, about to roll on runway 36. A short sharp call was made to tell the Lancair to stop.

- Another aircraft taxiing behind the Lancair on runway 09, a Mooney, observed the collision pair and radioed the Lancair to hold on the runway due to departing aircraft on 09. The Lancair had not yet begun to roll.

- QLINK 81 did not hear any of the traffic taxiing and entering and backtracking on 09 and was focussed on airborne aircraft, the Lancair did not hear QLINK at all.

- All calls were recorded on the CTAF frequency with mostly readable transmissions

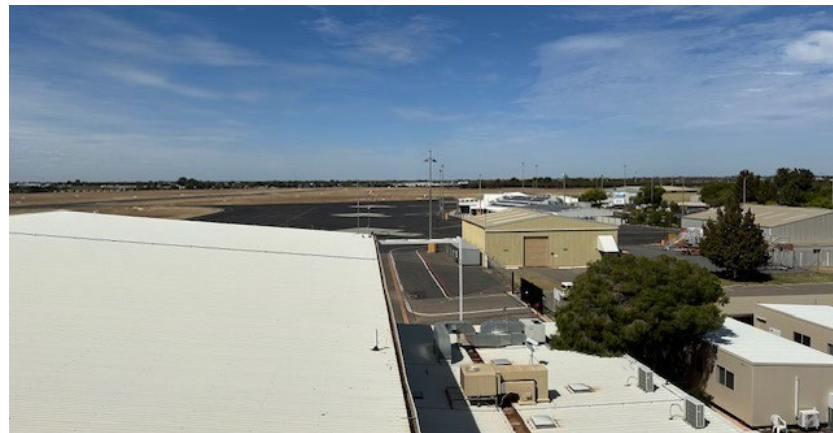
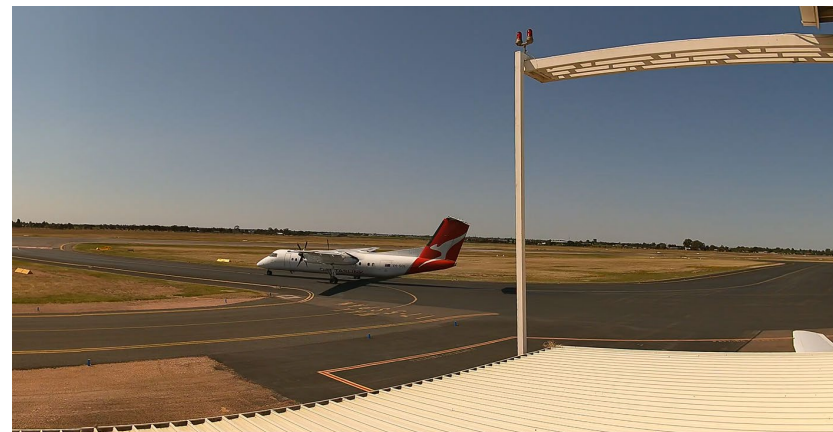
## Initial evidence gathering in Mildura 2 found

- that the operator suspected possible radio shielding due to buildings and conducted testing- which concluded that the aerodrome was the problem.
  - The aerodrome operator suspected radio issues with the aircraft from practical experience of on airport operations and provided their testing.
- In order to settle this, ATSB considered that independent testing had to be carried out
- We searched for historical examples of how this had been done in the past. Unable to identify that this style of testing had ever been conducted by ATSB, we were in uncharted territory
- Firstly, we would have to build a methodology for the testing regime, identify and involve affected stakeholders in the testing

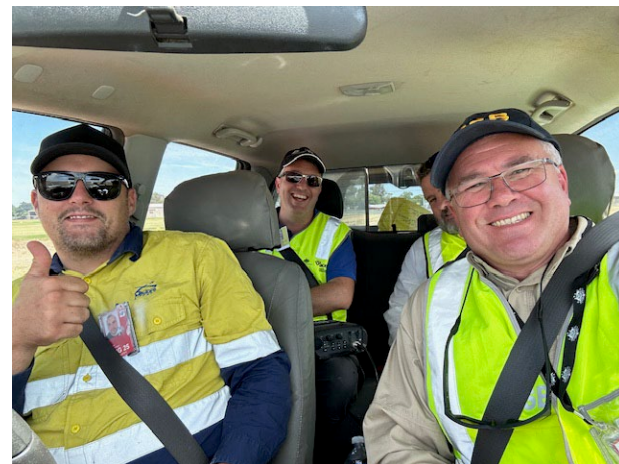
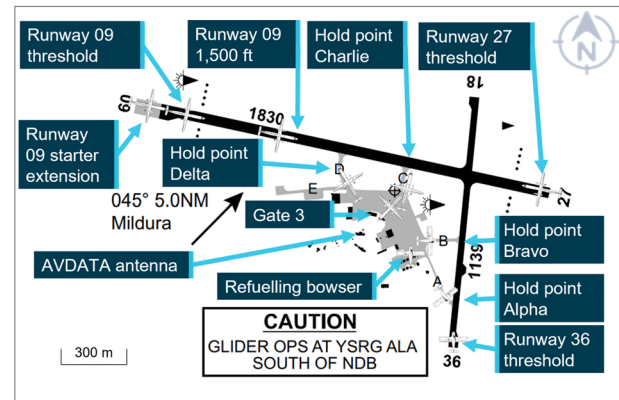
## Schedule 1 testing - What we found

The testing identified that between the radio transmission points on the aerodrome, the lesser the distance and greater the line of sight, the clearer the radio transmission was with a readability of 4 (readable with practically no difficulty) or more and signal strengths of greater than  $-70$  dBm.

The testing also identified that the most significant reduction in recorded signal strength and readability was received when transmitting greater distances at:

- Runway 36 to 09 thresholds, reduced readability to 3, slightly weaker signal strength
- Runway 27 to 09 thresholds, reduced readability to 3, slightly weaker signal strength
- Runway 09 threshold had slight general reduction in signal readability across all other runway thresholds and holding points but still perfectly readable, signal strength on average slightly reduced.

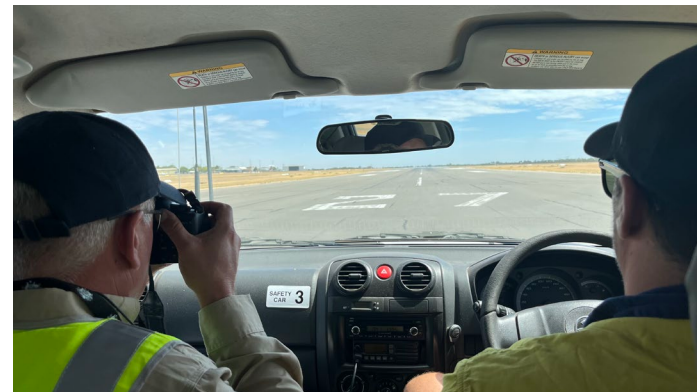
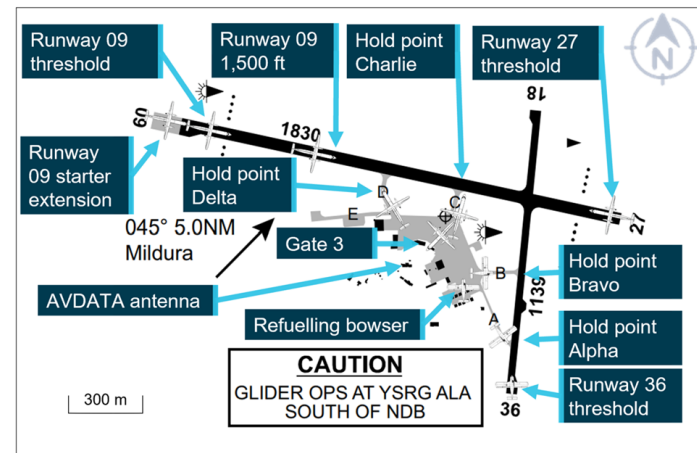
## Schedule 2 testing - What we found

The testing identified that the lesser the distance and greater the line of sight, the clearer the radio transmission was with a readability of 4 (readable with practically no difficulty) or more and signal strengths of greater than  $-70$  dBm.

The testing also identified that the most significant reduction in recorded signal strength and readability was received when transmitting greater distances and:

- from the Mildura fuel bowser to the threshold of runway 09, which may be indicative of close proximity hangar shielding
- when receiving from the fuel bowser, a general reduction in signal strength to taxiways and the runway 09 threshold

However, the readability scores in this testing did not score less than 3 (readable with considerable difficulty).

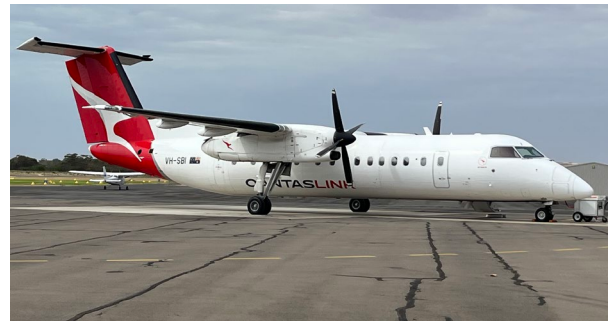
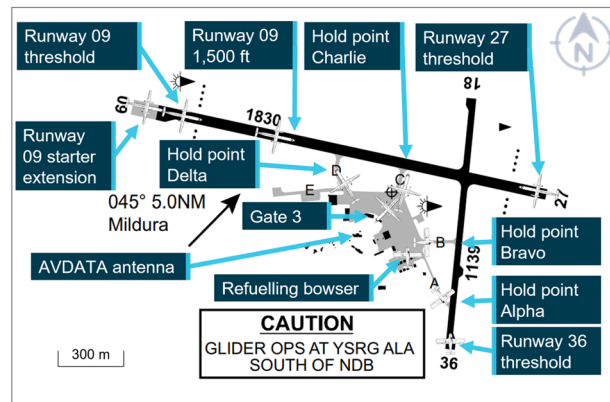
## Schedule 3 testing - What we found

The testing identified that the most significant reduction in recorded signal strength and readability was received when transmitting greater distances such as:

- receiving and transmitting from the runway 09 starter extension to the runway 36 threshold on VHF COM 2 scored a readability assessment of 2 (readable now and then), and signal strength weaker than the  $-70$  dBm acceptable signal strength limit
- receiving and transmitting from the runway 09 threshold to the runway 36 threshold on VHF COM 2 with a readability of 1 (unreadable), and  $-85$  dBm signal strength, 15 dBm weaker than the acceptable signal strength of  $-70$  dBm
- receiving transmissions from the 09 threshold or starter extension to taxiway Alpha on VHF COM 2 with a readability of 1 (unreadable), and  $-85$  dBm signal strength, 15 dBm weaker than the acceptable signal strength of  $-70$  dBm

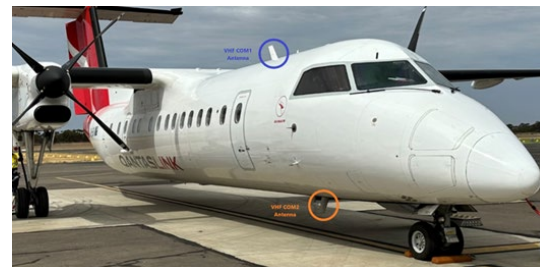
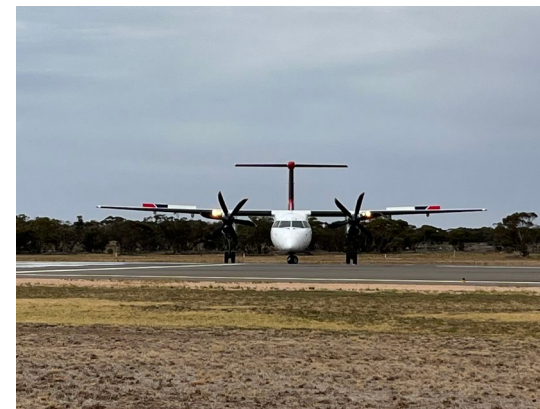
It was identified that transmission and reception from the Dash 8 were considered 1 (unreadable) from the runway 09 threshold to the runway 36 threshold on VHF COM 2, while these were 5 (perfectly readable) to 4 (readable with practically no difficulty) on VHF COM 1.

General trends identified from schedule 3 testing were that:

- Dash 8 VHF radio readability was most adversely affected by stations transmitting from directly behind the Dash 8 on both VHF COM 1 and 2 with slightly reduced readability and increasing signal weakness with increasing distance.
- VHF radio readability was adversely affected by increased distance between the ground-based stations, this was more evident on VHF COM 2, leading to unreadable radio signal readability and weaker signal strength.
- VHF readability was somewhat adversely affected from the runway 27 threshold to the runway 09 threshold using VHF COM 2, however Dash 8 reception from the runway 09 threshold reduced further to become only 2 (readable now and then).

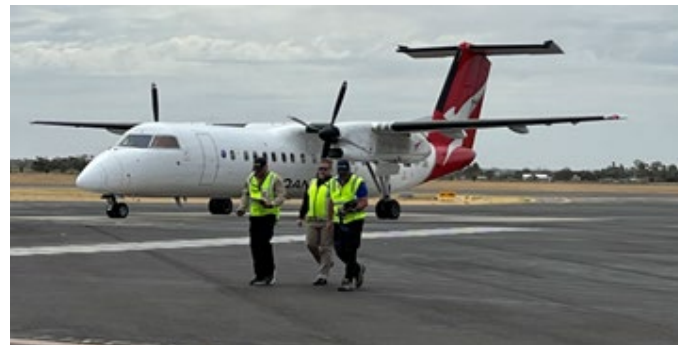
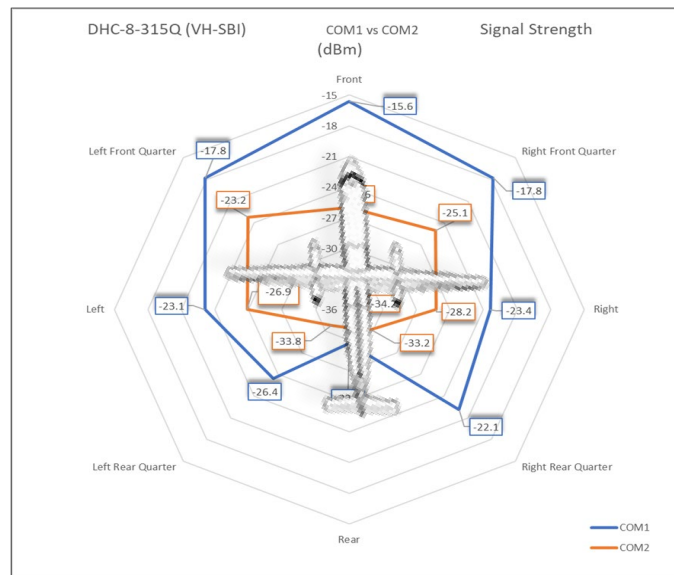
## Schedule 4 Testing- What we found

- The signal strength was strongest towards the front of the aircraft and weakest to the rear using VHF COM 1
- The signal strength of VHF COM 2 was consistently less (greater than half strength) at all locations with the VHF COM 2 maximum loss ( $-10$  dBm) at the front and right rear quarter most notable.
- The lowest VHF COM 1 strength ( $-32.7$  dBm) was recorded at the direct rear of the aircraft and was consistent with similar levels to VHF COM 2
- transmissions on VHF COM 2 on the ground had significantly reduced strength compared to VHF COM 1 and that radio reception and transmission strength to the rear of the aircraft was reduced on both VHF COM1 and VHF COM 2.
