Challenges in Material Selection for Repair and Re-manufacture

A study of the sometimes hidden complications associated with the selection of materials for customised repair, remanufacture or restoration schemes.

Cessna 404 *Titan,* VH-ANV Jandakot Airport, WA 11 August 2003

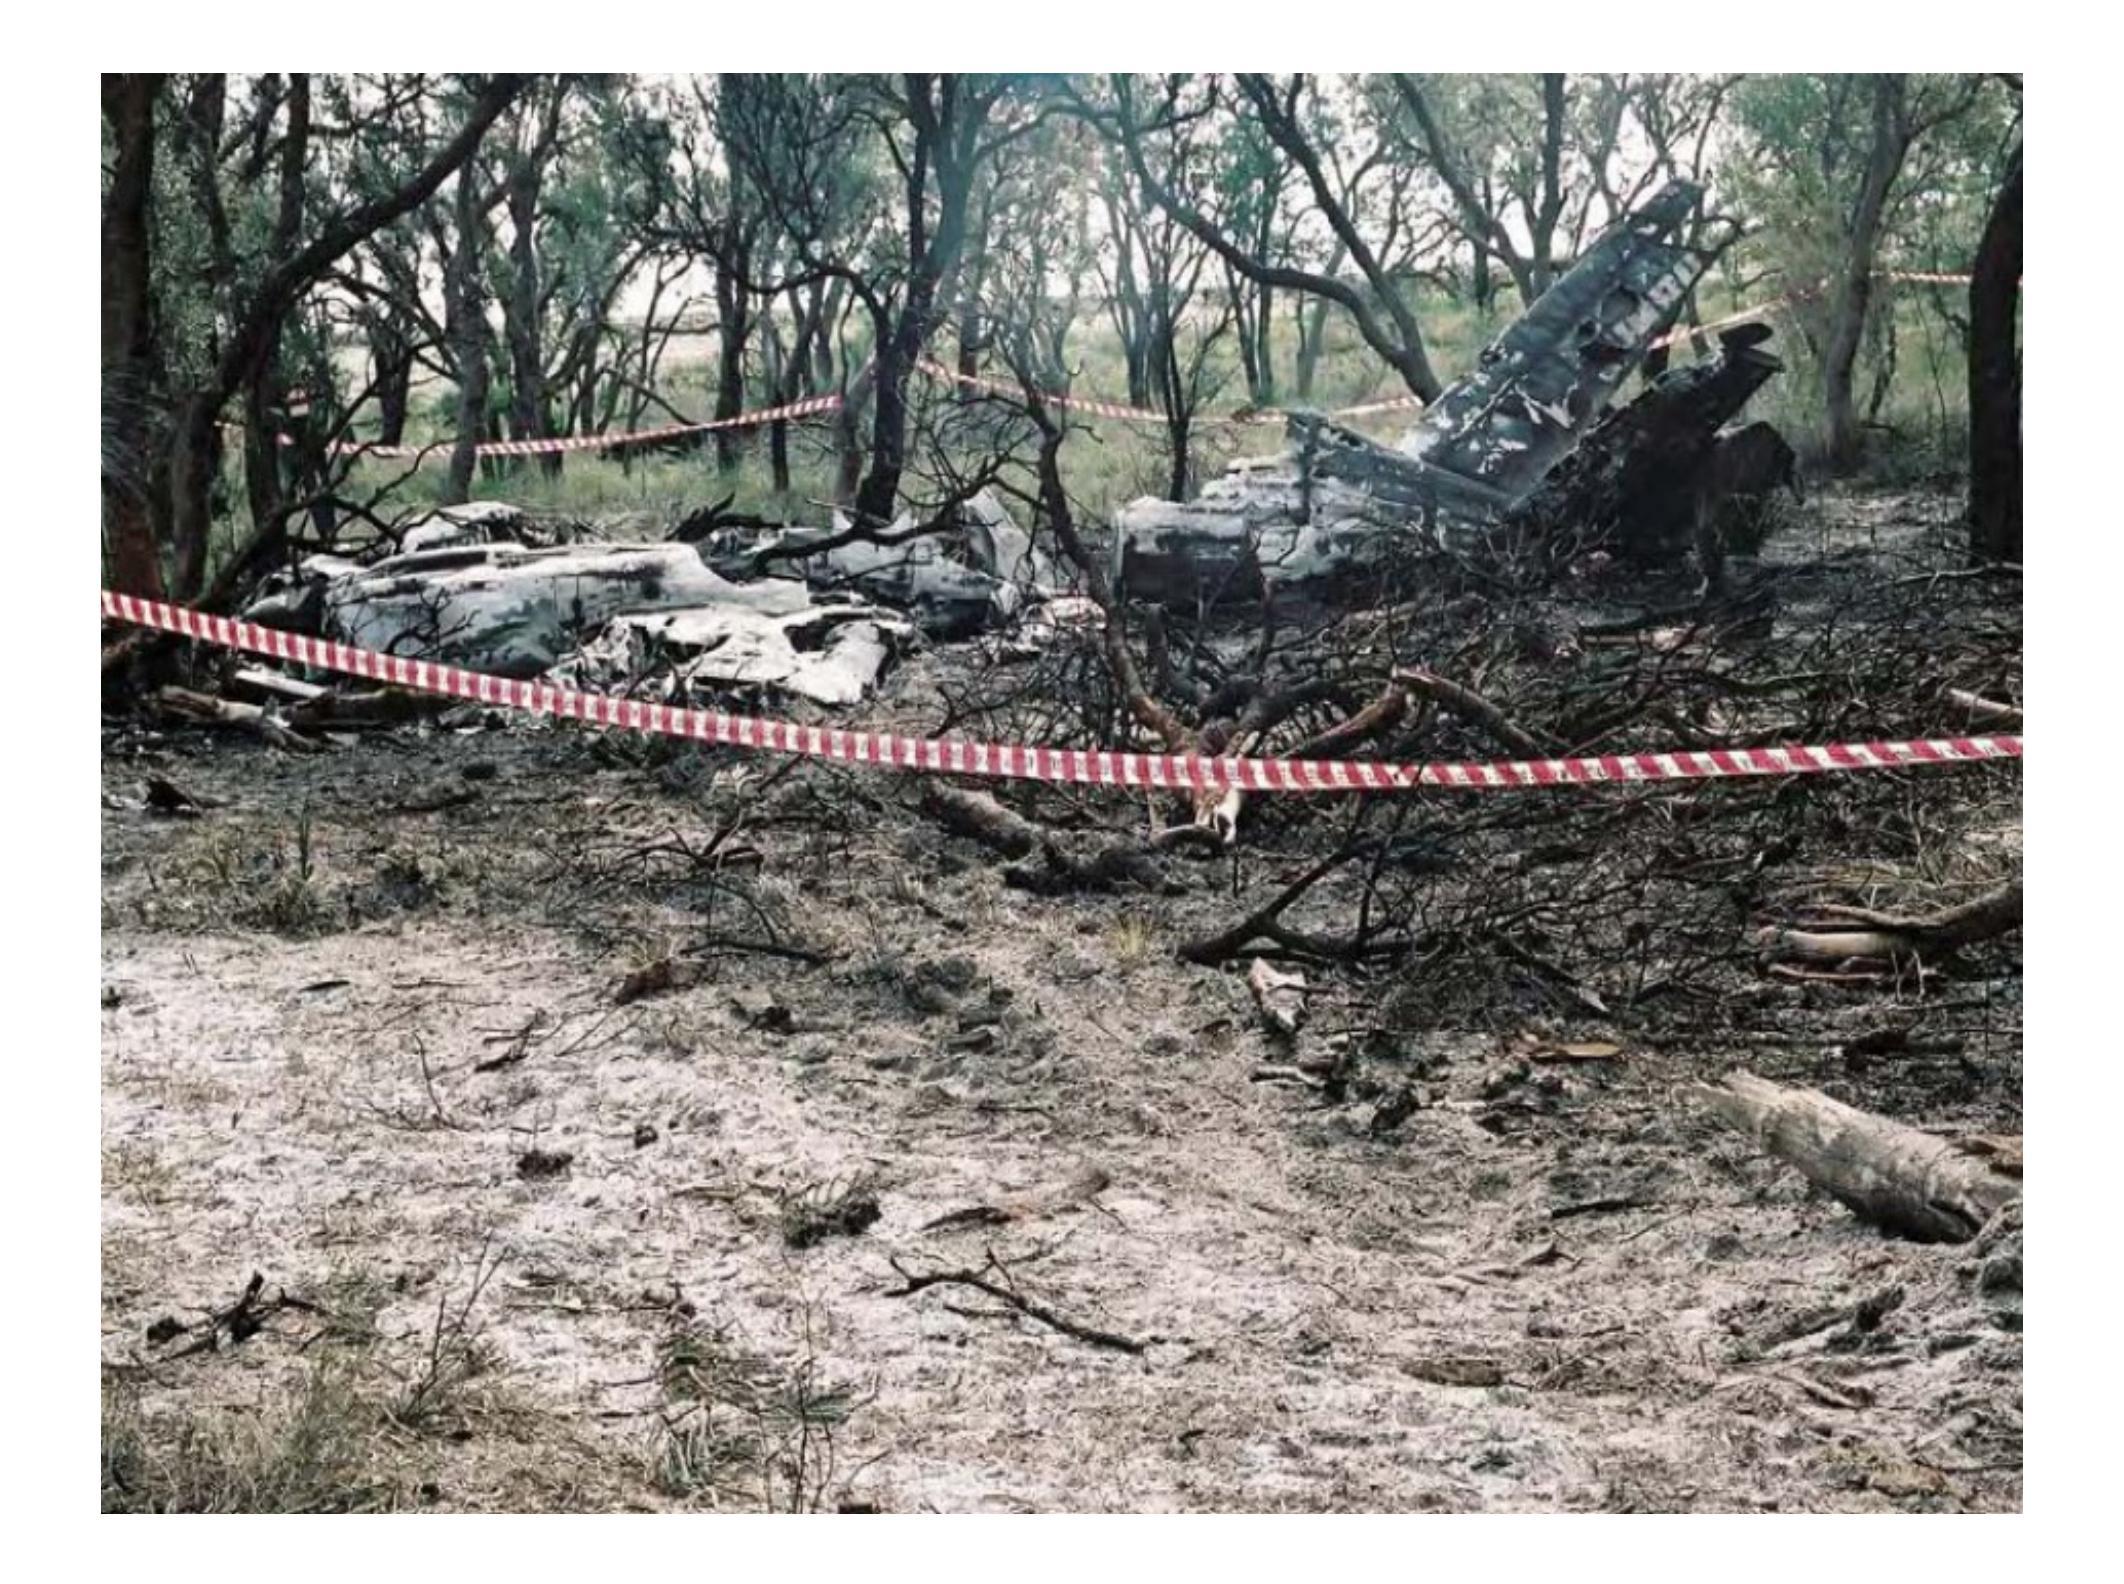
- •Departed Jandakot on a geotechnical survey flight, 6 pob + equipment - estimated MTOW margin 37 kg
- •Right engine lost power soon after rotation & was secured
- •Partial circuit completed, aircraft lost altitude and impacted trees and terrain
- •4 pax and the pilot escaped aircraft with burns one died from injuries 85 days later.

High voltage power transmission lines Aircraft wreckage

Tree contact

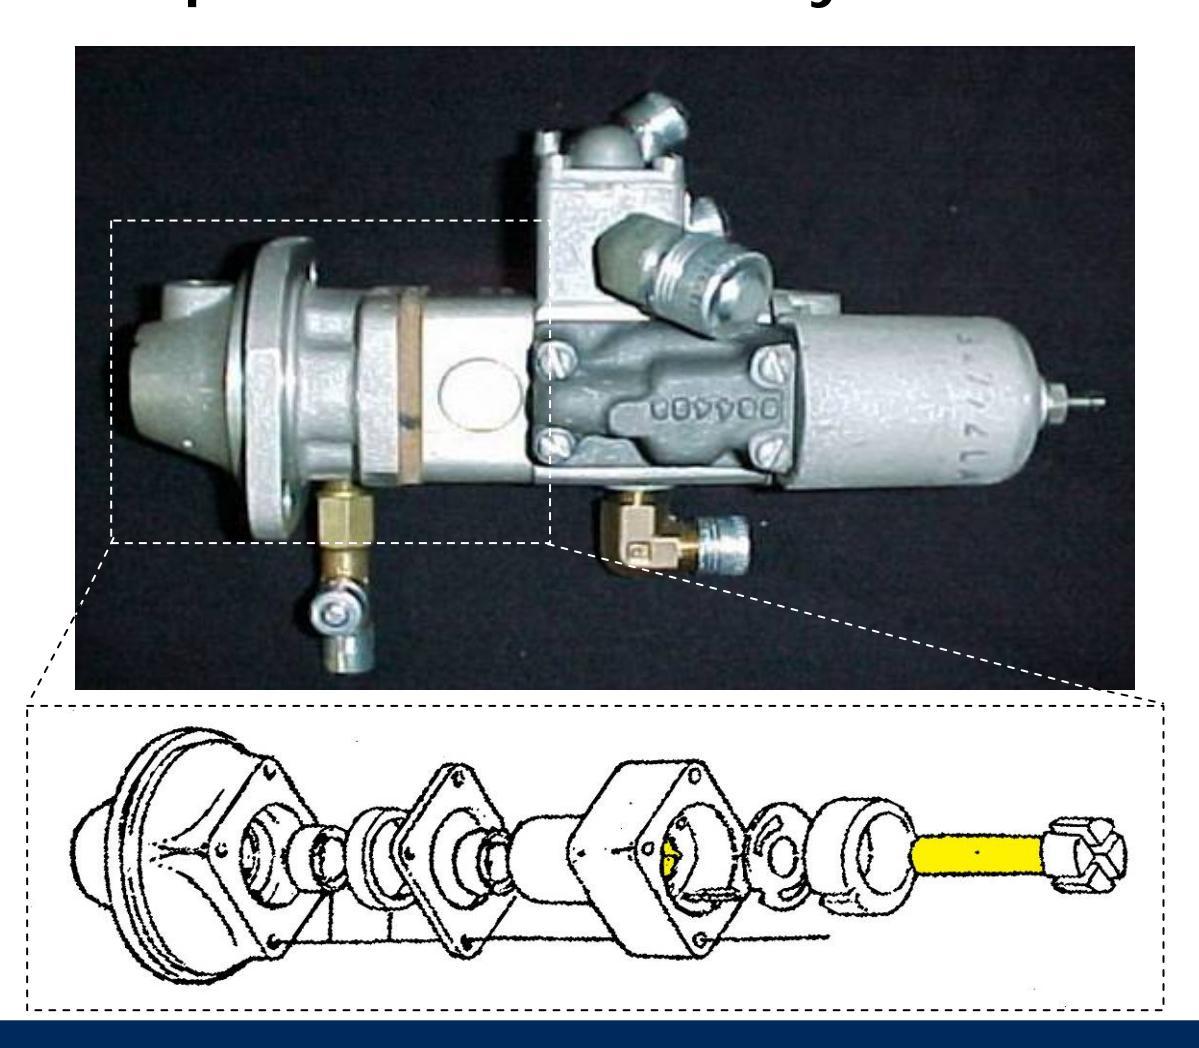
Cessna 404 *Titan,* VH-ANV Fuel Pump Failure: Assembly

•Right engine lost power due to fuel starvation, after the seizure of the right engine-driven fuel pump (EDFP)

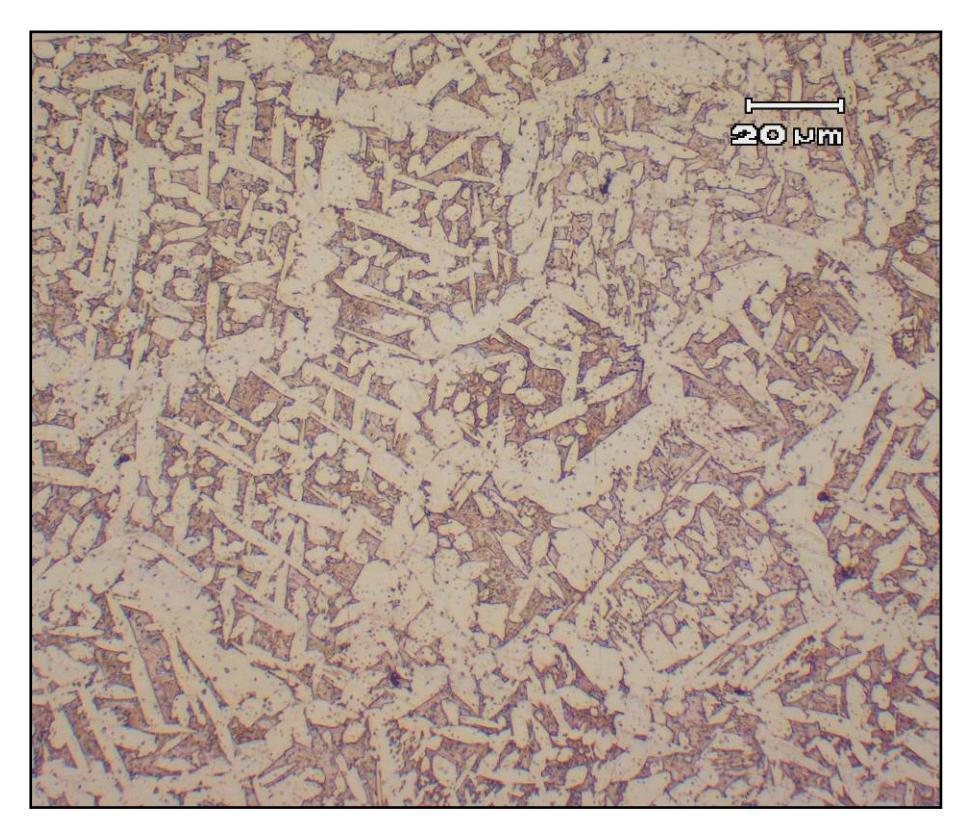
Cessna 404 *Titan,* VH-ANV Fuel Pump Failure: Bearing Materials

Analysis of the failed right pump sleeve bearing material showed it to be a Cu-Al-Fe-Ni alloy (**Aluminium Bronze**), with a typical hardness of ~190 HV_{10} and microstructure of Widmanstatten α -phase, in a β -phase matrix.

•The EO specified Aluminium Bronze as the material for sleeve remanufacture, yet the intent was a like-for-like replacement.

•No analysis or investigation of the OEM bearing material had been undertaken.

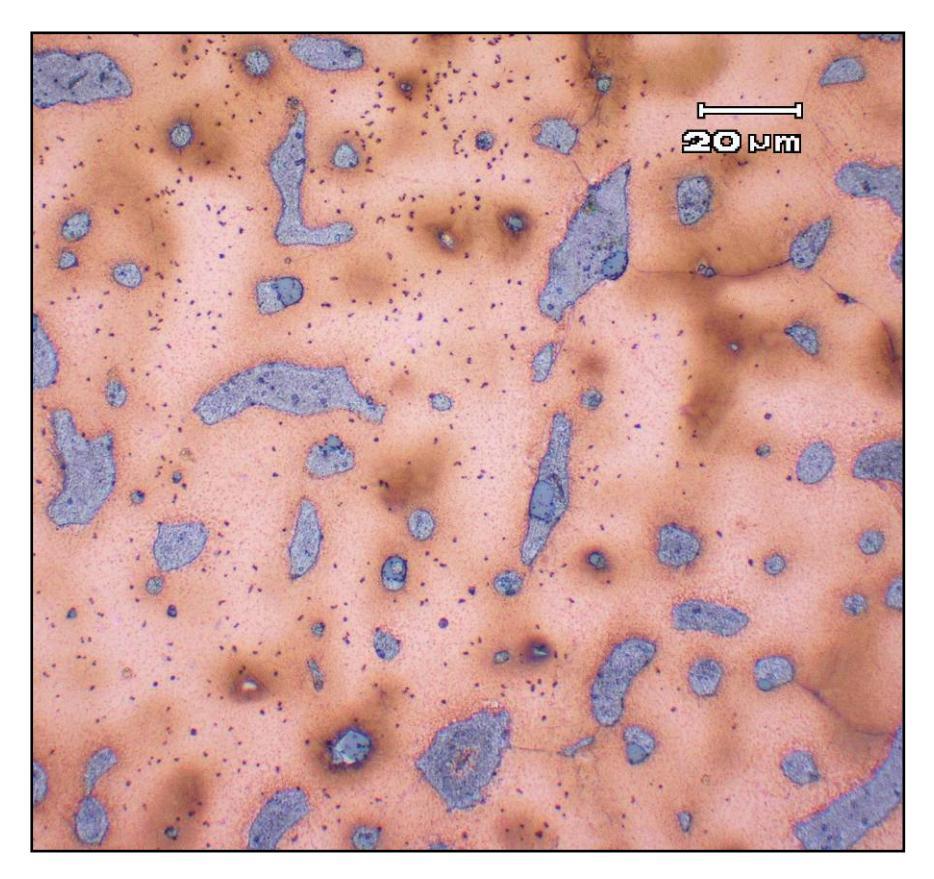
Cessna 404 *Titan,* VH-ANV Fuel Pump Failure: Bearing Materials

Comparative analysis of the serviceable left pump sleeve bearing material showed it to be a Cu-Pb-Sn alloy (Leaded Bronze), with a typical hardness of ~50 HV_{10} and microstructure of lead islands in a copper-tin matrix.
