Li-Ion Batteries, SMS and Incidents

ANZSASI

Michael Burdick

June 2017

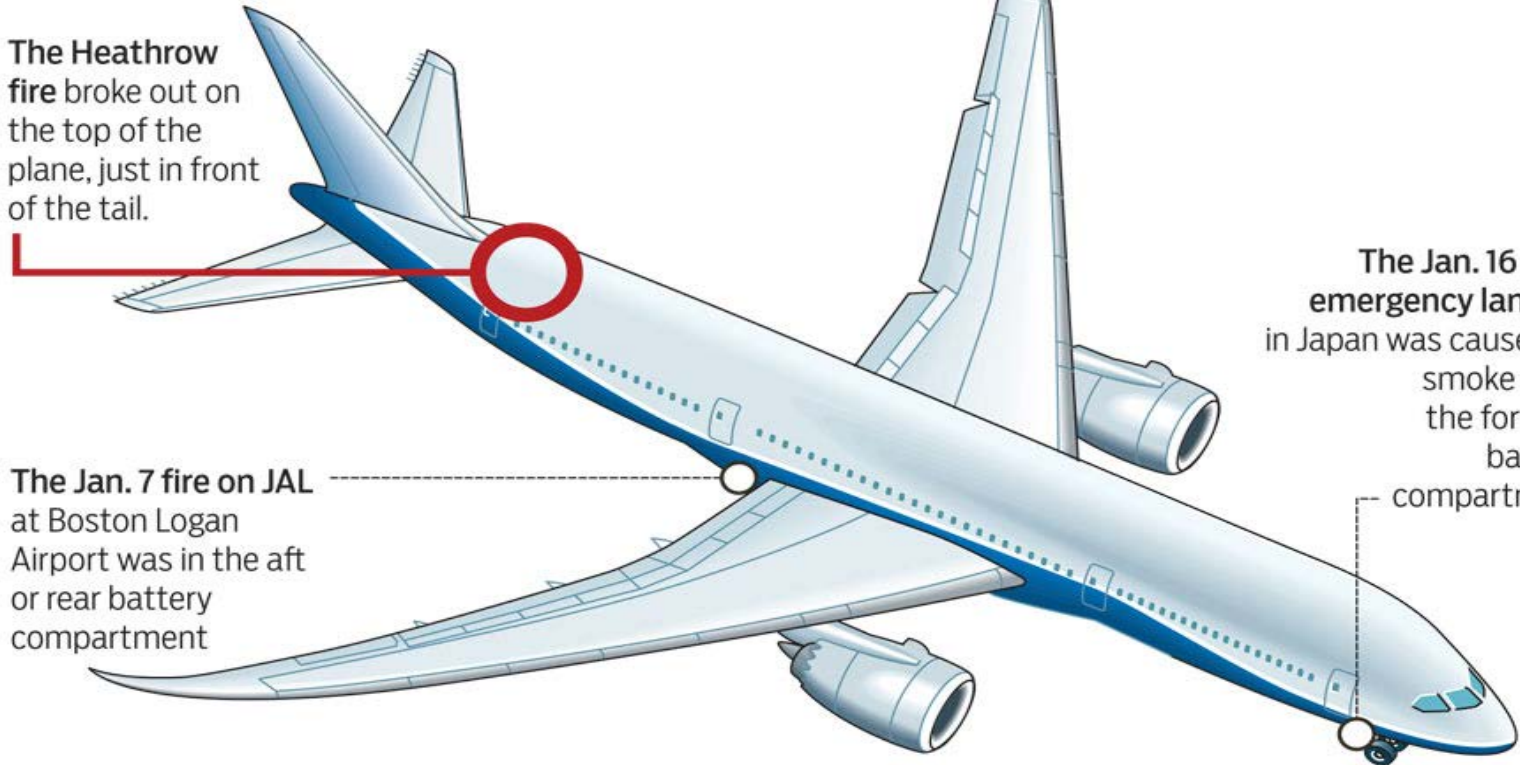
The Heathrow fire broke out on the top of the plane, just in front of the tail.

The Jan. 16 ANA emergency landing in Japan was caused by smoke from the forward battery compartment

The Jan. 7 fire on JAL at Boston Logan Airport was in the aft or rear battery compartment

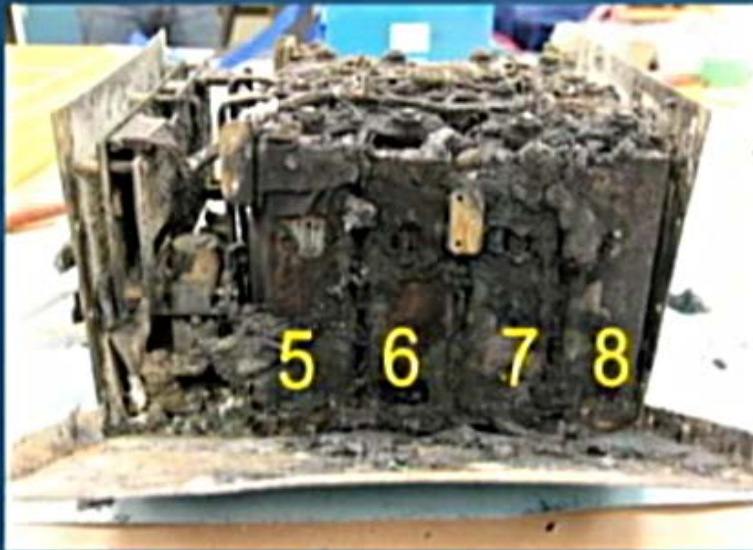
Cells on the left side

Substantial thermal damage

Battery in Japan Airlines Boeing 787 that caught fire in Boston.
January 7, 2013

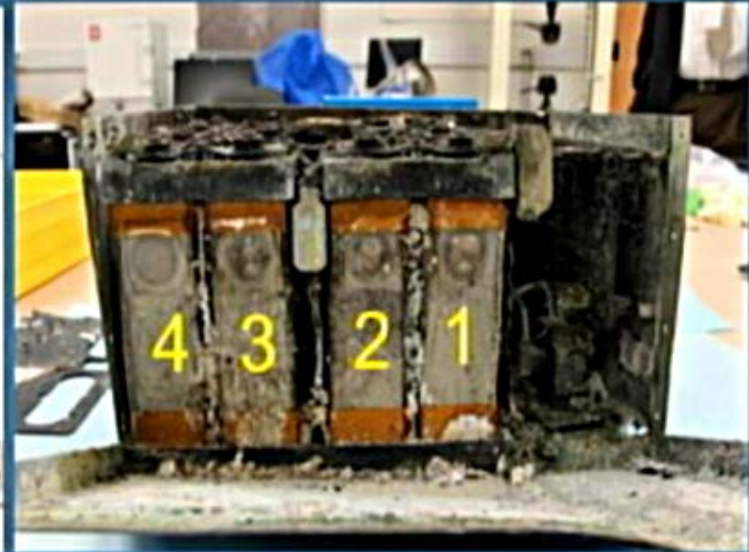
Cells on the right side

Moderate thermal damage

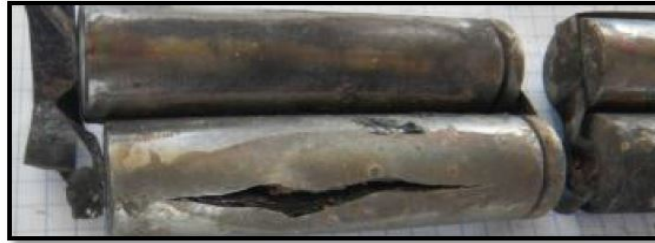
Fire damaged remains of battery pack with a fractured cell

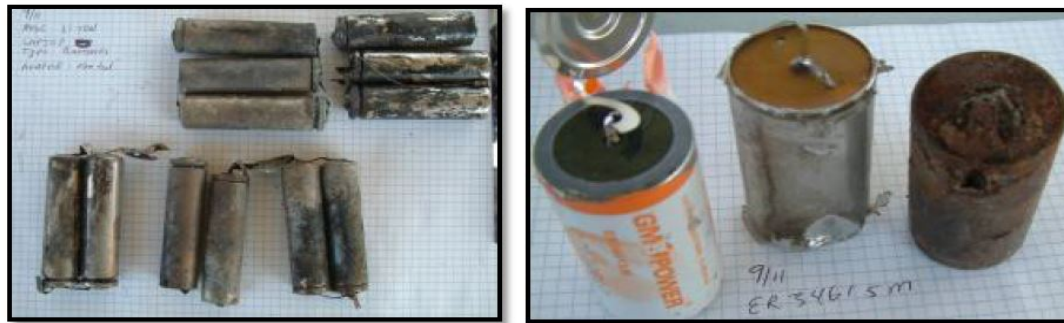
Additional battery pack remains [LH]/D-Cell size lithium primary batteries. Photo shows fire damaged and undamaged batteries [RH]

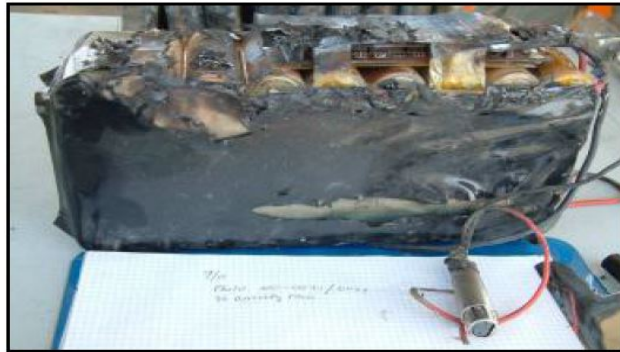
36-cell lithium-ion battery pack with thermal damage.

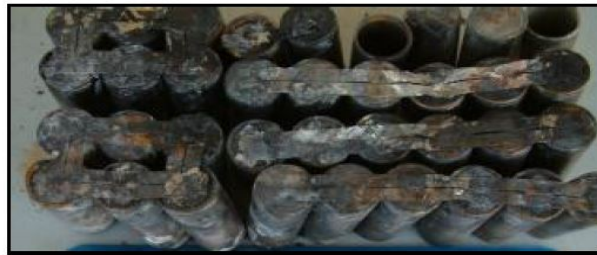
36-cell lithium-ion battery pack with multiple vented cells

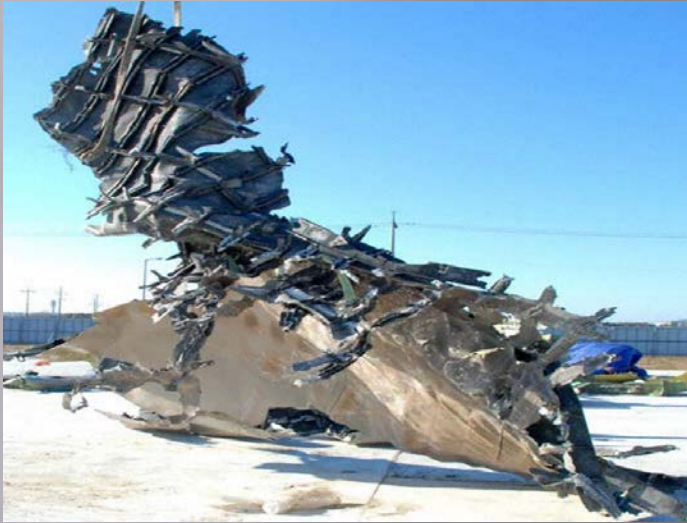
Burnt through skin panel (Photo: ARAIB)

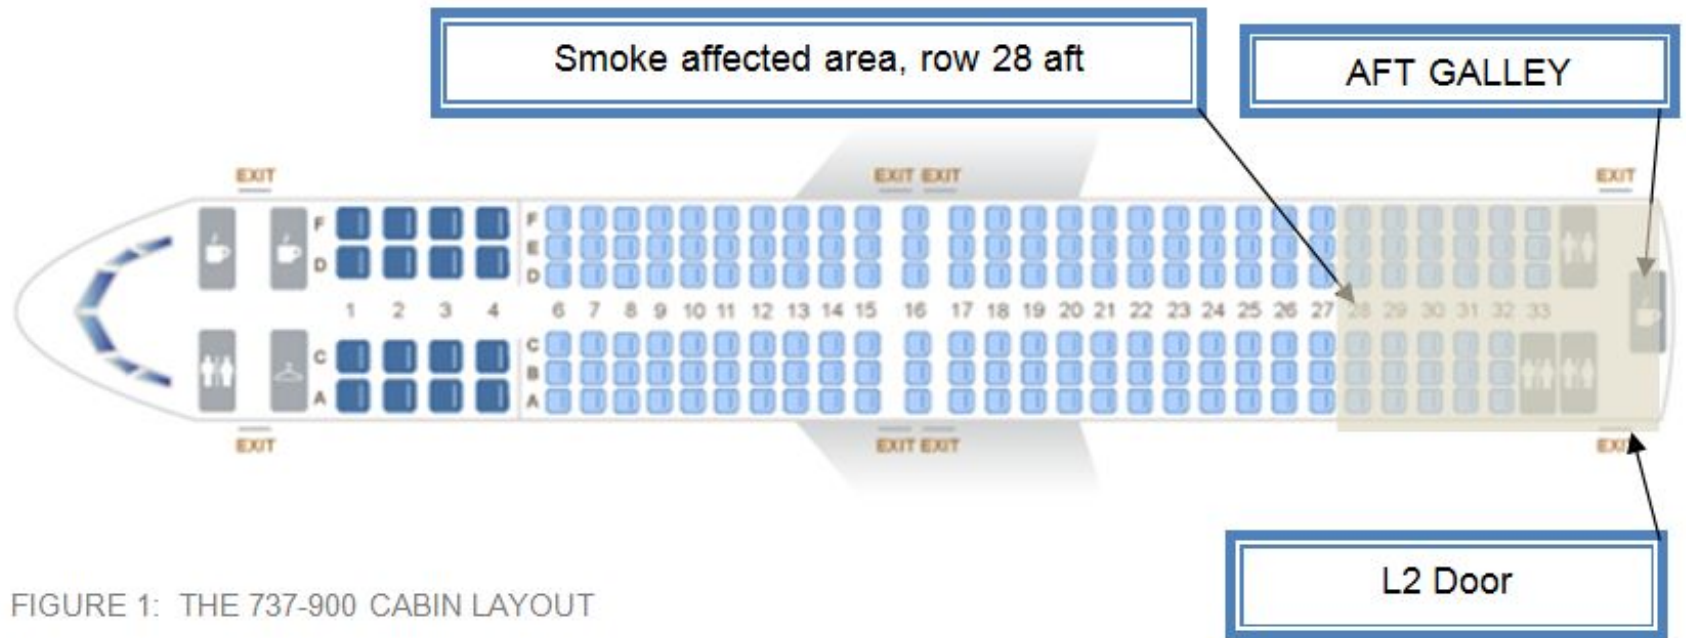
FIGURE 1: THE 737-900 CABIN LAYOUT

SMOKE AFFECTED AREA
