ENGINEERING ANALYSIS

Garrett TPE 331 engine turbine failure

The engine was fitted to a Metro II aircraft engaged in a freight run.

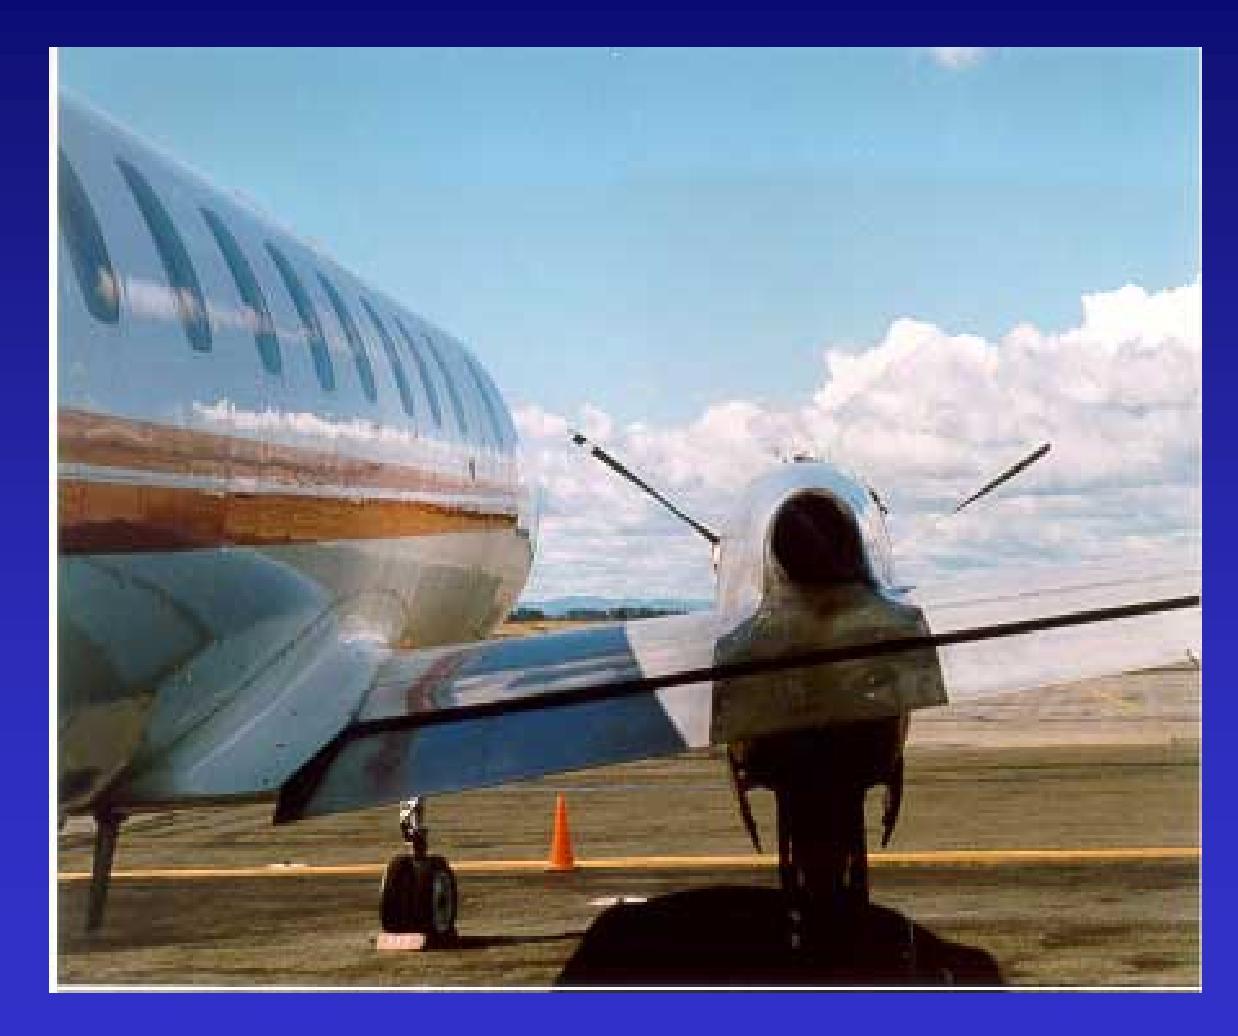
Fragments of the turbine punctured three holes into the right engine cowling indicating that the turbine disintegrated into three major fragments.

Their location was indicative of a 2nd stage turbine failure.

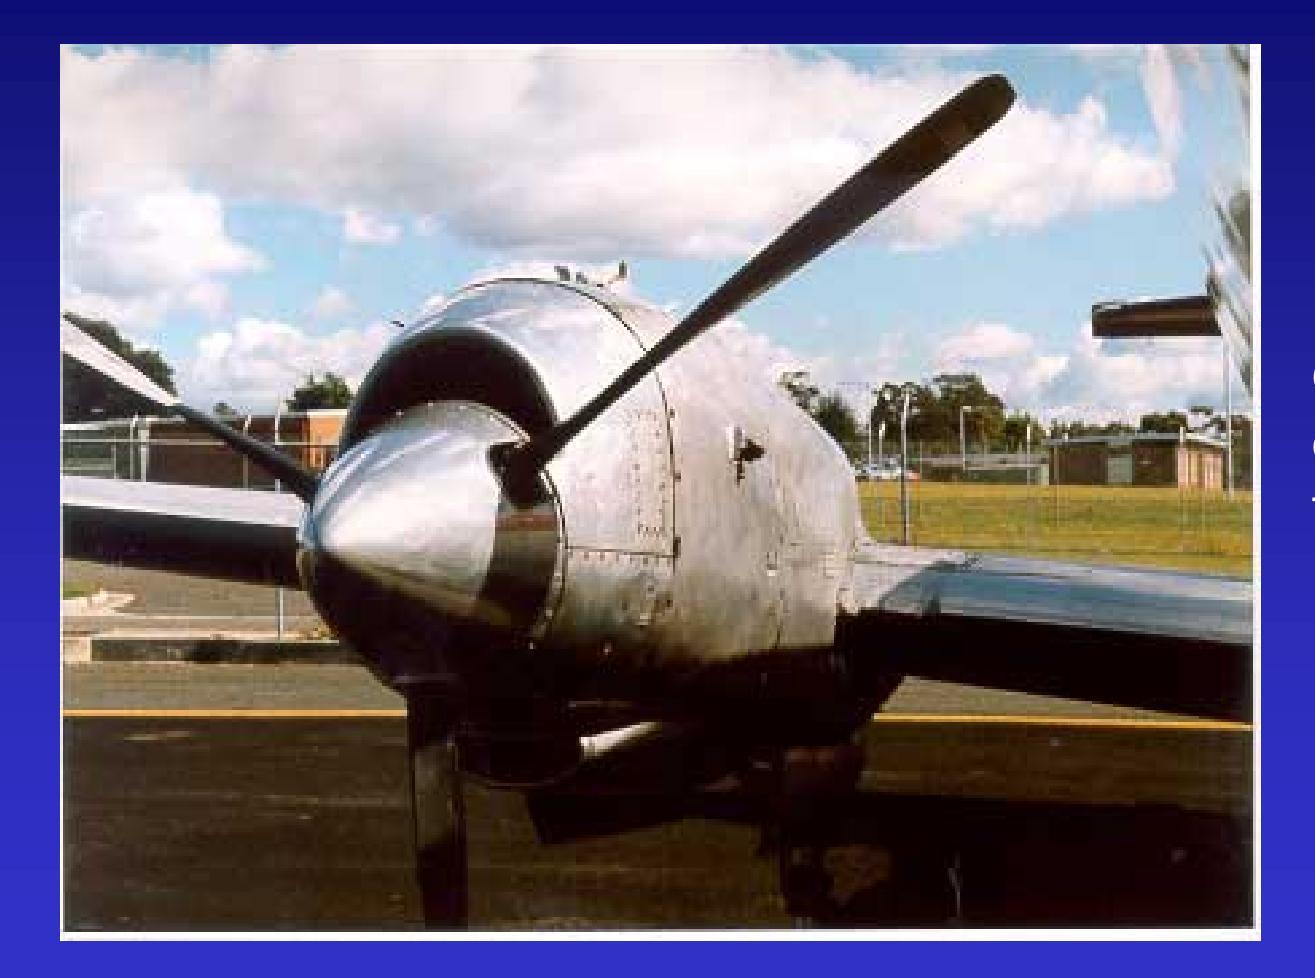
One hole was directly opposite the fuselage.

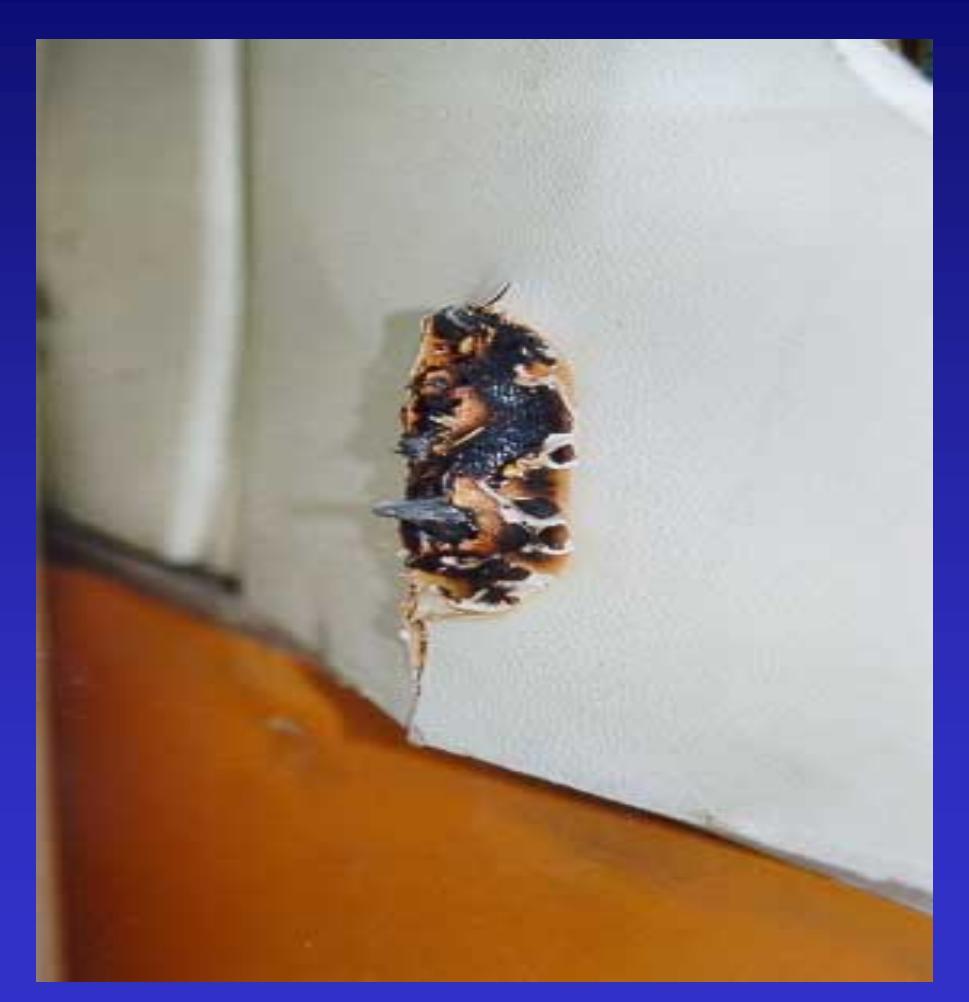
A fragment remained embedded in the fuselage, becoming caught between the outer skin and the inner lining.

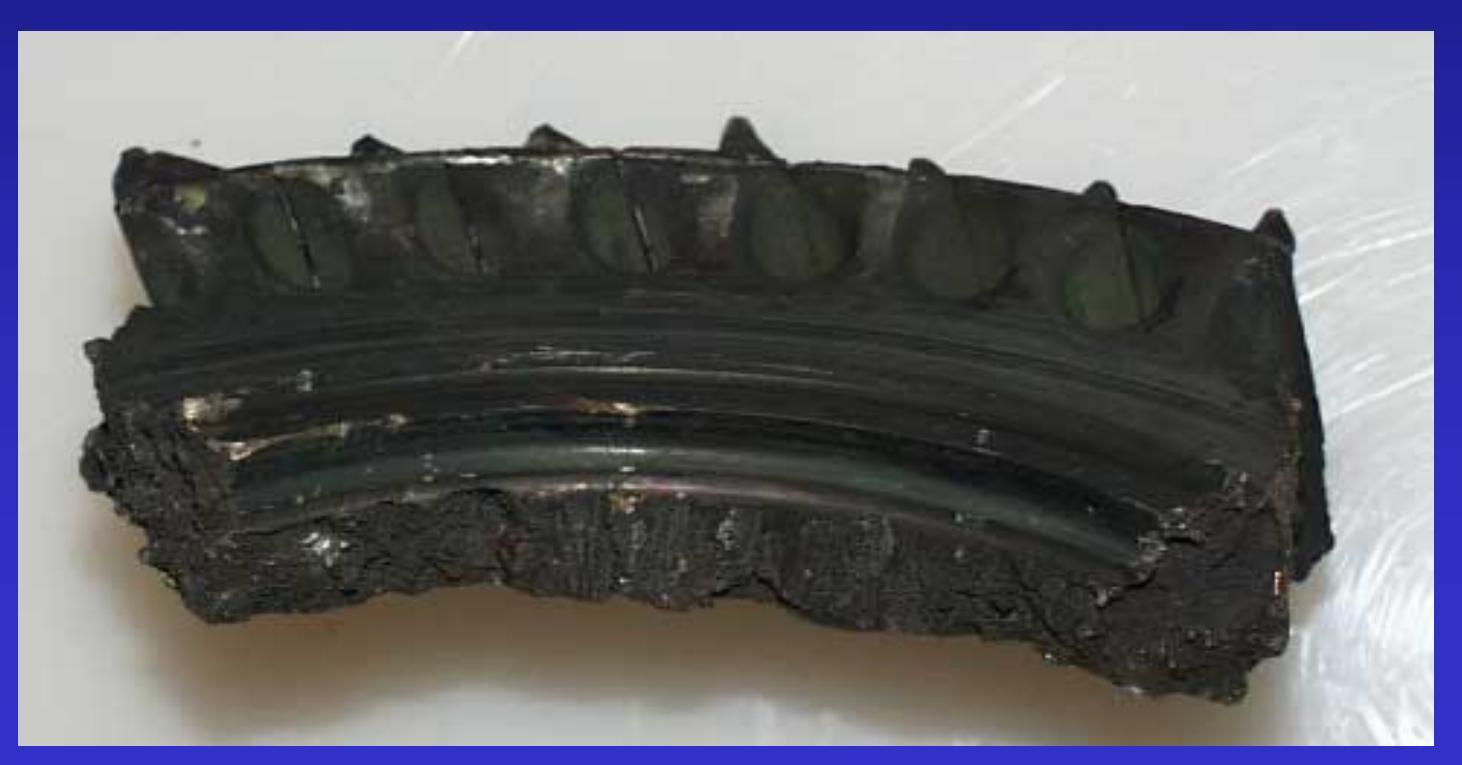
It was the only fragment of a substantial size recovered, the other two major fragments were lost.

The 2nd stage turbine has 39 blades; the recovered section contained the remains of 7 blades.

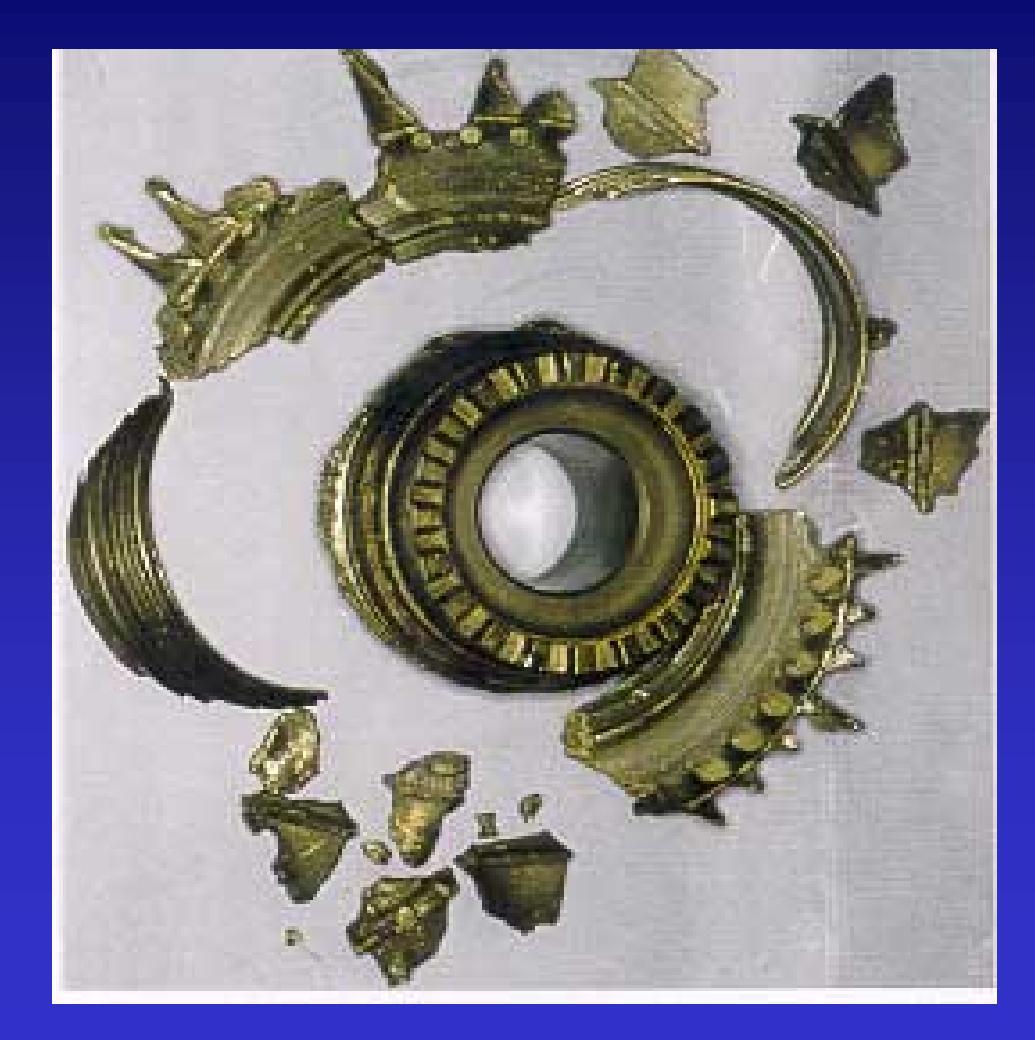
Uncontained failure of the 2nd stage turbine disc was confirmed.

A further two fragments, consisting of three blades, and a number of smaller fragments were found caught under the cowling and later during the engine strip.

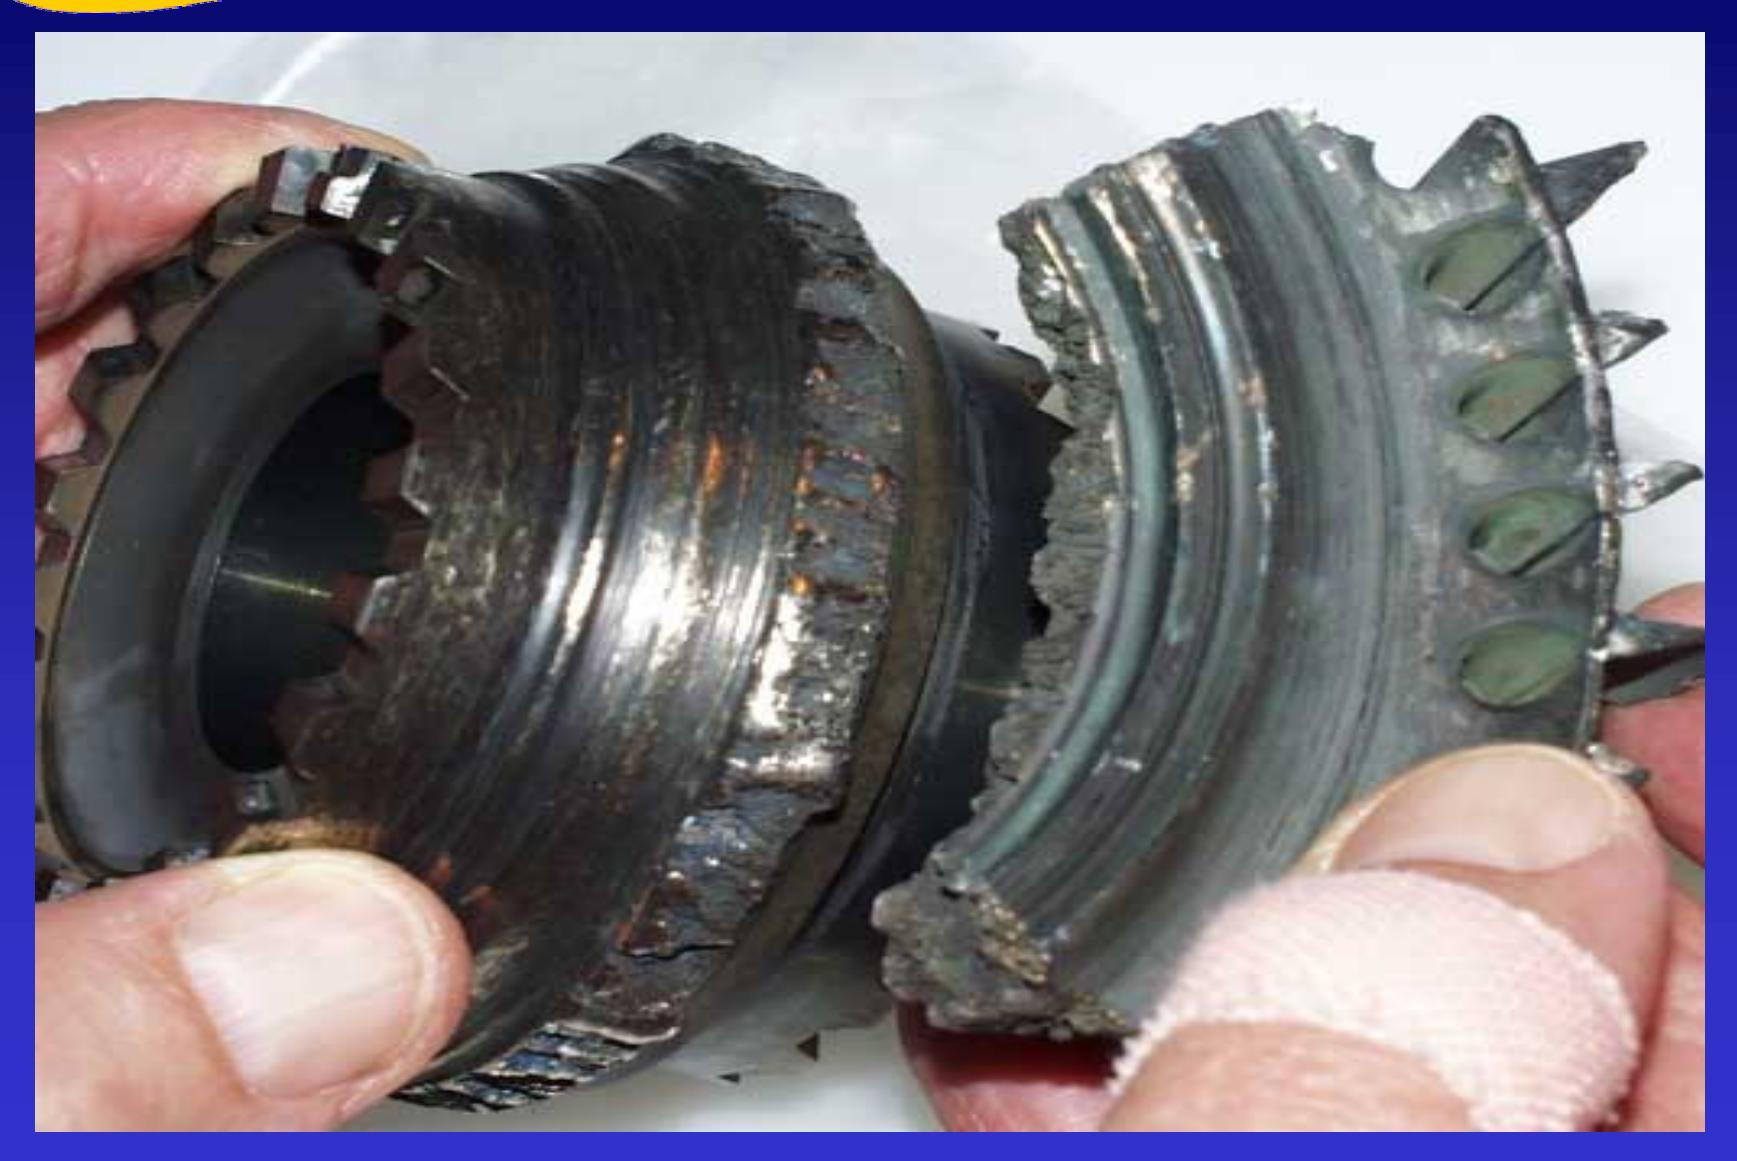
It was observed that the wheel cross section near the transition from the wheel hub to web was significantly reduced.

The fracture ran through the thinnest part of the disc.

The reduction of the cross section took part along a smooth, regularly formed surface line.

It gave an impression of having been purposefully made during disc manufacture.

The surface appearance and finish were identical to those of the rest of the disc.

The ATSB material specialist recognised that the cross section reduction might have been a product of a sliding contact between the disc and fragments of the split labyrinth seal.

The pieces could be positioned so that they matched perfectly with the shape of the disc.

The sliding contact would have to be present over an extended period of time.

Reduction of the cross section increased the stress loads within the disc, until the stress exceeded the remaining material load bearing capabilities and the disc failed.

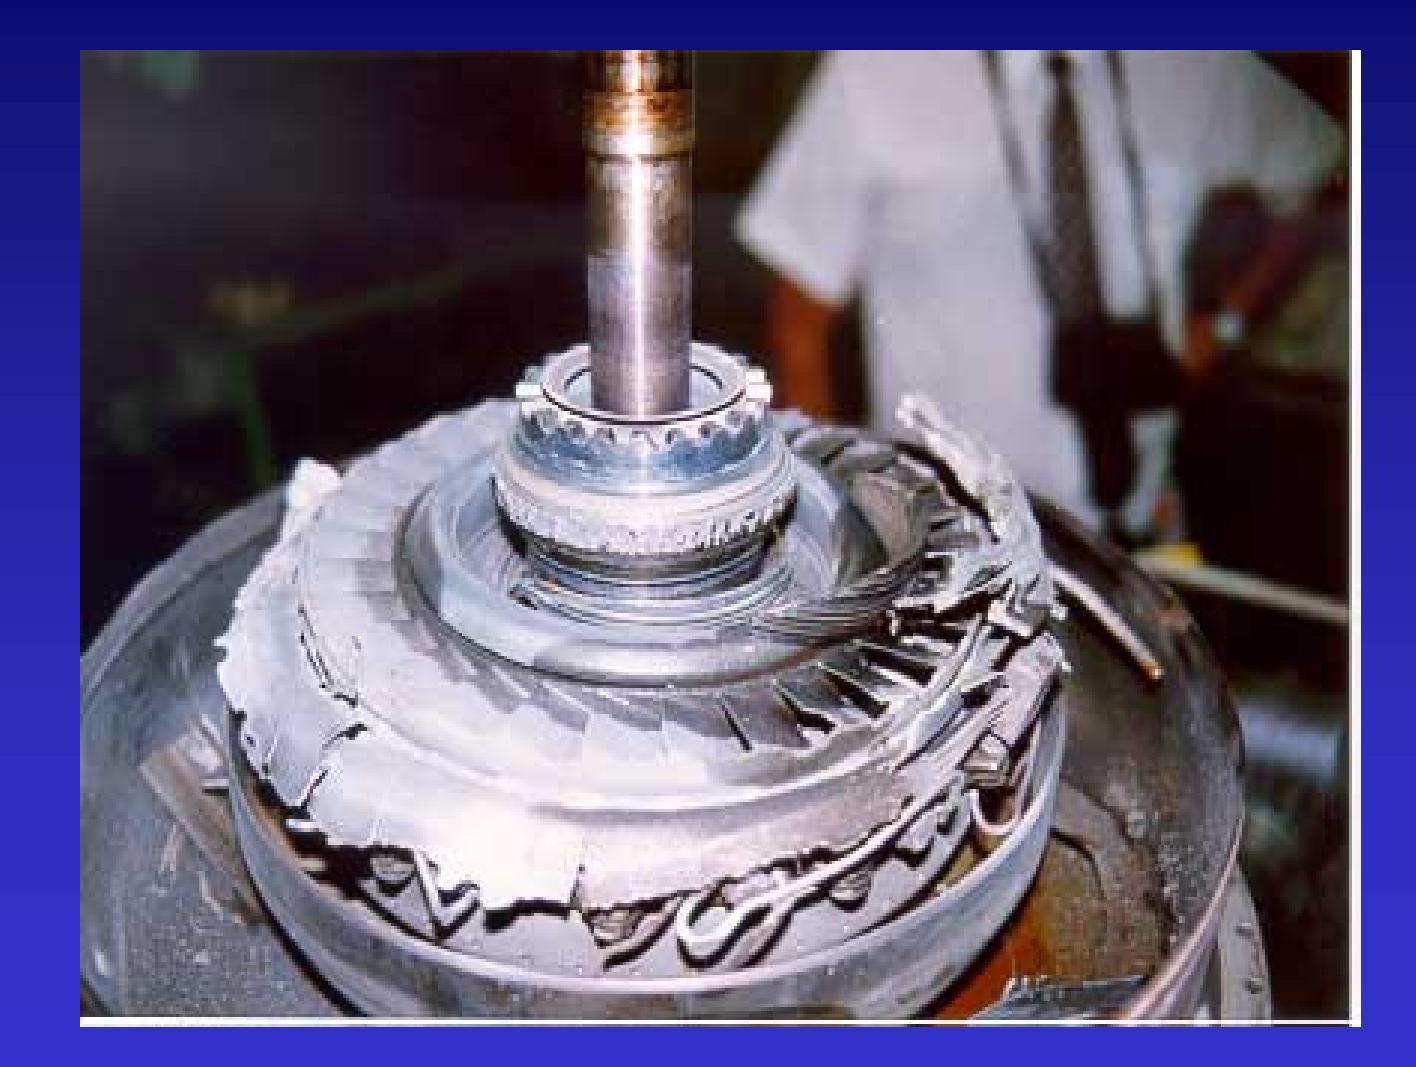
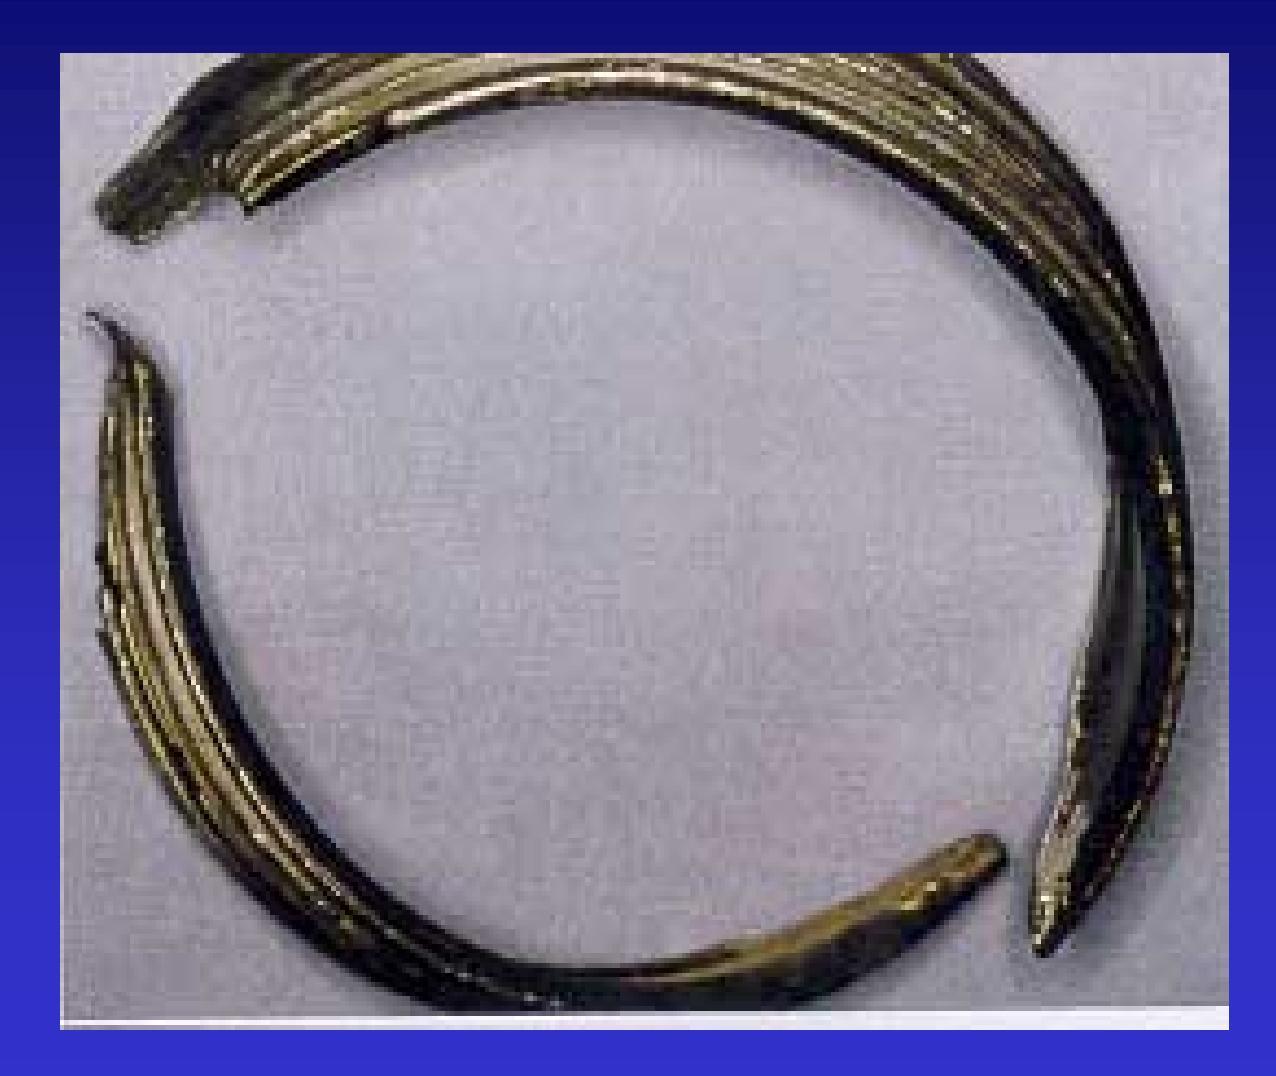
The components surrounding the 2nd stage turbine were extensively damaged by liberated turbine pieces.

Also broken was the air or labyrinth seal between the 1st and the 2nd stage discs.

Two large pieces were recovered.

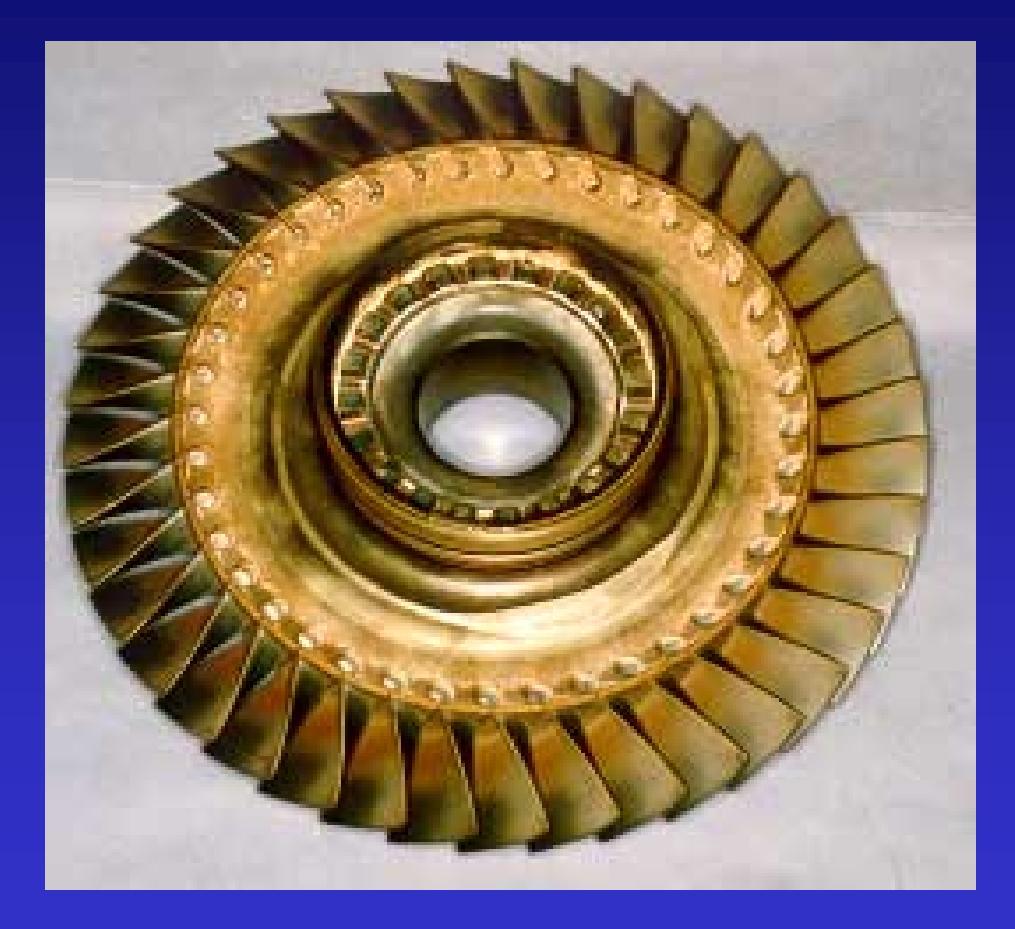
The seal is close to the disc axis, it is light and is not subjected to other then centrifugal loads.

The seal is pressed onto the turbine wheel during manufacture and it becomes an integral part of the turbine.

It is very difficult to replace the seal in service.

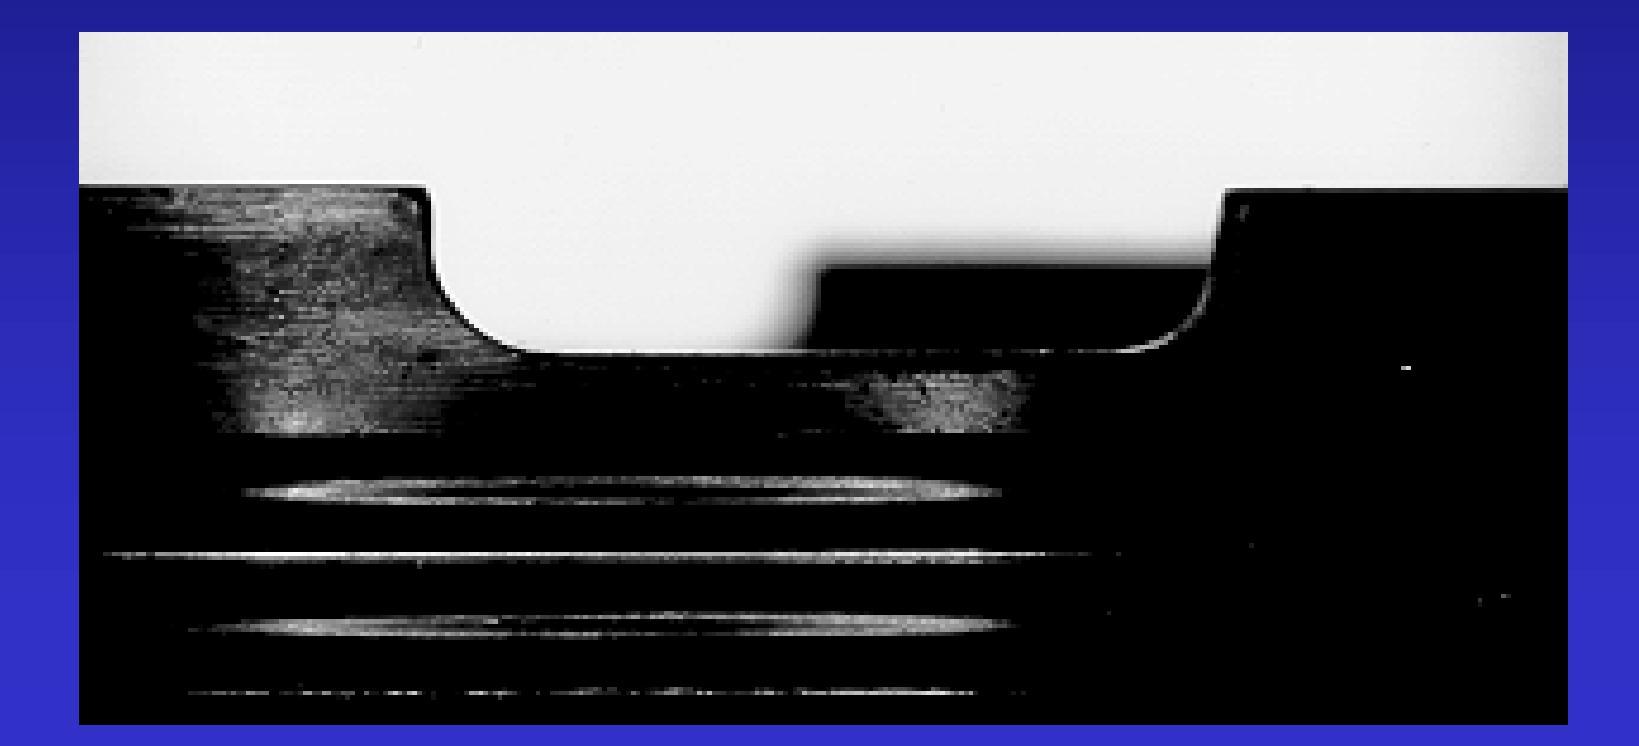
Two fatigue cracks were found initiating from the radius at the corner slots.

The radius at the corner was small.

The radius is quite loosely defined on the manufacturer's drawings.

The ATSB made recommendations to the engine manufacturer to review the labyrinth seal design criteria in respect of the corner radii and substantiation of fatigue life.
