Underwater Recovery Operations off Sharm el-Sheikh

Bureau d'Enquêtes et d'Analyses pour la Sécurité de l'Aviation civile, France

On 3 January 2004, Flash Airlines flight FSH604, a Boeing 737-300 registered as SU-ZCF, operating as a chartered flight from Sharm el-Sheikh, Egypt to Paris, France, crashed into the Red Sea approximately six nautical miles southwest of the airport.

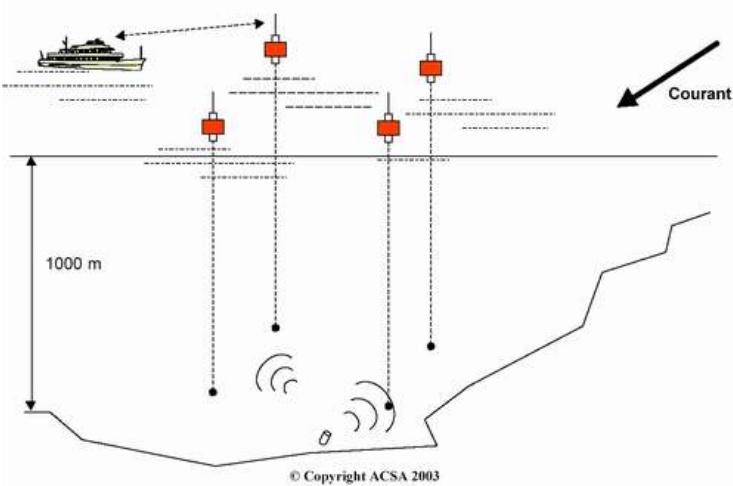
Figure 1: GIB system

The hydrophones, immersed 450 meters down around the initial identified position, drifted with the current while continuously transmitting information on their position and any signals received (figure 1). An algorithm integrated all data to determine the recorder's fixed position.

To narrow the search area, the French Navy contracted ACSA and its partner ORCA Instrumentation to supply a GIB system (GPS Intelligent Buoys). For the purposes of the investigation, they adapted a network of four acoustic receivers to conduct a search at a depth of around one thousand meters.

The use of a GIB system proved to be essential in this context since the ROV (Remotely Operated Vehicle) only used visual means to search for the recorders and could not be guided by acoustic information to home in directly on the beacons. The FDR was ultimately found in the area defined by the Navy, just twelve meters from the position computed by ACSA.

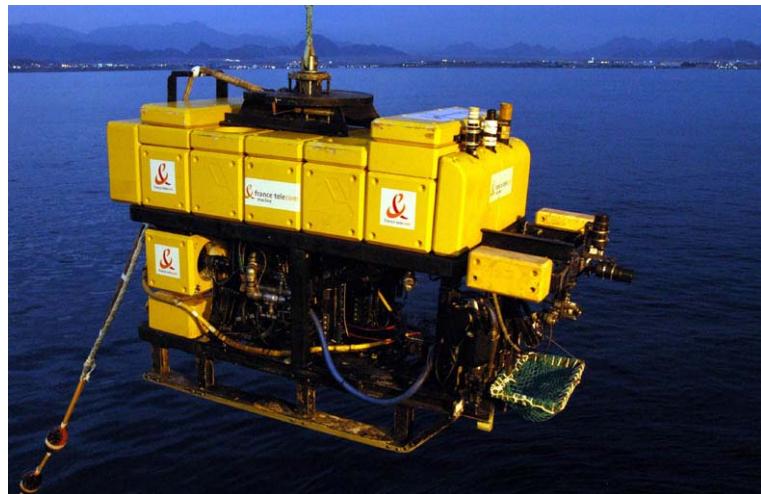
Figure 2: Scorpio ROV operated from *Ile de Batz*

The *Ile de Batz*, owned by Alcatel (LDA), was designed to lay and maintain submarine communication cables, and is ideally suited for this type of search mission. This powerful ship is equipped with Dynamic Positioning II (DP II) enabling it to maintain its position at a given point in spite of adverse weather conditions. The *Ile de Batz* is approximately 140 meters long and can operate at great depths. The Scorpio ROV (work class, see figure 2), provided by France Télécom Marine (FTM), was installed with its fifty tons of equipment on the ship's main deck.

The Scorpio robot started searching for the recorders using its cameras based on an initial determination of the position of its beacon. This position was then refined by the ACSA system. That produced a theoretical position with a precision of plus or minus ten meters over one hundred meters.

Squares of twenty by twenty meters were systematically searched by the ROV. While finishing one run, this visual search finally led to the discovery of the FDR, which was in fact located approximately twelve meters from the estimated position.

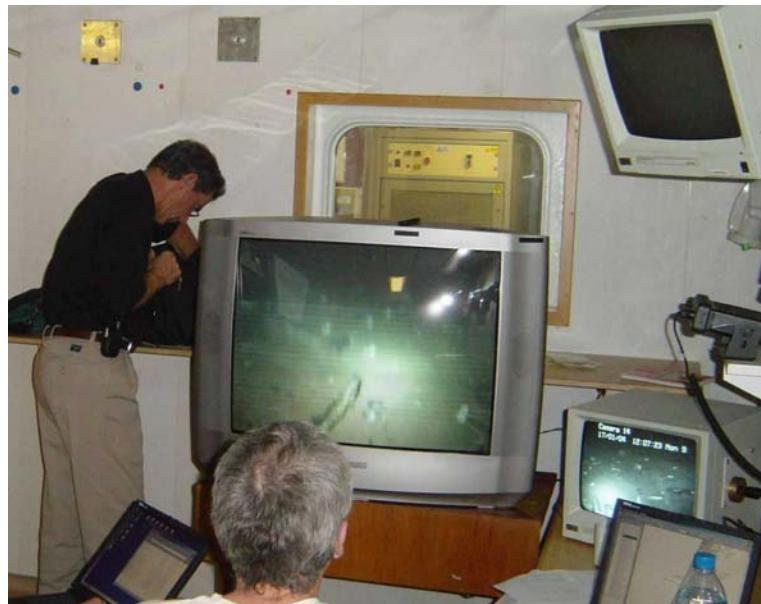
Figure 3: investigators' workroom

The use of a large television screen connected to the panoramic camera helped in identifying its position (see figure 3) as the CVR was spotted during a 180 degree turn between search lines. The facilities on board the *Île de Batz*, which contributed greatly to enhanced teamwork and coordination, were a key element in the rapid recovery of the recorders.

During these operations, it was important to have aeronautical specialists who were able to coordinate the search and identify the debris. Each Scorpio and Super Achille ROV dive was filmed. On board of the *Île de Batz*, the workroom was equipped with a video recorder, which allowed some dives to be reviewed during ROV maintenance.

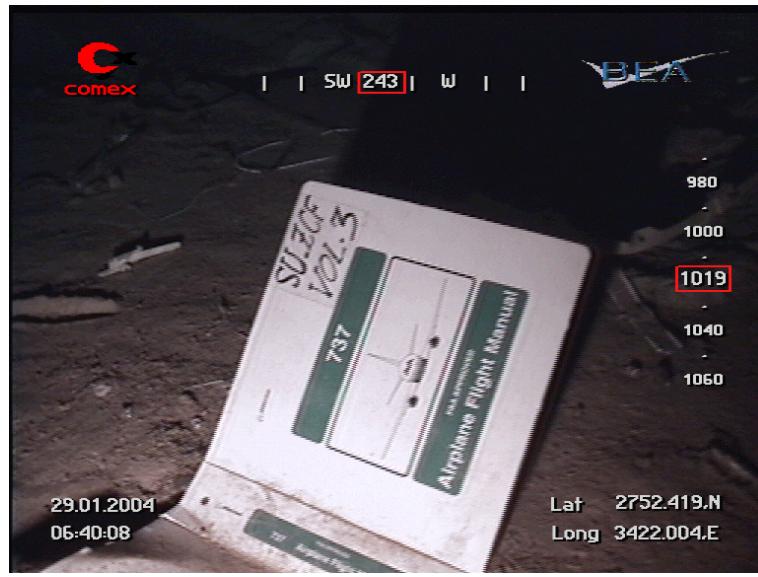
Figure 4: underwater picture taken by Super Achille

The digital video system on the Super Achille was also able to take digital stills of the airplane parts considered interesting to map and examine (see figure 4: flight manual) with the still featuring an inset with parameters such as latitude, longitude, depth, heading, etc.

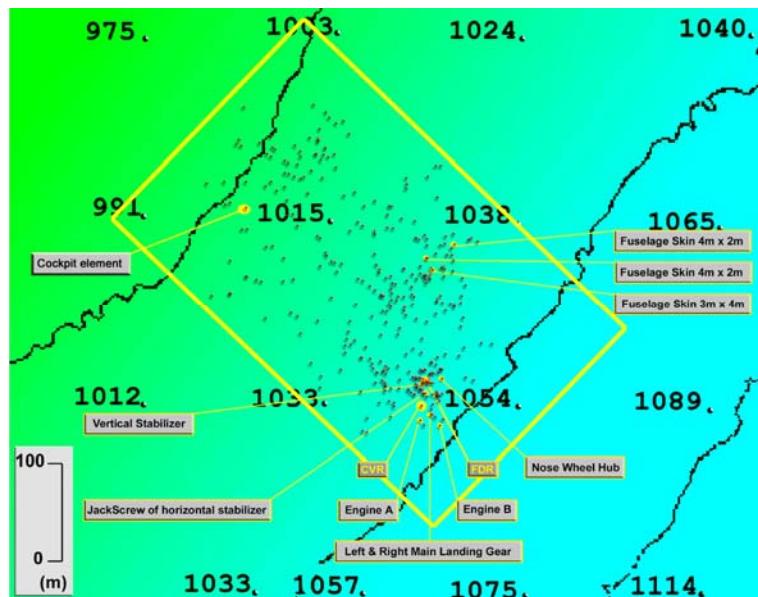
Figure 5: wreckage distribution

The following figure shows the wreckage distribution and the extent of the search area (a rectangle 440 by 275 meters). Super Achille also traveled on the seafloor towards the location of the northern echo, search a hundred by hundred meter square and did not find any pieces of wreckage nor the pinger.

The wreckage distribution is compatible with the last recorded heading (311°) and the northeast current measured by the *Beautemps-Beaupré*. The heavy parts (engines and main landing gear) were close to the point of impact whereas lighter debris drifted with the prevailing current during their thousand meter descent.

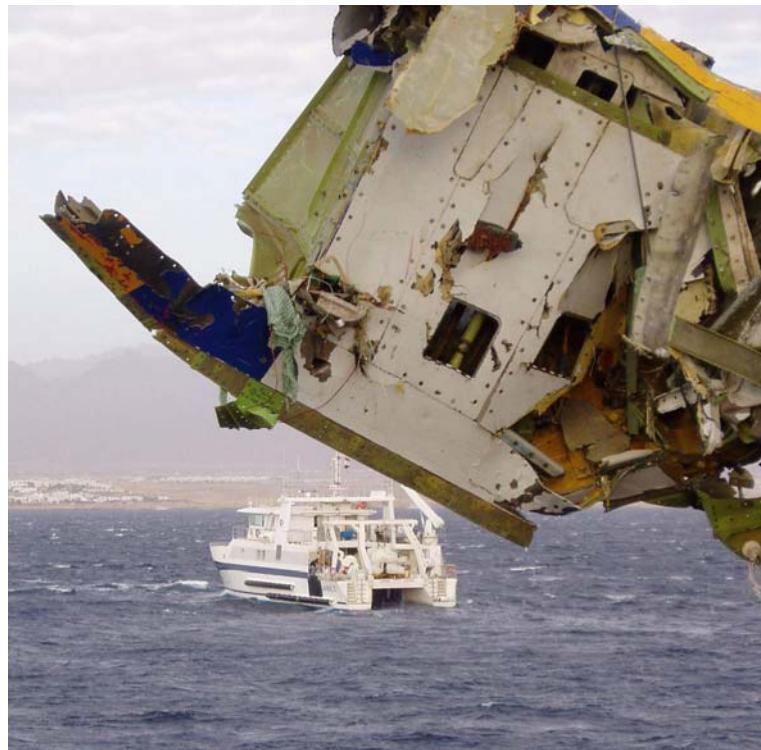
Figure 6: rudder recovery

The work performed jointly by the *Janus II* and the *Ile de Batz* (both with dynamic positioning) made it possible to recover large parts such as the rudder and the elevator.

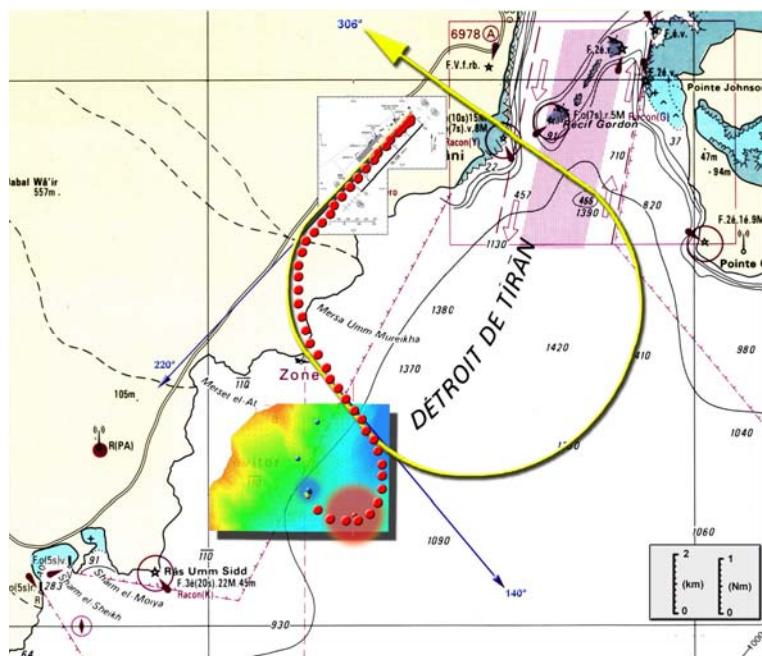
Figure 7: combined data on one map

The recorders were recovered in less than two weeks although they were in a relatively uncharted area about a thousand meters deep. Figure 7 combines on a maritime map, airfield data, bathymetric data and the airplane track from the FDR readout.
