On 1 June 2006 a Beechcraft Bonanza was on final approach to Bathurst Island, NT, at approximately 0845 CST, in VMC conditions, the aircraft sustained loss of engine power and crashed into bush land, approximately 1.2 km to the north-west of the Bathurst Island runway. The pilot was fatally injured.

The presentation will cover aspects of the accident investigation, paying particular attention to the recovery of data from a new type of engine indicating and recording instrument with a non-volatile memory.

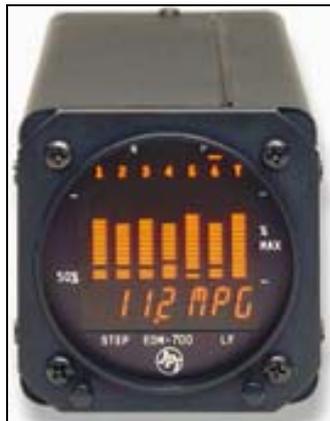
Figure 27: EDM 700

An Engine Data Management instrument, the EDM 700 was found fitted to the aircraft. The instrument is predominantly an engine indicating device, it indicates the following parameters:

- Exhaust gas temperature from all cylinders in Fahrenheit (EGT)
- Cylinder head temperature from all cylinders in Fahrenheit (CHT)
- Differential EGT in Fahrenheit (DIF)
- Rapid cooling of cylinders in Fahrenheit (CLD)
- Fuel flow in gallons per hour (FF)
- Fuel used in gallons (USD)
- Battery bus voltage (BAT)

The EDM 700 has a non-volatile long term memory for engine trend monitoring purposes. If the instrument is set to record, it will store all the information displayed once every six seconds or at a programmed interval between two to five hundred seconds.

The typical amount of data stored is 20 engine operating hours at 6 second intervals. When the memory becomes full, the oldest data will be discarded to make room for the newest data.

When the engine is started and the EGT reaches 500 degrees F, the instrument starts recording, the recordings are separated by engine start and stop sequences, each engine start and stop sequence is given a flight number, flight time and date, each six second recording is time stamped in Universal time co-ordinated (UTC).

The recorded data can be downloaded using manufacturer software and a standard computer. The instrument stops recording when the battery bus voltage falls below 11 volts DC, the radio master is switched off, or the electric power supply is cut.

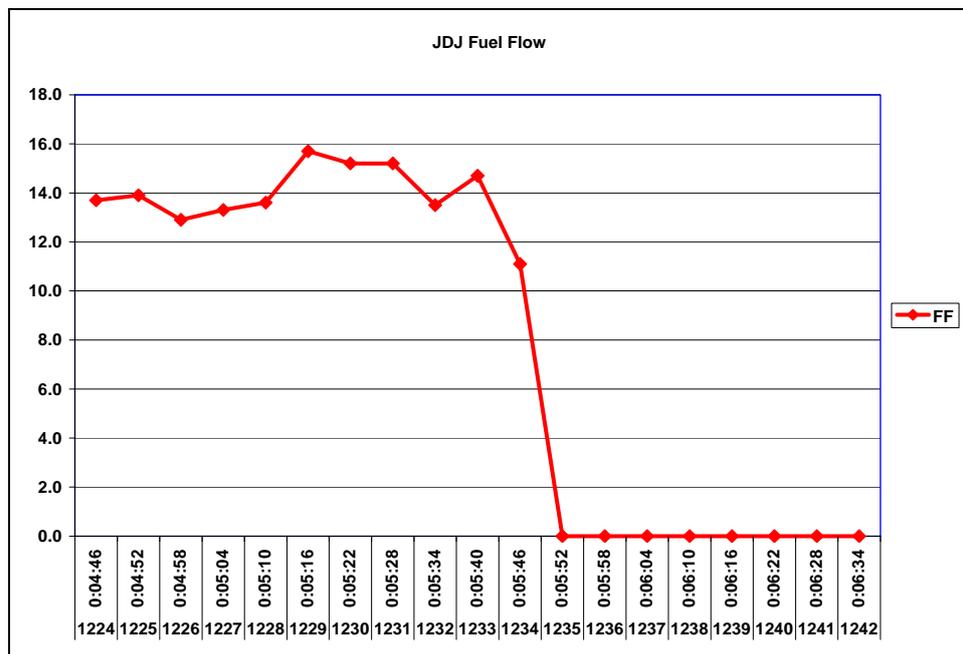
Figure 30: Fuel flow graph for the last 84 seconds of flight

Figure 30 is a fuel flow graph of the last 114 seconds of flight. The last 48 seconds shows a clear drop in fuel flow to zero.

Although there was zero indicated fuel flow in the last 48 seconds of flight, the engine was still turning. This is indicated in the data, by battery voltage remaining constant (refer to figure 29, the green column titled BAT).

If the engine had completely stopped, the alternator would have stopped turning, this would have caused a corresponding drop in indicated voltage from the battery bus, from 28.2 volts DC to a maximum of 24 volts DC, which is the maximum discharge voltage of the battery.

The propeller may have continued turning because it was windmilling or perhaps the engine was receiving just enough fuel to keep the engine running at a severely reduced rate.

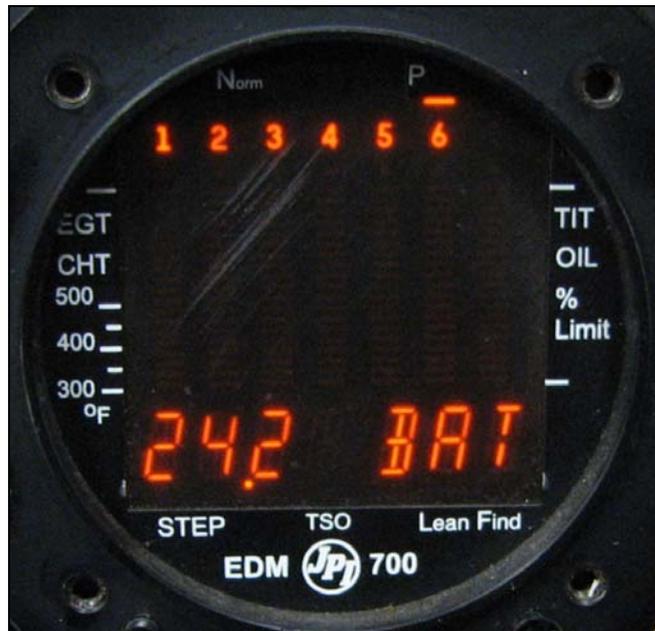
Figure 31: EDM 700 indicating battery voltage

Figure 31 shows the EDM 700 connected to a DC power supply, the power supply output voltage was 24.2 as indicated on the instrument. This shows that the instrument was indicating the correct voltage.
