Bird Strikes – Is the risk increasing?

Prepared by Alan Moffat
Mount Cook Airline

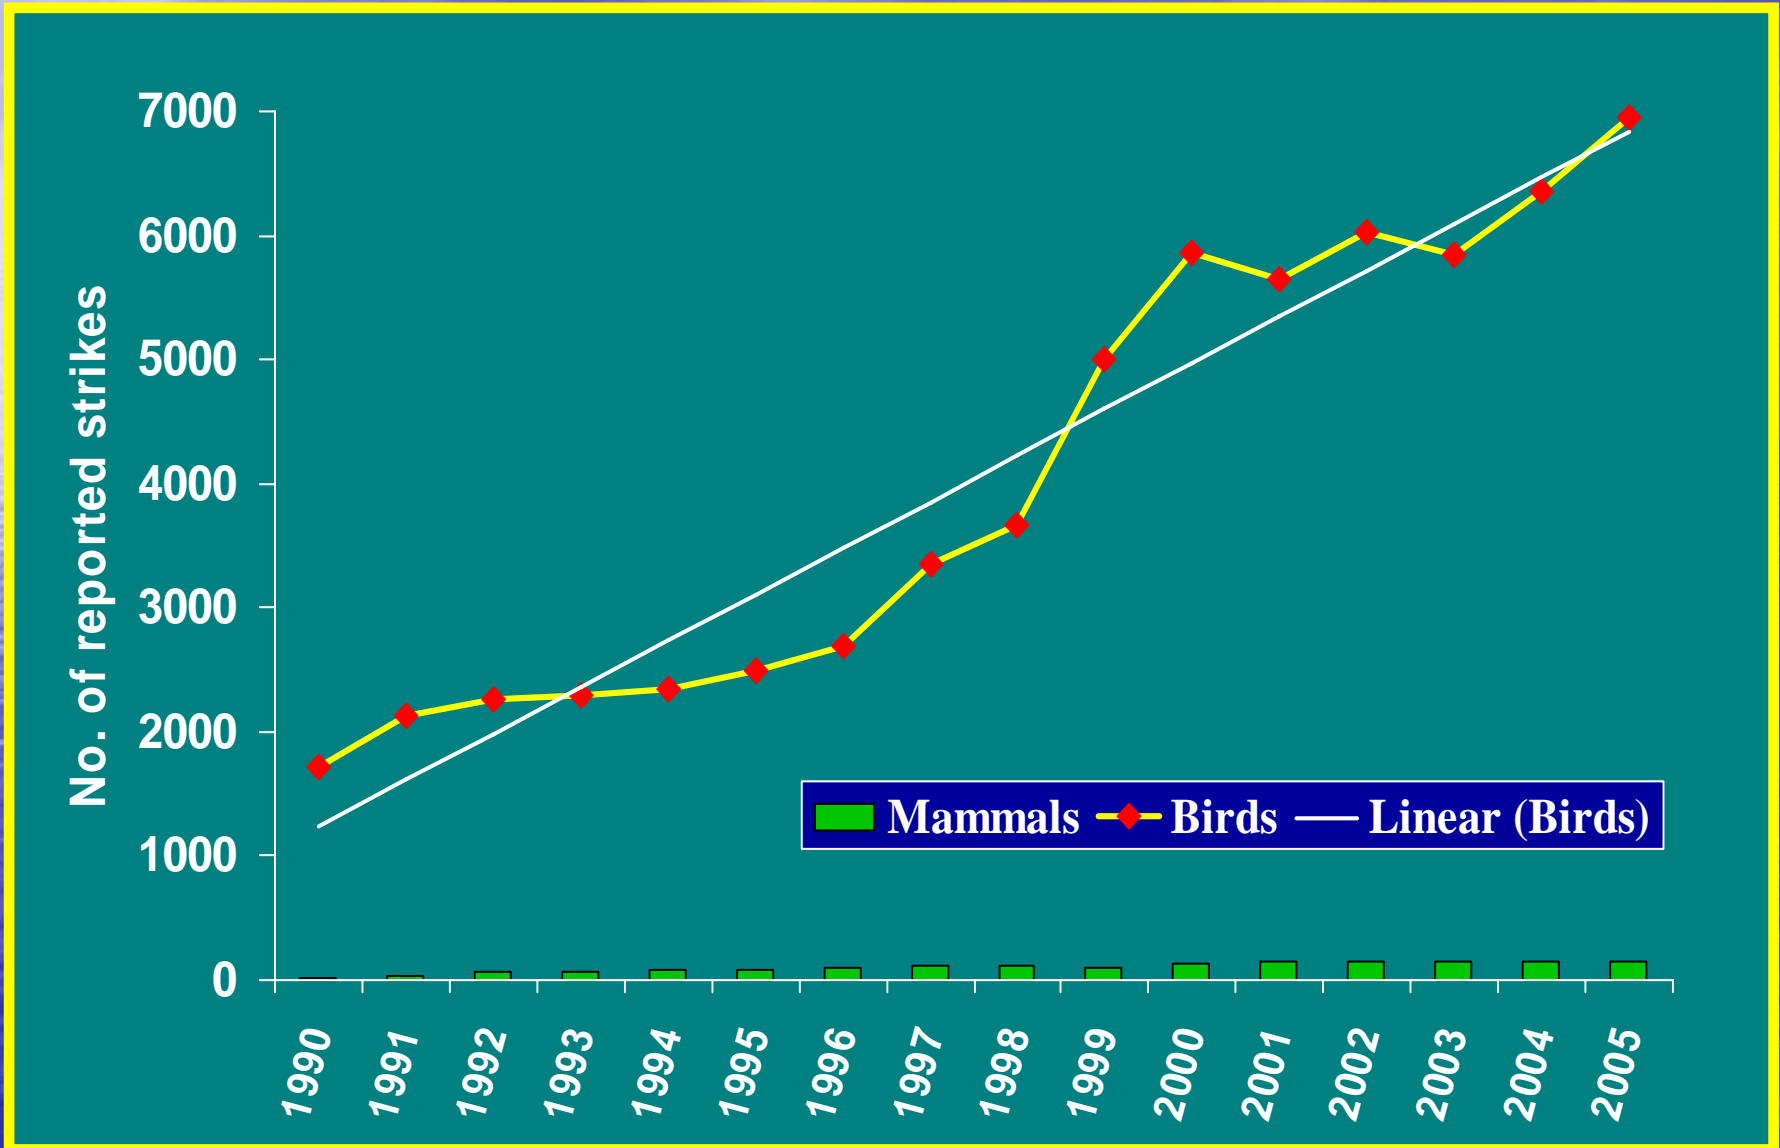
Reported Wildlife Strikes with Civil Aircraft in USA Tripled, 1990-2004

Source – US Fish and Wildlife Service

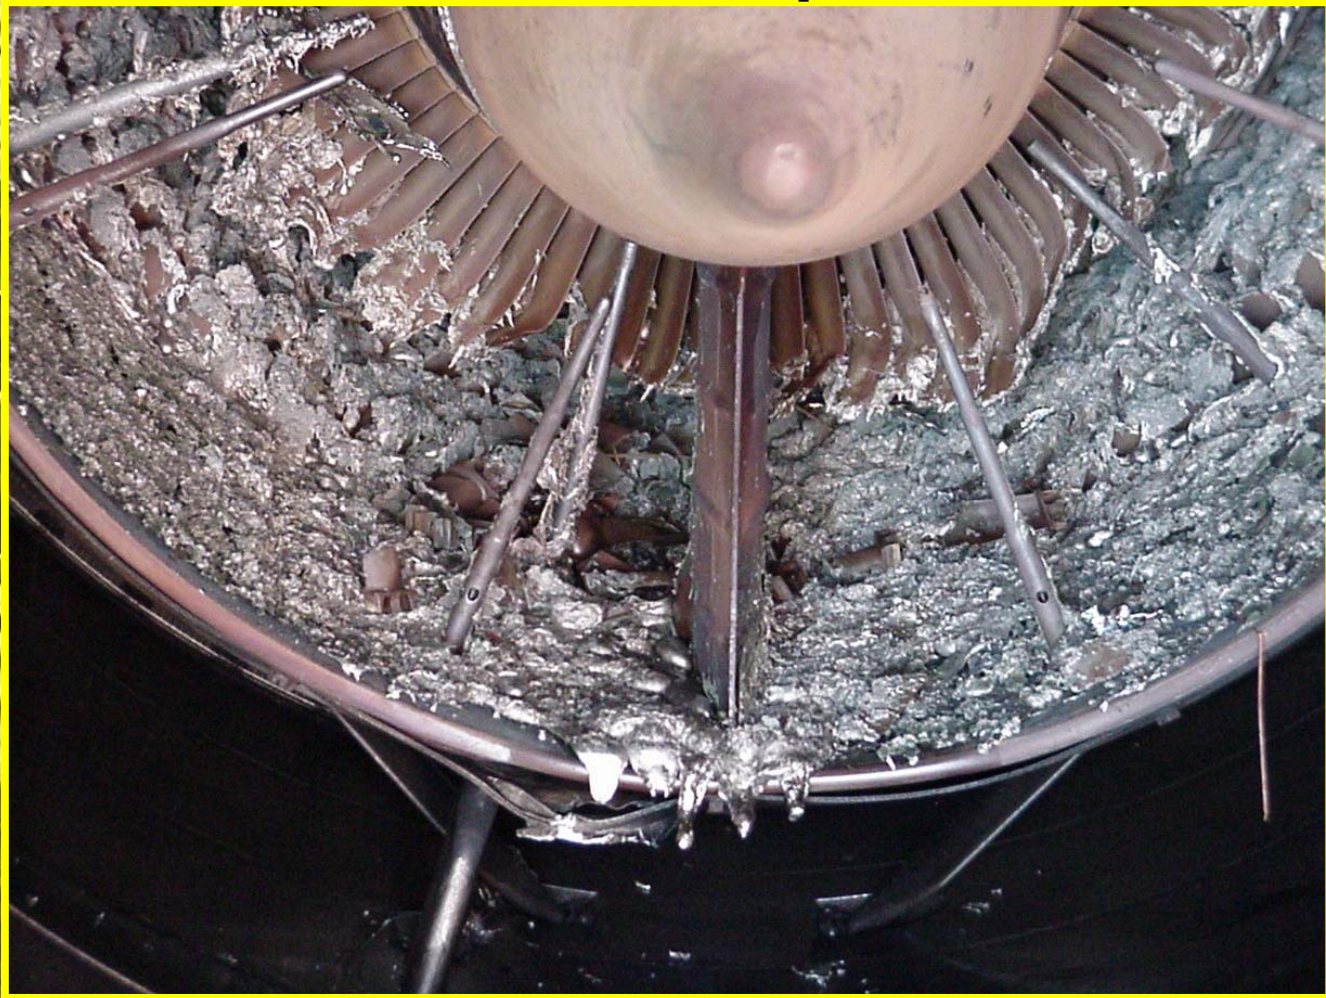
Boeing 727 engine after ingesting a Canadian Goose, April 2000

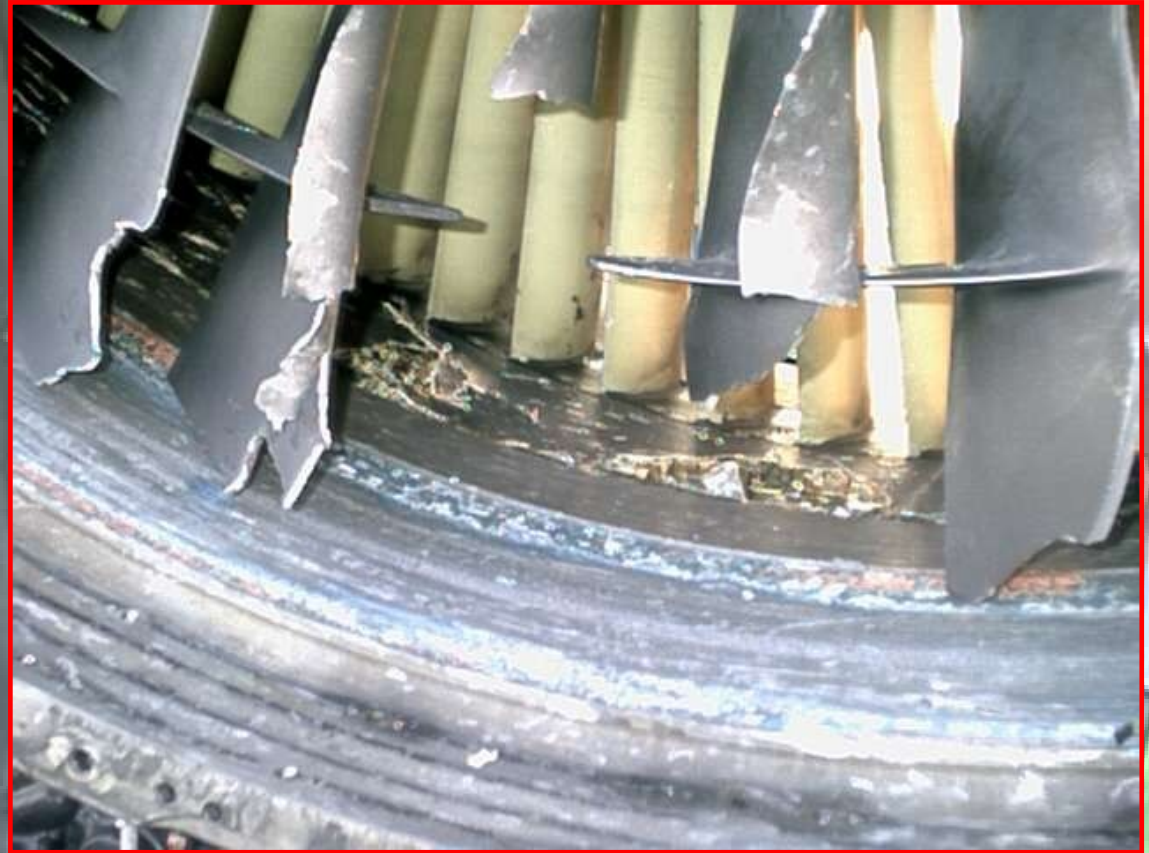
A320 engine totally destroyed after ingesting a Canadian Goose

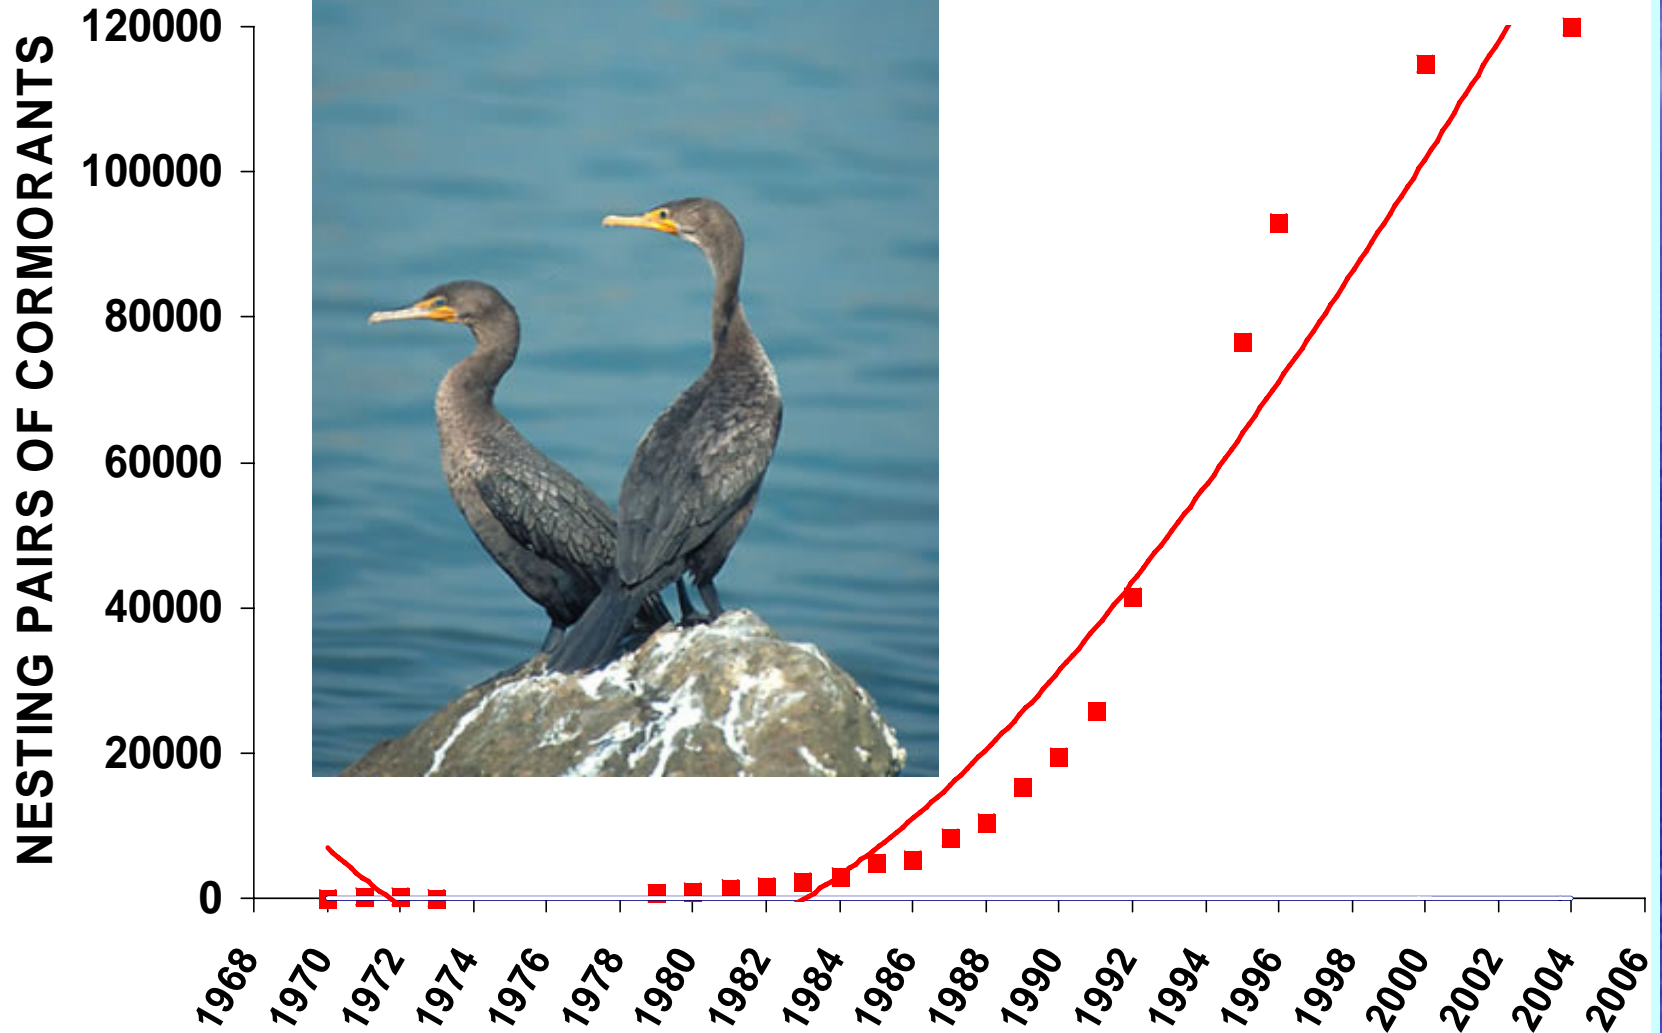
BREEDING POPULATION OF CORMORANTS INCREASED OVER 1000-FOLD ON THE GREAT LAKES, 1972-2004

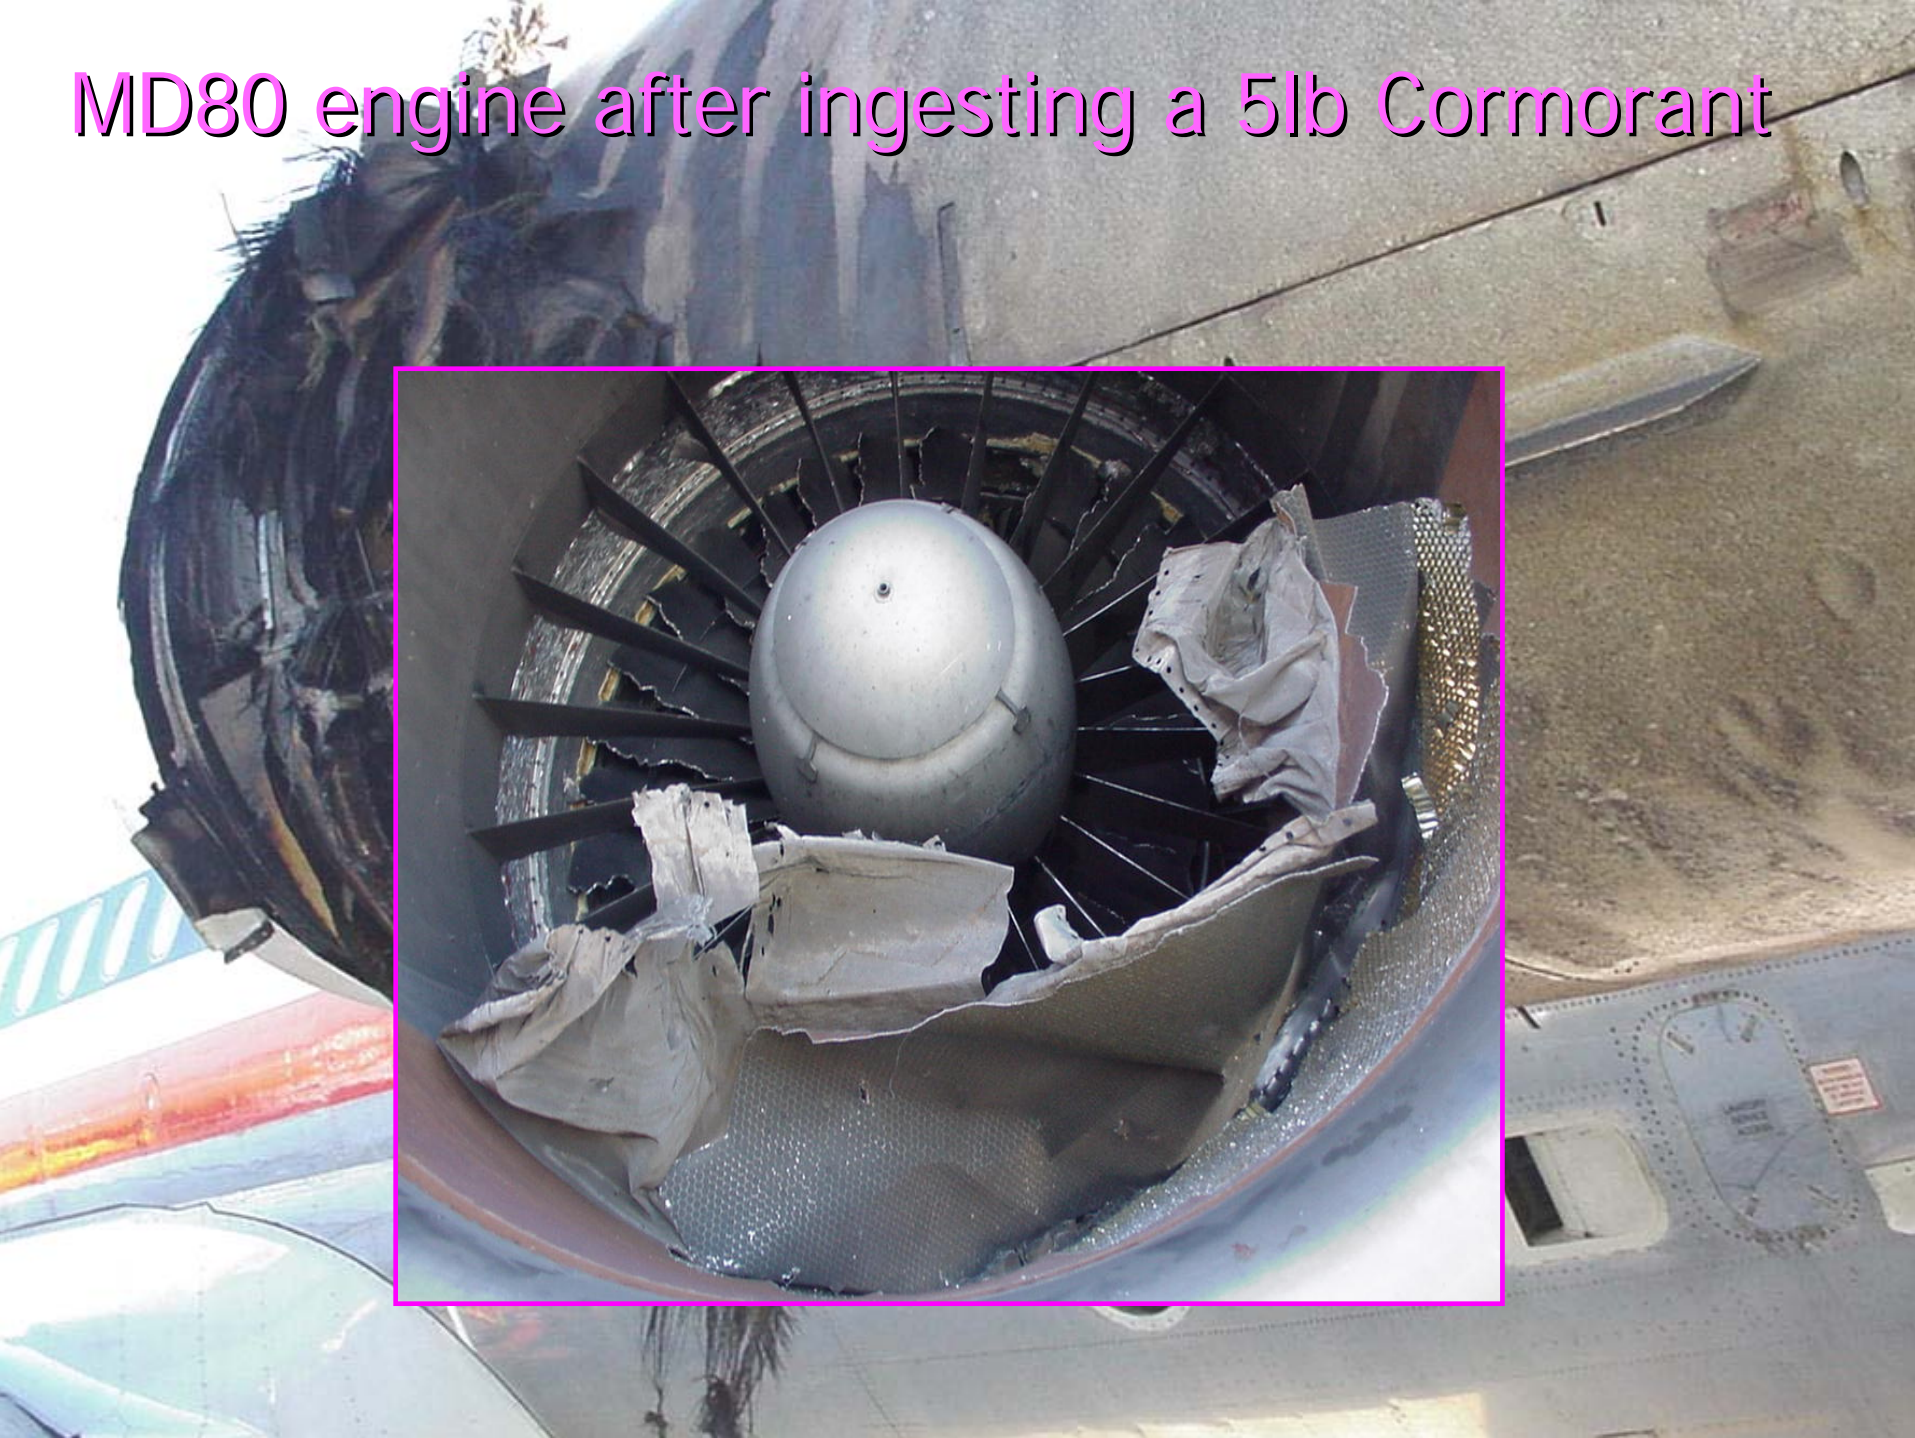
MD80 engine after ingesting a 5lb Cormorant

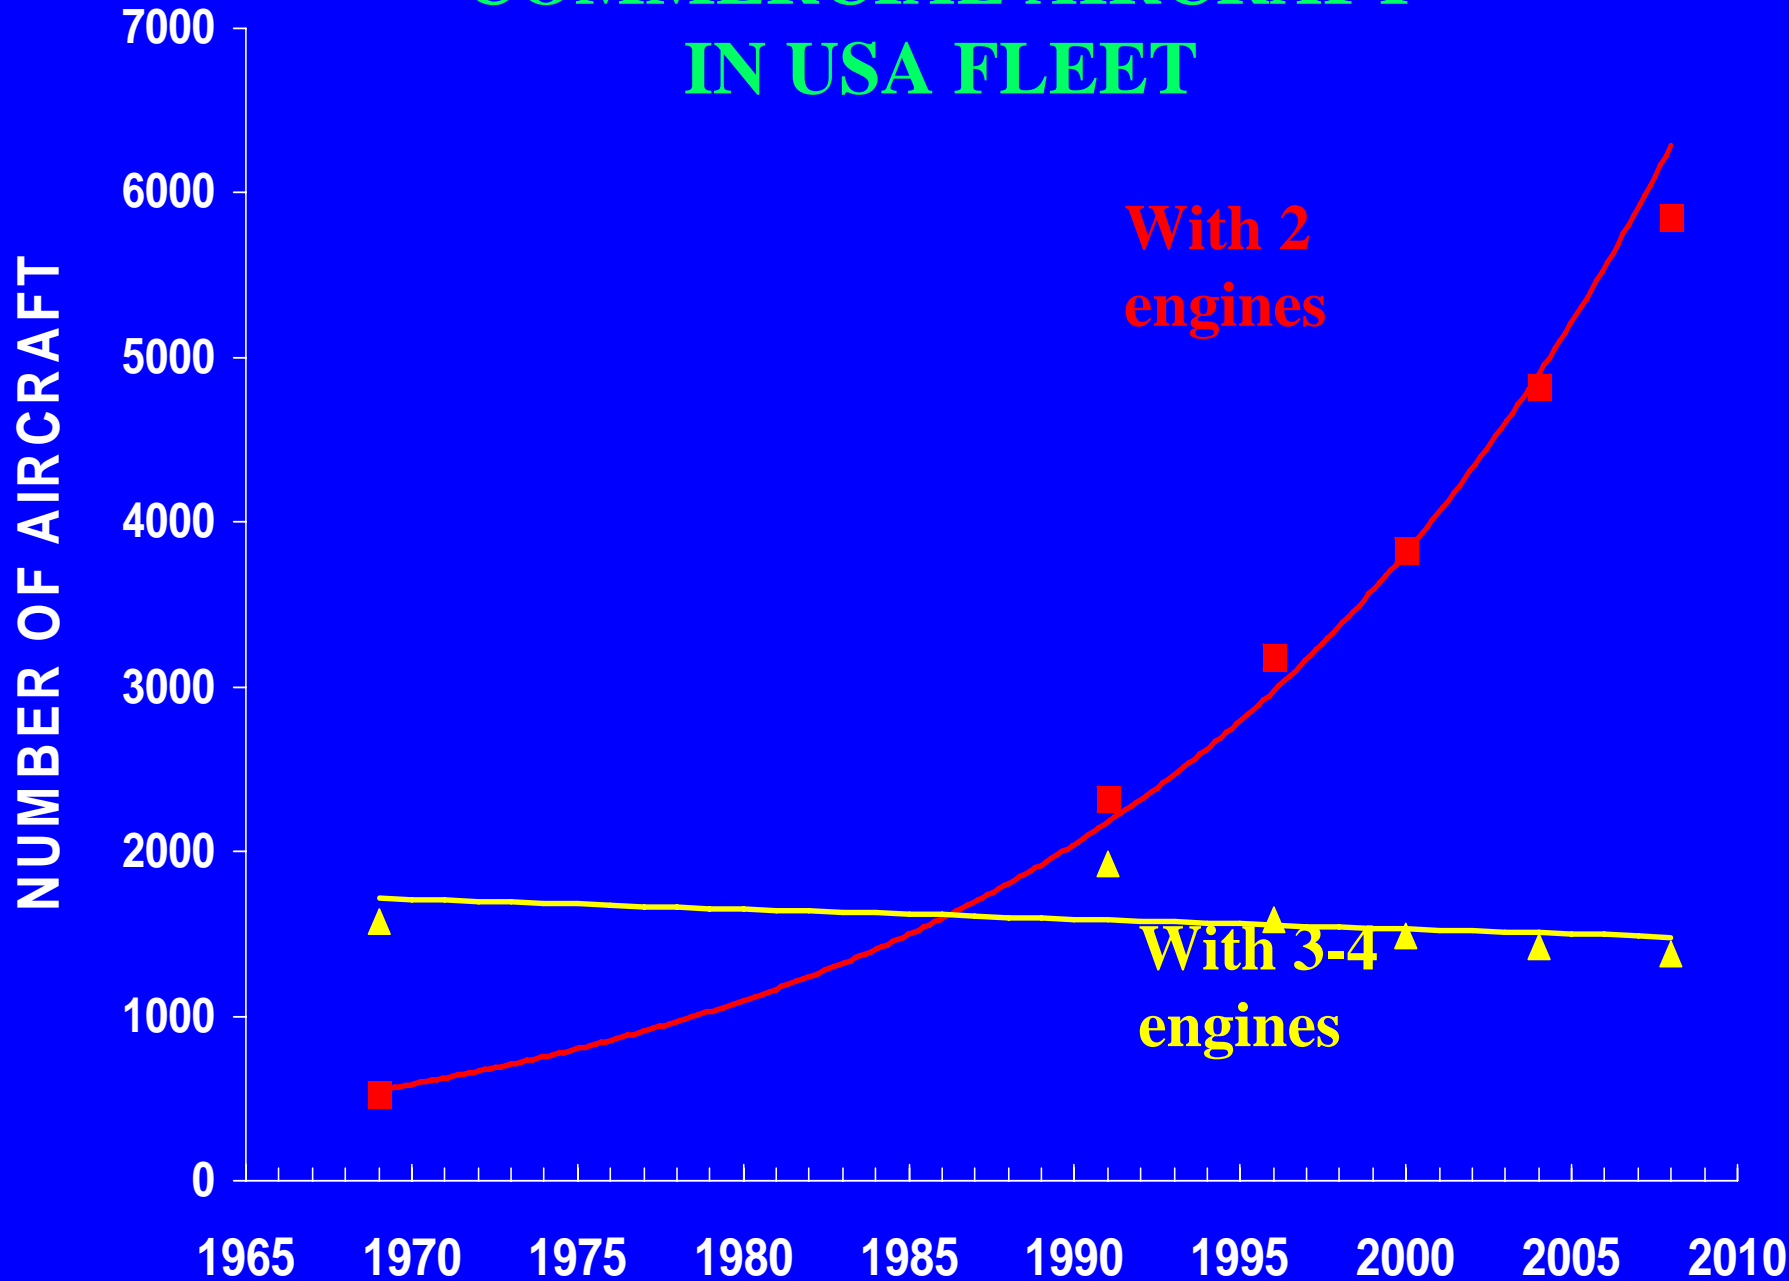
COMMERCIAL AIRCRAFT IN USA FLEET

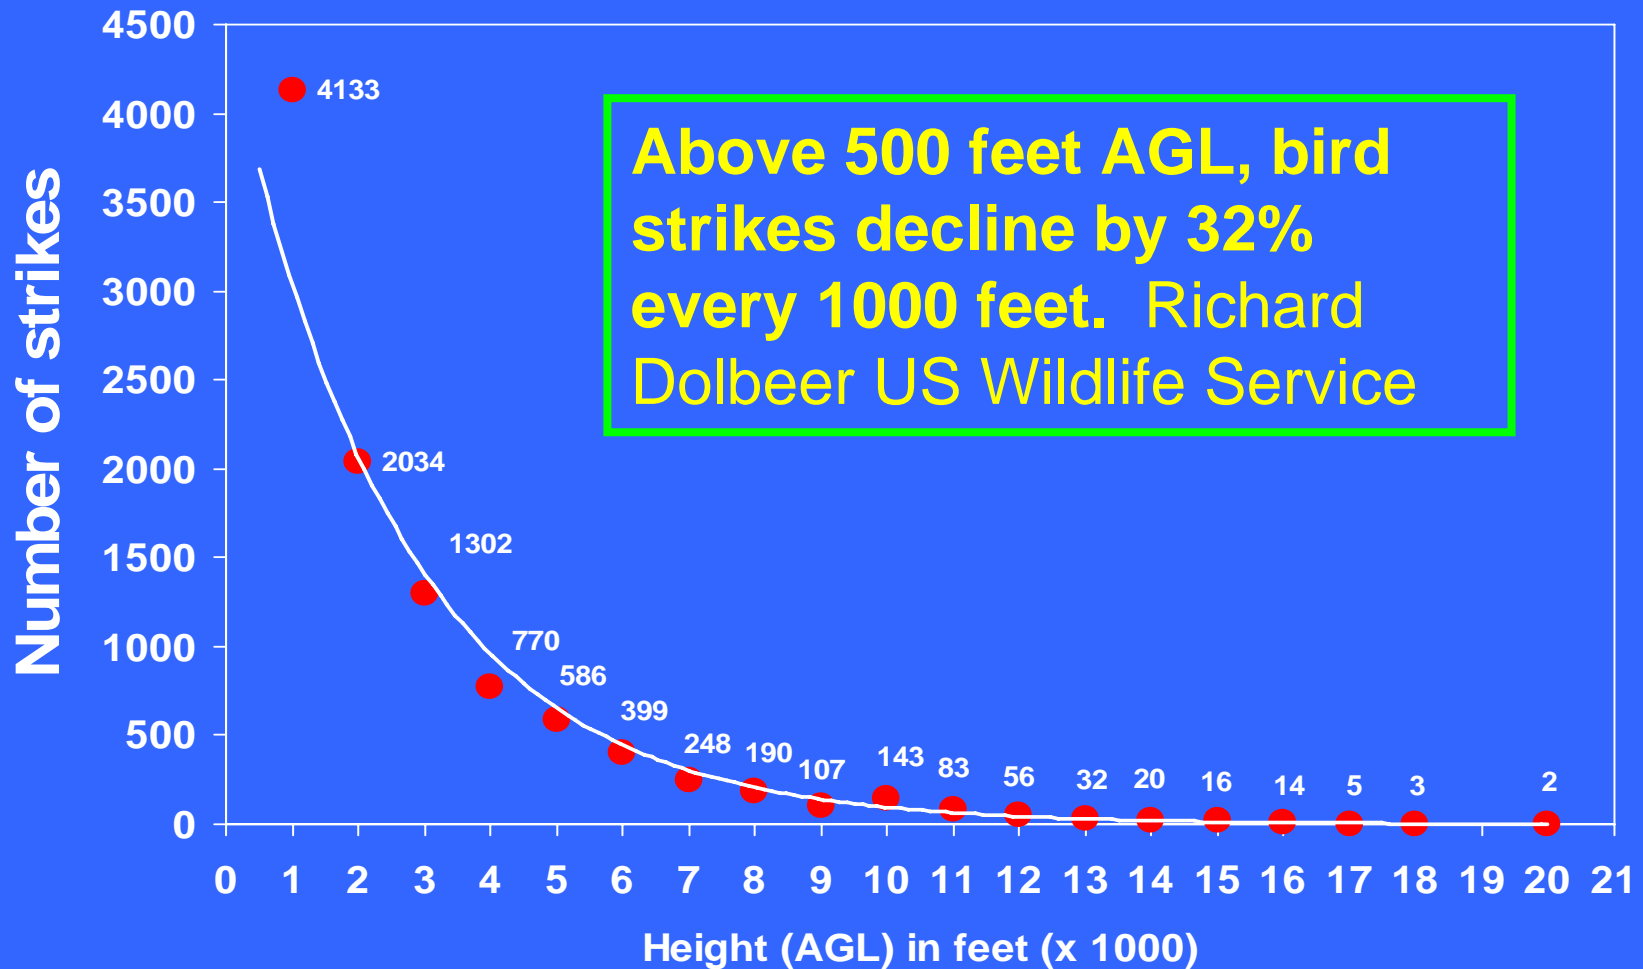
Number of strikes by 1000-ft intervals (501-20,500 ft AGL) (civil aircraft, USA, 1990-2004)
