Lessons from a helicopter winching accident: linking research with industry

Presented by
Rob Chopin
Senior Transport Safety Investigator

Occurrence details

- AO-2013-136
- near Mansfield, Vic
- 31 August 2013
- VH-VAS
- Bell 412EP
- 3 crew, 1 patient
- VMC

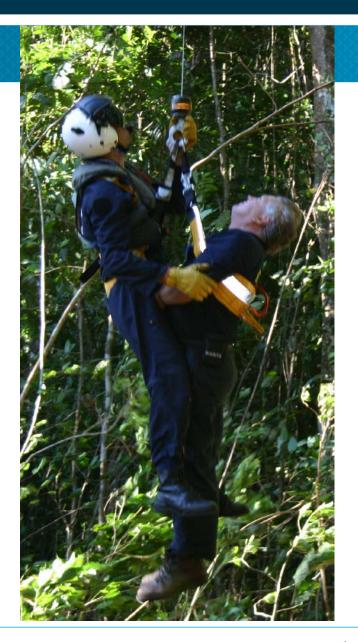
Winching task

- Helicopter returned 20 minutes later, winch area cleared
- Double lift with patient in rescue strop
- 80ft hover, about 20ft above tree canopy
- When clear of ground, winch paused for 6 seconds to confirm patient and paramedic were stable
- At about 30-40ft, winch paused for 9 seconds to reposition patient and paramedic, clear of trees

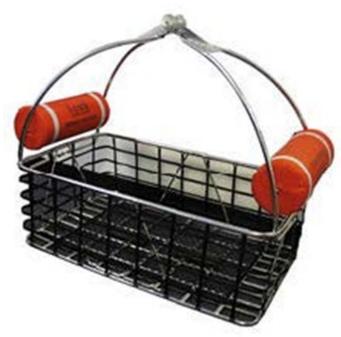
Research and testing Murphy et al, 2011

- Expanded testing to include a rescue basket
- Utilised 26 adults, different weights (45-106kg)
- Tested:
 - Forced Expiratory Volume in 1 sec (FEV1),
 2 sec (FEV2), 3 sec (FEV3)
 - Forced Vital Capacity (FVC)
 - Inspiratory Capacity (IC)
 - Heart and respiratory rates

- Murphy conclusions:
 - Rescue strop: significant decreases in FEV1, FVC,IC, significant increases in heart and respiratory rates
 - Rescue strop/hypo and stretcher: decreases in FEV1 and FVC, no other significant changes
 - Rescue basket: no influence on any of the parameters
 - Caution required regarding use of rescue strop
 - Rescue strop with hypo more benign option
