Main Rotor Blade Analysis in Helicopter Accident Investigation

by Sam Webb

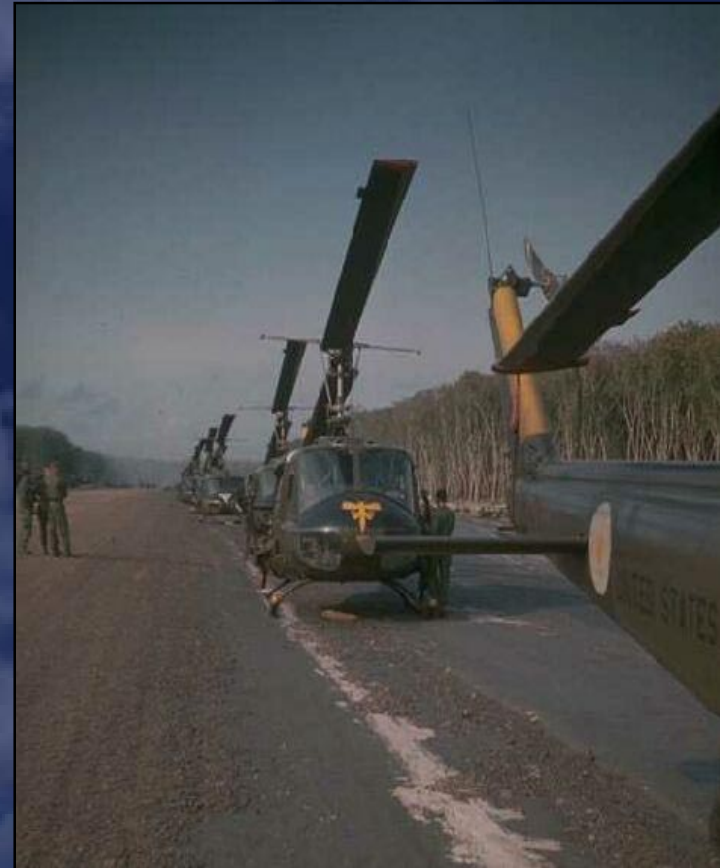
**Two Bladed Systems,
(teetering, semi-rigid)**

- Normally wider cord / longer length blades
- Higher main rotor RPM/ higher blade inertia

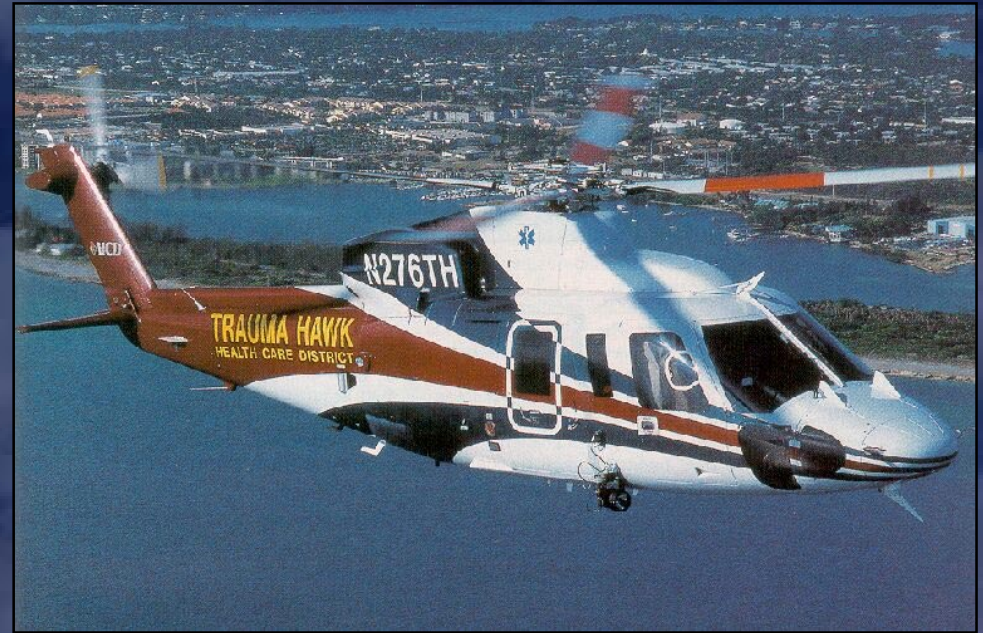
Fully articulated, multi-blade systems

- Blades usually lighter construction, less cord, less length
- Main rotor RPM values marginally lower to compensate for cord area differences

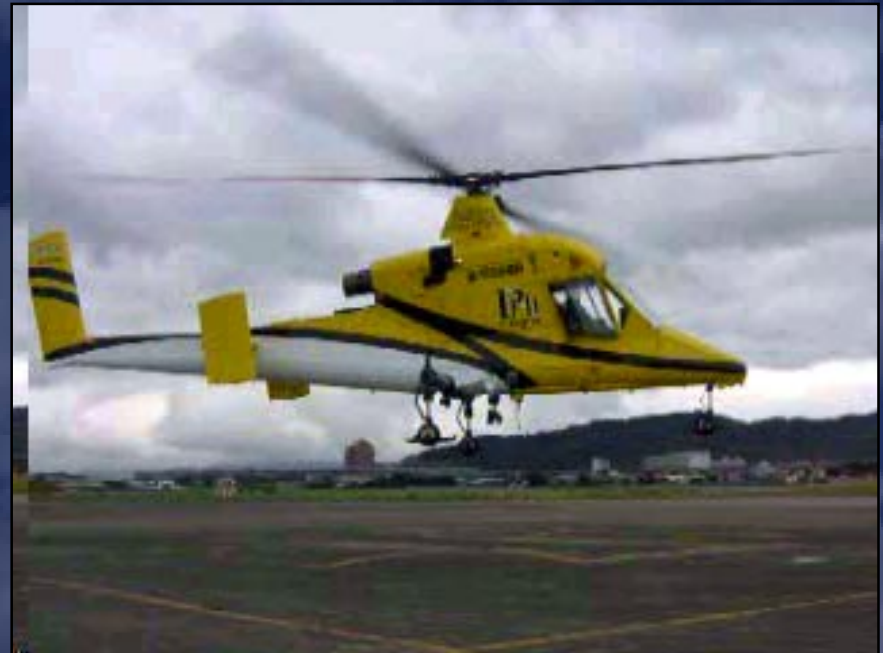
Coaxial- counter rotating, multi-blade systems

- Blades same construction as multi-bladed system
- Main rotor RPM values same as multi-bladed system

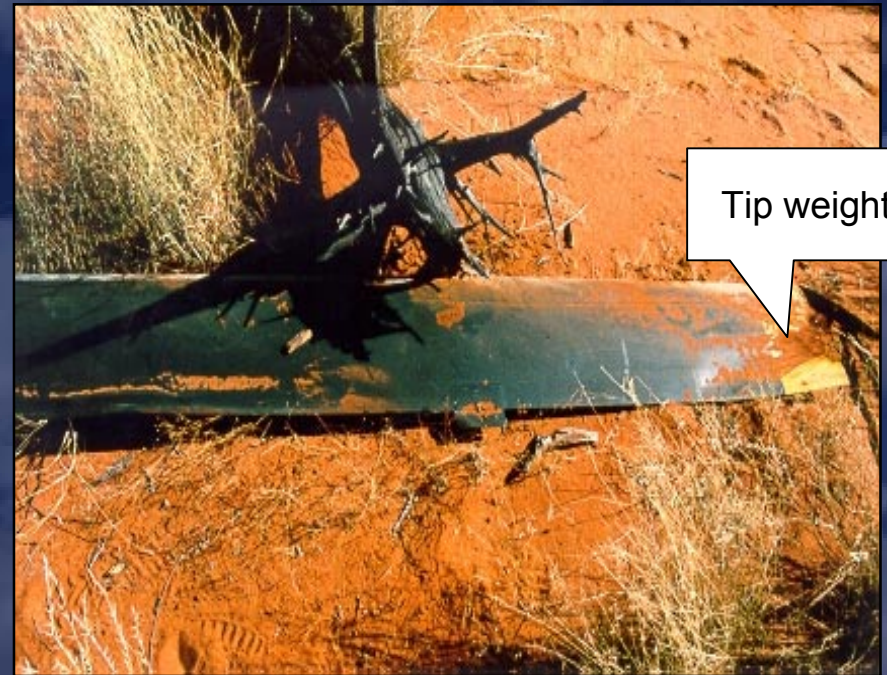
Low Main Rotor RPM

- Blade bending, not shattering
- Blades generally intact
- Blade bending inboard and downward
- High angle of attack = blade tearing aft of spar

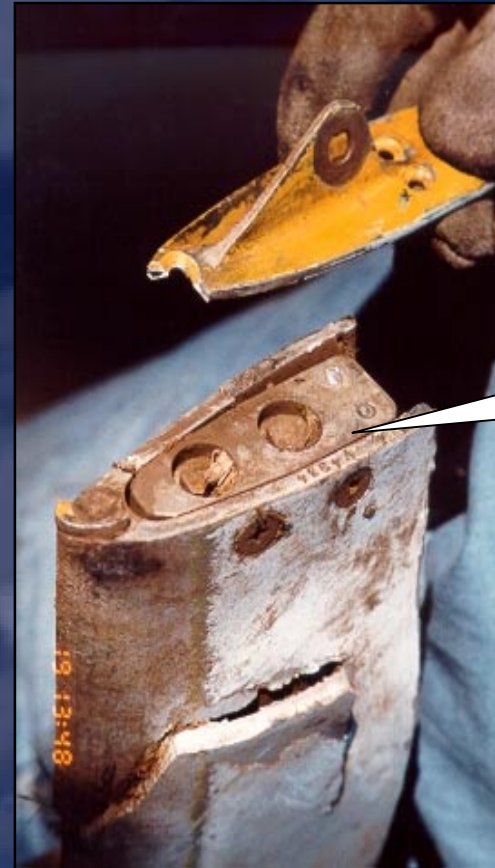
Weights

→ Blade tip weights intact

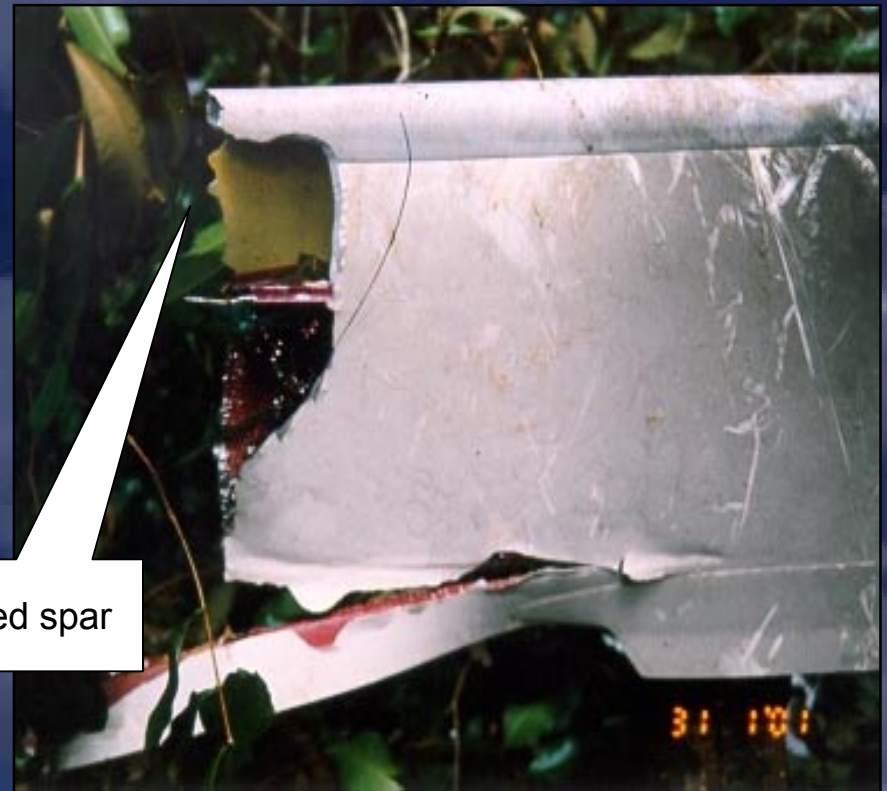
Fractured spar

- Spar fractures, trailing edge separation
- Honeycomb fractured and separated
- Damage mainly to outboard sections of blade

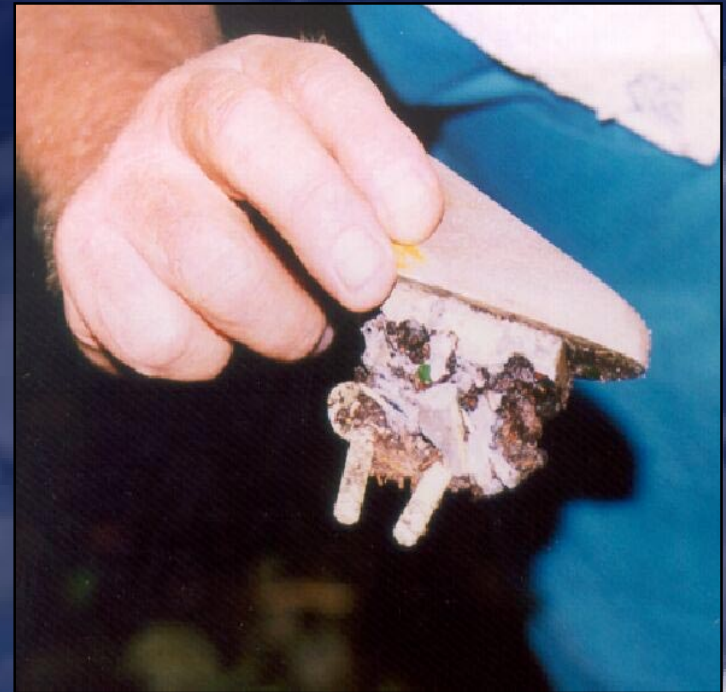
High Main Rotor RPM

- Tip weights “ejected”
- May travel for kilometres from the impact site (farther distances for multi-bladed systems)

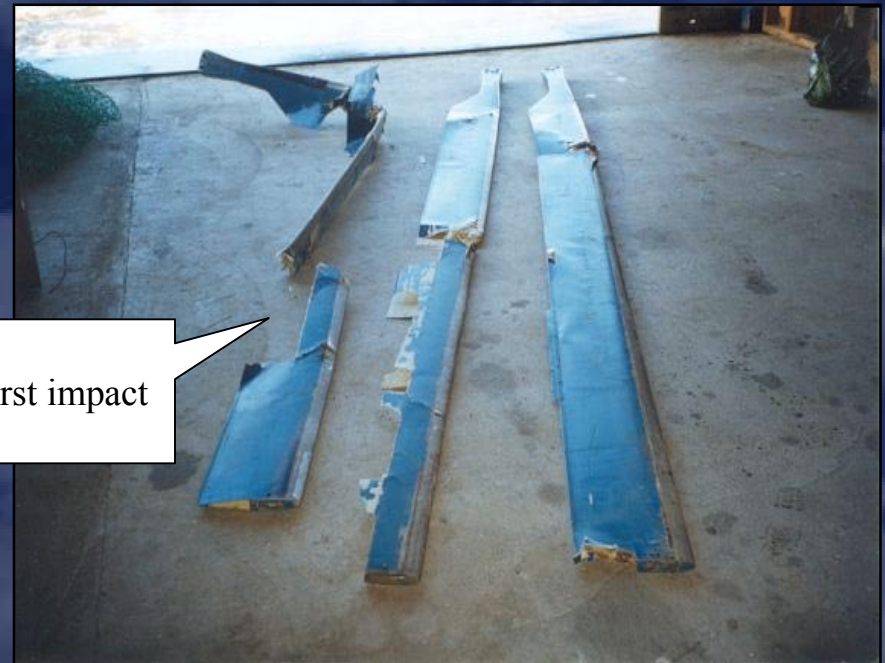
High Main Rotor RPM

- First blade to impact surface most damaged
- Following blades exhibit lesser damage due to main rotor inertia bleed off

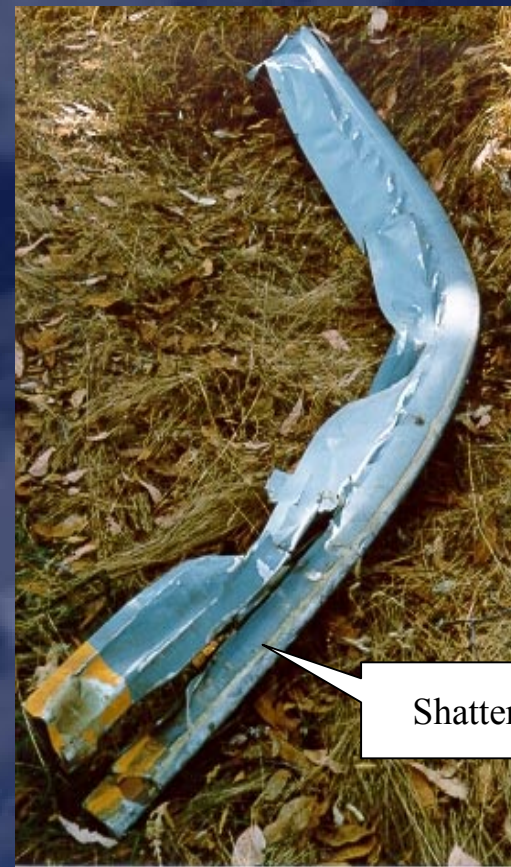
Shattering

→ Damage is in plane

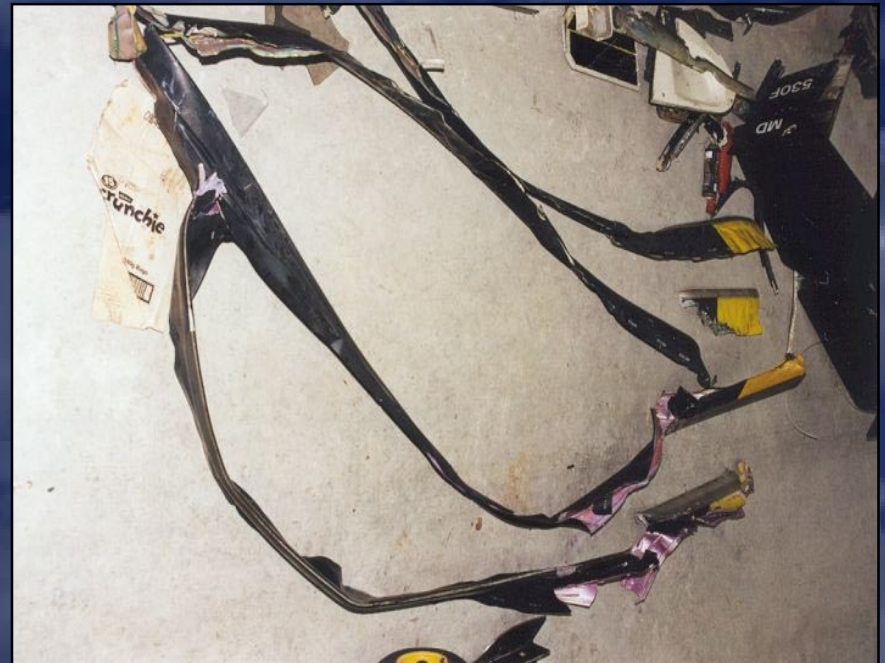
High Main Rotor RPM

- Massive blade distortion on multi-bladed systems
- Blades sustain more damage due to lighter construction
- Articulated systems, dynamic stops fail

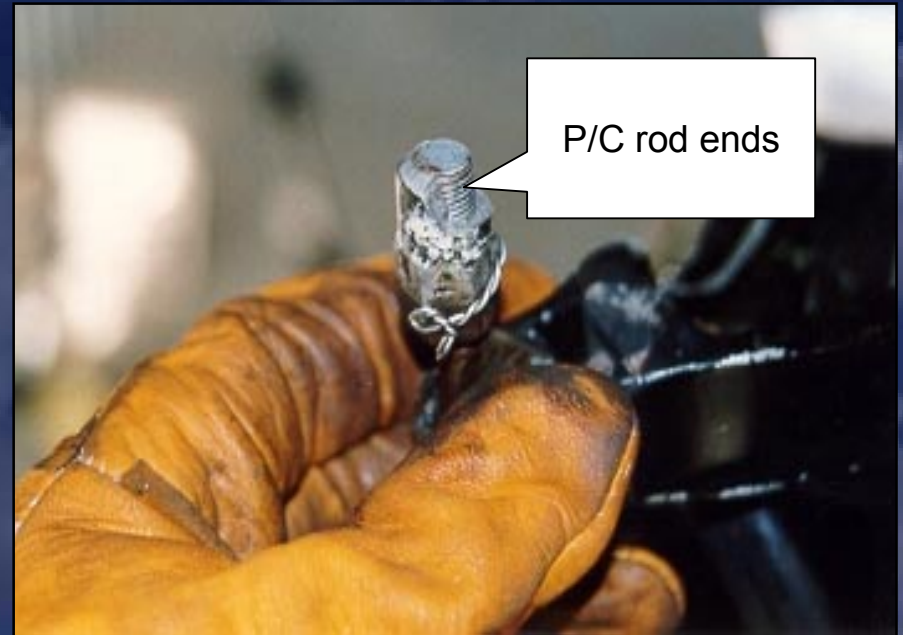
Main Rotor Controls

- Will collaborate other evidence
- Distorted or broken
- Direction of force will collaborate power on or off and autorotation

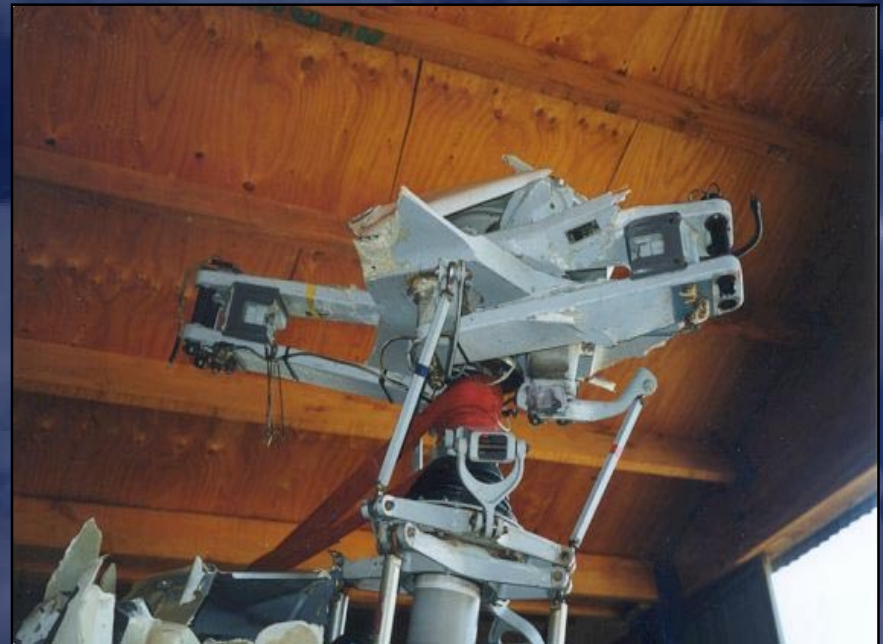
Main Rotor System

→ Damage to pitch horn, blade grip, mast assembly on semi-rigid and rigid systems = indication of high RPM

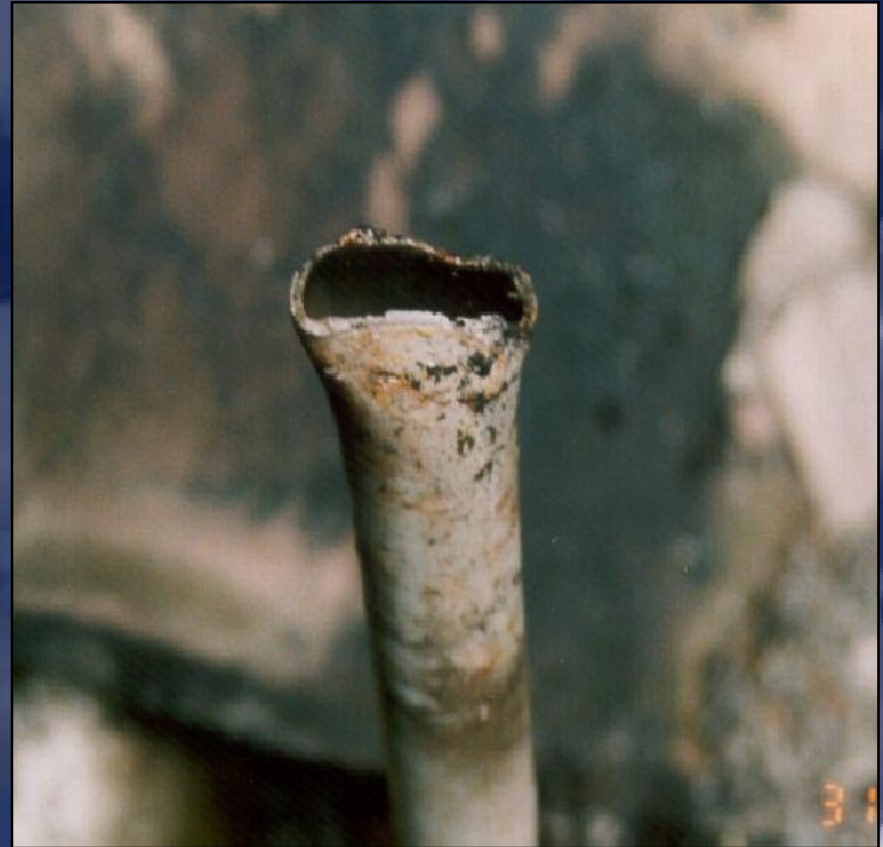
Main Rotor Controls

- Pitch change rod end attachment damage
- Static overload indications= high RPM
- “Necking” indications= low RPM
