Propulsion System Health Monitoring

An Insight into Wear Debris Analysis

ANZSASI Seminar, 6 June 2015
Auckland, New Zealand

Adrian Weller, NZ Defence Technology Agency
a.weller@dta.mil.nz

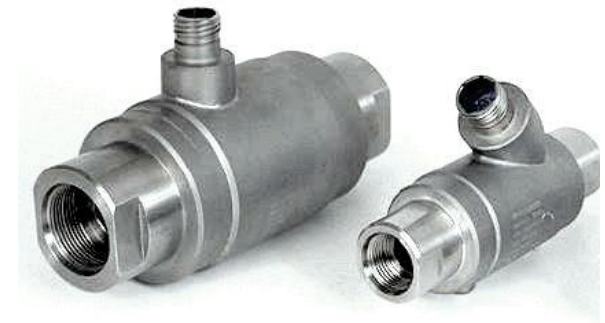
Wear Debris Analysis – Typical Aircraft Systems

- WDA employed by OEMs as a prime means of detecting oil-wetted component defects
 - In-line Magnetic chip detectors (MCDs) – indicating/passive
 - Filter debris analysis
 - In-line real-time particle detection (very limited application)

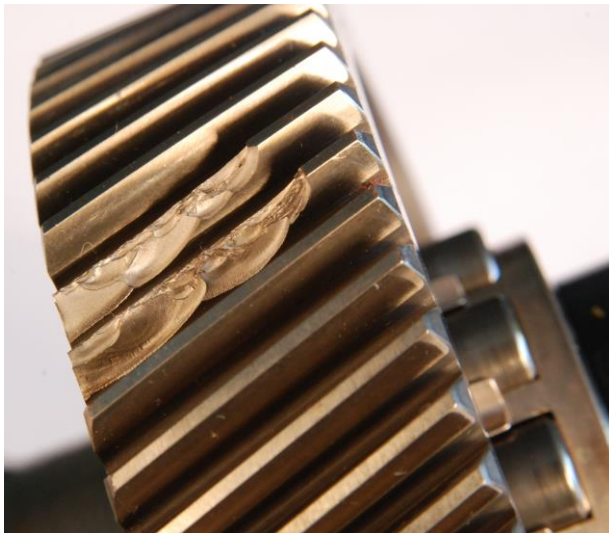
Case Study –Iroquois T53 gearbox

- Multiple MCD indications over period of 100+ hours – all assessed as ‘S’
- Final in-service MCD indication – serviceability check
 - Further MCD indication 3 min into 20 min hover check
 - Teardown found 2 fractured gear teeth, abnormal wear on gear surfaces
 - Wear debris precursors not detected

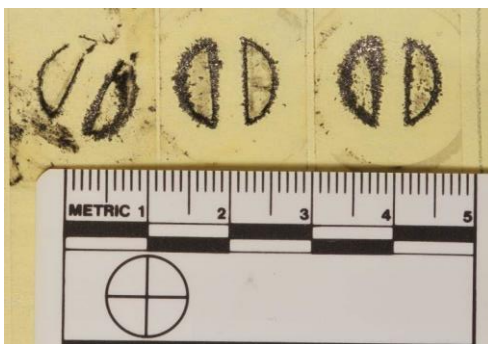
AGB Lower mag plug: Visual

- Aircraft deployed on operation
- Mag plugs checked – Accessory Gearbox Mag plug had debris
- Debris assessed as ‘fuzz’ and within limits – sample sent to DTA slow time for review
- Results:
 - ‘Fuzz’ shown to be fatigue spall flakes of bearing material
 - Particles <1/16th inch limit
- Engine changed

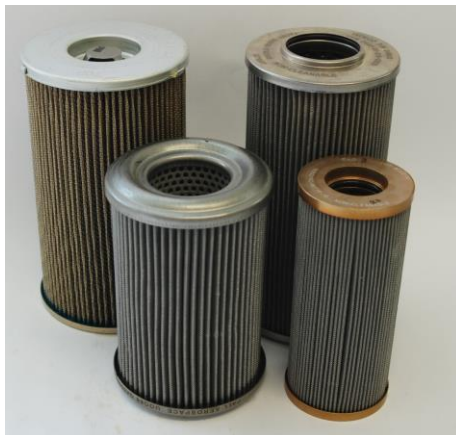
- Filters contain valuable wear debris data
- Potential to provide significant lead time to failure over MCDs alone [3]
- Advantage – applicable to all fleets without modification
- FDA under utilised
 - Time consuming
 - Limited guidance
 - Lack of capability to extract and analyse debris
 - Visual inspection of filter pleats inadequate to reliably detect bearing spall particles (200 μm)

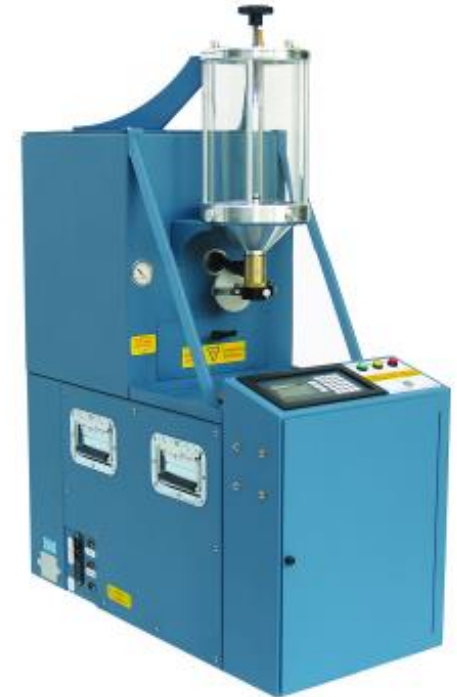
FilterCHECK FC400

- RNZAF procured GasTOPS FC400 in 2009 on DTA advice
 - Automatic debris extraction
 - Quantifies debris (Inductive sensor)
 - Produces debris patch for further analysis (if needed)
 - XRF system can provide aggregate composition (NOT used)
- DTA developed analysis processes/limits ^[4]
- RNZAF routinely sample filters for trending
 - Reduced inspection interval trending if defects detected

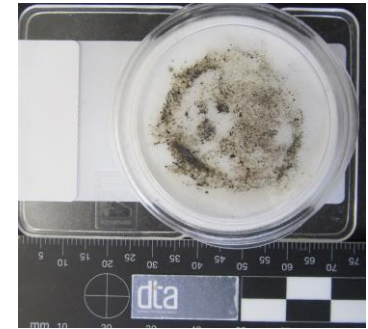
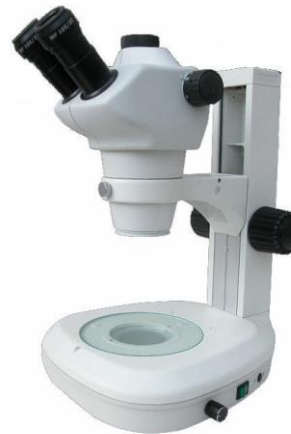
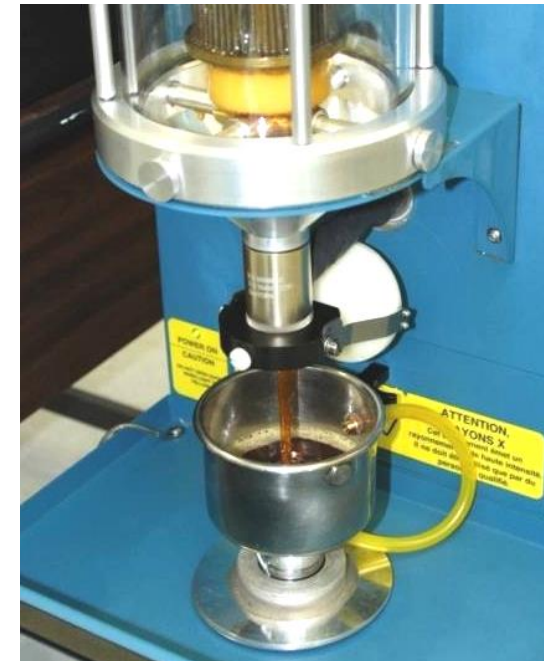
FilterCHECK FC400 –Debris Patch

- All debris collected above 60 μm in size on filter patches
- Debris Patches reviewed by RNZAF
 - Morphology inspection via optical microscope
- DTA developed visual inspection guidance used

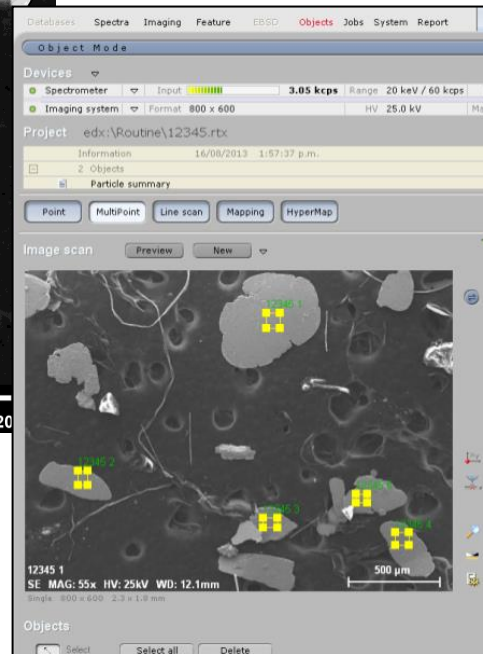
- Scanning Electron Microscope (SEM) - morphology analysis
- Energy dispersive x-ray spectroscopy (EDS) - elemental composition

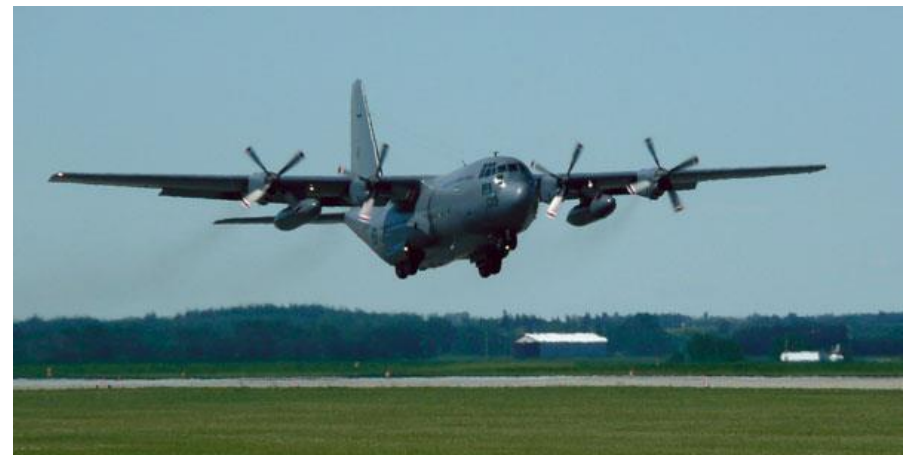
Case Study – T56 Reduction Gearbox (RGB) Pinion Bearing

- Cruise FL280
- No. 1 engine Torque and RPM fluctuations
- Excessive red fluid streaming from engine
- Engine shutdown – return to origin
- Un-eventful landing after 4 hours on 3 engines

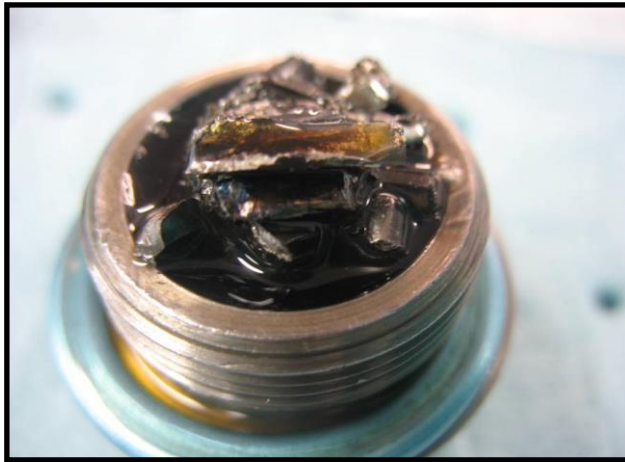
Magnetic Chip Detector Debris (Post Failure)

- SEM/EDS Analysis sample at failure:
 - M50 NiL bearing steel (AMS6278) – Match to pinion bearing
 - 9310 (AMS 6265) gear steel fragments
