ATSB: Some recent experience in underwater recovery

Presented by
Simon Grummett
Senior Transport Safety Investigator

1. Loss of control and impact into water
Cessna 172 aircraft
Maingon Bay, Tasmania
2. Recovery of a Westwind 1124A aircraft
near Norfolk Island
3. Lessons Learned from these activities

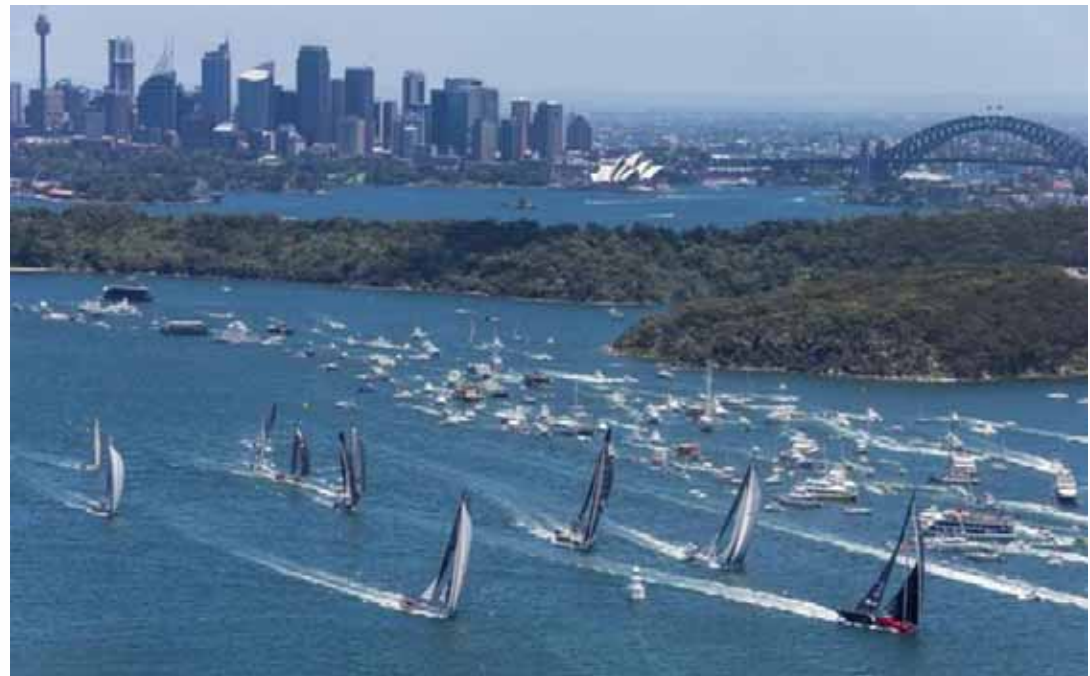
Recovery of a Cessna 172 aircraft from Maignon Bay, Tasmania

- 29 December 2014
- 2 POB, pilot and photographer
- Accident occurred during the sailing of the 2014 Sydney Hobart yacht race
- Aircraft was being utilised for aerial photography

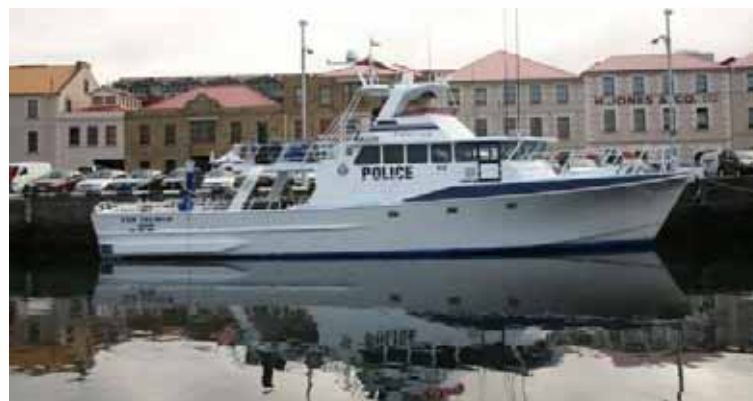
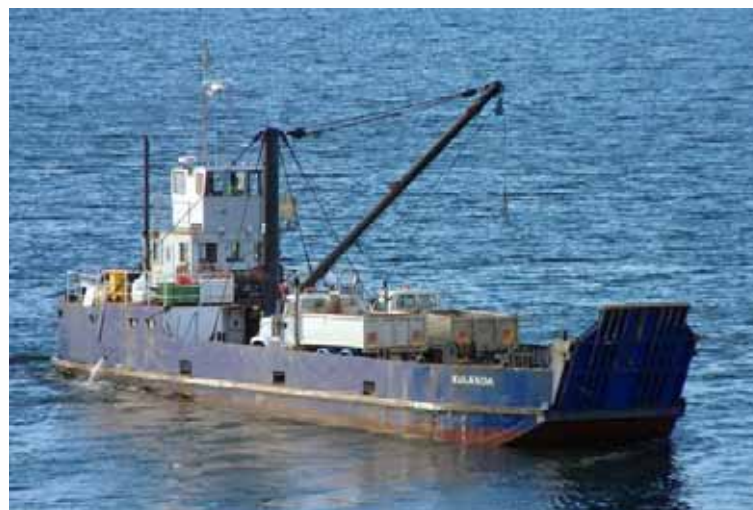
PV Van Diemen

- 22.58m LOA
- 2 tonne deck crane (tender launch)
- 8 crew
- 98.76t gross tonnage
- Class 2B (limited to 200nm to seaward)
- Range 1,000nm

MV Kulanda

- 32.35m LOA
- derrick capacity 8t / 6t
- motorised landing vessel
- 95t deck capacity
- landing vessel capable of negotiating shallow waters 1.5m draft

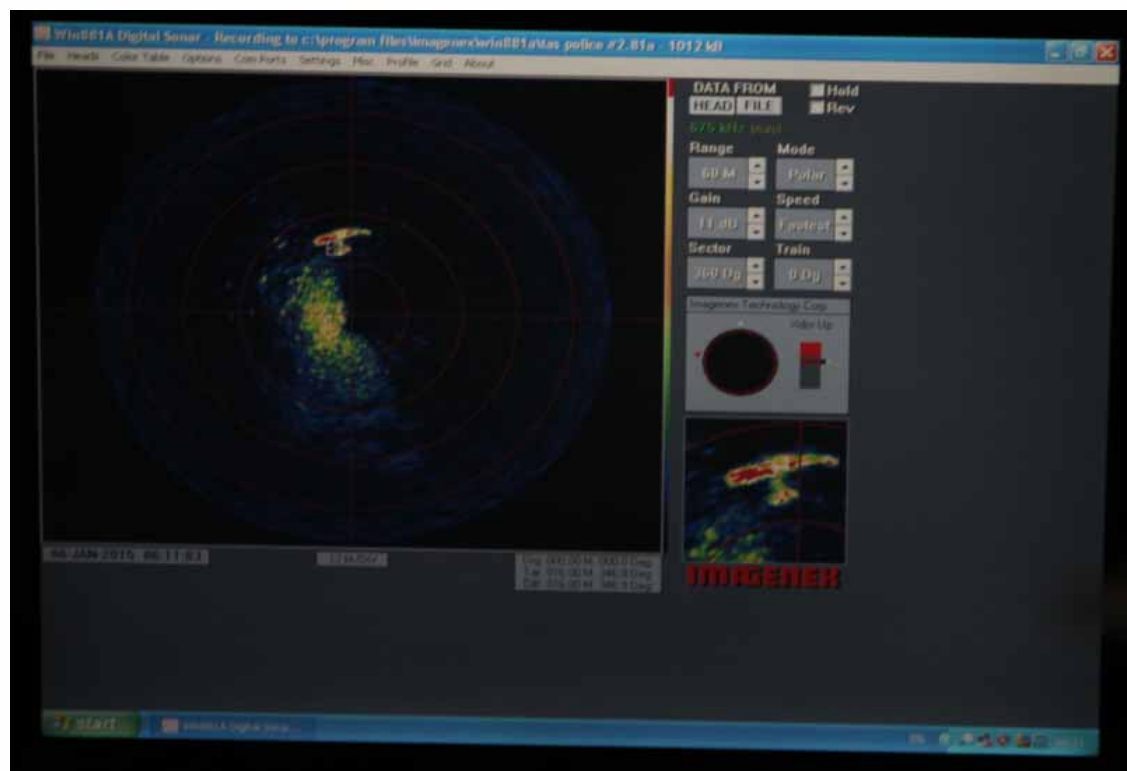
Recovery attempt #1

- 31 Dec 2014
 - PV Van Diemen Falcon ROV
- Aircraft located by ROV sonar in 92m of water
- Aircraft rigged, however lifting equipment failed at 30m water depth
- Photographer's camera successfully recovered from the sea floor using the ROV

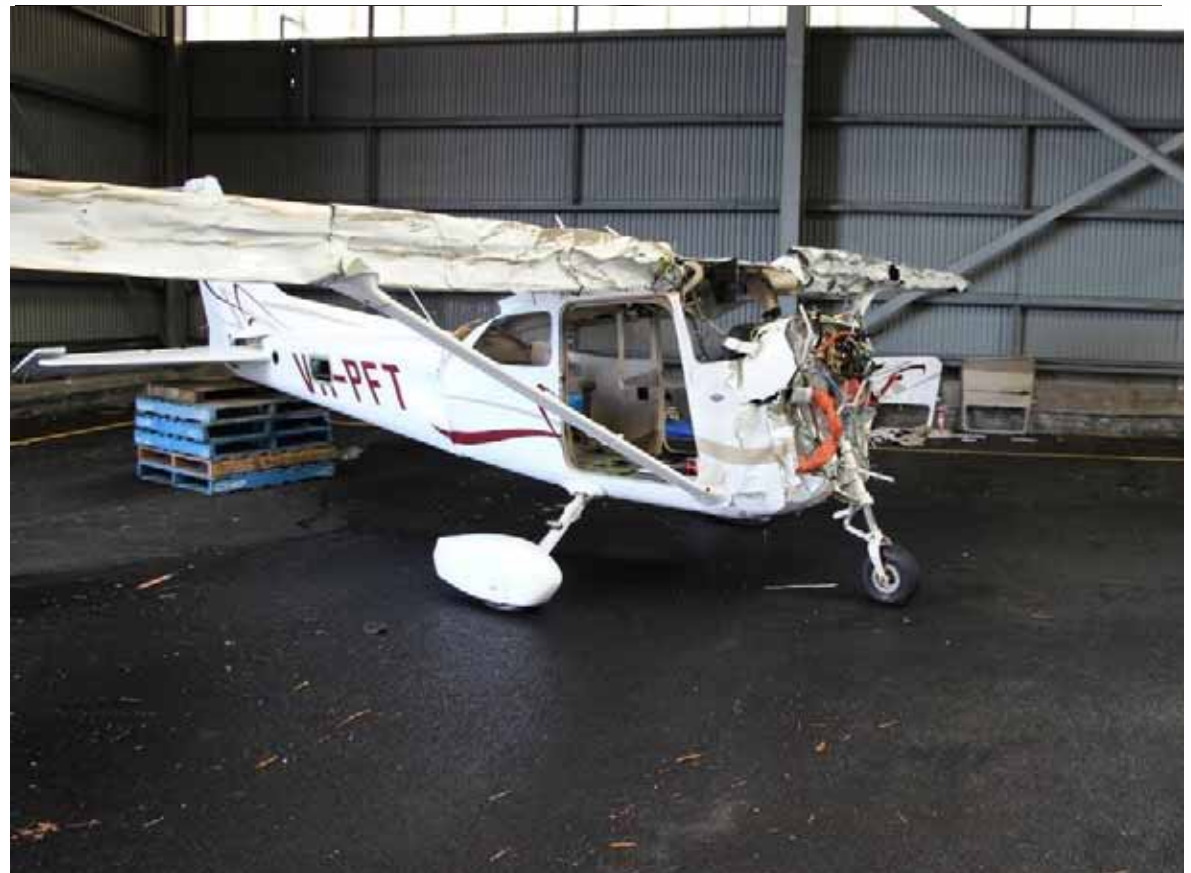
Recovery attempt #2

- 6 Jan 2015
 - PV Van Diemen
 - Falcon ROV
 - Kulanda barge
- Aircraft relocated using ROV sonar and rigged using lifting strops
- Success with the lift, recovery and stowage onto Kulanda working deck

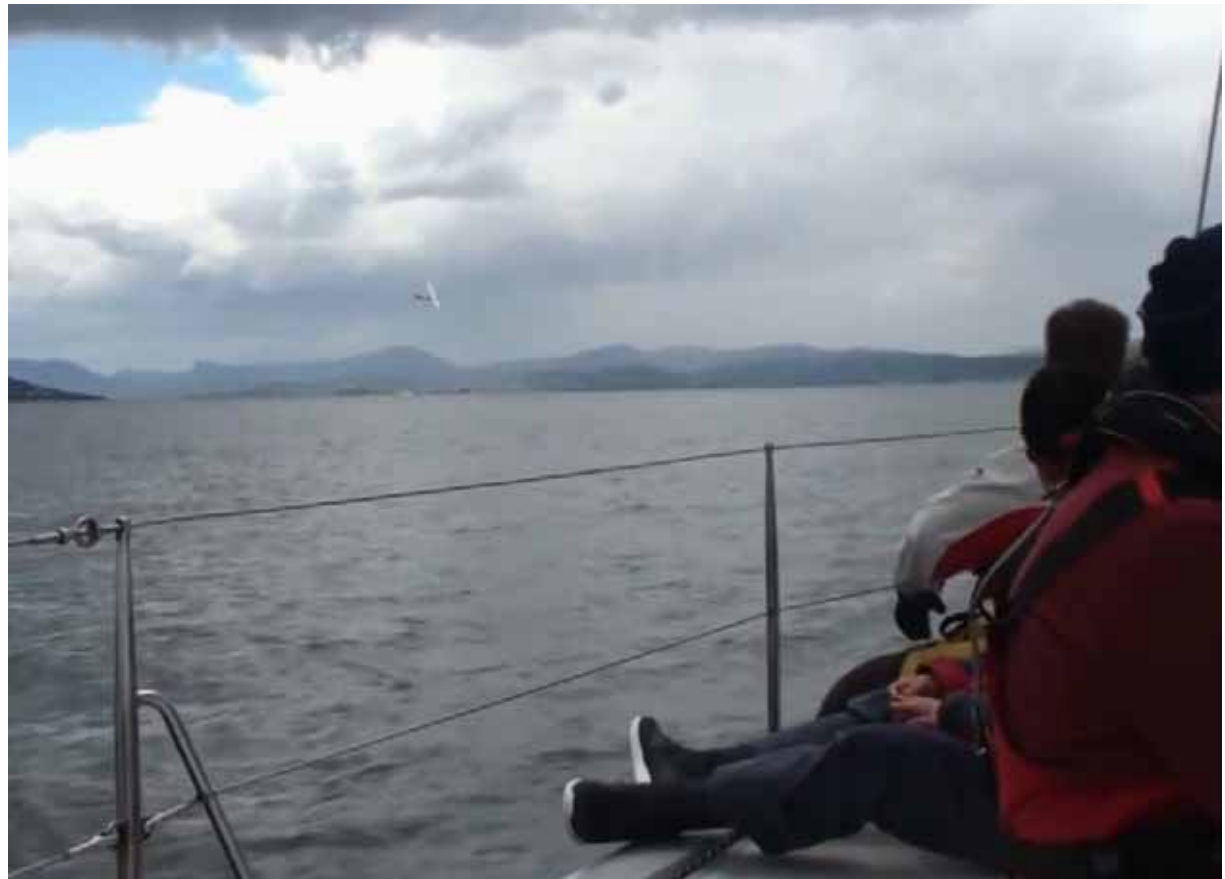
Recovery of a Cessna 172 aircraft from Maignon Bay, Tasmania

Summary of VH-PFT recovery operation from 92m water depth

- The Tasmanian Police Service funded and coordinated the recovery operation. ATSB tasked as specialist advisors to the Police Service.
- Dive Works, a Victorian-based ROV and Commercial Diving Company, supplied equipment and personnel

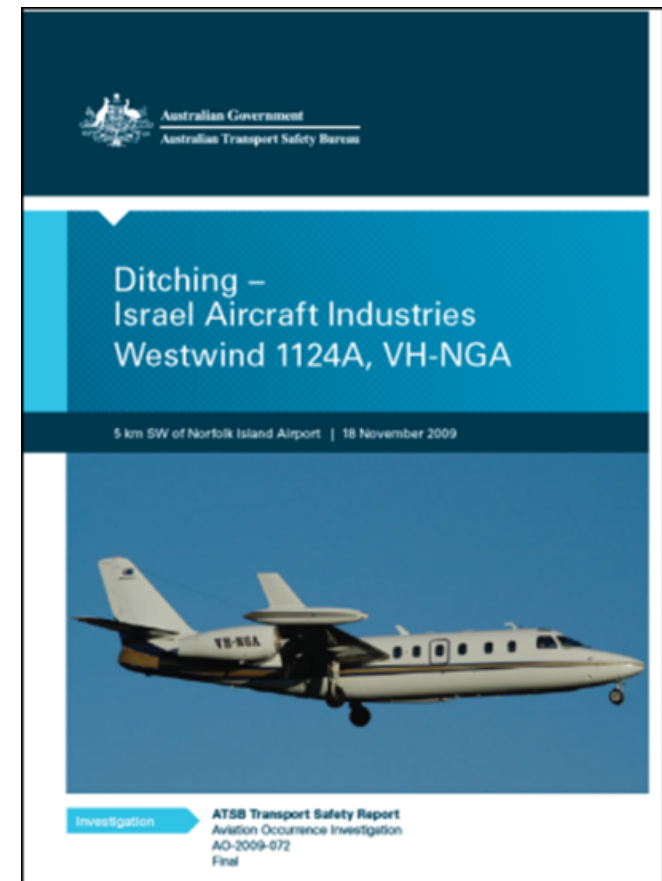
Recovery of a Westwind 1124A aircraft near Norfolk Island

- Pel-Air Westwind 1124A aircraft, VH-NGA
- 2 flight crew and 4 PAX
- Sydney – Norfolk – Apia – Norfolk
- Weather conditions deteriorating
- 4 attempts at landing
- Flight crew elected to ditch the aircraft

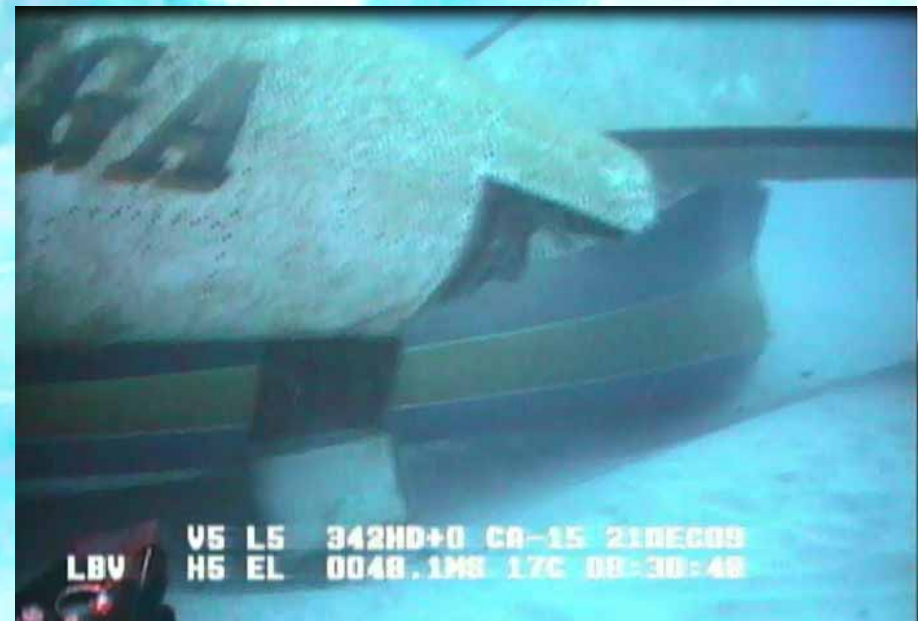
- *Dec 2009 wreckage located 4 km West of Norfolk Island:
S 29 03.2700
E 167 52.4160*
- *ATSB Benthos hydrophone used to
locate and triangulate ULB signal*
- *water depth: 48m*
- *VicPol Seabotix LBV300 ROV survey
confirmed that the aircraft had
broken into two main pieces*
- *Tail section containing flight recorders
was intact*

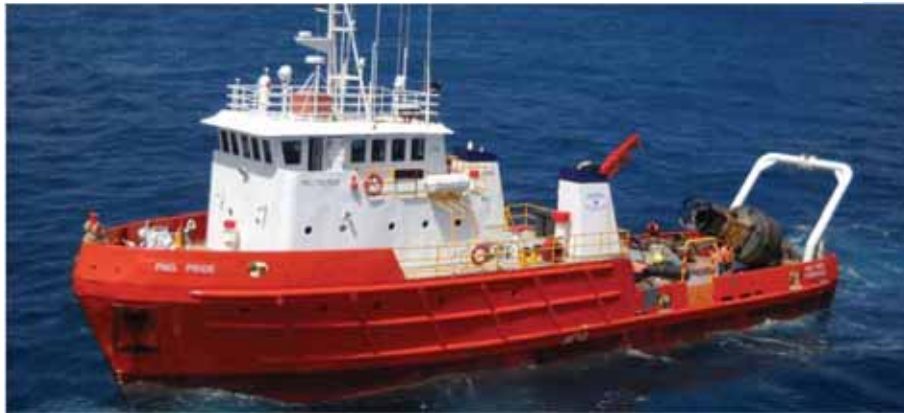
PMG Pride

Class: ABS A1 AMS Circle E

LOA: 31.48m

Deck space: 110m²

Useful Equipment: 10 t A-frame and 15 t winch
1.75 t deck crane
bow and stern thrusters
3 point mooring

Accommodation: 22 person

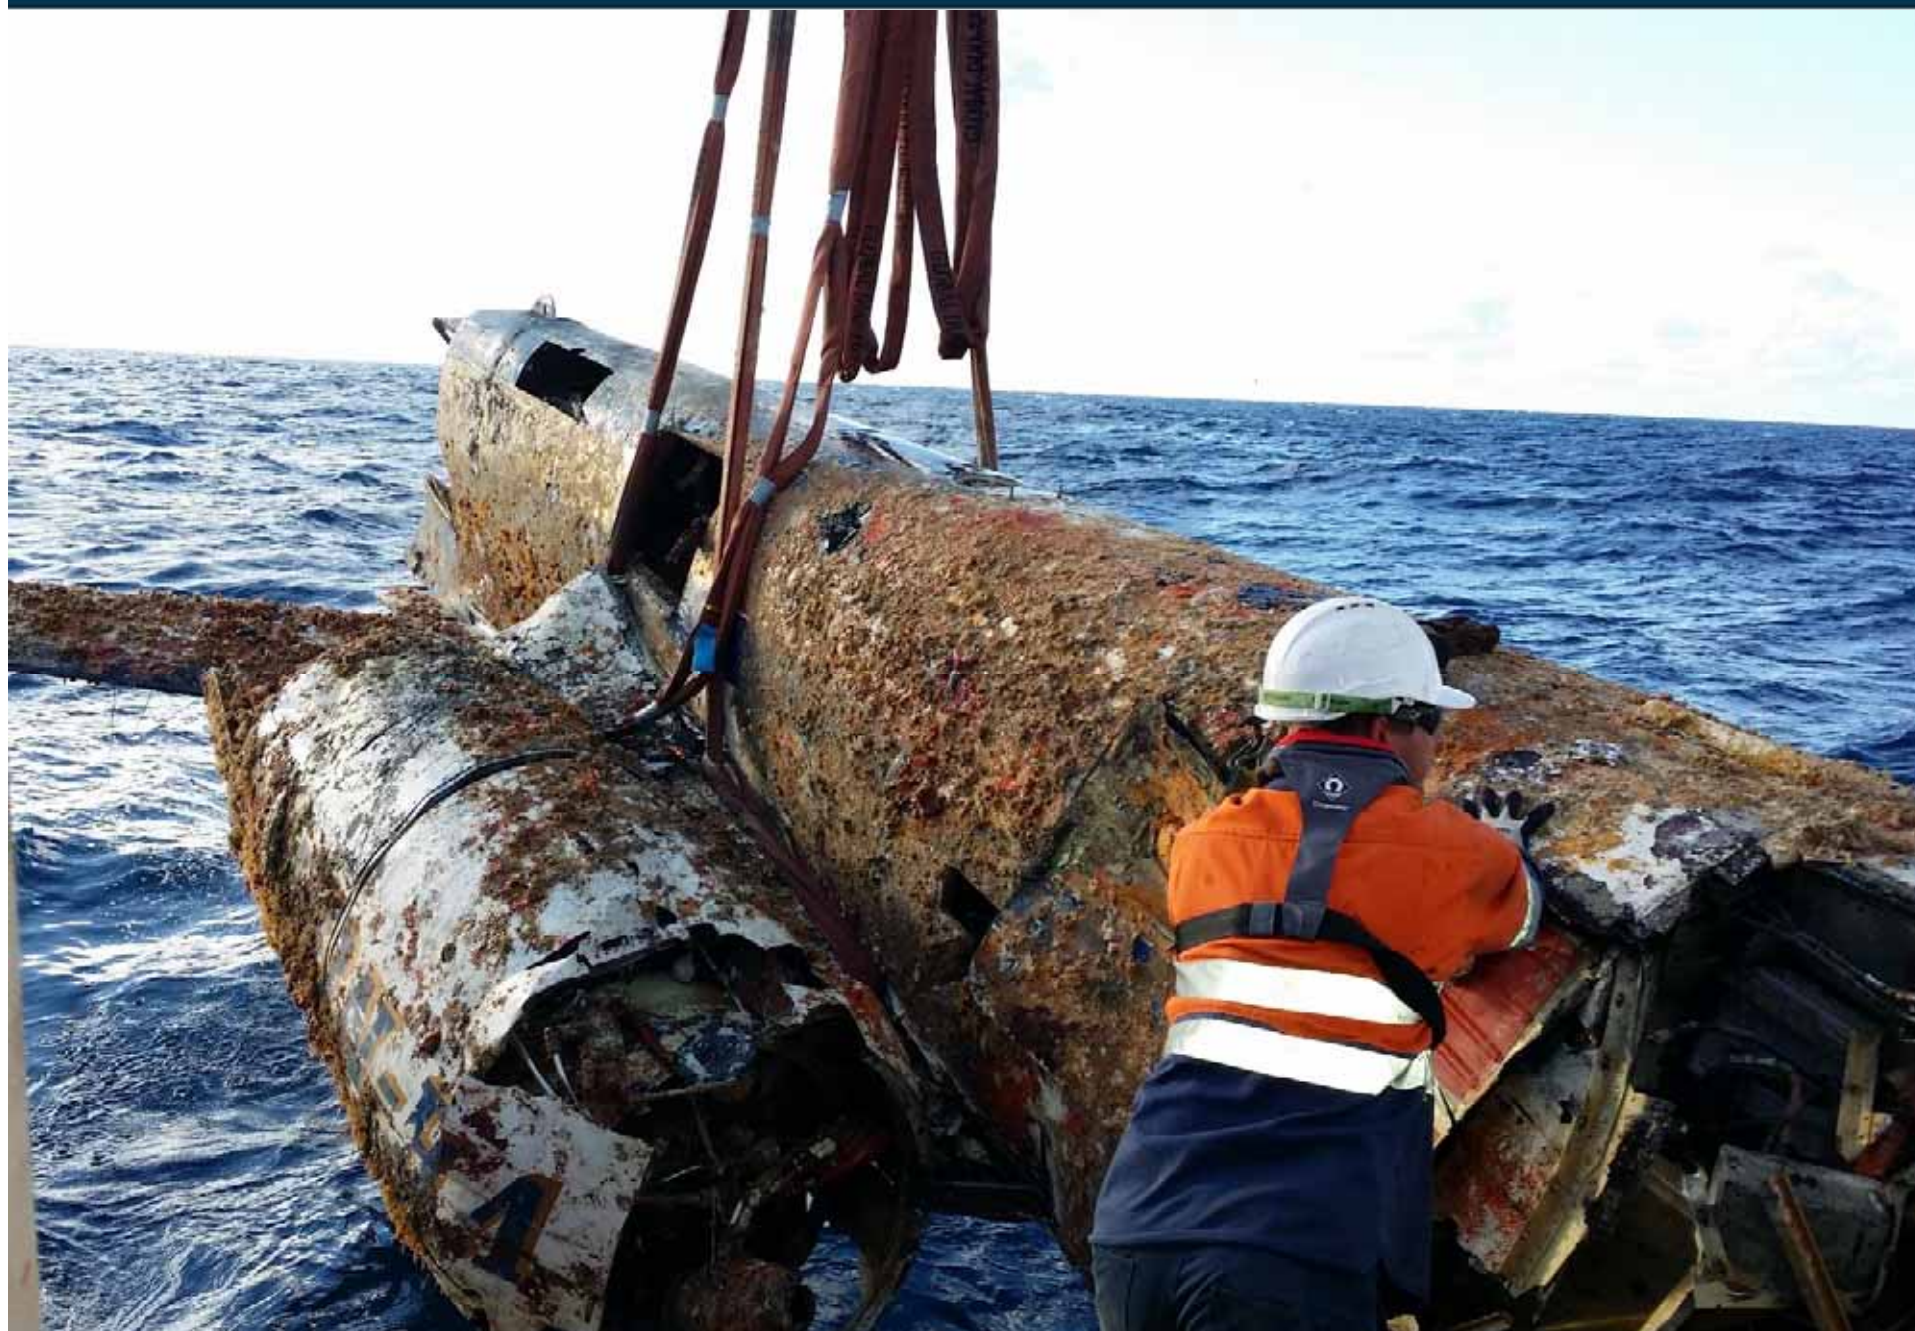
Flight data recorder (FDR)

- Loral Data Systems F1000
 - solid state memory modules
 - 5 parameters:
 - elapsed time
 - pressure altitude
 - indicated airspeed
 - magnetic heading
 - vertical acceleration
- About 100 hours of data was recorded, including the entire accident flight
- **data OK**

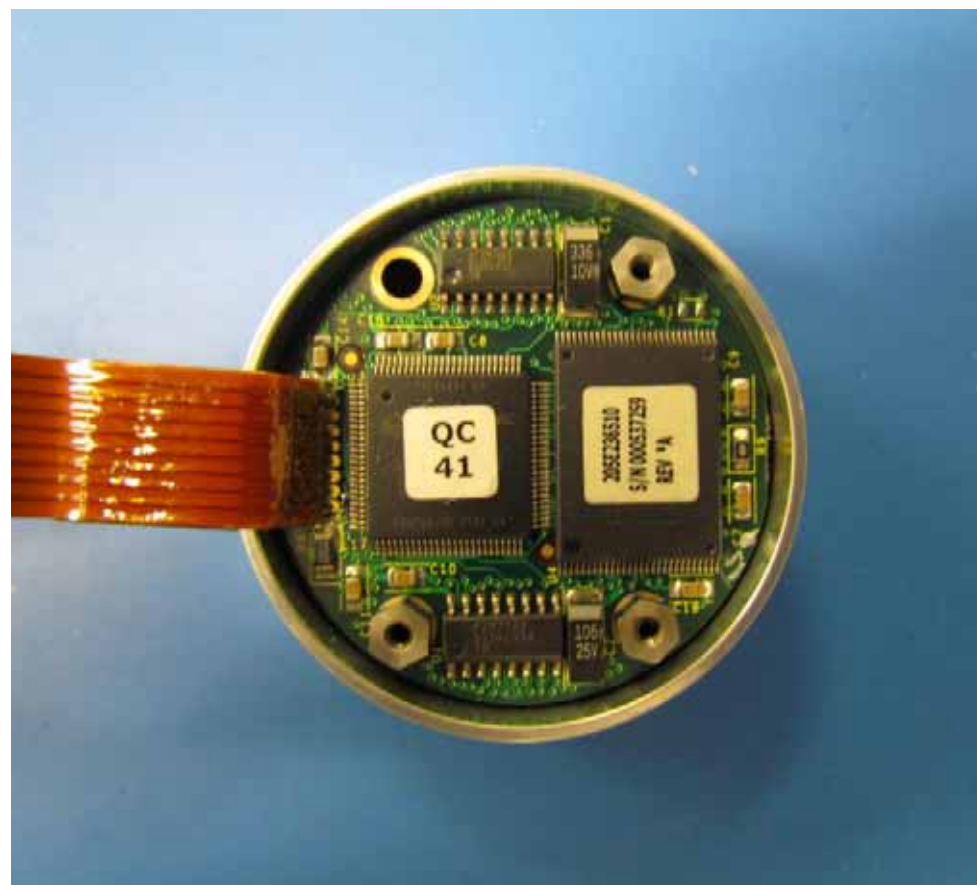
Cockpit voice recorder (CVR)

- L-3 FA2100
- solid state memory modules
- 120 mins hours of audio information
- endless loop principal
- Audio inputs
 - pilots' headsets
 - cockpit area microphone
- **Data was successfully recorded and downloaded OK**
