# Behind the scene

## The 737 LAT accident

**Presented by**  
Angus Mitchell  
Chief Commissioner

ATSB aviation msg: At 1616 WST, an air attack supervisor called in an emergency that a US registered Boeing 737 (Bomber 139) air tanker had collided with terrain while conducting firefighting operations. 2 POB (pilots) extracted alive. Occurred in Fitzgerald River National Park (between Esperance and Albany WA). Registration N619SW, operated by Coulson Aviation. ATSB is investigating. MikeW

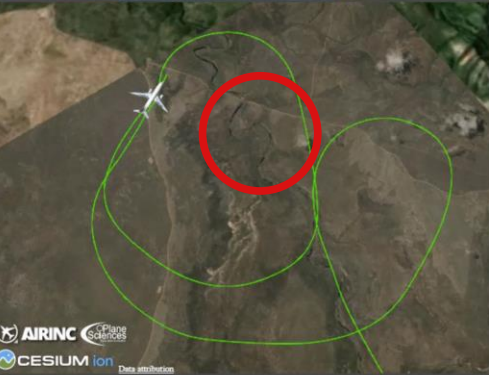
This animation has been developed from data obtained during the investigation and is for illustrative purposes only.

FIRE RETARDANT DROP 2  
AIRINC Plane Sciences  
CESIUM ion Data simulation
