AIRCRAFT ACCIDENT REPORT

OCCURRENCE NUMBER 01/44

BELL 204 (UH-1F)

ZK-HVY

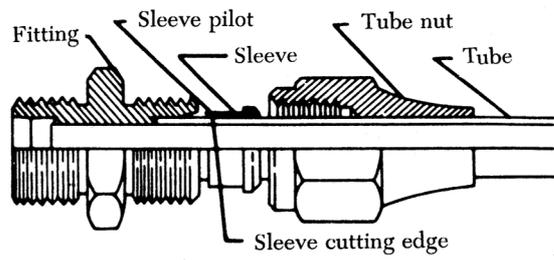
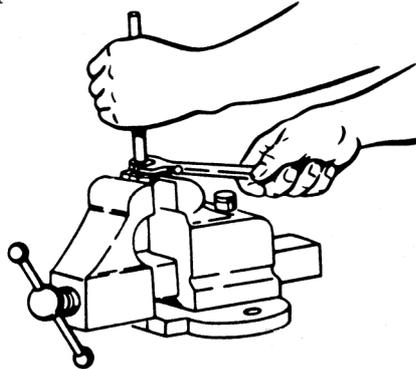
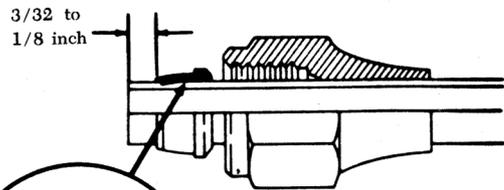
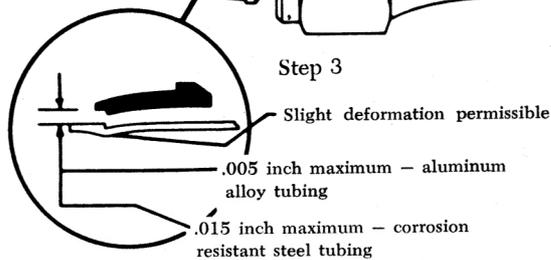
Figure A2
Presetting MS flareless fitting

- 2.5 In any case, it is reasonable to expect that an aircraft maintenance engineer would be familiar with the characteristics and limitations of the MS flareless fittings and would not attempt to overtighten a fitting to stem a leak. The overtightening and filing are more likely to have been performed by somebody with mechanical skills, but with no training in aircraft maintenance. The simple remedy is to replace a leaking line; the components are readily available and are not expensive. The overtightening could have been done at any time in the past, and once the leak had been remedied, could have gone undetected until the failure occurred.

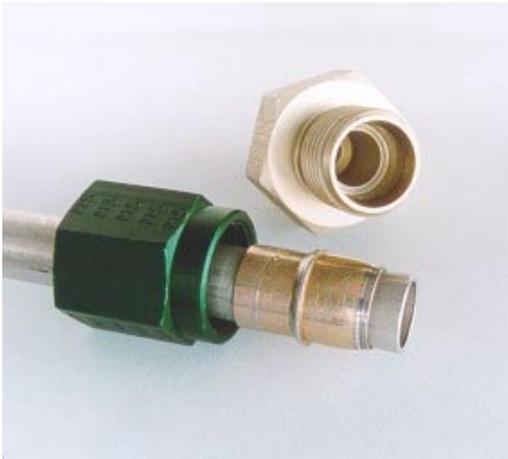
Sleeve and nut configurations differ slightly from those illustrated in Figures A3 and A4.

Figure A3
MS flareless fitting components
(Tube, MS21921 nut, MS21922 sleeve,
MS21916D reducer)

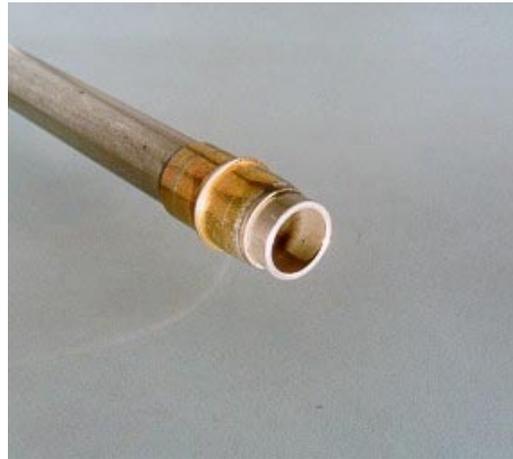
Figure A4
Properly formed tube end (new)
(Permissible deformation is visible inside
tube end)
