AO-2008-070, In-flight upset  
154 km west of Learmonth, WA  
7 October 2008, VH-QPA  
Airbus A330-303

Based on ATSB *Interim Factual Report*  
(6 March 2009) available at  
[www.atsb.gov.au](http://www.atsb.gov.au)

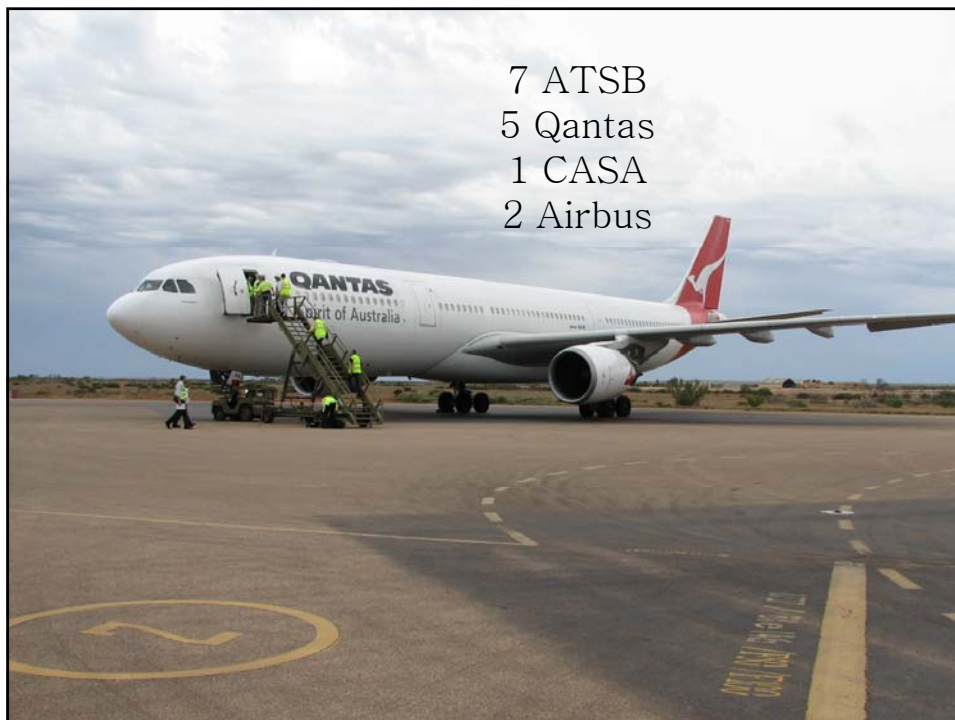
- Cabin inspection (impact damage)
- Aircraft inspection (no damage)
- Cargo / loading (no problems)
- Recorded data
  - preliminary FDR, QAR, CVR analysis
  - post flight report (PFR), maintenance data
  - (indicated ADIRU 1 problem)
- Functional testing
  - ADIRU 1 removed
  - (no problems found with other systems)
