# Degraded Dampers

## A Case study in Engine Torsional Vibration

2009 Asia – Pacific Regional Seminar

Justin Williams  
Applied Vehicle Systems  
Defence Technology Agency

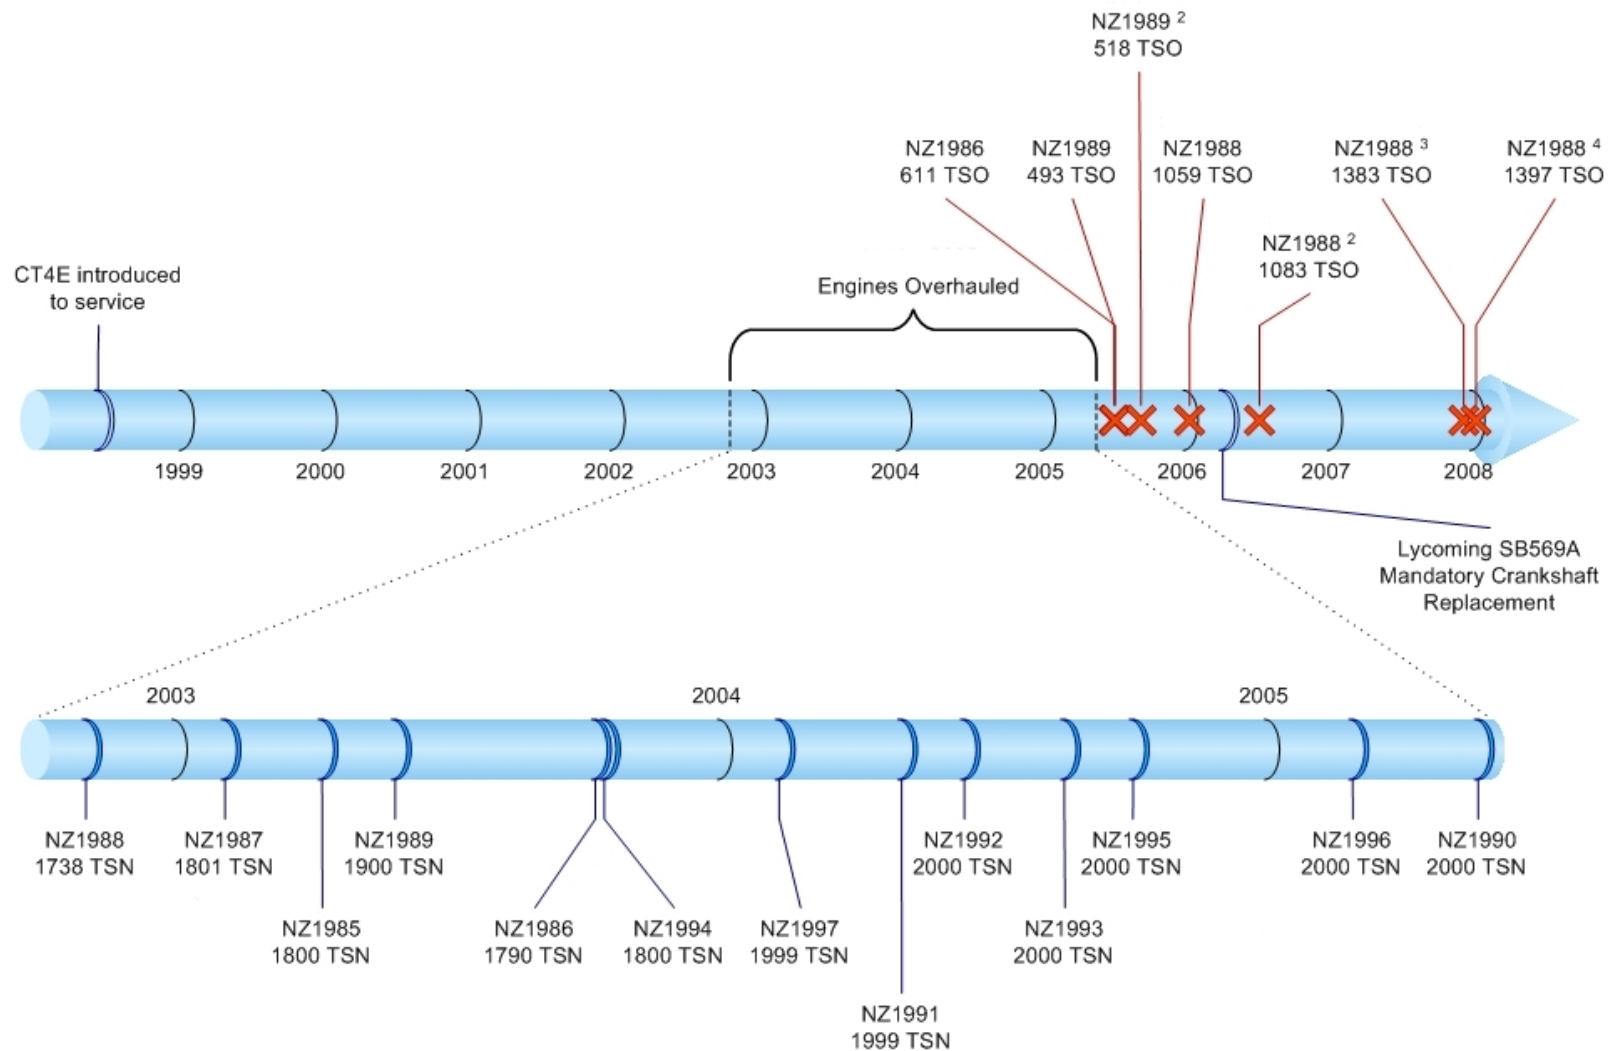
# History, 1 of 2

- Accumulated 6 in-flight failures of engine driven fuel pump (EDFP) couplings
- Resulting 2 Mayday and 4 Pan calls
- 1 cracked coupling found during inspection
- Failures at substantially less than normal life

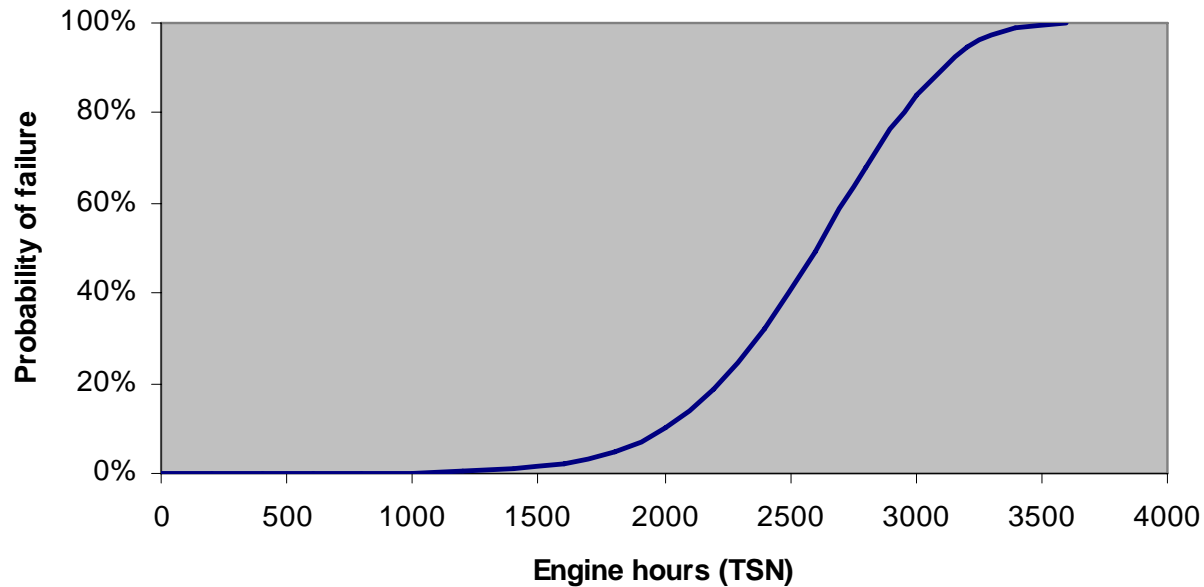
# History, 2 of 2, Weibull analysis

**Probability of first EDFP coupling failure**  
**beta=7, eta=2750**

- Lycoming recommended TBO, SI1009AS, 1400 hours
- Lycoming approved TBO, 1800 hours
- Extended TBO, 2000 hours

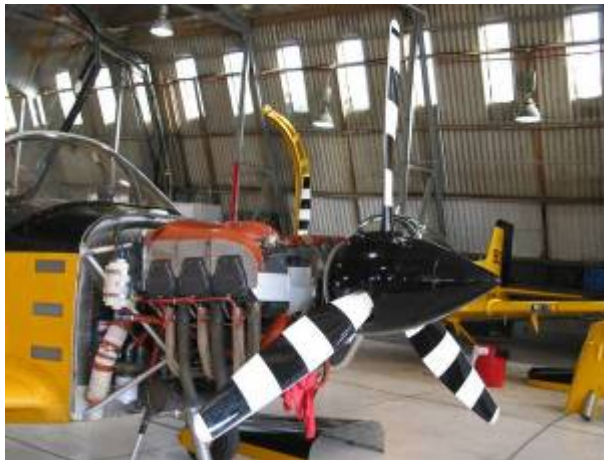
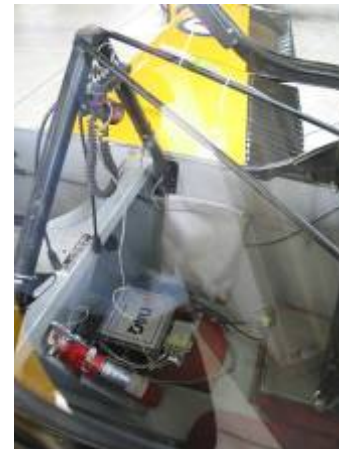
- Assess the 3 failure aircraft for differences from un-failed fleet to identify potential sources of torsional loading
  - Engine run up in increments from idle to full power
  - Parameters recorded
    - EDFP vibration (3-axis linear)
    - Fuel pressure at EDFP inlet, outlet and auxiliary pump outlet
    - Fuel temperature (manually recorded)

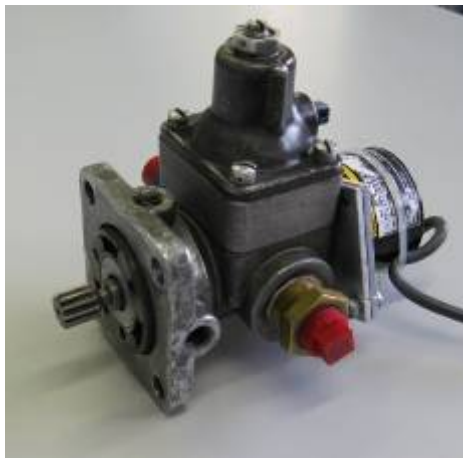
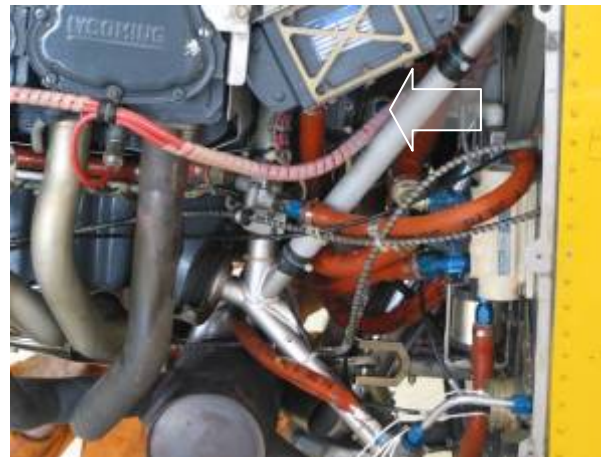
- Addition of torsional vibration measurement to examine EDFP coupling motion
- Installation of a modified EDFP
  - Omron optical rotary encoder, attached to pump rotor and installed in a modified pump
  - EDFP run dry and fuel bypassed. Fuel supplied by backup electrically driven pump
  - Rotary encoder outputs 100 pulses per revolution (1 pulse per 3.6 degrees)

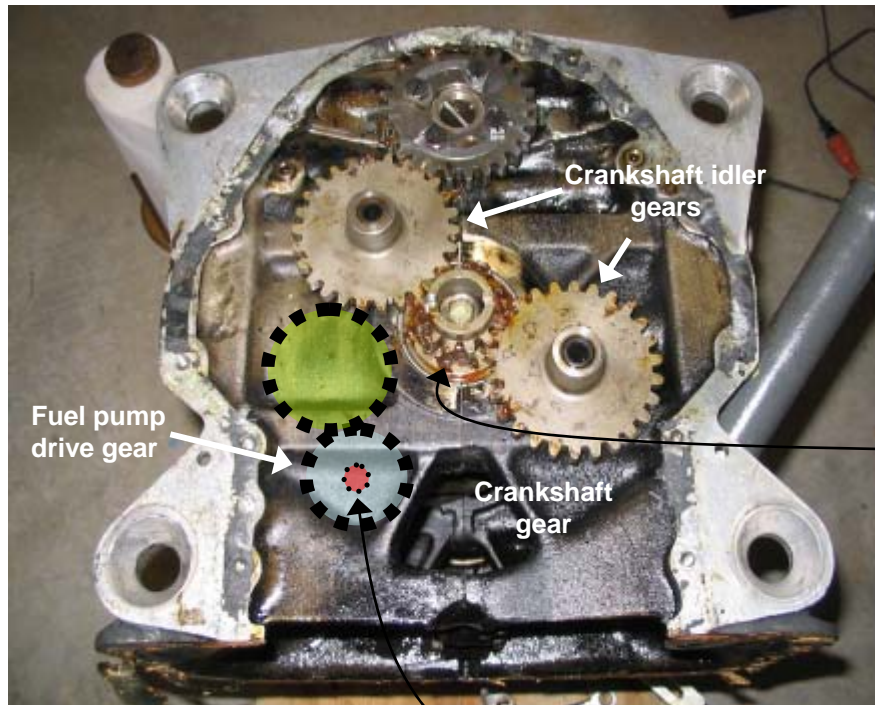
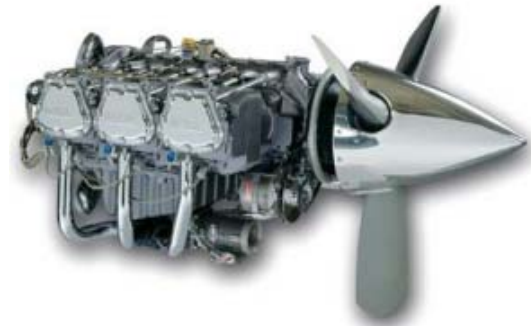
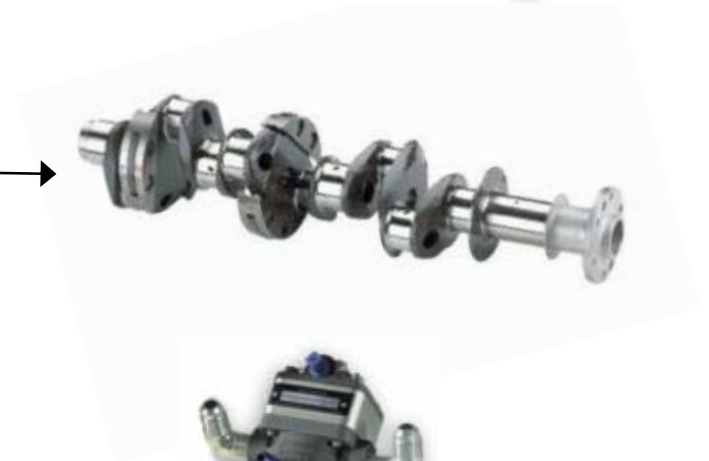
- Torsional vibration from the engine crankshaft is transmitted through the accessory gears to the EDPF

- Engine selected which had experienced 4 EDFP coupling failures
- Left hand magneto drive (torsional) damper had failed

- Excessive wear on accessory drive train
- Gear backlash results are not repeatable

- Crankshaft and counterweight bushes were worn beyond serviceable limits. One bush, 5 times over the serviceable limits
